**Re: Land Use Permit W2017D0004
Mining & Associated Activities
Ekati Diamond Mine, Northwest Territories**

ENVIRONMENTAL INSPECTION REPORT

Permittee:	Dominion Diamond Ekati – Misery Underground	Inspection Dates: March 19 th , 2019
------------	---	---

Location(s) Inspected:	The Ekati Mine Misery Underground Project and Misery Camp.
------------------------	--

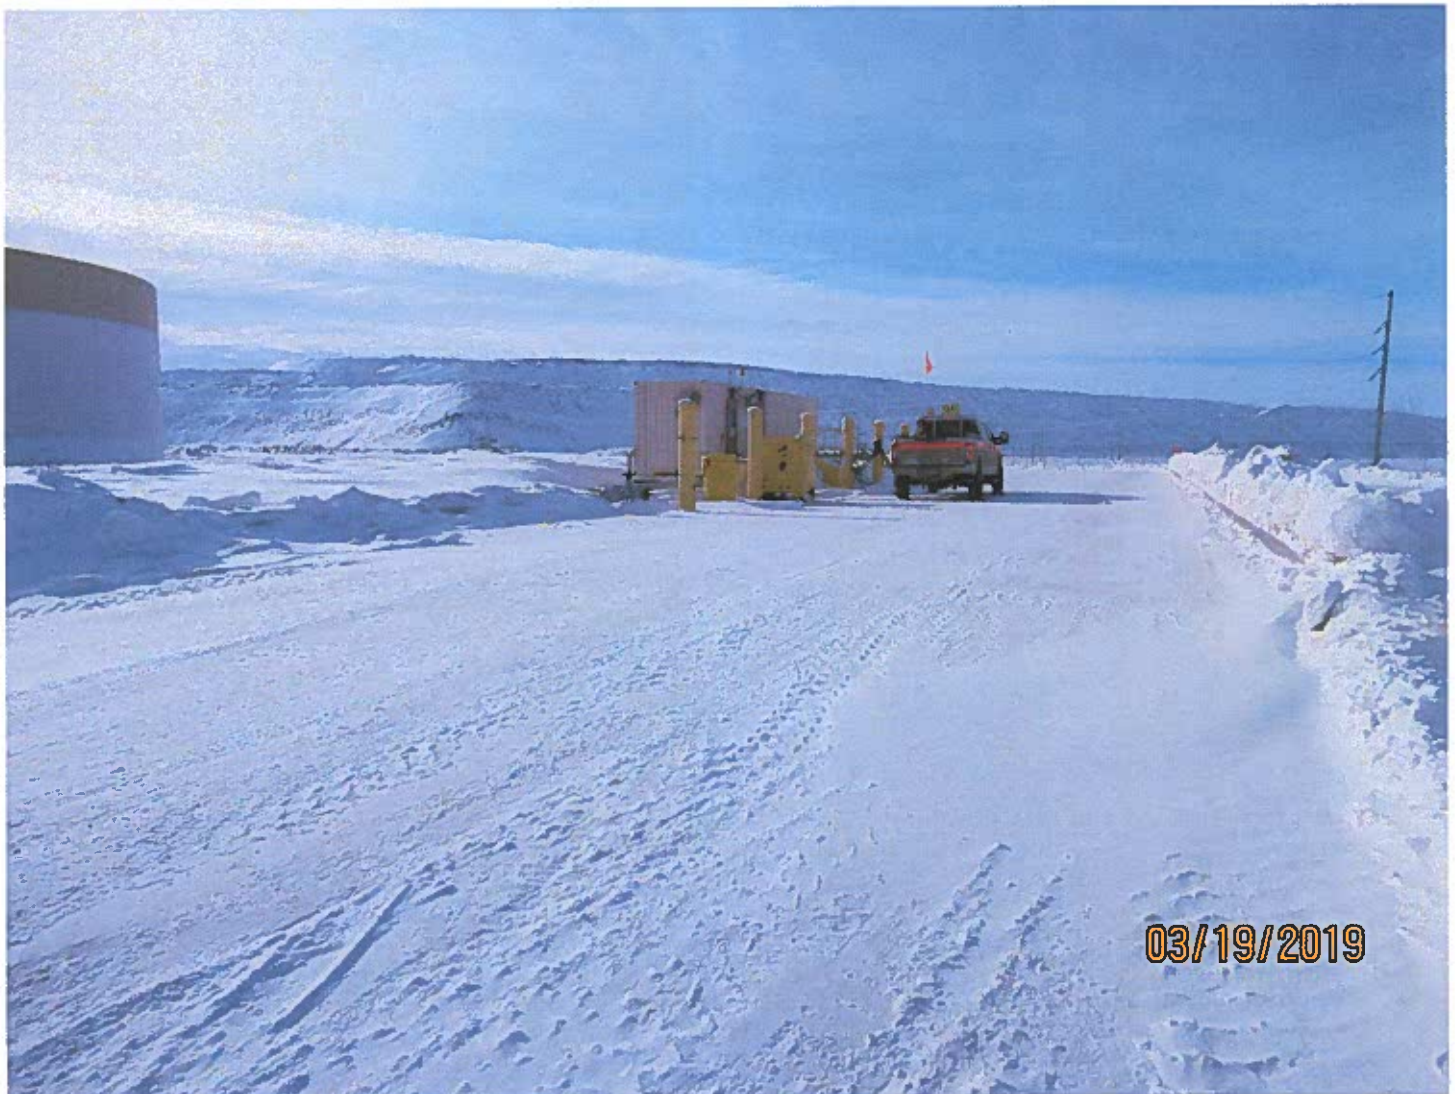
Photo #14 - W2017D0004 MUG Project
The camp bulk fuel offload station appeared to have been scraped clean with equipment.

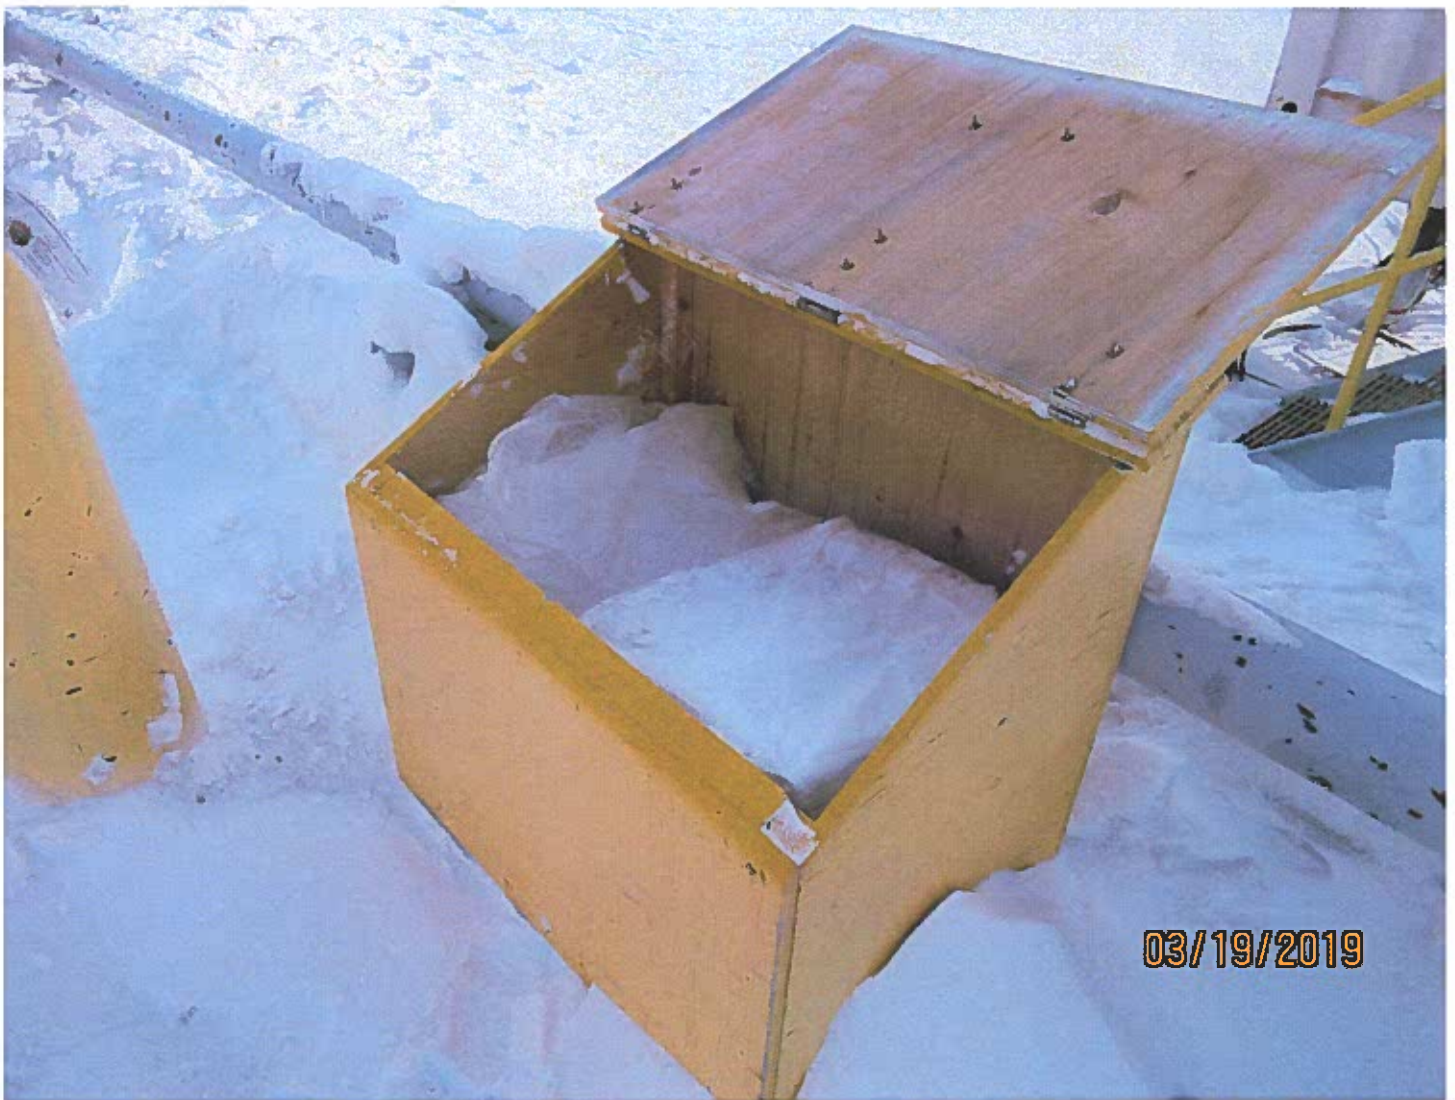
Photo #15 - W2017D0004 MUG Project
There were readily available spill response materials at the bulk fuel transfer facility.

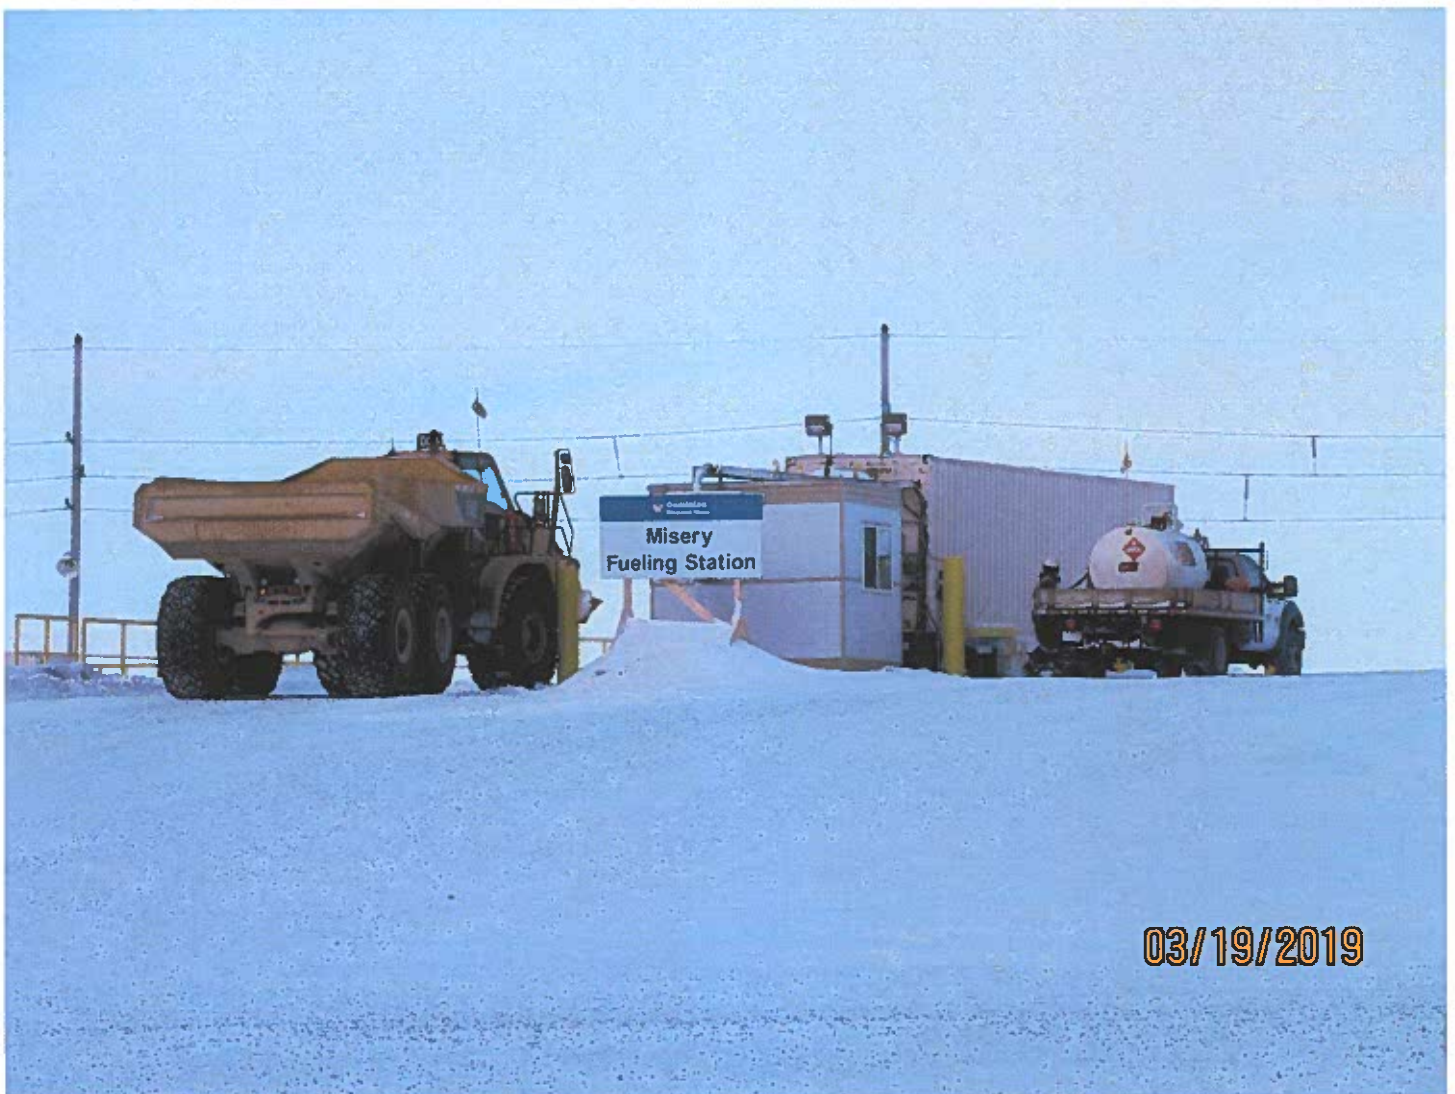
Photo #16 - W2017D0004 MUG Project
The Misery Camp fueling station.

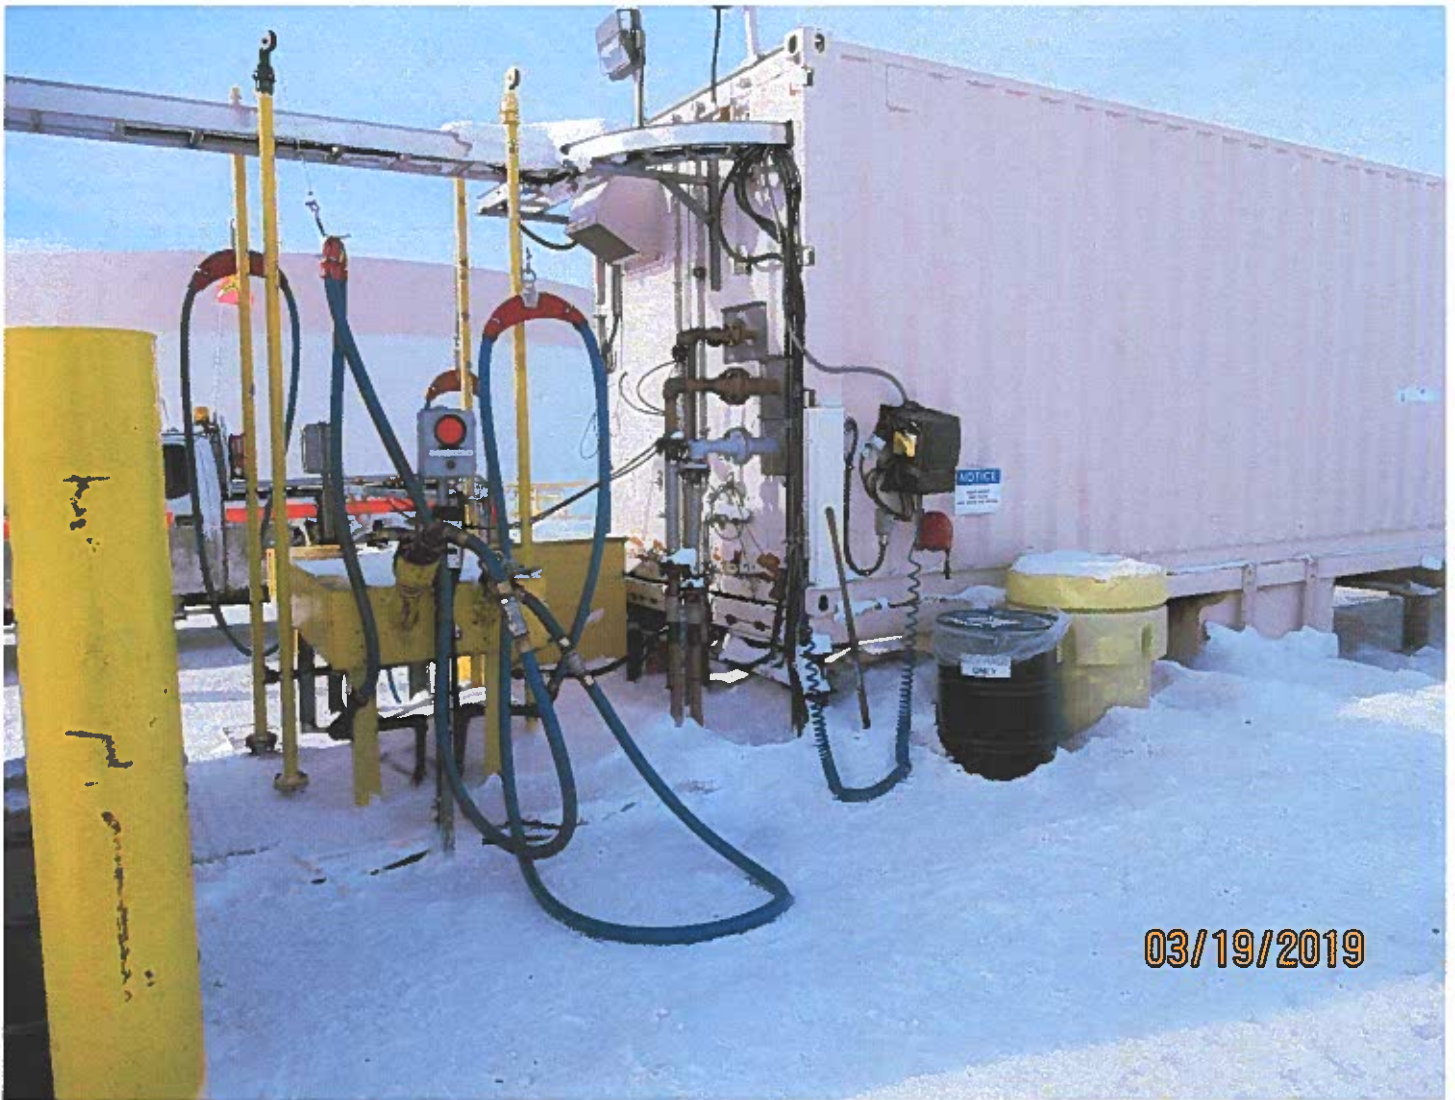
Photo #17 - W2017D0004 MUG Project
Nozzles were in secondary containment and there were adequate clean up & response materials.

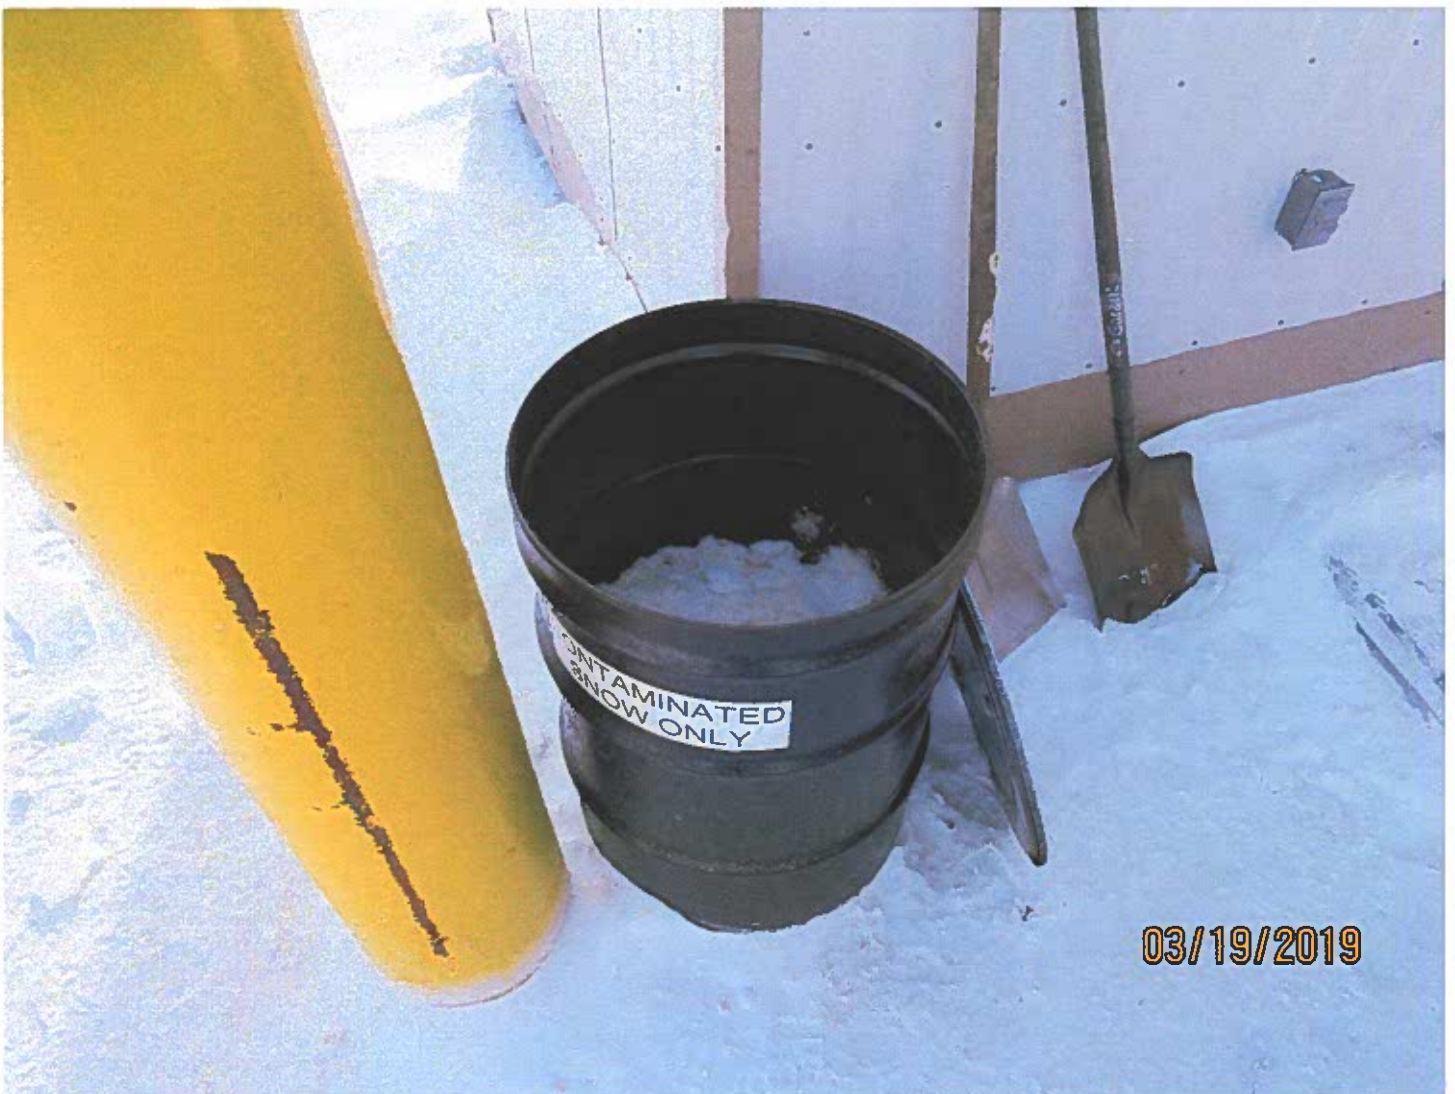
At the Misery Camp fuel transfer stations, it appeared snow was being regularly cleared with equipment and hydrocarbon impacted snow was being cleaned up and placed into containers (Photos #13-#18). There were adequate and readily available spill response materials available at the fuel transfer stations and throughout the land use area. Only a minor amount of impacted snow was noted in the area and personnel must use secondary containment when conducting fuel transfers in the land use area (Condition #32). Fuel transfer areas must also be diligently monitored for spill and spills must be cleaned up as they occur (Condition #38).

Photo #18 - W2017D0004 MUG Project
Hydrocarbon impacted snow was being cleaned up and placed in properly labeled containers.

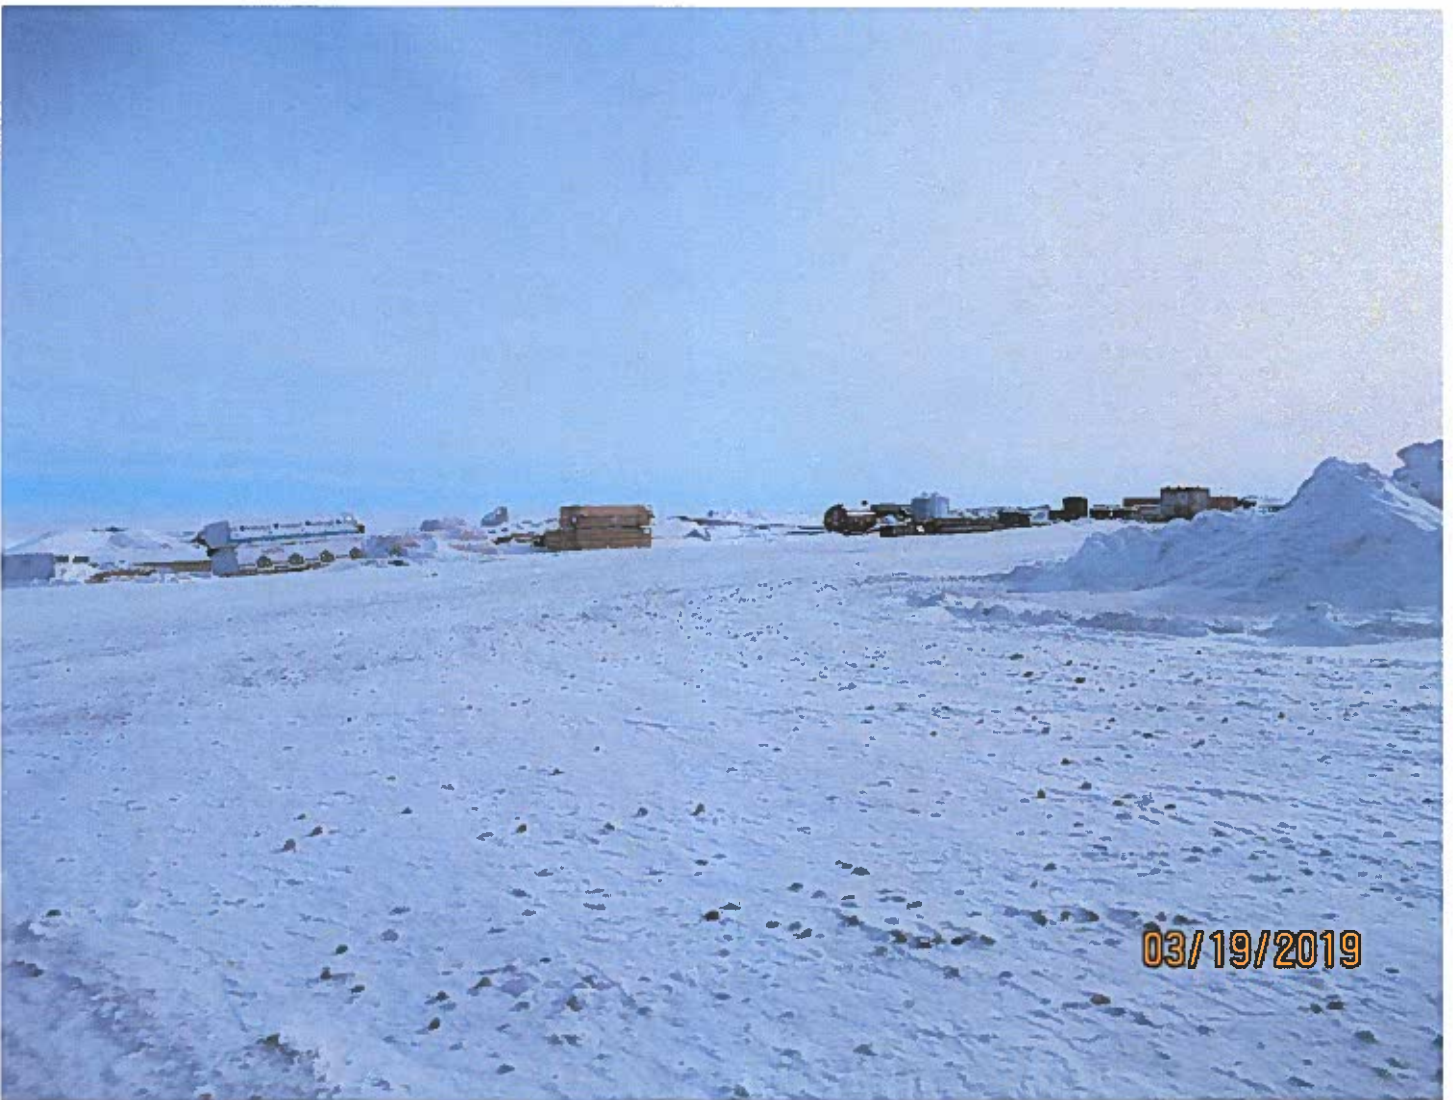
Photo #19 - W2017D0004 MUG Project
The underground laydown at the top of the Misery Pit ramp.

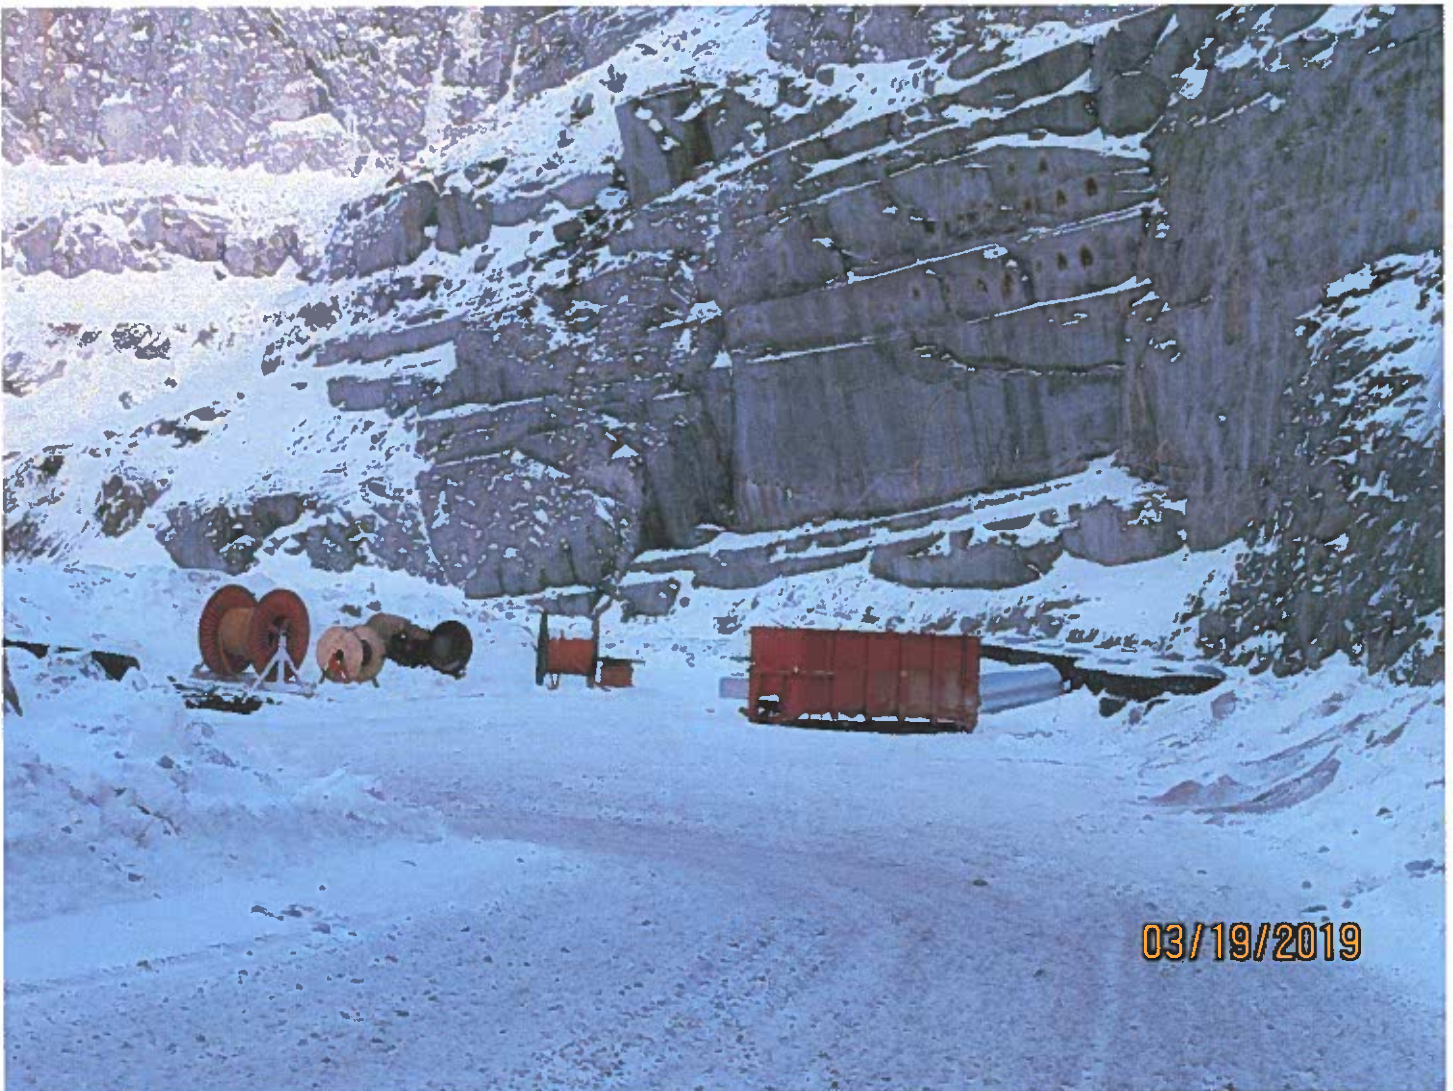
Photo #20 - W2017D0004 MUG Project
The Misery Pit swichback laydown on the ramp towards the 2235 Portal.

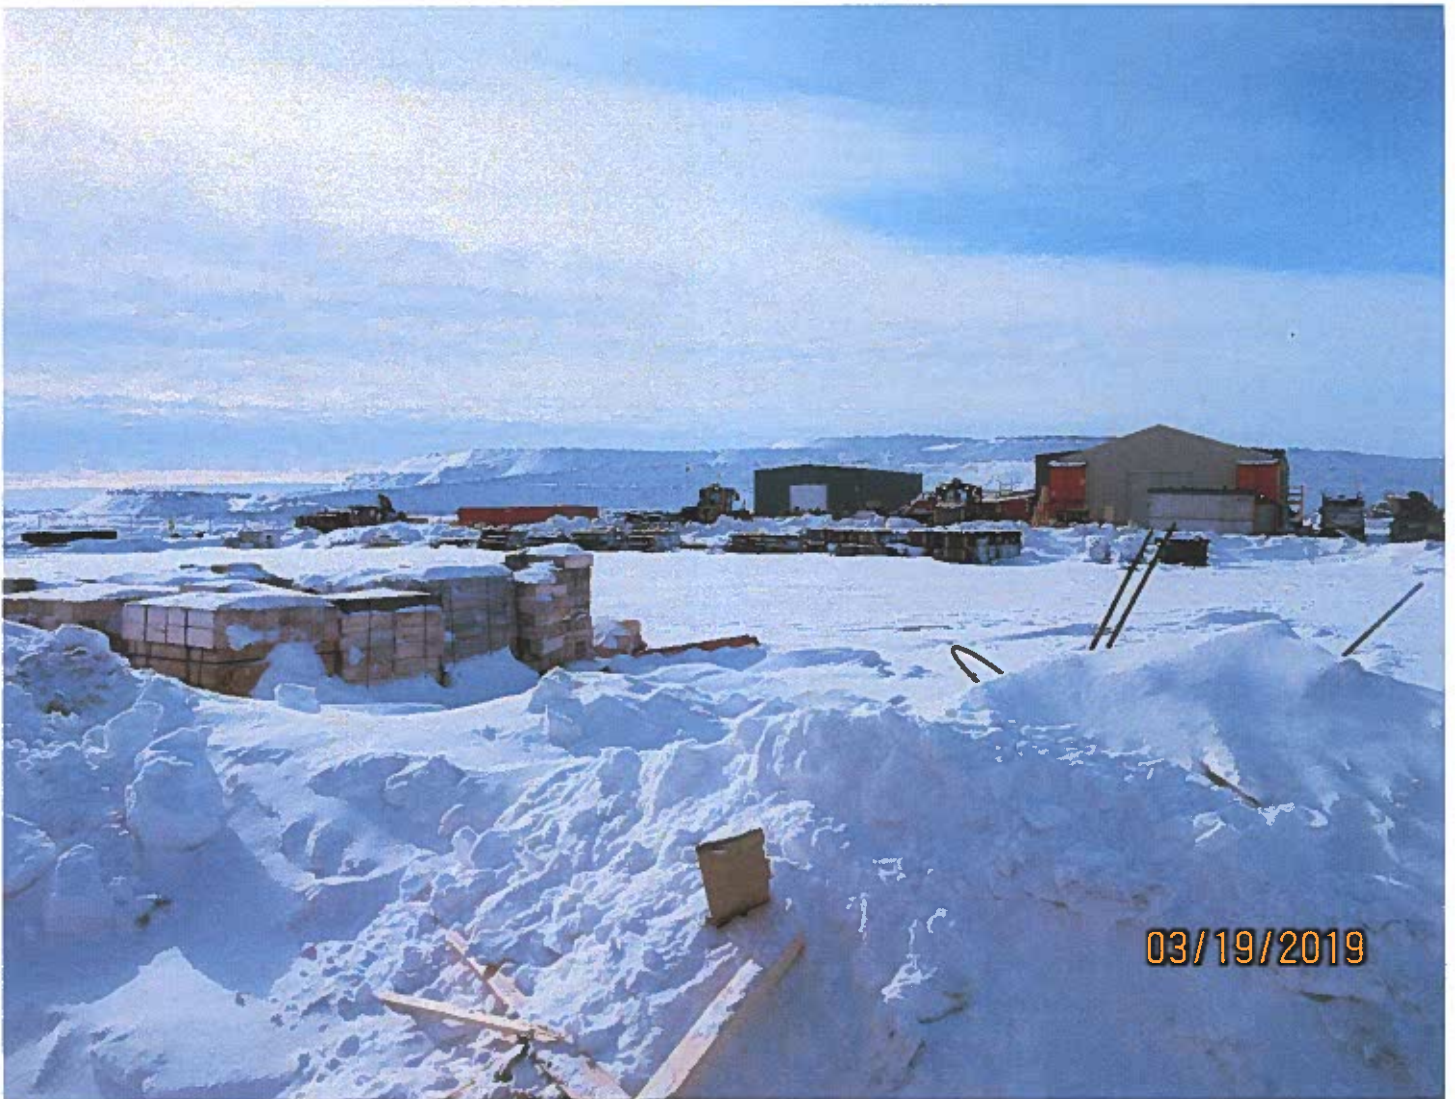
Photo #21 - W2017D0004 MUG Project
This laydown behind the camp welding shop appeared organized.

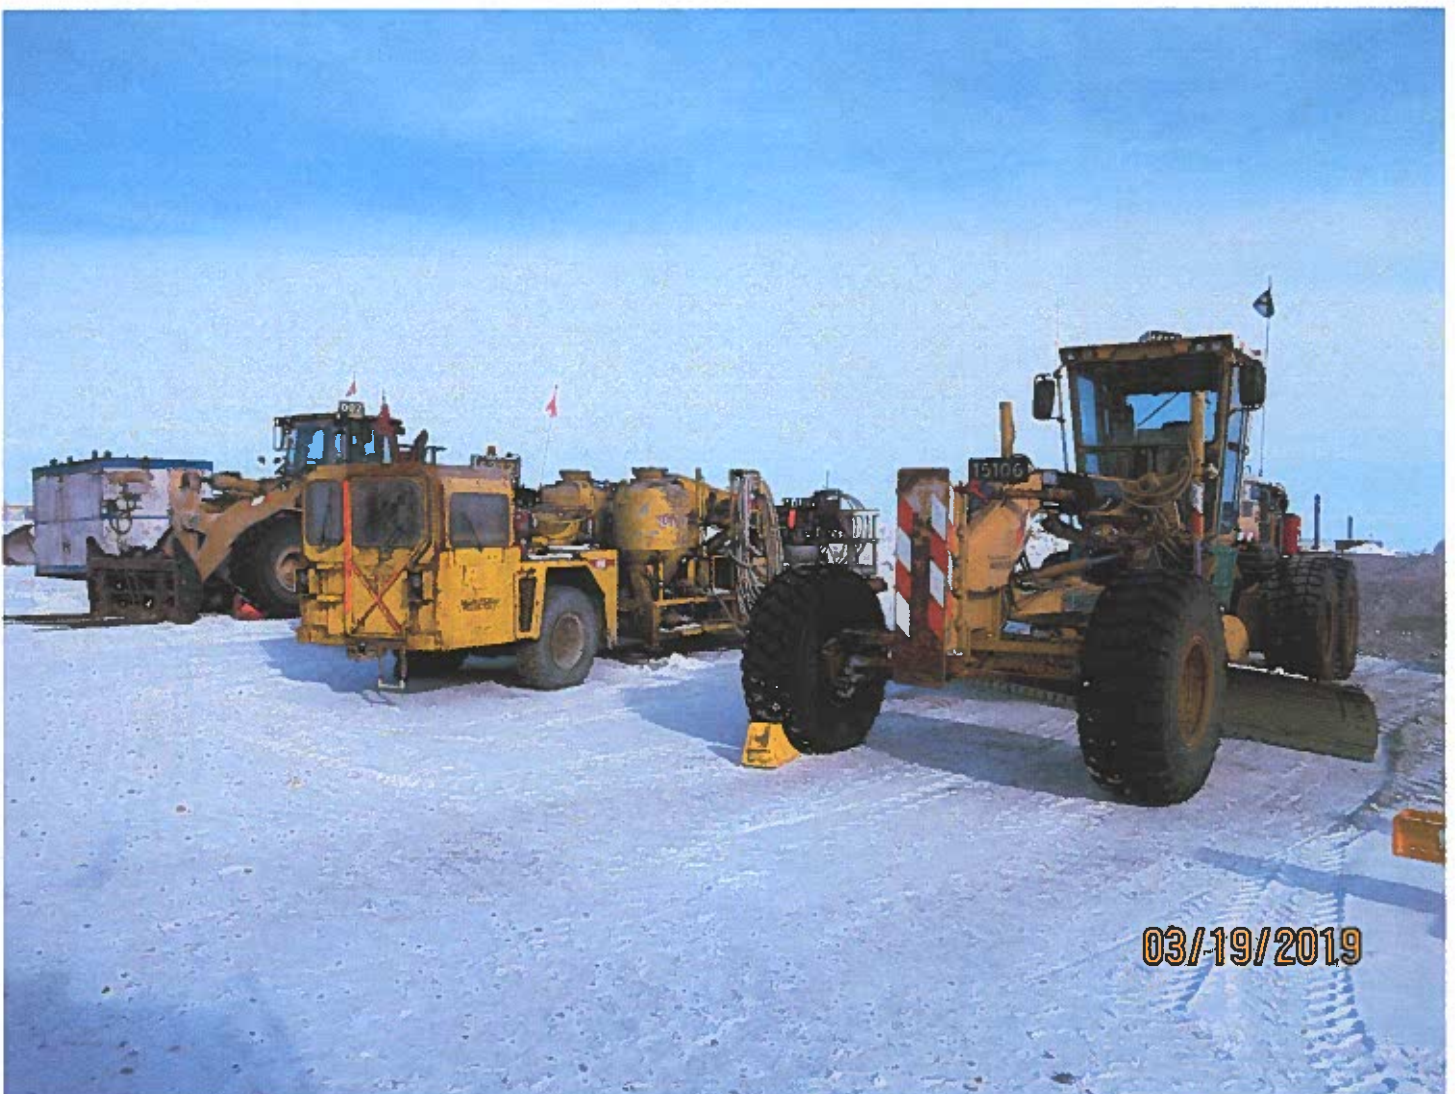
<p>Explanatory Remarks</p> <p>At the pit and camp laydowns (Photos #19-#22), it appeared there was not any major hydrocarbon staining, but the Inspector noted equipment staged behind the camp welding shop that appeared to be parked for more than two hours did not have any secondary containment structures underneath. As per Condition #37 of the permit, all equipment parked for two hours or more throughout the land use area must have secondary containment structures placed underneath. In addition, there were batteries in a snow-filled secondary containment tray at the Misery Camp equipment laydown that were exposed to the air. As per Condition #16, all waste batteries must be properly stored and managed as per the Ekati <i>Waste Management Plan</i>. No other concerns were noted during the inspection.</p> <p>Conclusion</p> <p>It is imperative that as environmental compliance issues are identified in the field, the discrepancies are being adequately addressed in a timely manner. The importance of complying with all operating conditions of LUP W2017D0004 during the Misery Underground Project cannot be over-stated, particularly the need for proper fuel handling and waste management practices. It is the expectation of the Inspector that fuel handling and waste management practices are improved upon & maintained throughout the life of the Misery Underground Project.</p>

Photo #22 - W2017D0004 MUG Project
Equipment parked for two hours or more requires secondary containment.

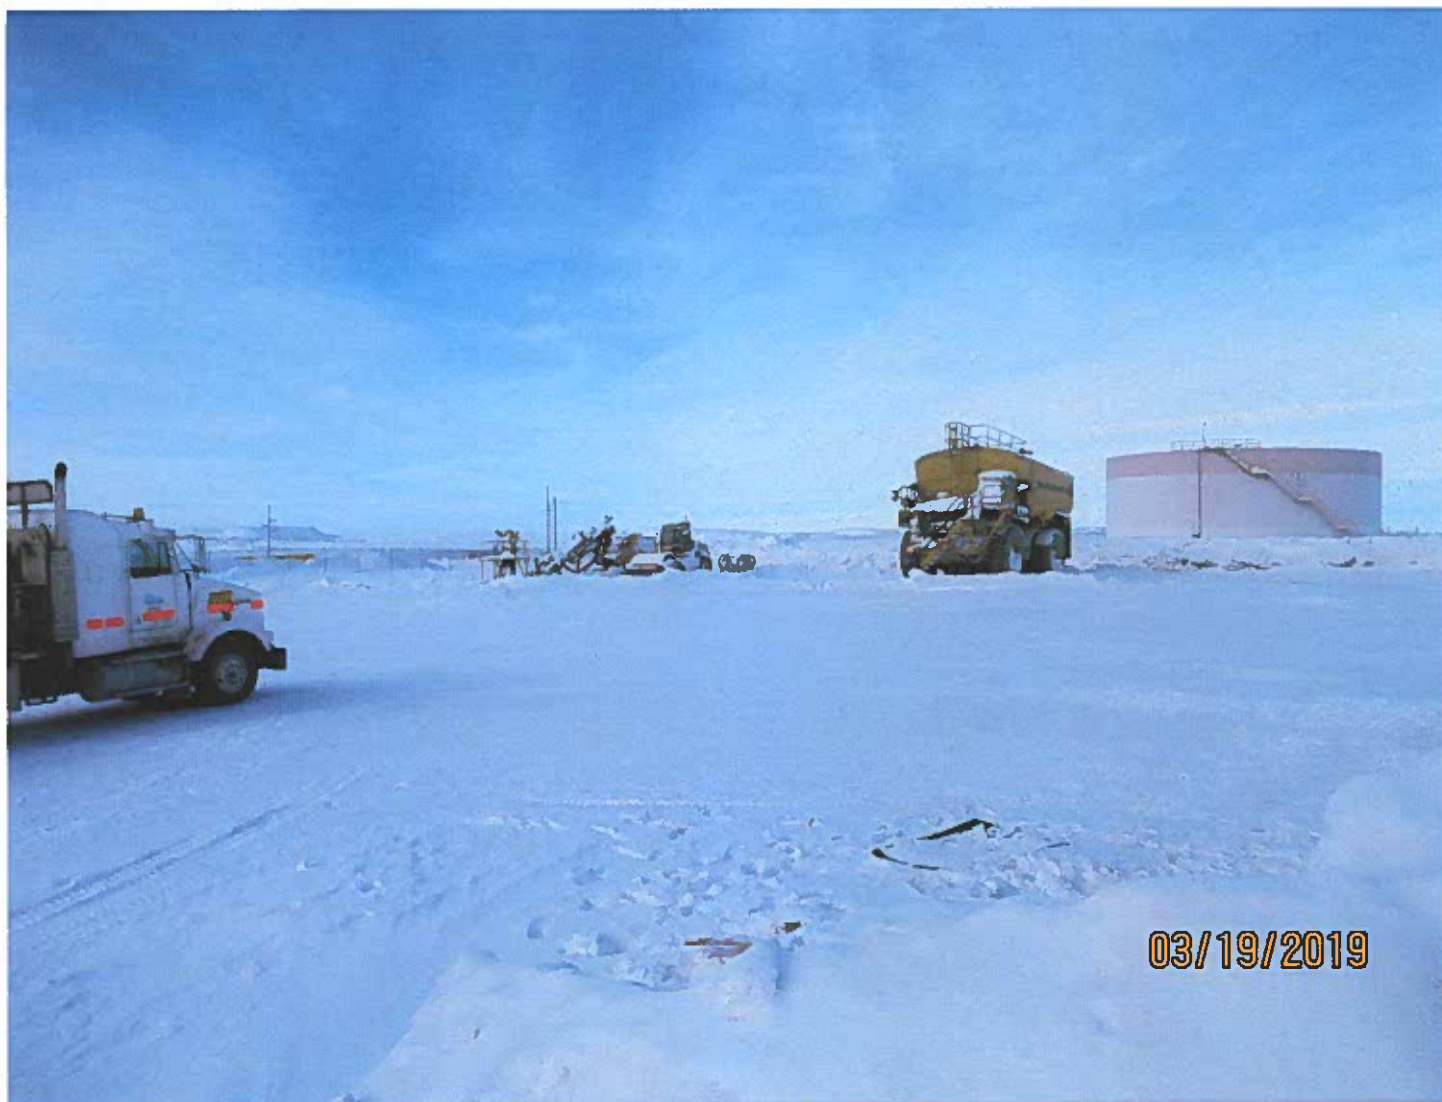
Photo #23 - W2017D0004 MUG Project
The heavy equipment laydown at the Misery Camp.

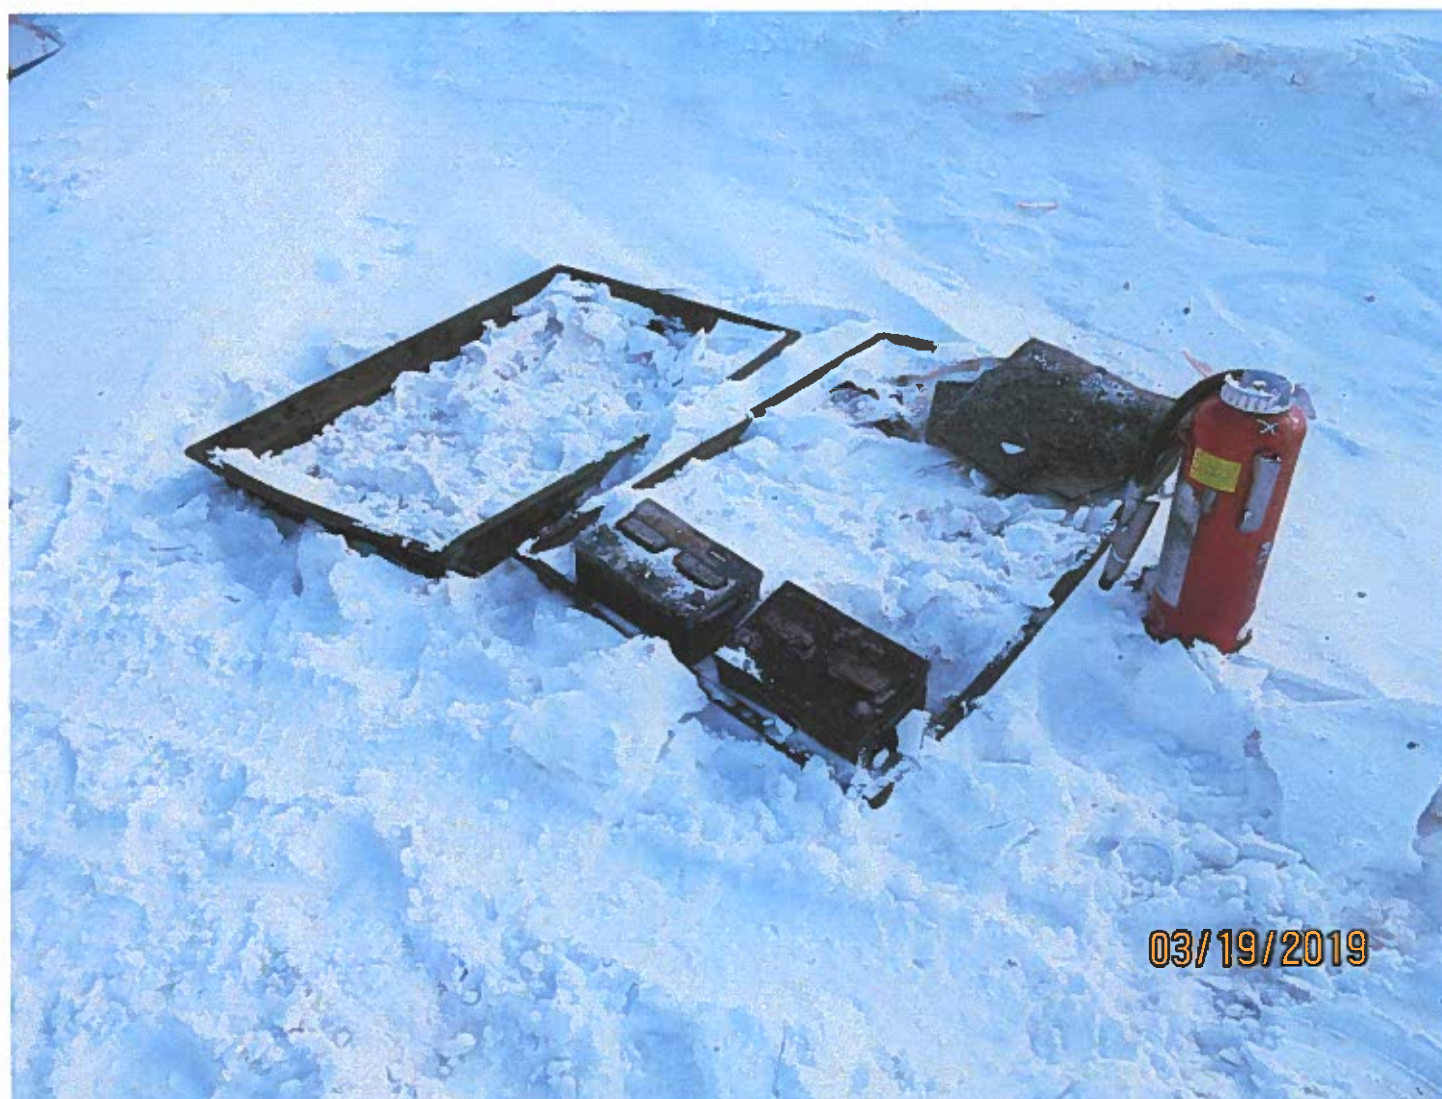
Photo #24 - W2017D0004 MUG Project
These batteries were exposed to the open environment and must be properly handled.
