**File: W2017D0004**

**Re: Land Use Permit W2017D0004  
Mining & Associated Activities  
Ekati Diamond Mine, Northwest Territories**

**ENVIRONMENTAL INSPECTION REPORT**

| Location(s) Inspected: | The Ekati Diamond Mine Misery Underground Project. |

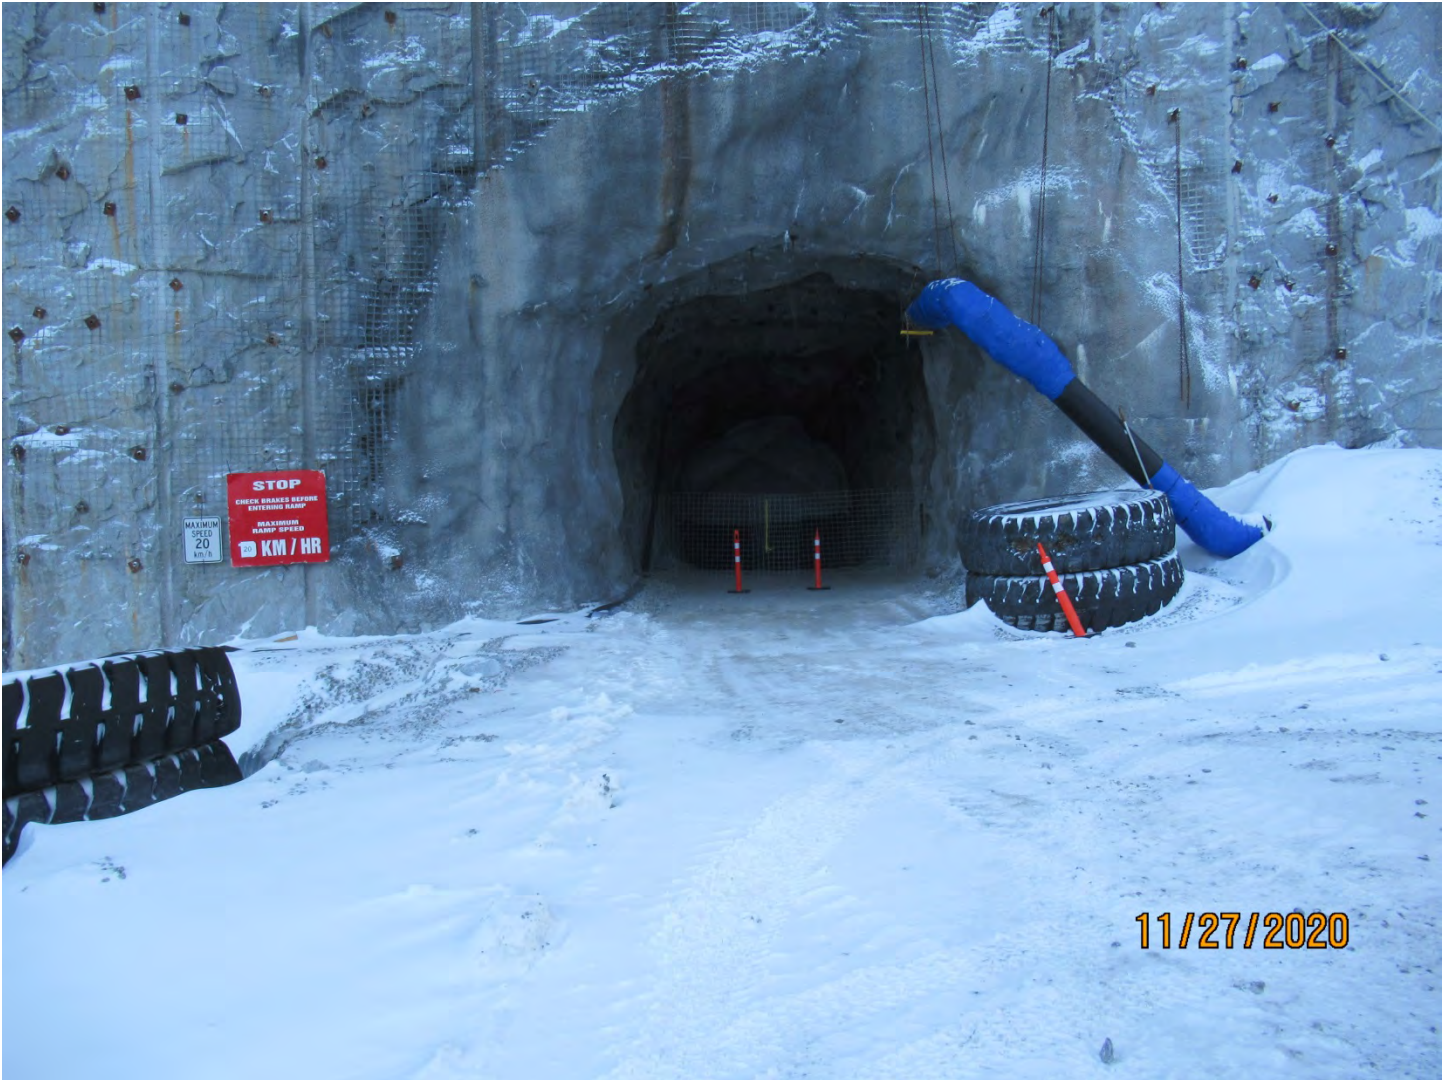
Currently, two access portals to the underground workings have been developed: the 2235 Lower Portal and 2340 Upper Portal. The 2340 Upper Portal is currently blocked off with fencing to prevent access and a temporary bulkhead (large canvas) has been placed to cover the entrance (Photos #1 & #2). The temporary bulkhead has been put in place to prevent the heated air from the Fresh Air Raise (FAR) station on the Misery Pit 440 Bench from escaping the underground as its being pumped down and to allow for the proper, planned air flows to resume.

Photo 1: A heat-traced water line is used to discharge water into King Pond via the 2340 Upper Portal.

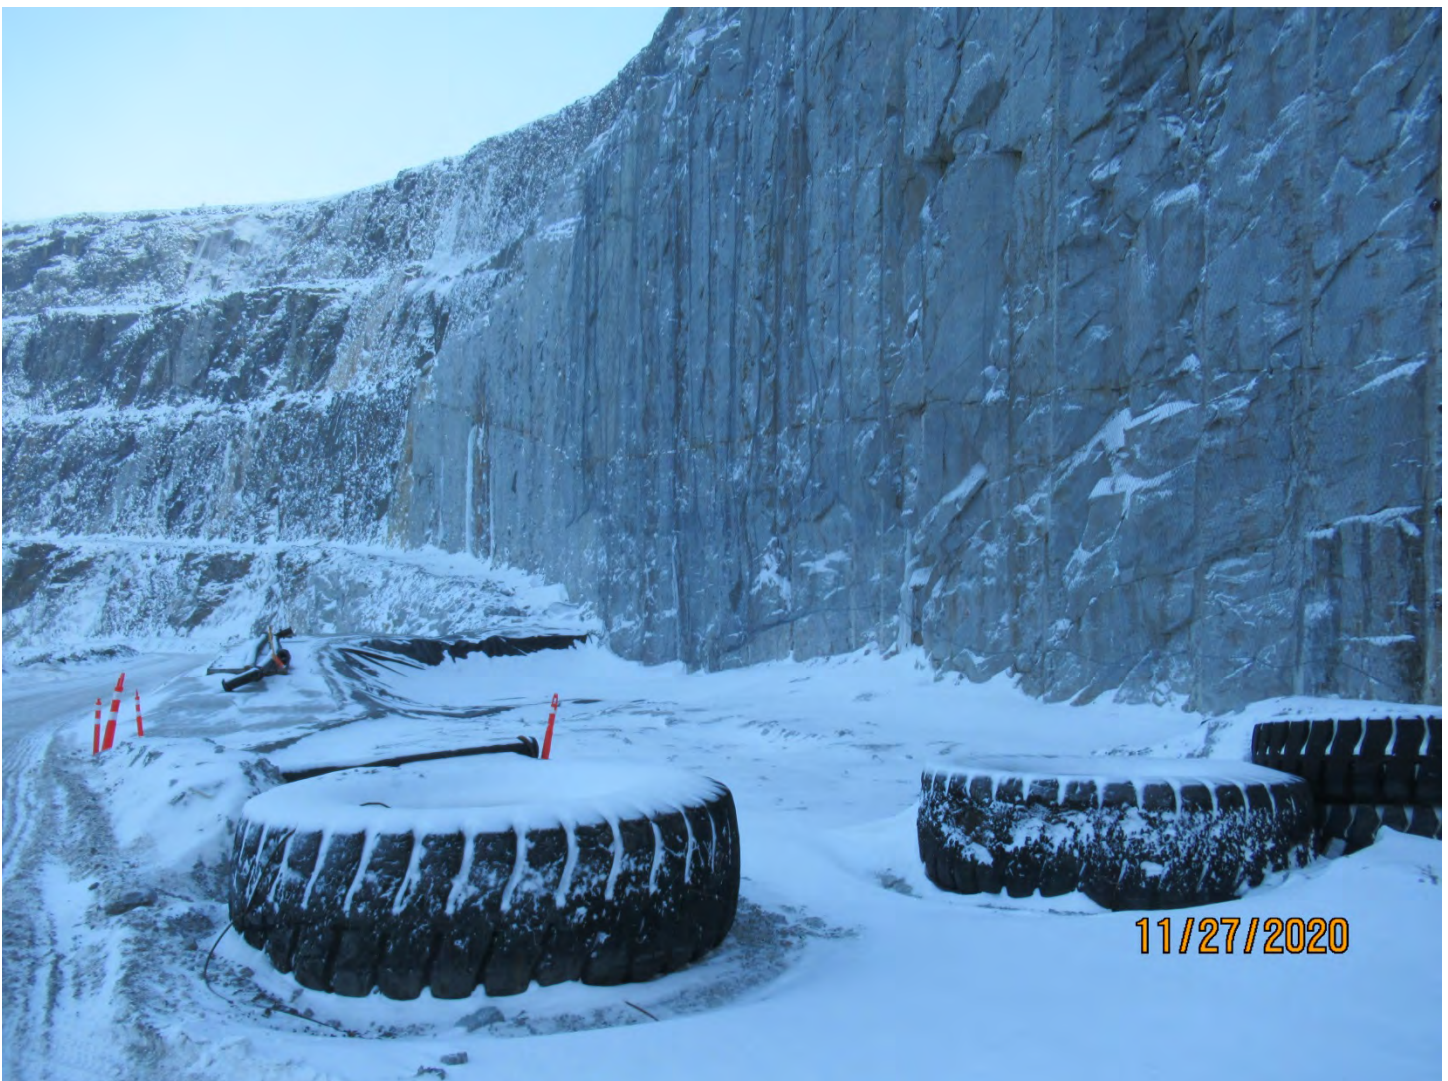
Photo 2: A water sump has been established downgrade and adjacent to the 2340 Upper Portal.

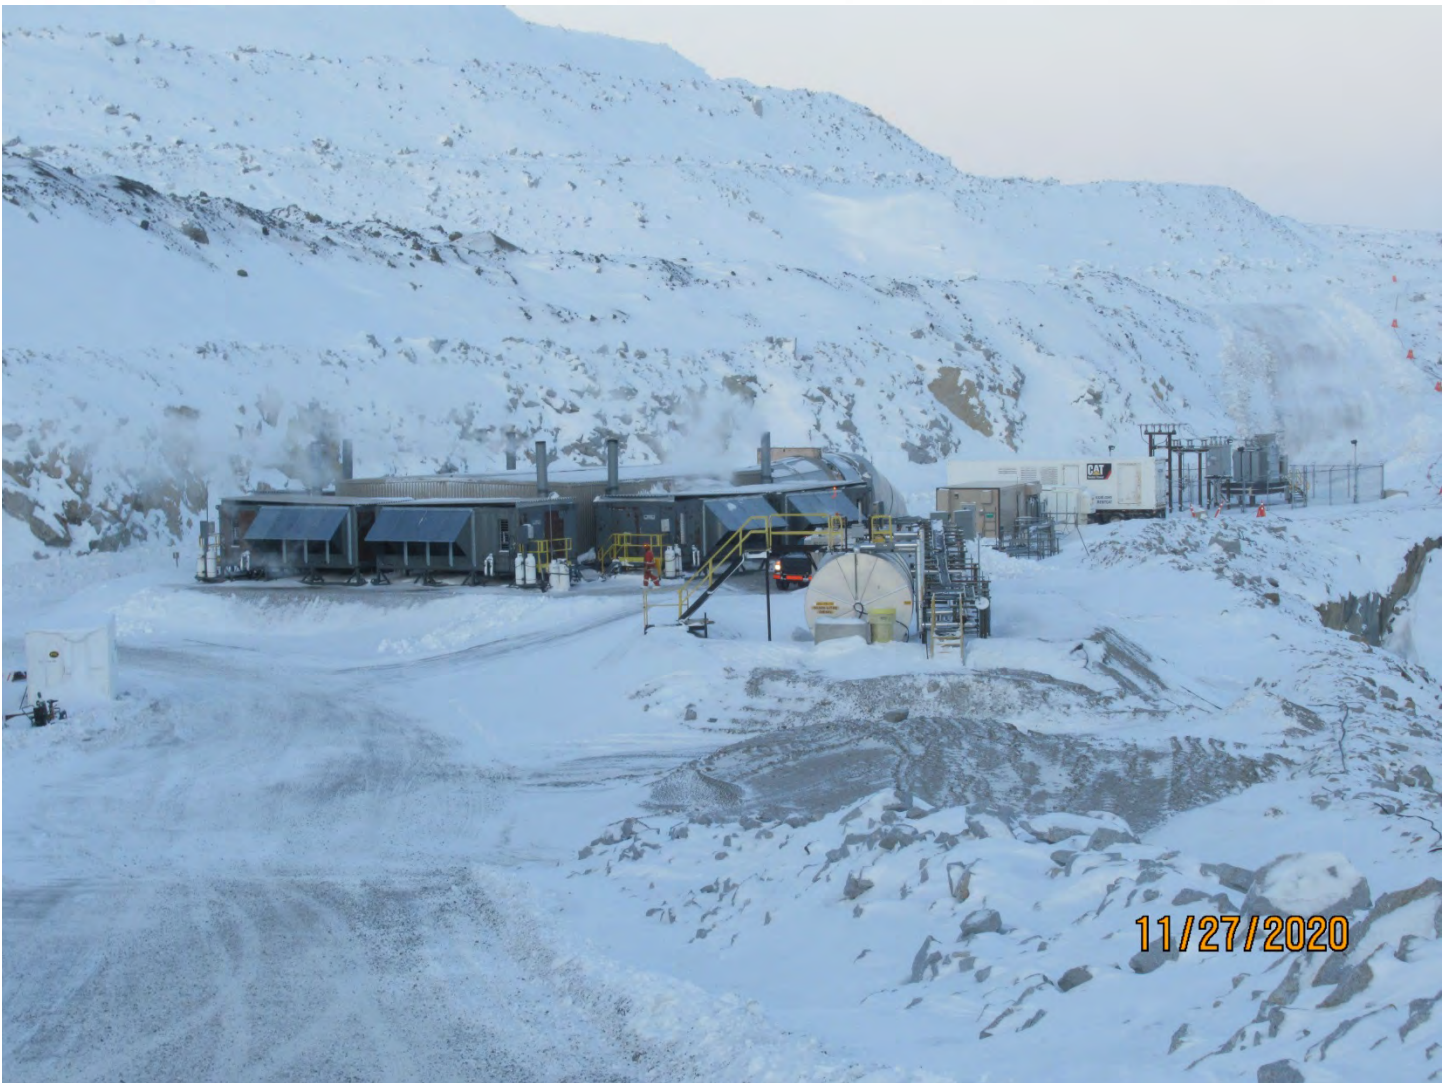
As mentioned previously, the FAR on the 440 Bench was commissioned on February 27<sup>th</sup>, 2020 and the electrical workings to the underground were commissioned on March 4<sup>th</sup>, 2020 (Photo #3). The commissioning of the FAR and the electrical allowed for the removal of the temporary infrastructure staged along the 2235 Lower Portal ramp. As seen in Photos #4-#11, equipment such as the electrical generators, fuel tanks, vent tubes, air heaters and other assorted staging seacans have been removed as they are no longer required to support the underground operations. The underground compressors, escapeway seacan, staff room seacan, and a washroom remain on the ramp.

Photo 3: The FAR on the Misery Pit 440 Bench has been commissioned along with the electrical to the underground. A backup generator has also been installed in the event of electrical failures.

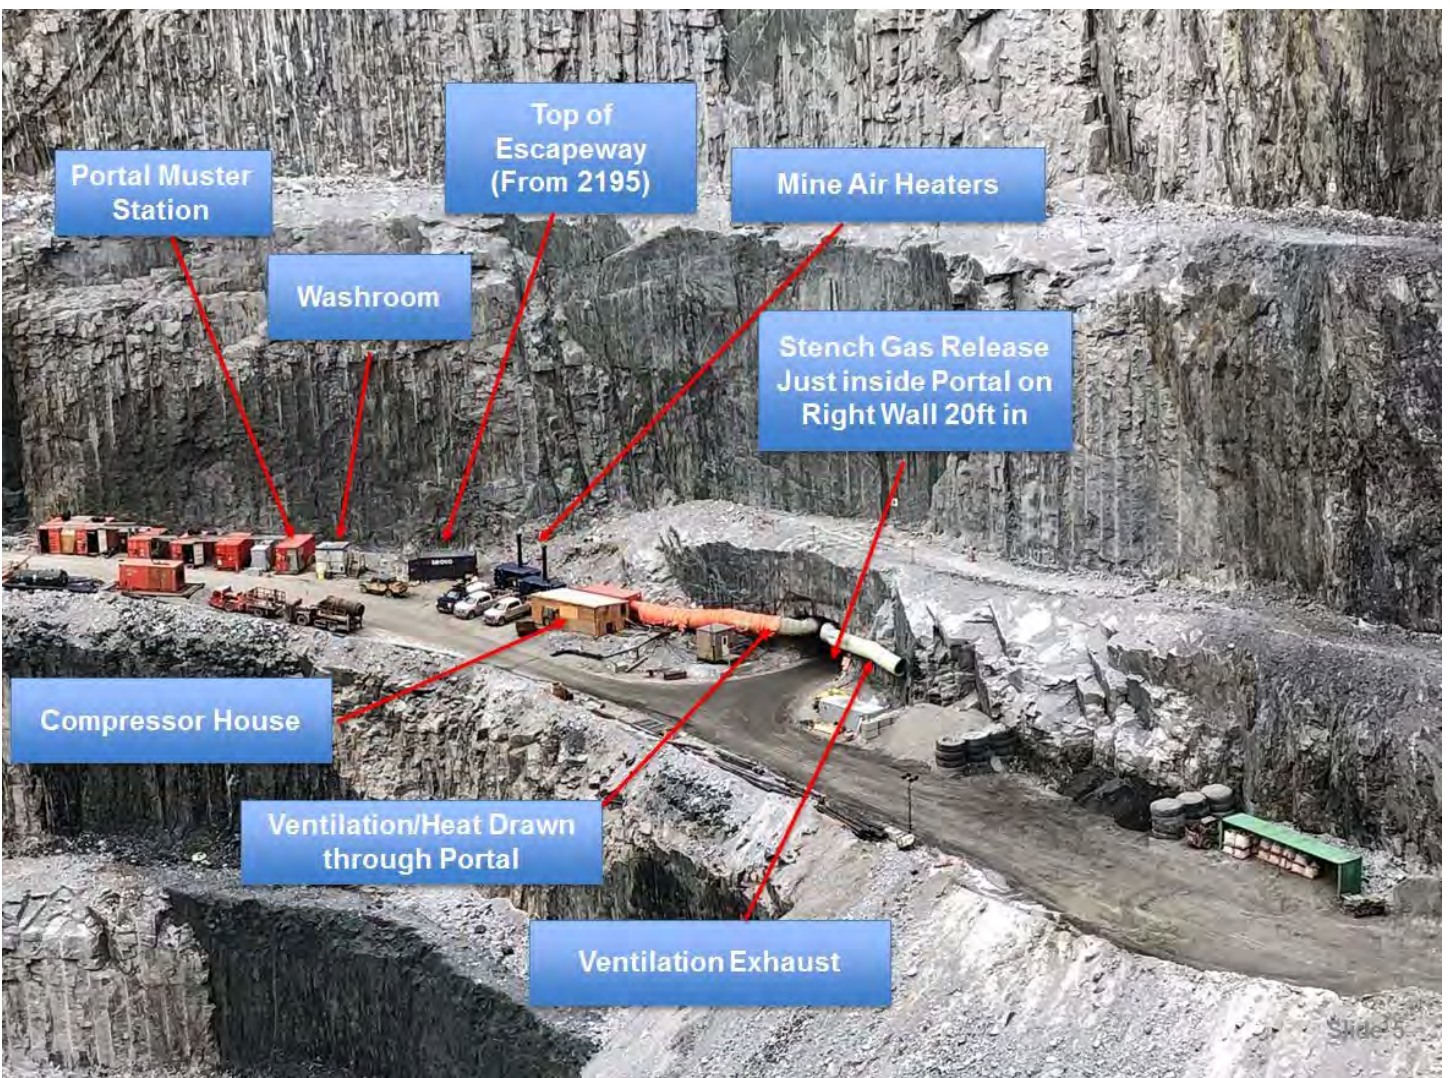
Photo 4: This equipment was staged on the 2235 Lower Portal ramp to support the underground operations (Photo courtesy DDM).

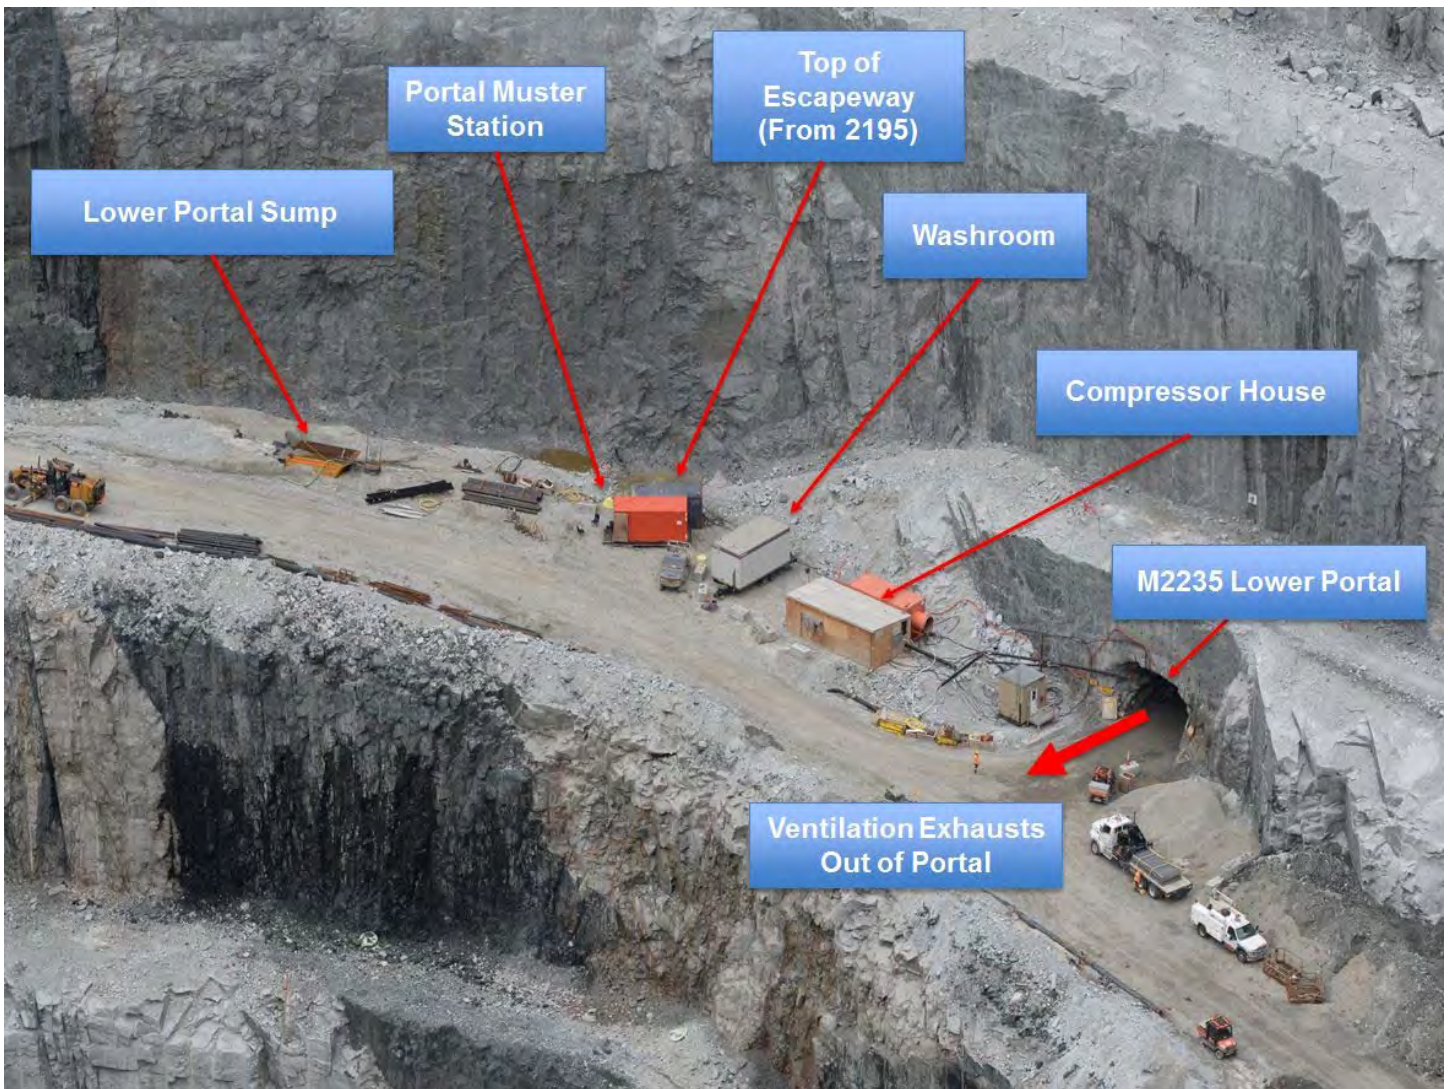
Photo 5: As seen in this photo, the majority of the equipment staged on the 2235 Lower Portal ramp was removed as it was no longer required to support the underground mining activities.

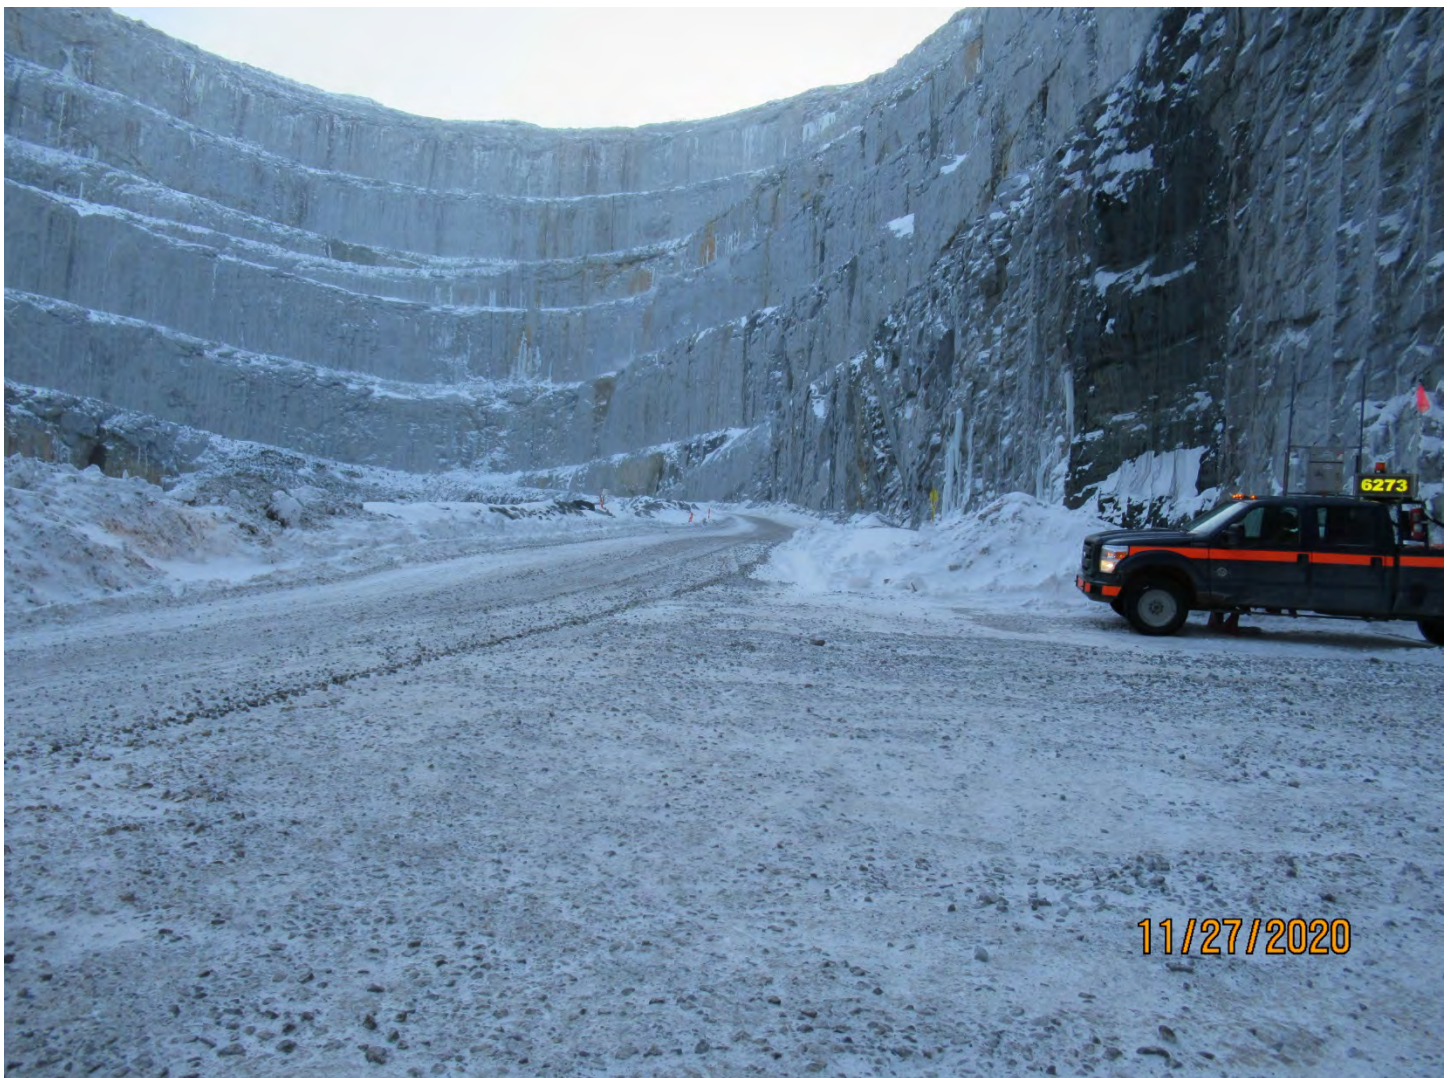
Photo 6: As seen, fuel tanks, generators and other equipment are no longer present on the 2235 Lower Portal ramp.

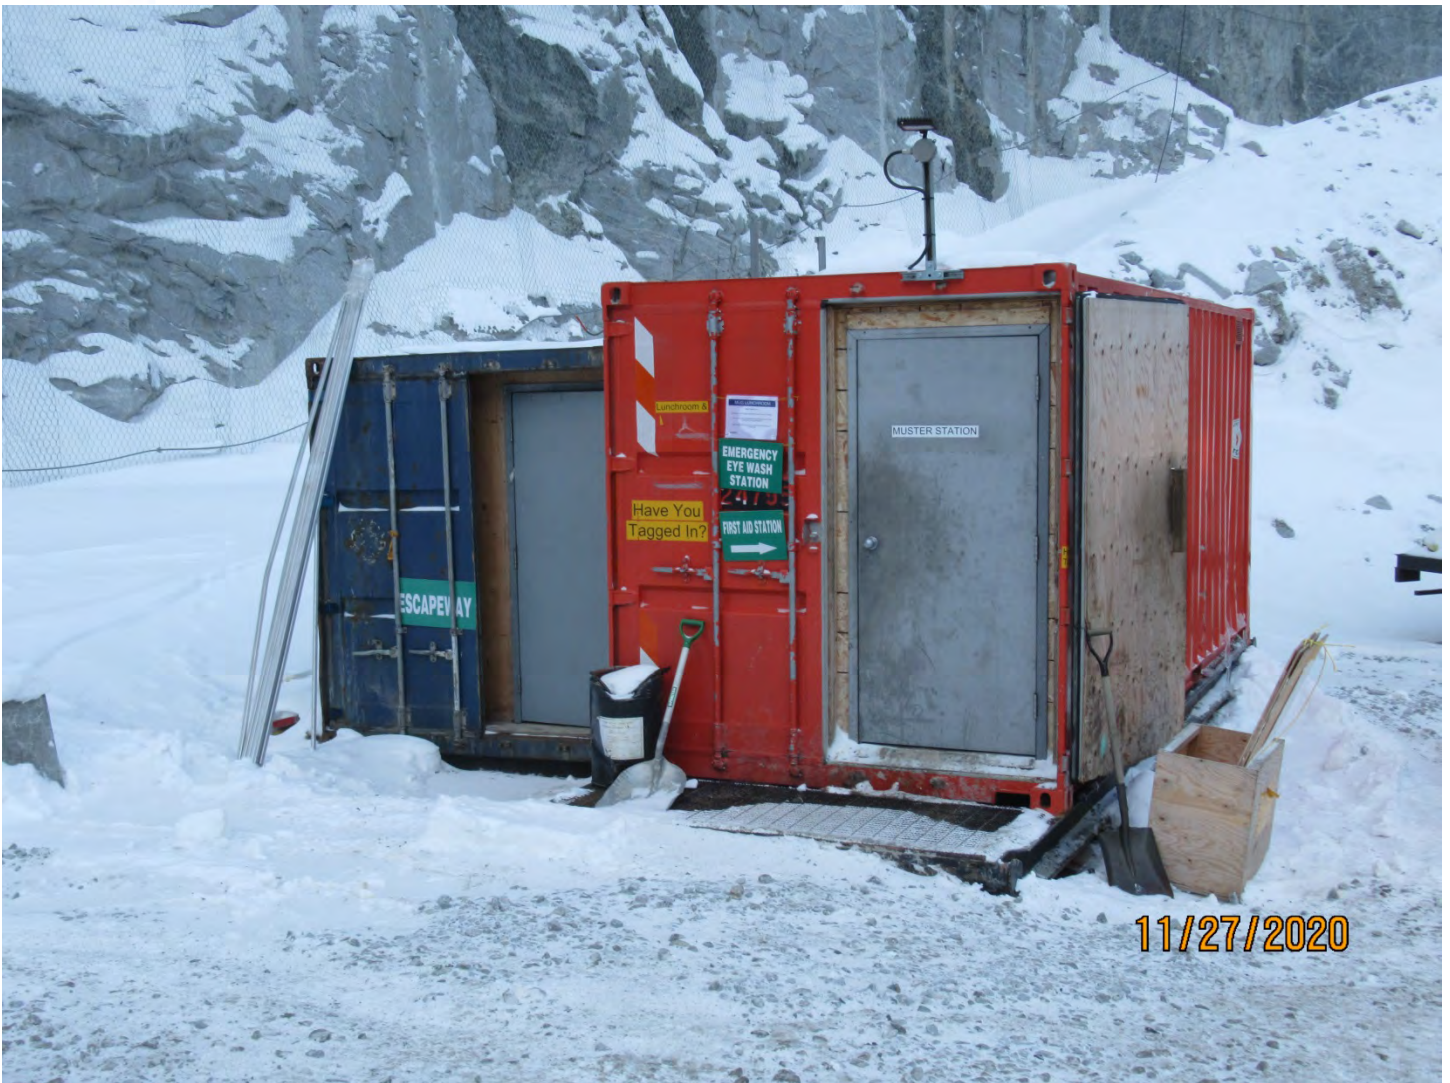
Photo 7: Seacans housing the escapeway portal (L) and lunch room (Muster Station) on the 2235 Lower Portal ramp.

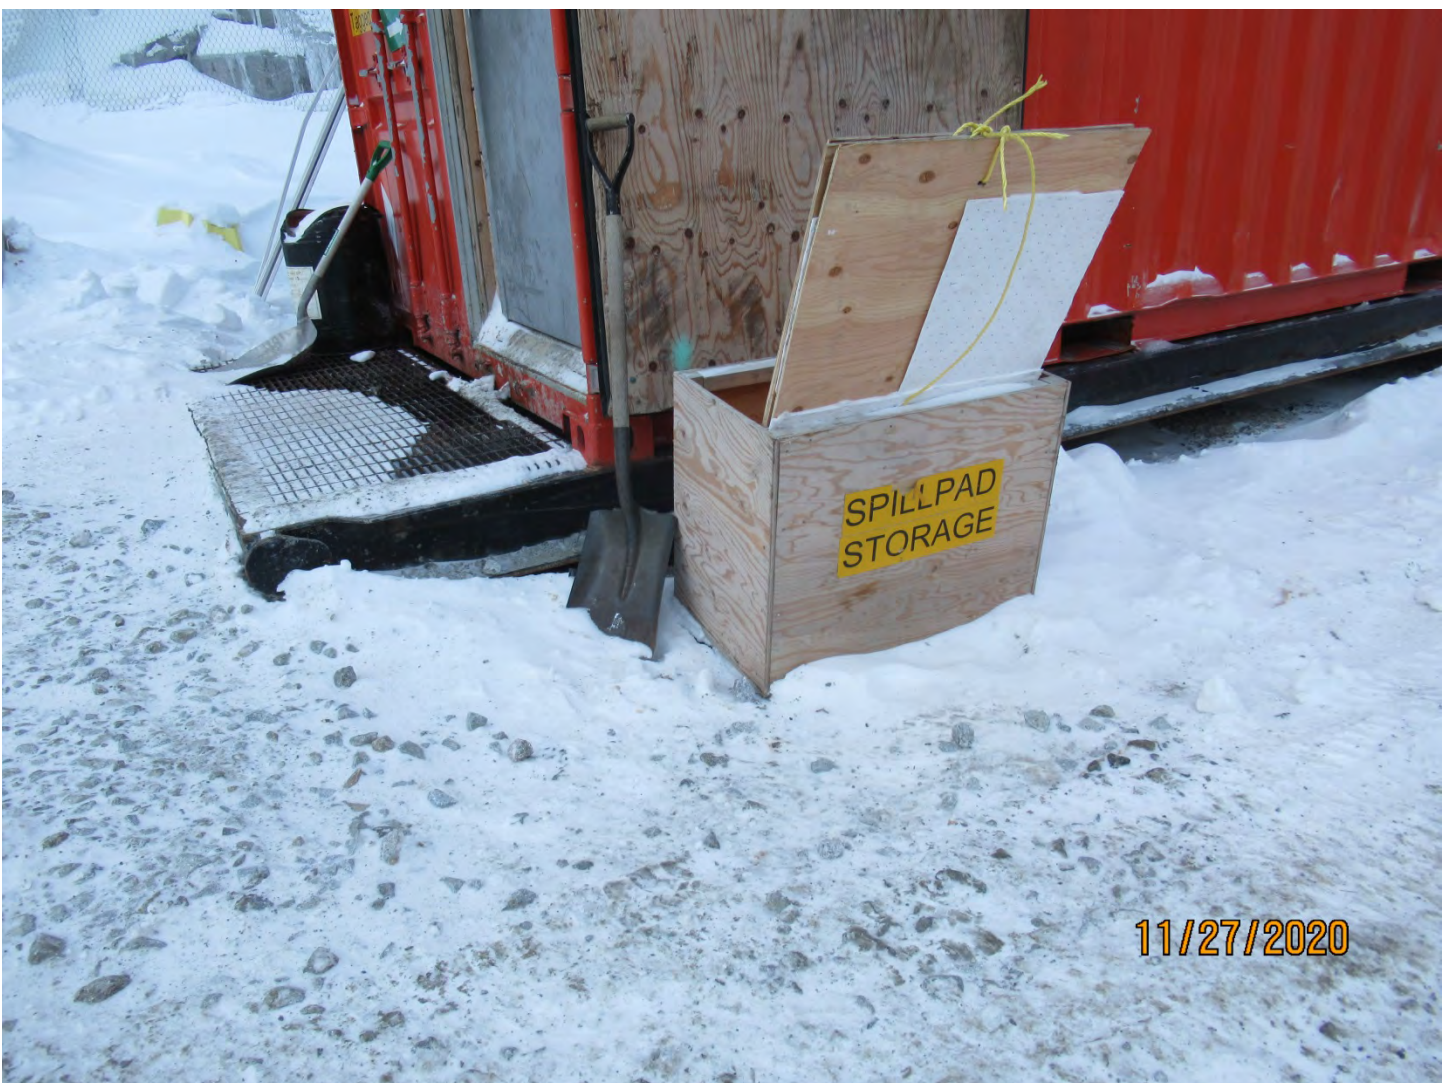
Photo 8: These drip boards are placed under parked equipment to help contain hydrocarbons on the 2235 Lower Portal ramp.

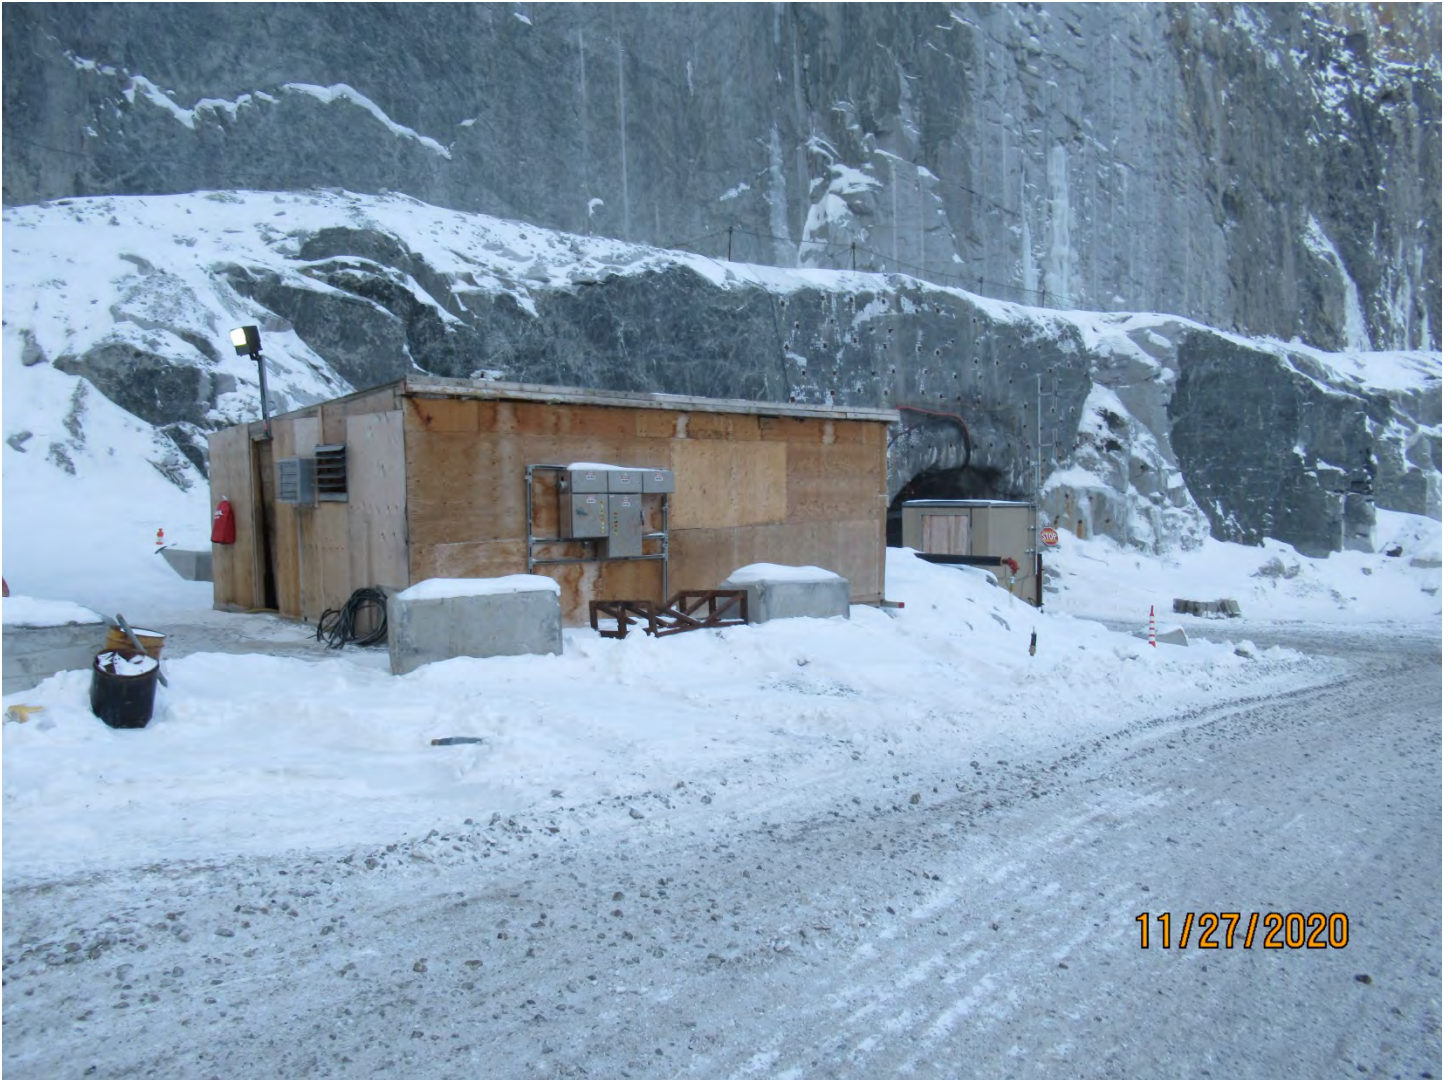
Photo 9: Compressors on the 2235 Lower Portal ramp will remain in use until a compressor station is established at the U/G 2150 Level.

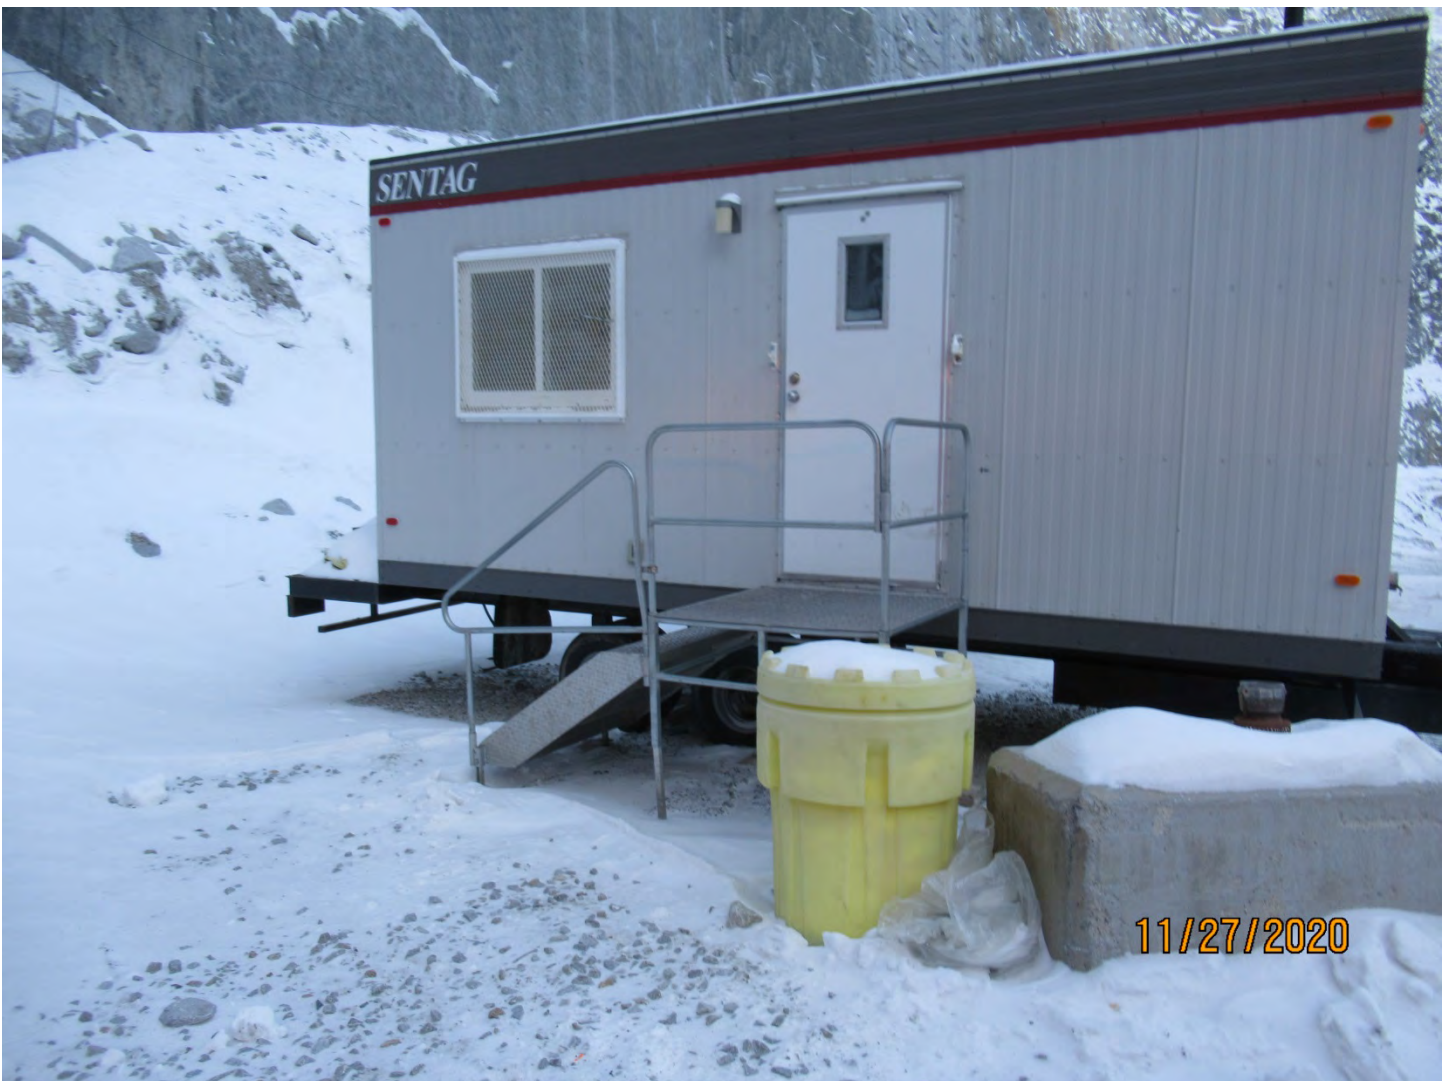
Photo 10: Spill response materials were readily available at the washroom building on the 2235 Lower Portal ramp.

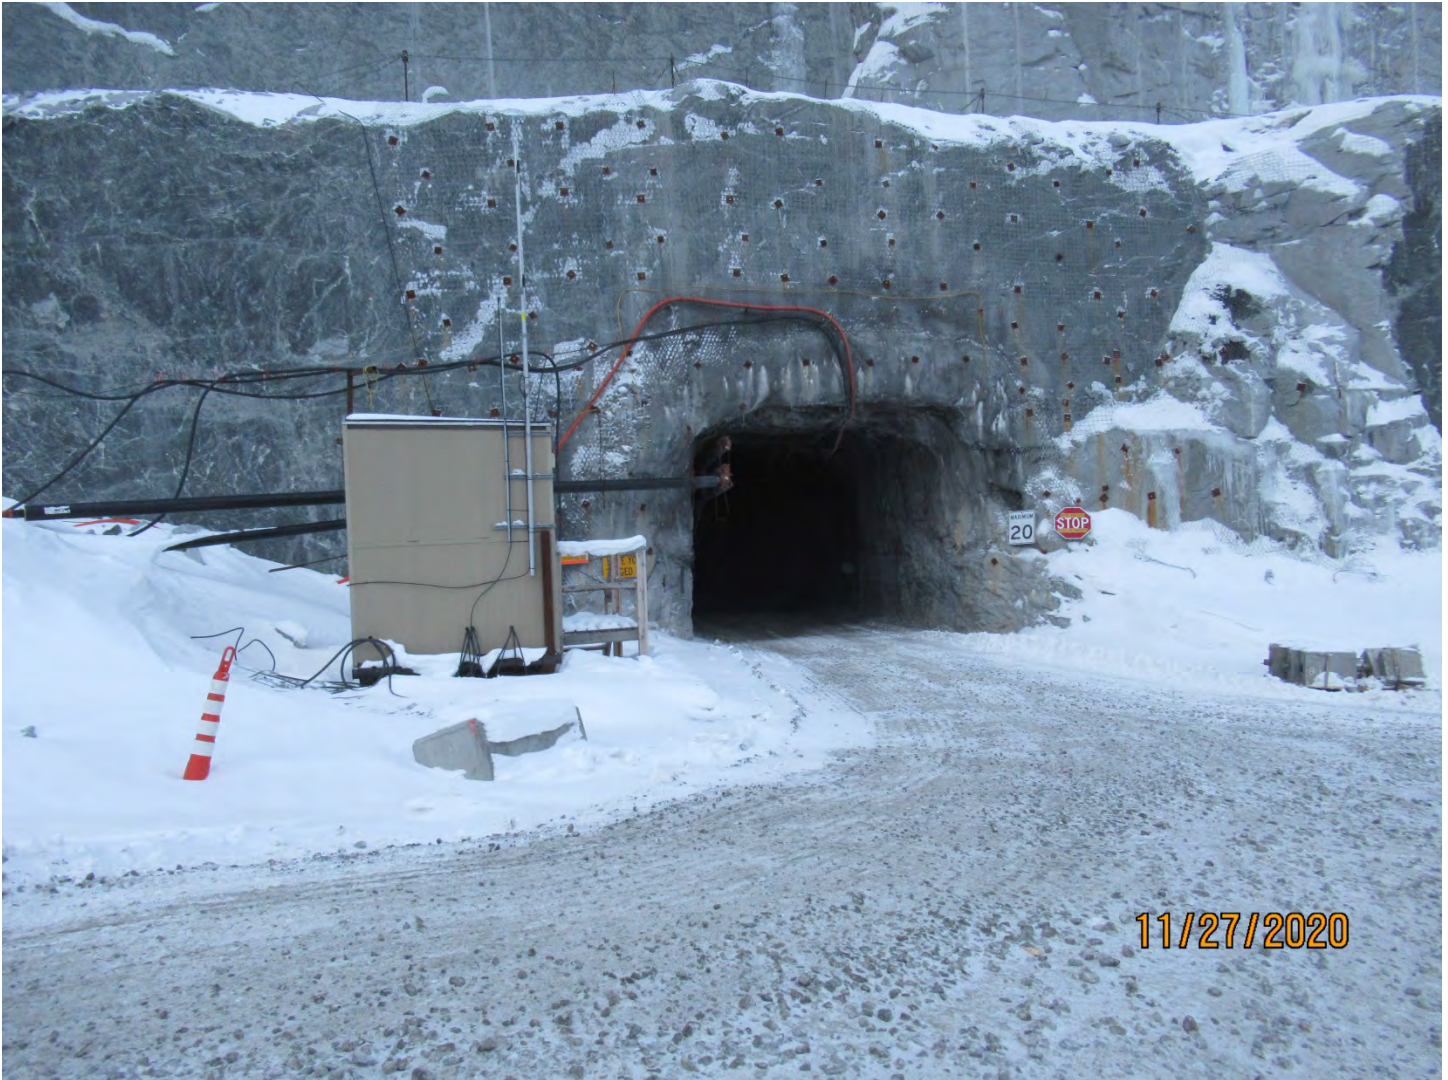
Photo 11: Heated air and vent lines have been removed at the 2235 Lower Portal as they are no longer required.

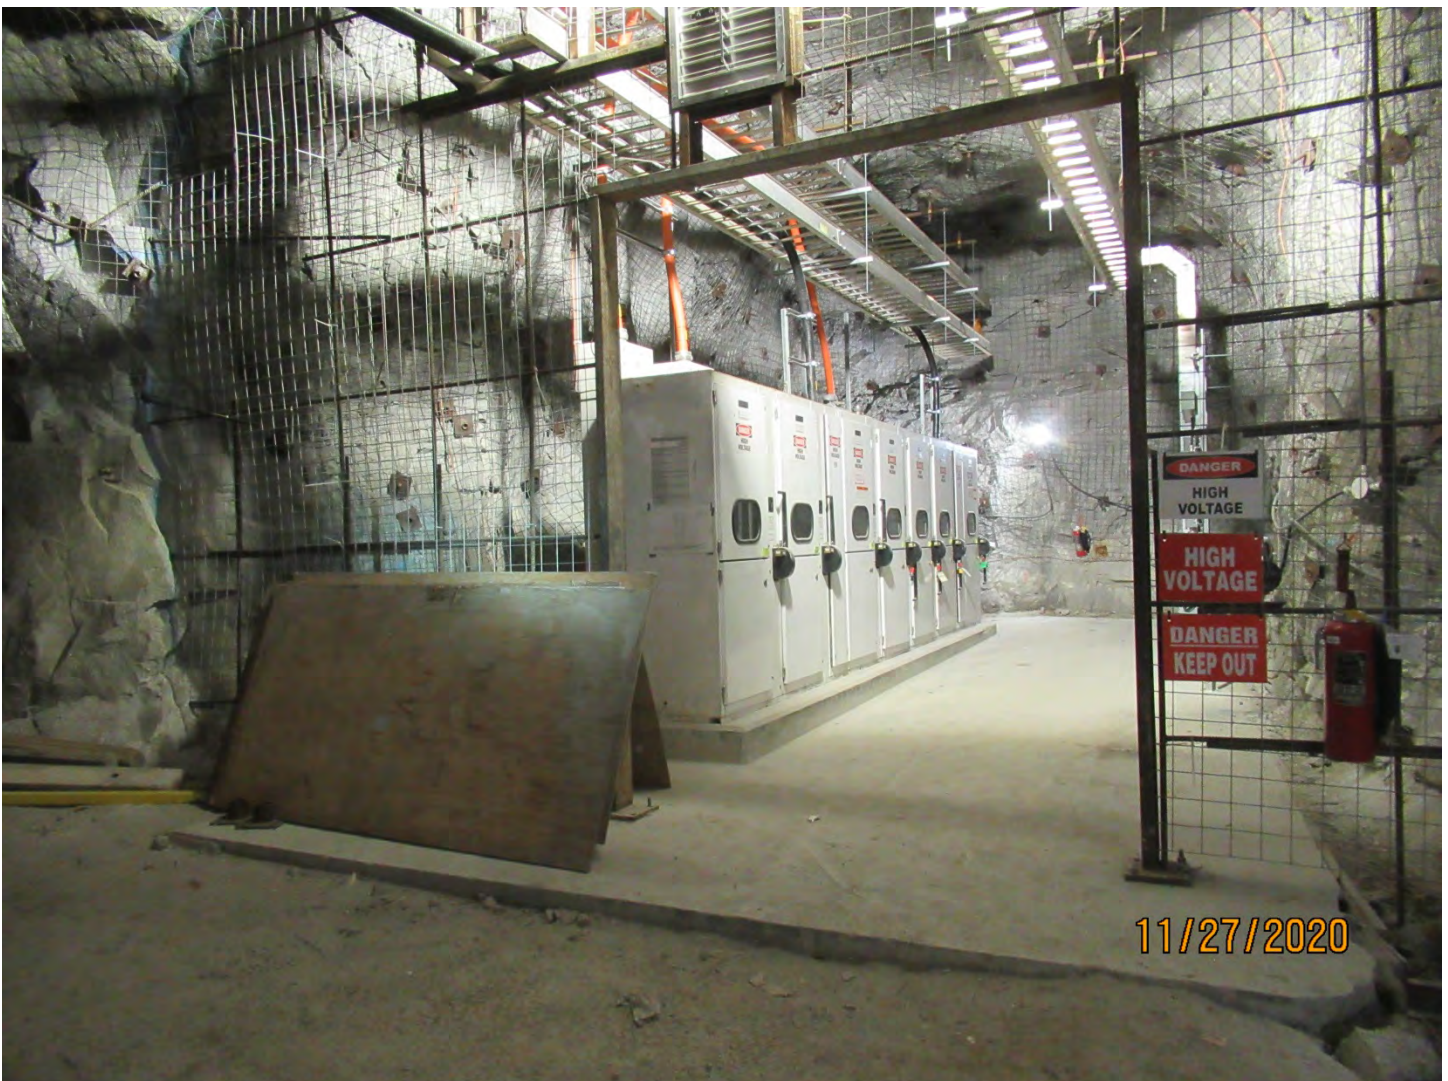
At the U/G 2150 Level, the majority of the electrical (Photo #12), MudWizard (water separation units – Photo #13), and 500 hp water pumps along with the corresponding control panels have been commissioned and are supporting the underground workings. As seen in Photo #14, concrete is being used to construct water collection tanks behind the water pumps. The collection tanks allow a place for water to hold prior to its use in the underground operations or its discharge out of the underground up into King Pond. Water volumes pumped from the underground are currently calculated using figures from the pump readings in Photos #15 & #16. Additionally, the compressor pad in Photo #17 has been poured and is being readied for the installation of compressors that will support the underground operations.

Photo 12: The electrical distribution unit at the U/G 2150 Level.

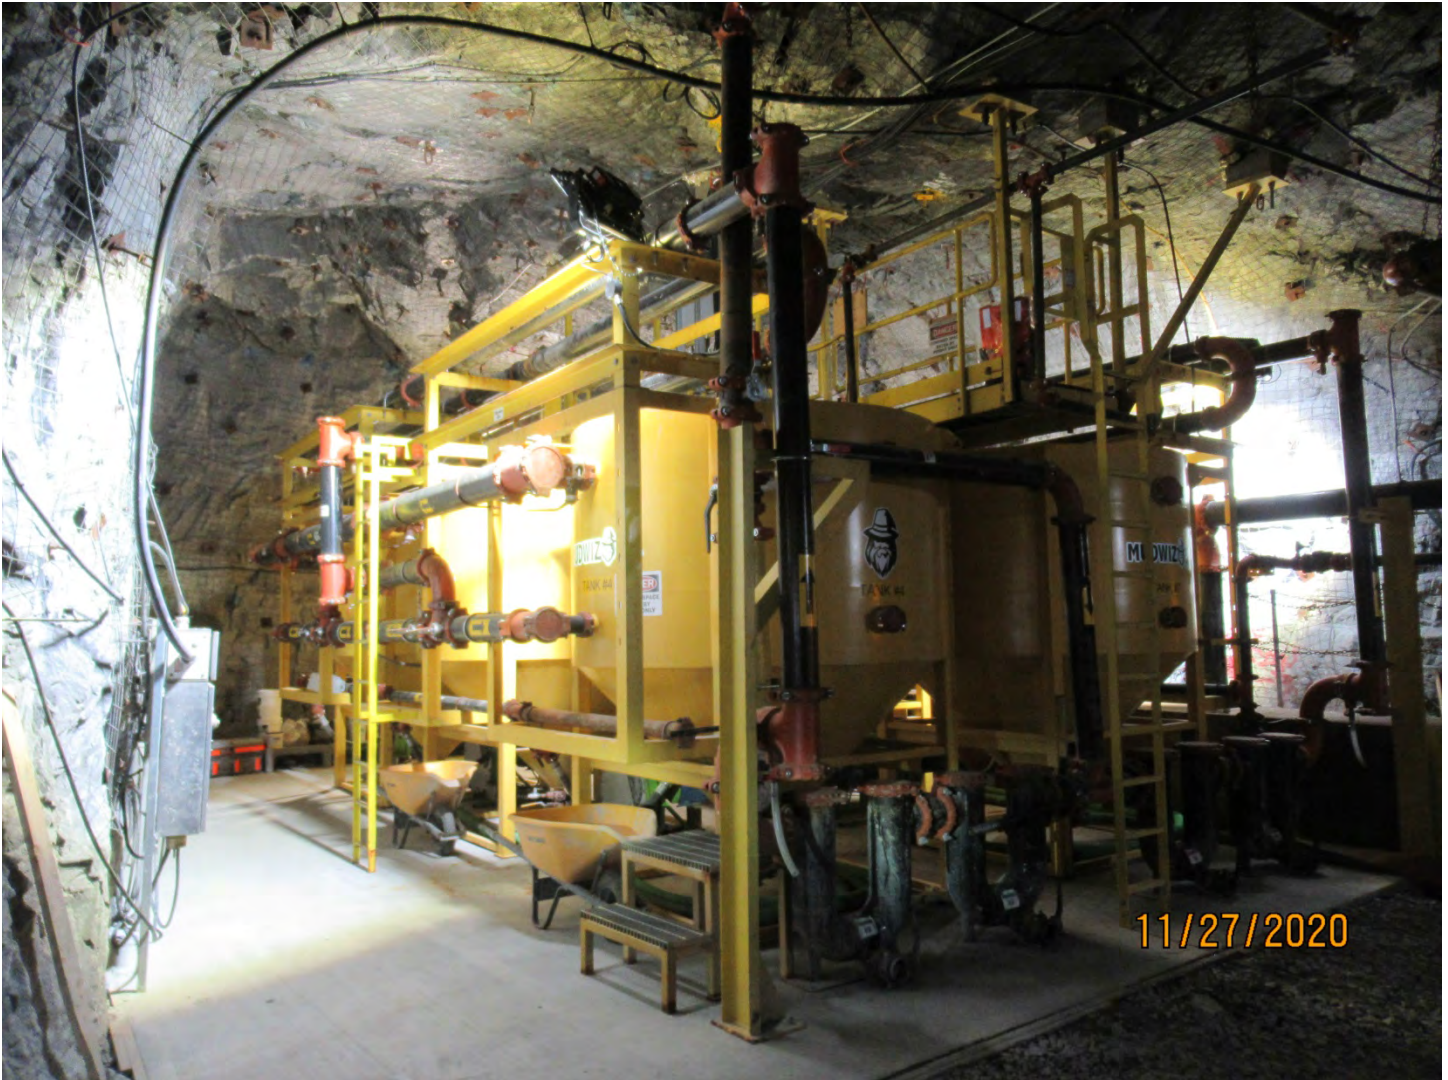
Photo 13: The MudWizard water treatment system is fully commissioned at the U/G 2150 Level.

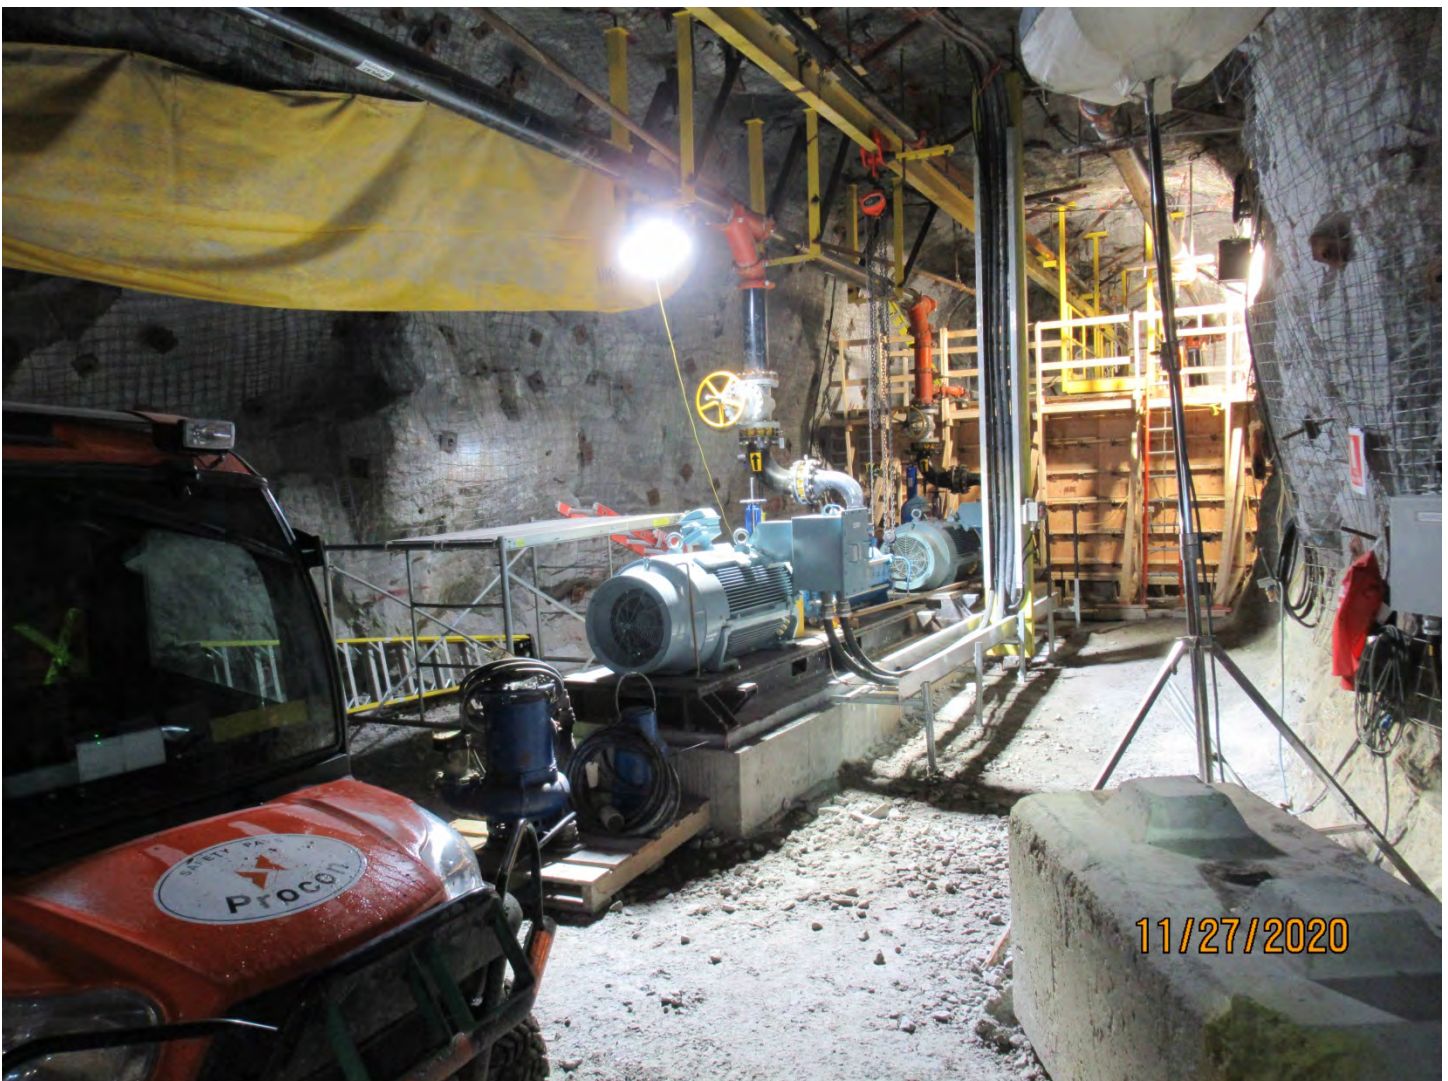
Photo 14: These 500 hp pumps are used to pump water to King Pond. In the background, concrete is being formed to establish one of the two water holding tanks.
