**File: W2017D0004**

**Re: Land Use Permit W2017D0004  
Mining & Associated Activities  
Ekati Diamond Mine, Northwest Territories**

**ENVIRONMENTAL INSPECTION REPORT**

| Location(s) Inspected: | The Ekati Diamond Mine Misery Underground Project. |

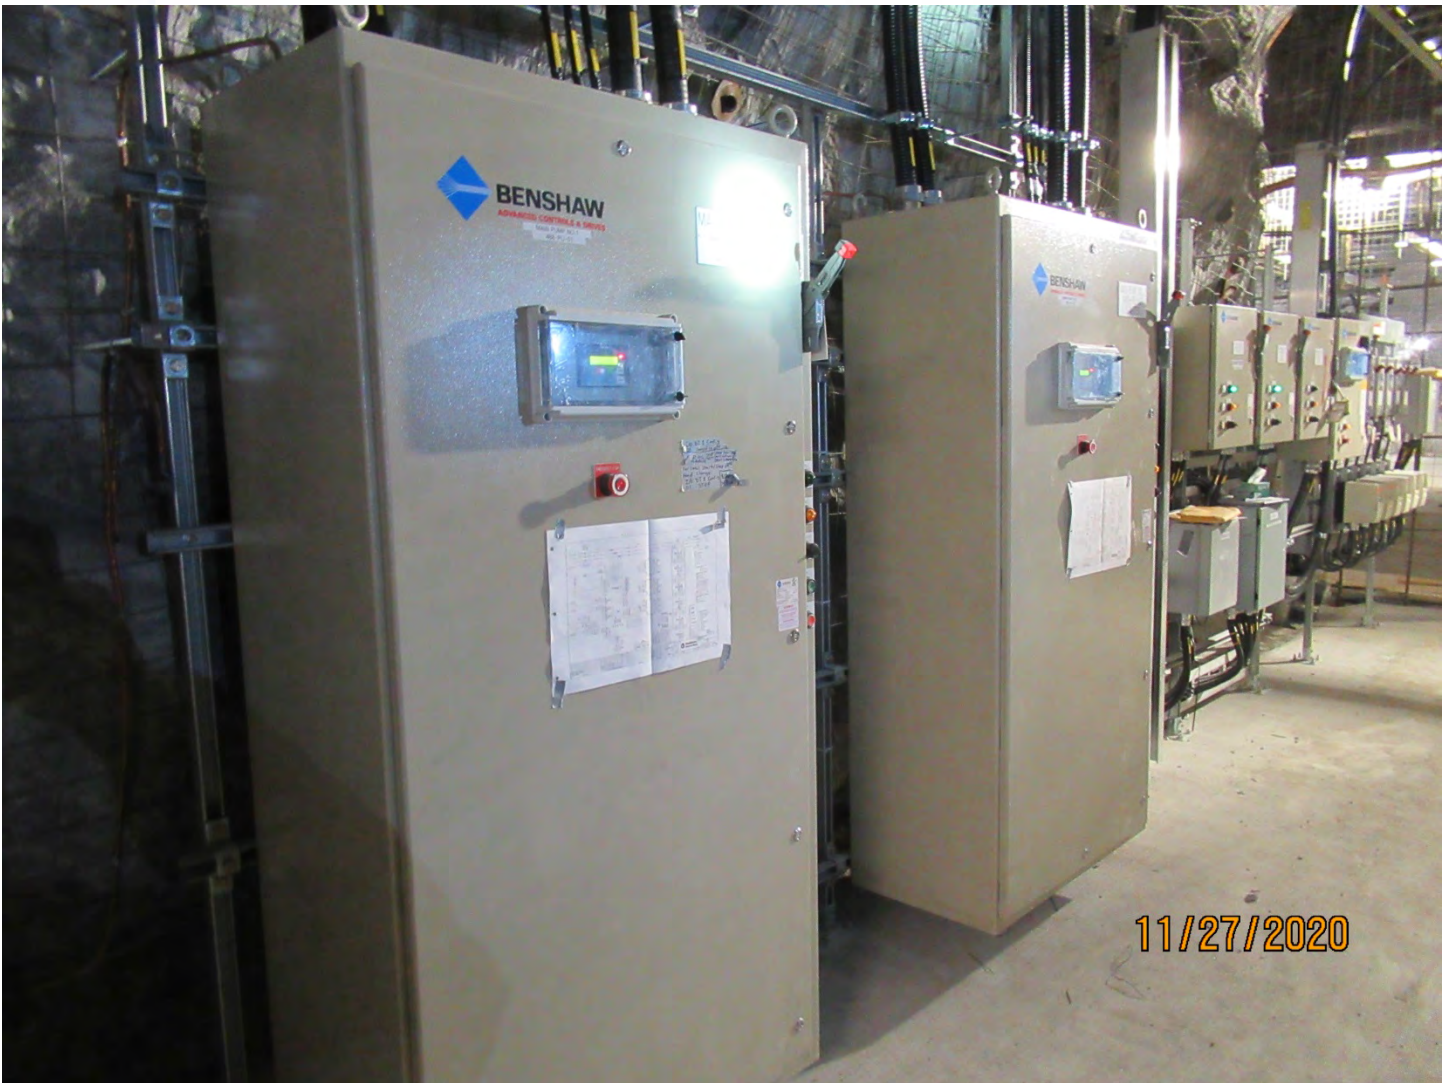
Photo 15: These control centres are used to operate the pumps in Photo #14. There is a dedicated control for each pump.

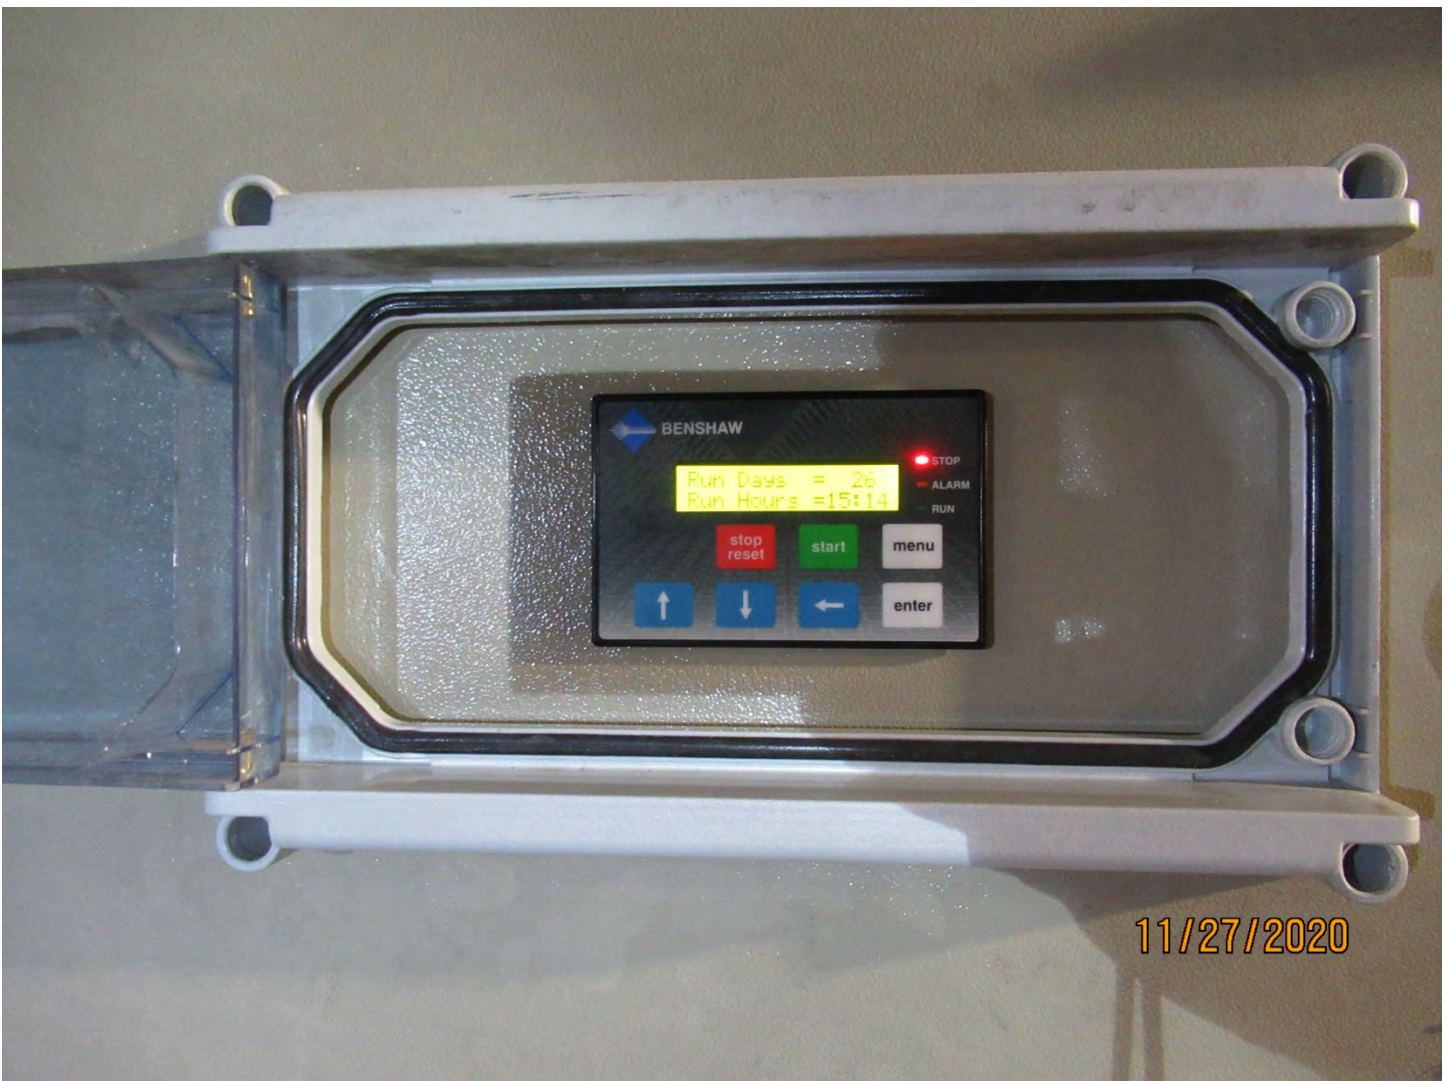
Photo 16: Water volumes pumped in the underground are currently calculated using these readings until flow meters are installed.

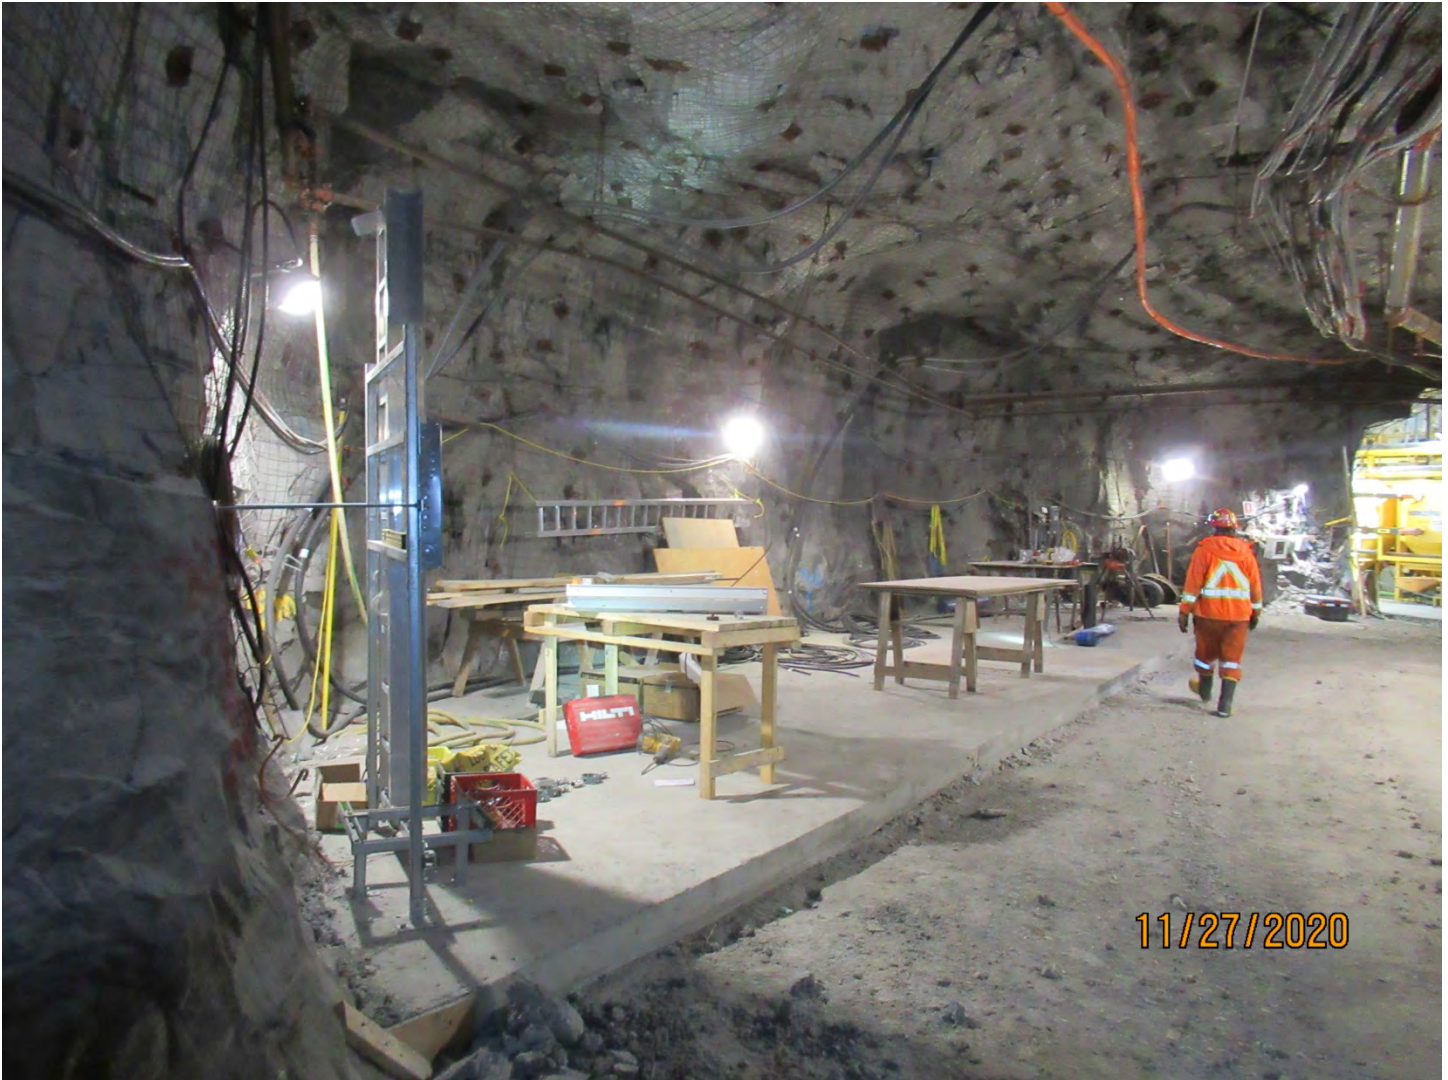
Photo 17: A compressor station will be installed on this concrete pad at the U/G 2150 Level.

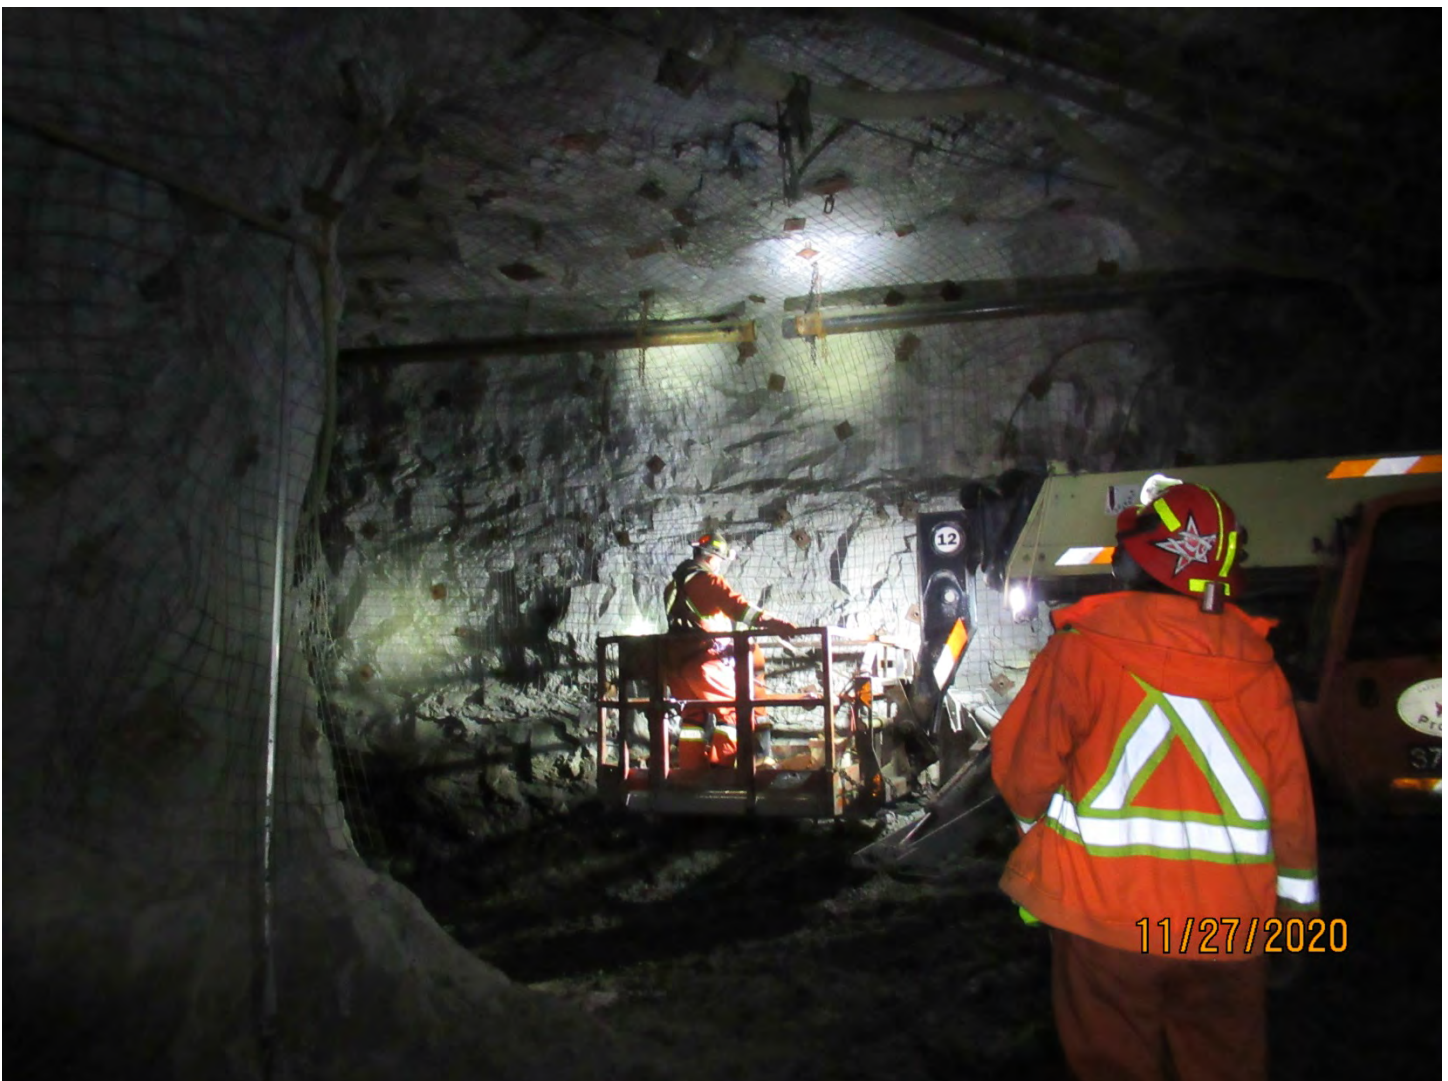
Photo 18: Crews were plumbing in water lines at the U/G 2100 Level.

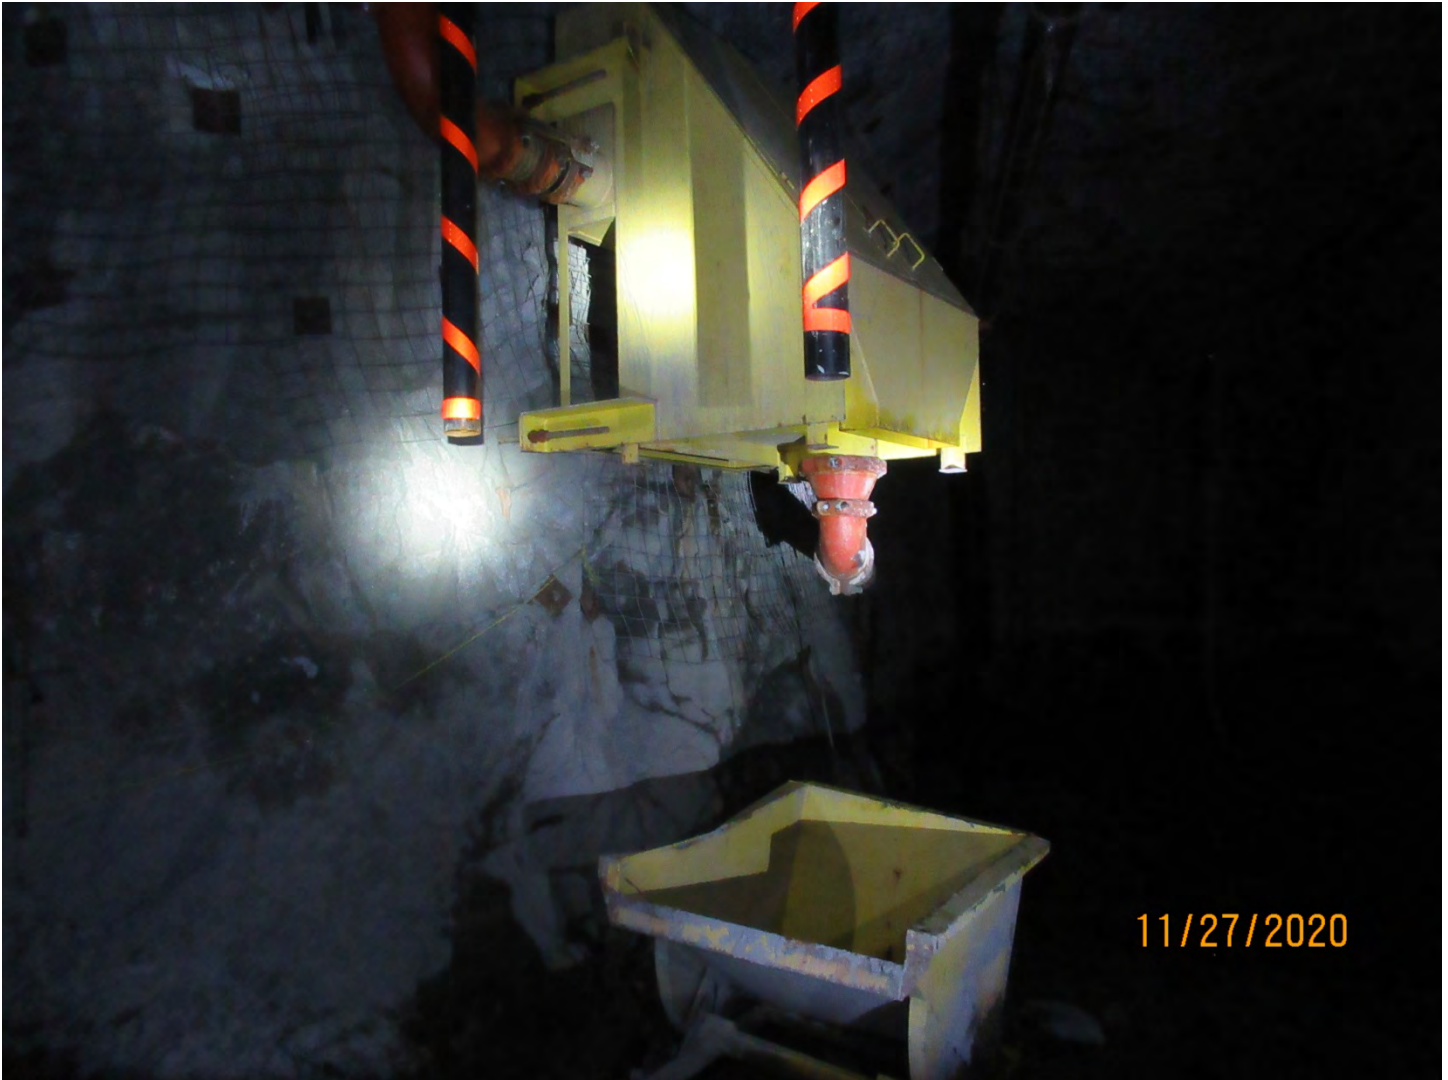
Photo 19: This screen is used to separate sediments and other debris from water in the underground.

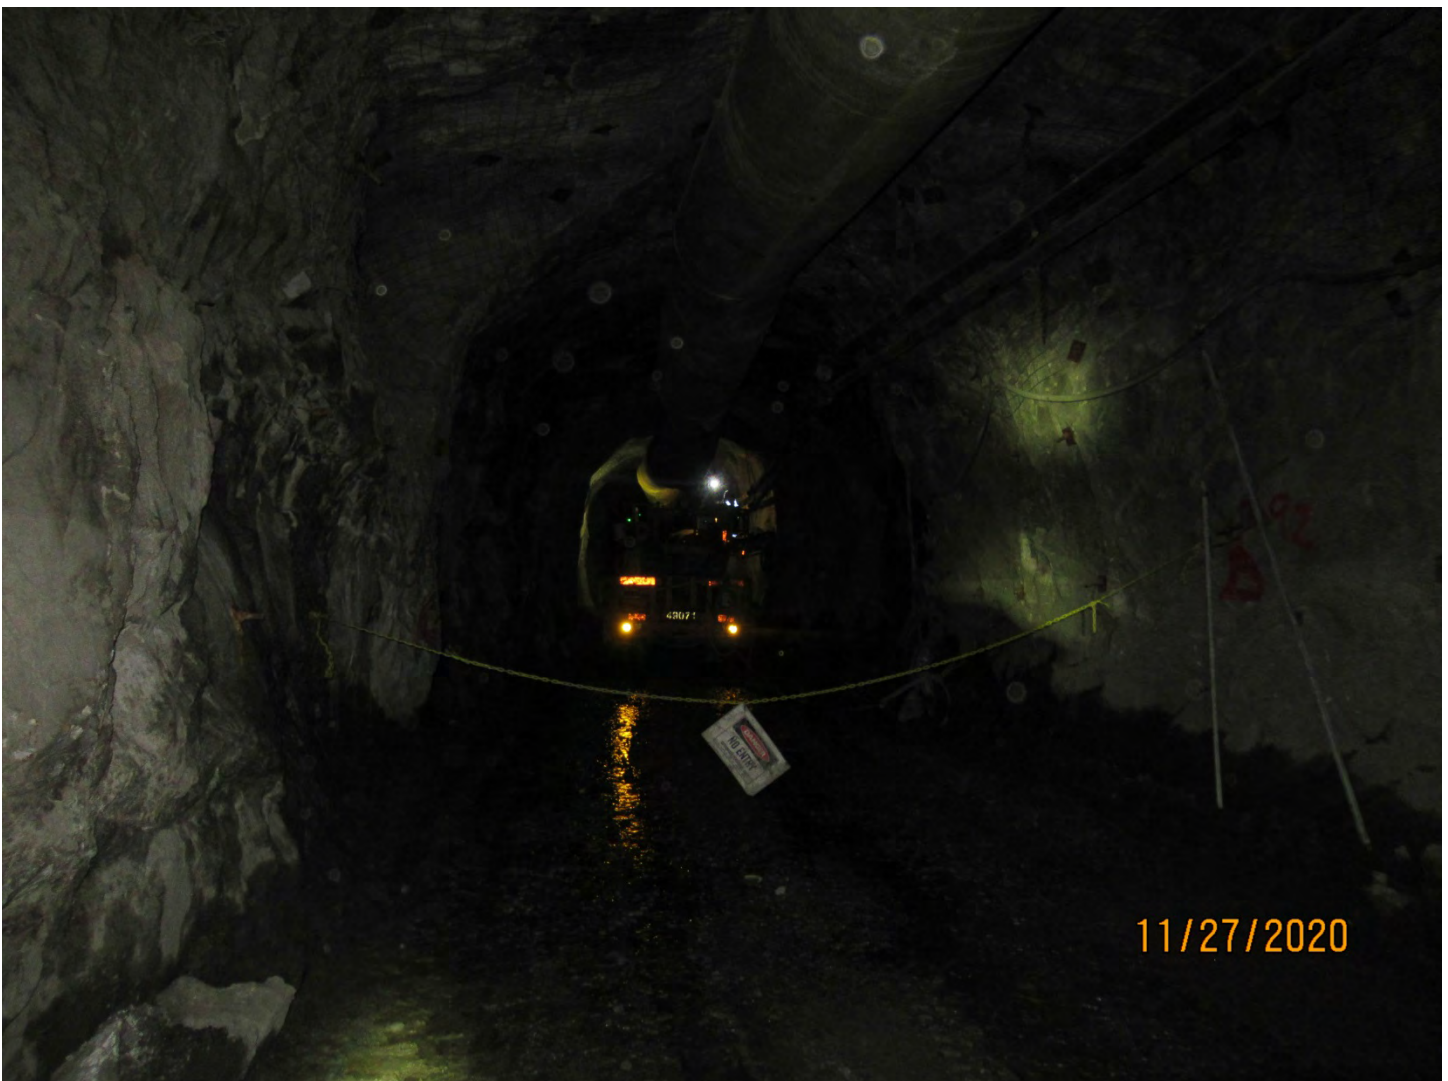
Photo 20: This Maclean Bolter was being used to hang screen at the U/G 2100 Level as part of the ongoing drift rehabilitation work.

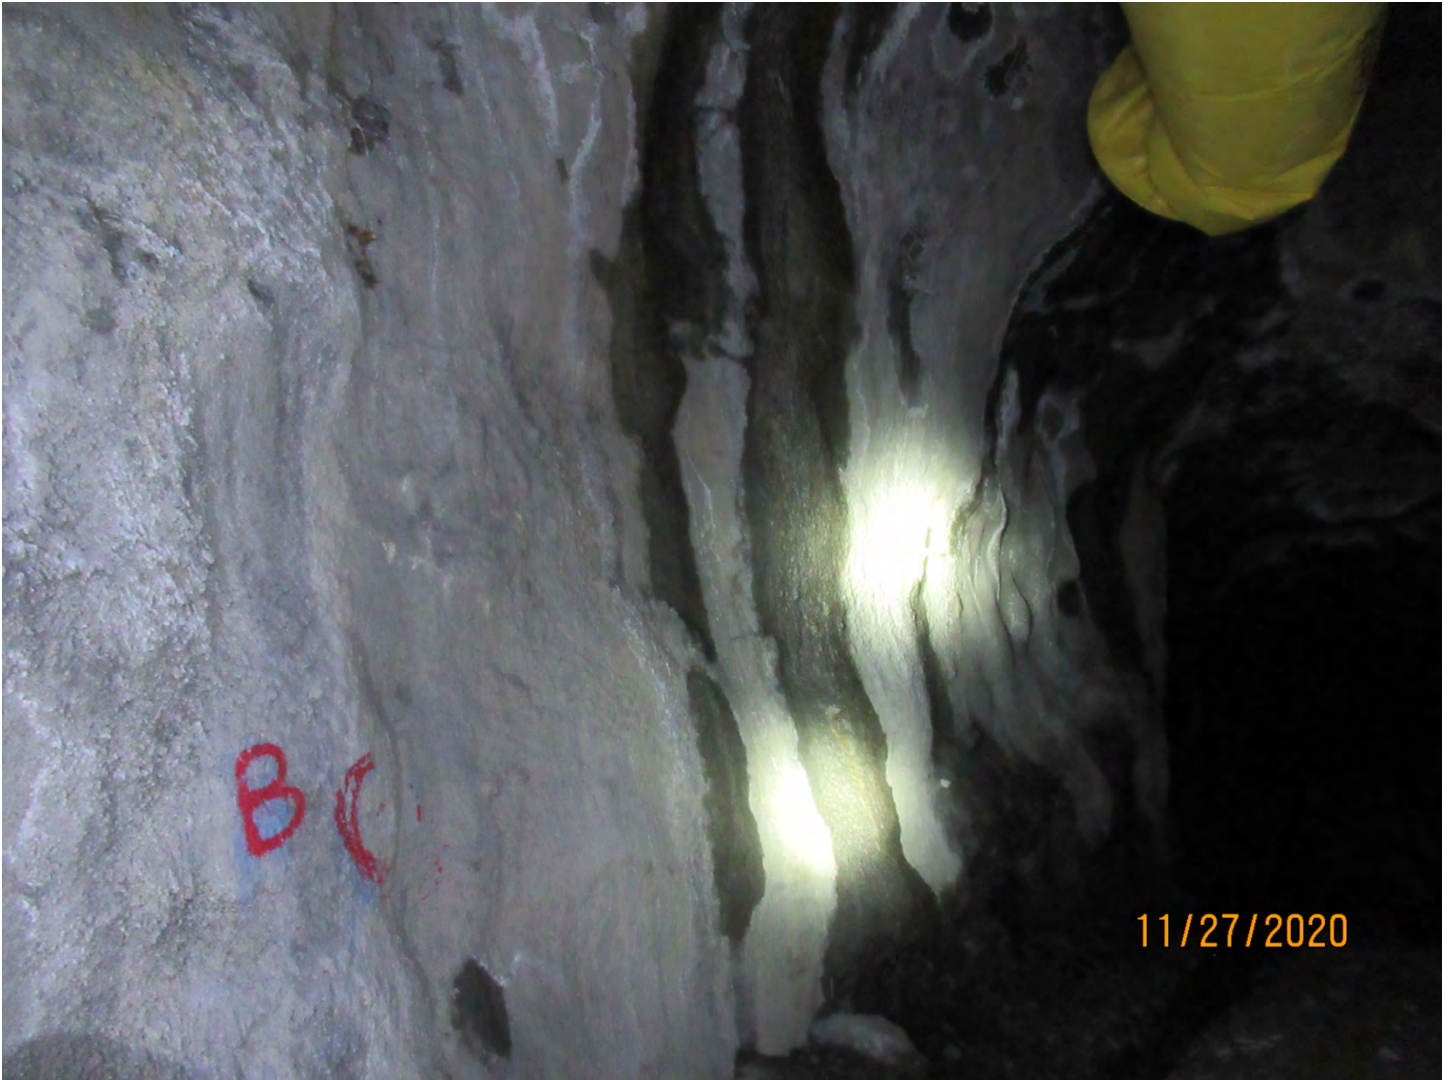
Ekati is currently operating under a temporary Care & Maintenance status and no mining of the Misery Underground (MUG) Project kimberlite pipe is occurring. However, crews continue to ensure mining readiness as evidenced by the ongoing development of the underground along with the installation of equipment that is used to support the underground operations (Photos #18 & #19). As seen in Photo #20, crews were using a MacLean Bolter to hang screen along the U/G 2100 Level production drifts as part of the ongoing drift rehabilitation activities (Photo #21).

Photo 21: As seen, shotcrete was being used to stabilize production drifts at the U/G 2100 Level. Soft vent lines are installed to ensure a proper air supply in working areas of the underground.

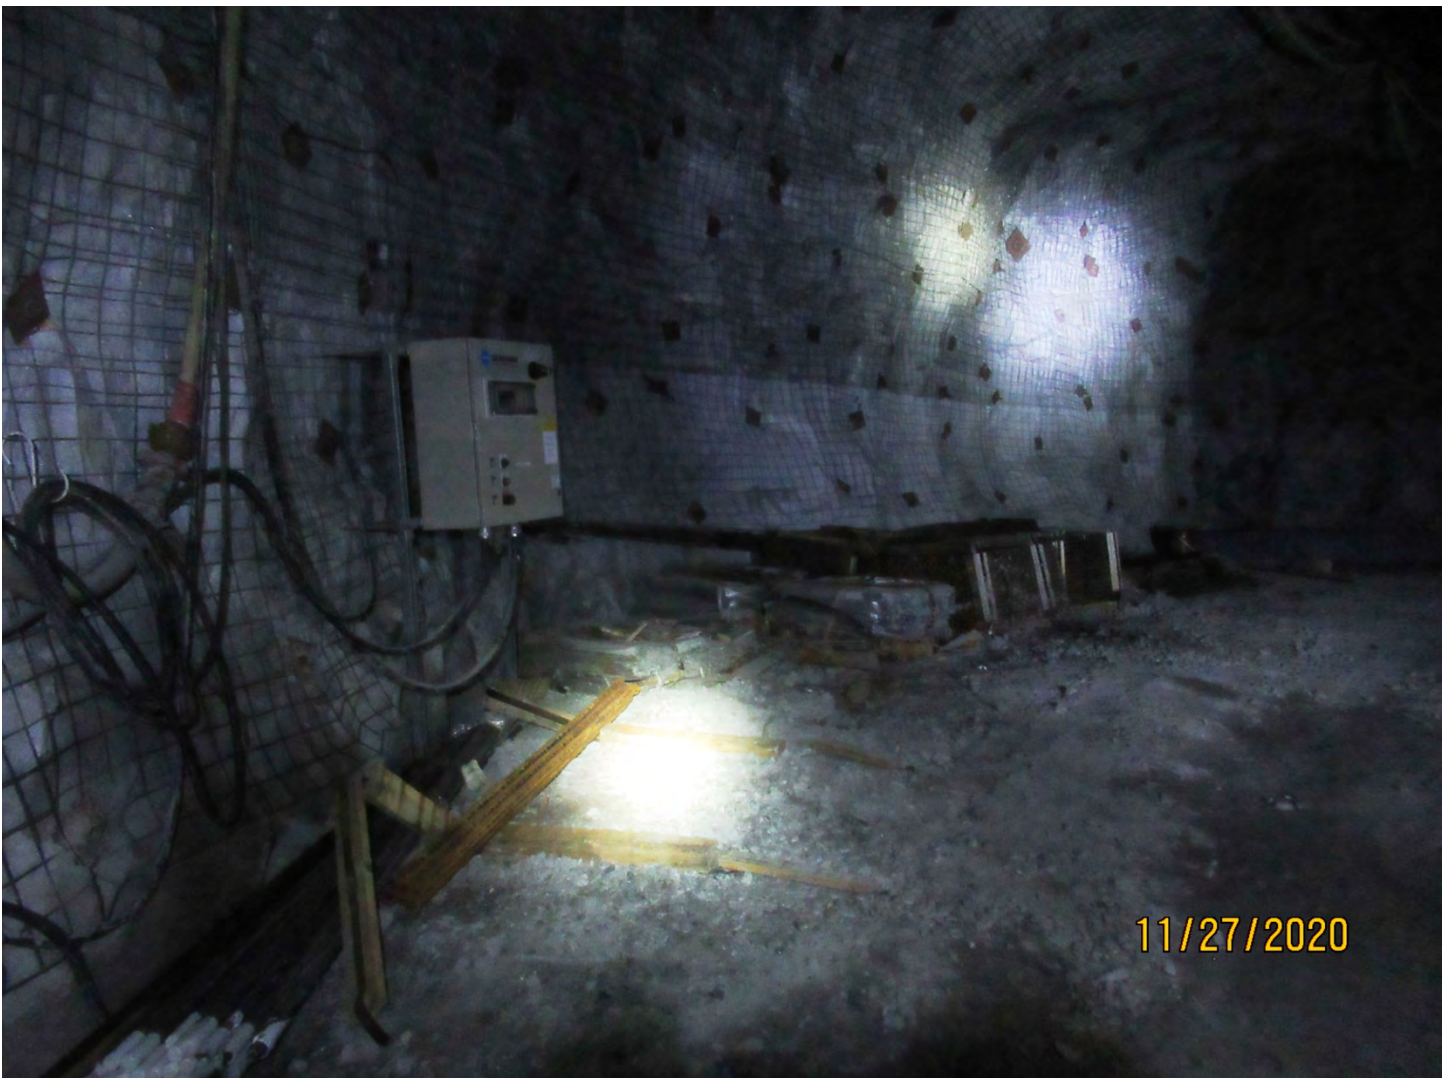
Once the mining of the kimberlite re-commences, crews will continue to drill, blast and remove ore from the U/G 2120 (Photos #22 & #23) and 2100 Levels and development will continue towards the U/G 2075 Level. Prior to the restart of active mining operations in the Ekati Diamond Mine Misery Underground Project, the Inspector is reminding the Permittee of the requirement to comply with all operating conditions attached to Land Use Permit W2017D0004. The Inspector did not note any major concerns regarding the underground operations.

Photo 22: These supplies used in drift rehabilitation activities are staged at the U/G 2120 Level.

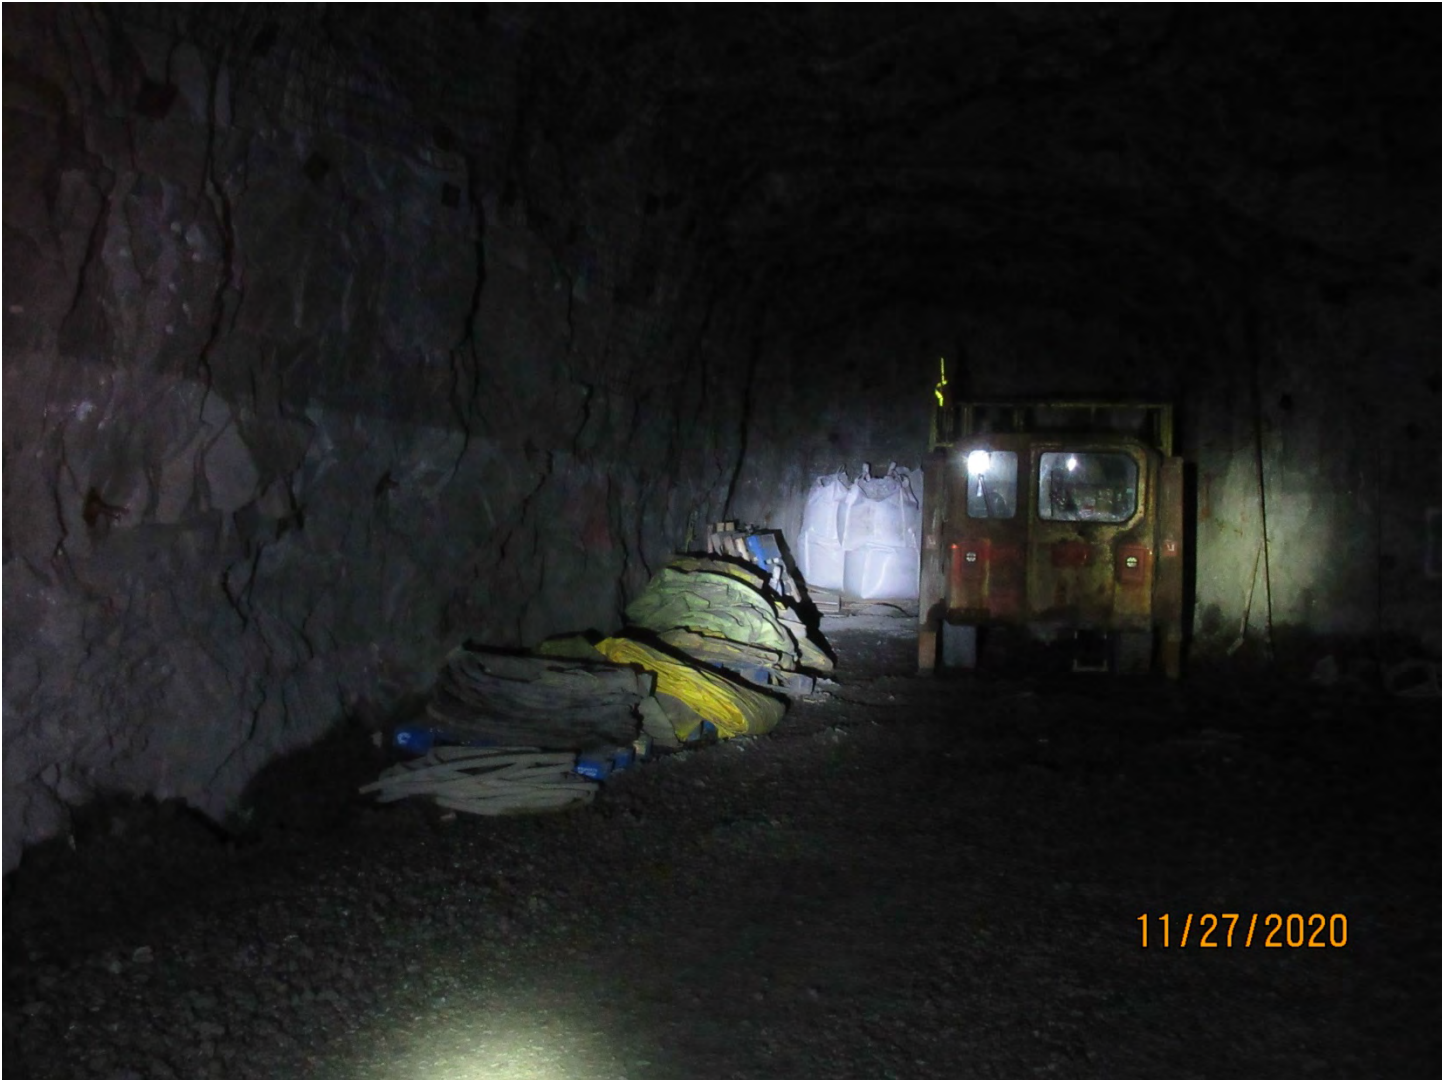
Photo 23: Bags of shotcrete and soft vent lines are also being staged at the U/G 2120 Level.

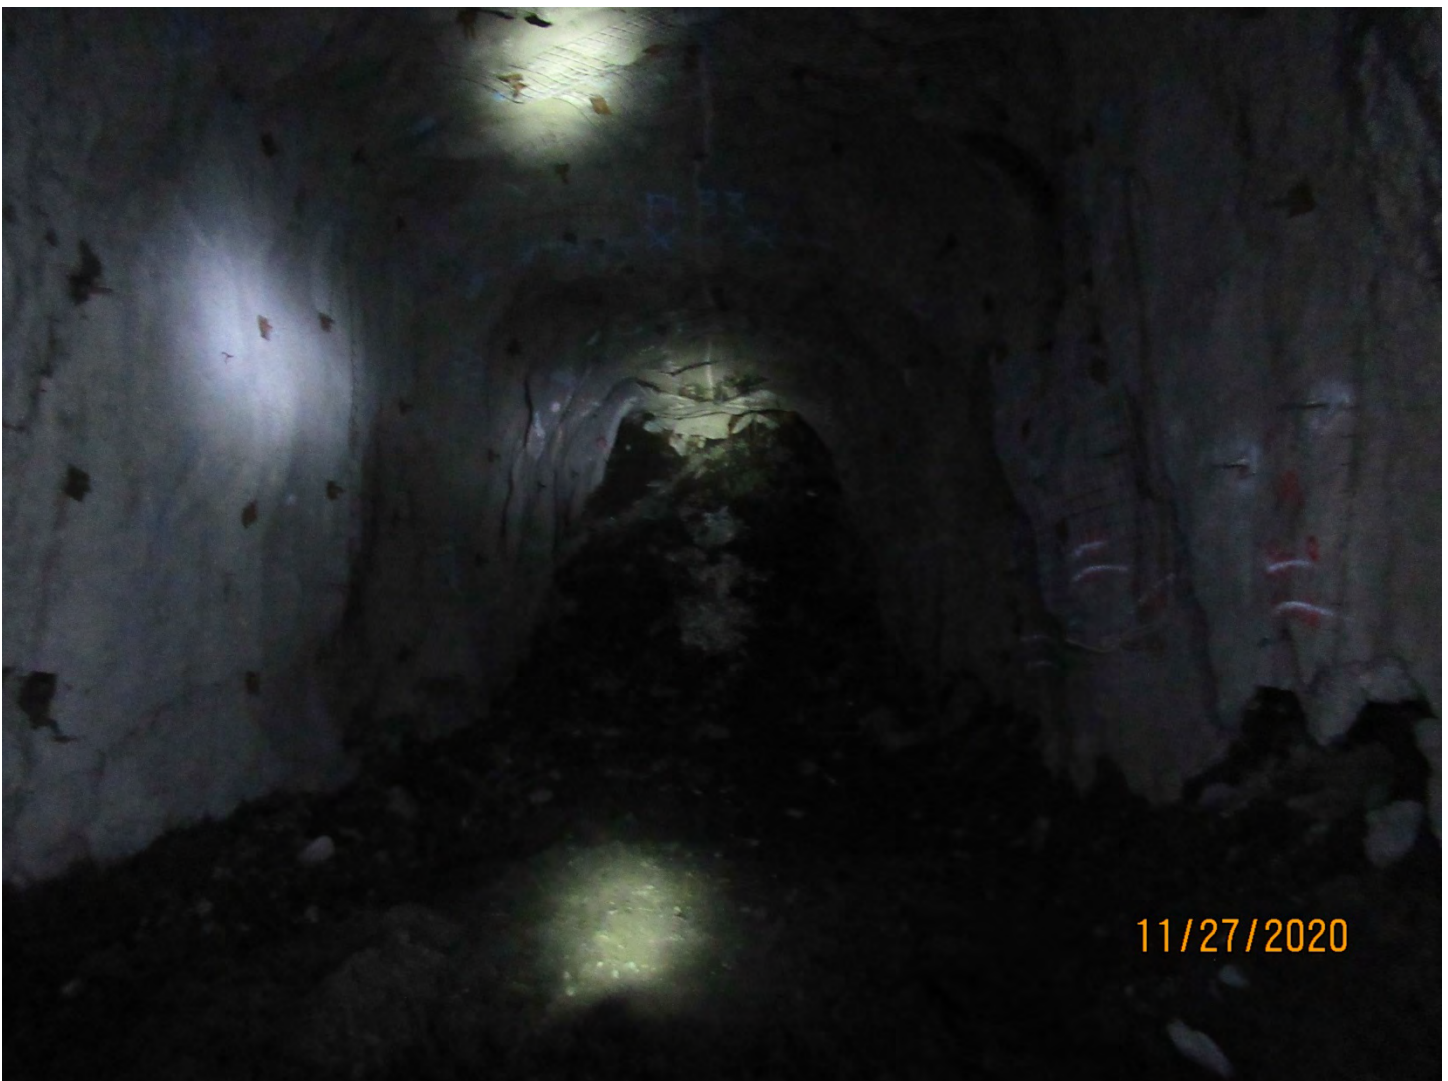
Prior to the mine entering its Care & Maintenance status in March 2020, drill patterns were established and holes were loaded with explosives in the production drifts. Once mining activities paused, the loaded blast holes were left in place. Upon the re-commencement of active mining of the kimberlite, new patterns will be established, loaded and blasted. The blast will generate enough heat to volatize the old explosives and help to remove any risk that may be associated with the old blast materials (Photo #24).

Photo 24: Blast patterns will be re-established at this production drift at the U/G 2100 Level.
