**Re: Land Use Permit W2017D0004
Mining & Associated Activities
Ekati Diamond Mine, Northwest Territories**

ENVIRONMENTAL INSPECTION REPORT

Permittee:	Dominion Diamond Ekati – Misery Underground	Inspection Dates: October 18 th , 2018
------------	---	---

Location(s) Inspected:	The Ekati Mine Misery Underground Project and Misery Camp expansion including site roads and laydown areas.
------------------------	---

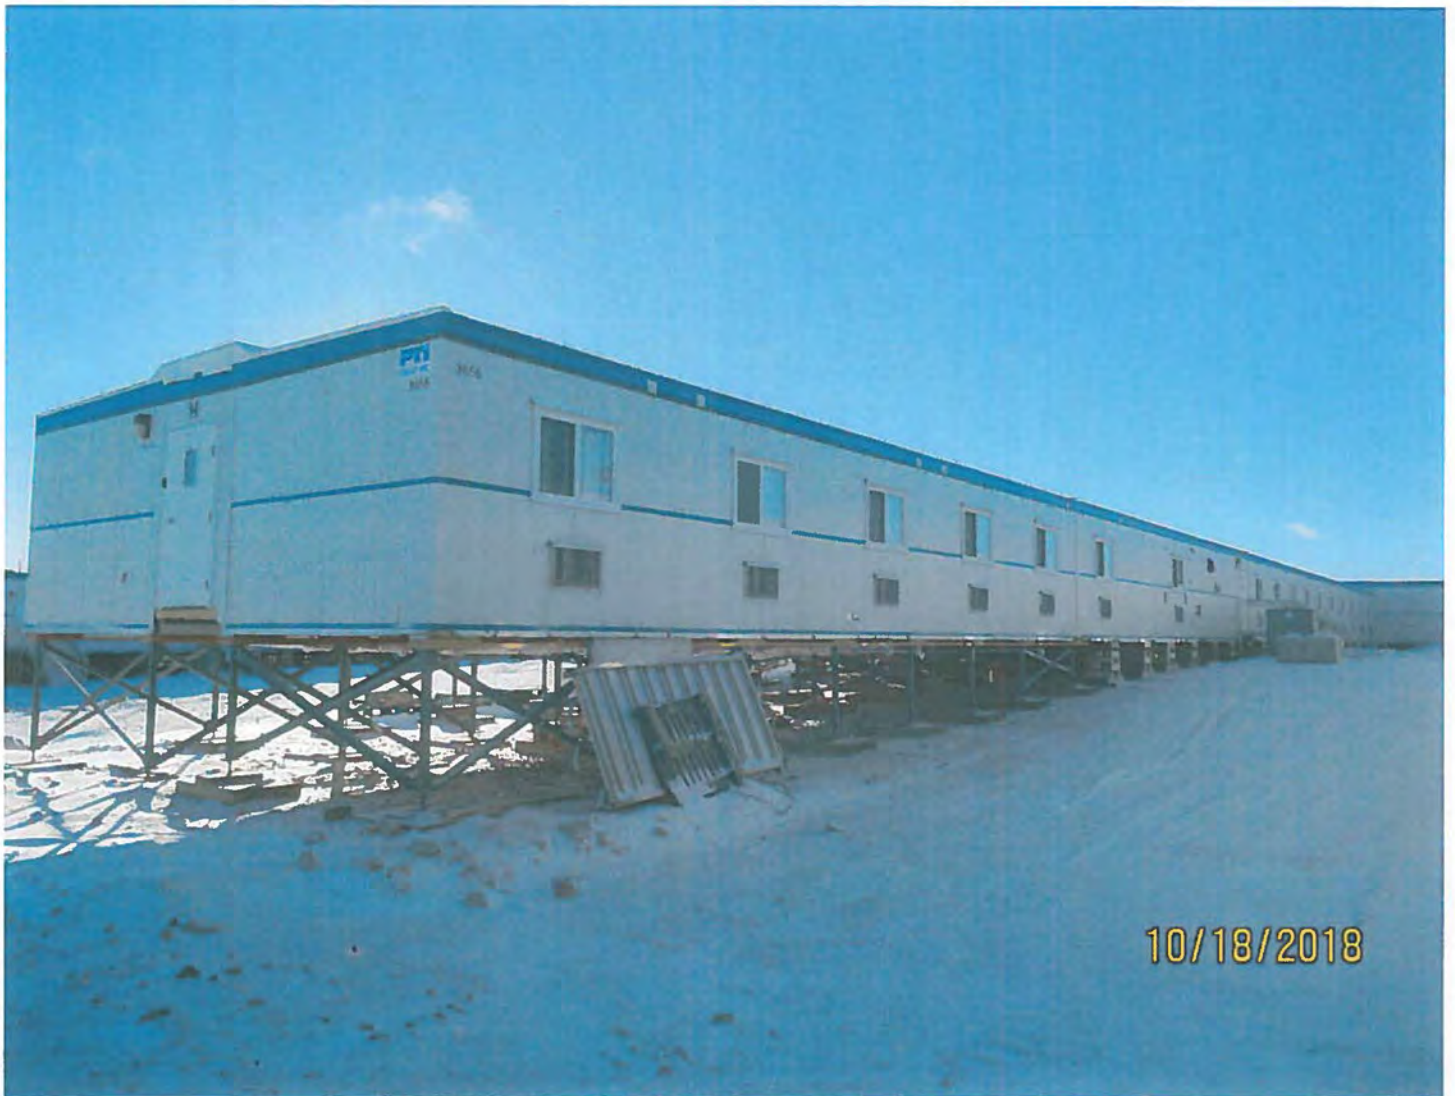
Photo #1 - W2017D0004 MUG Project

Accommodations buildings to house extra personnel to support the Misery Underground Project are still under construction.

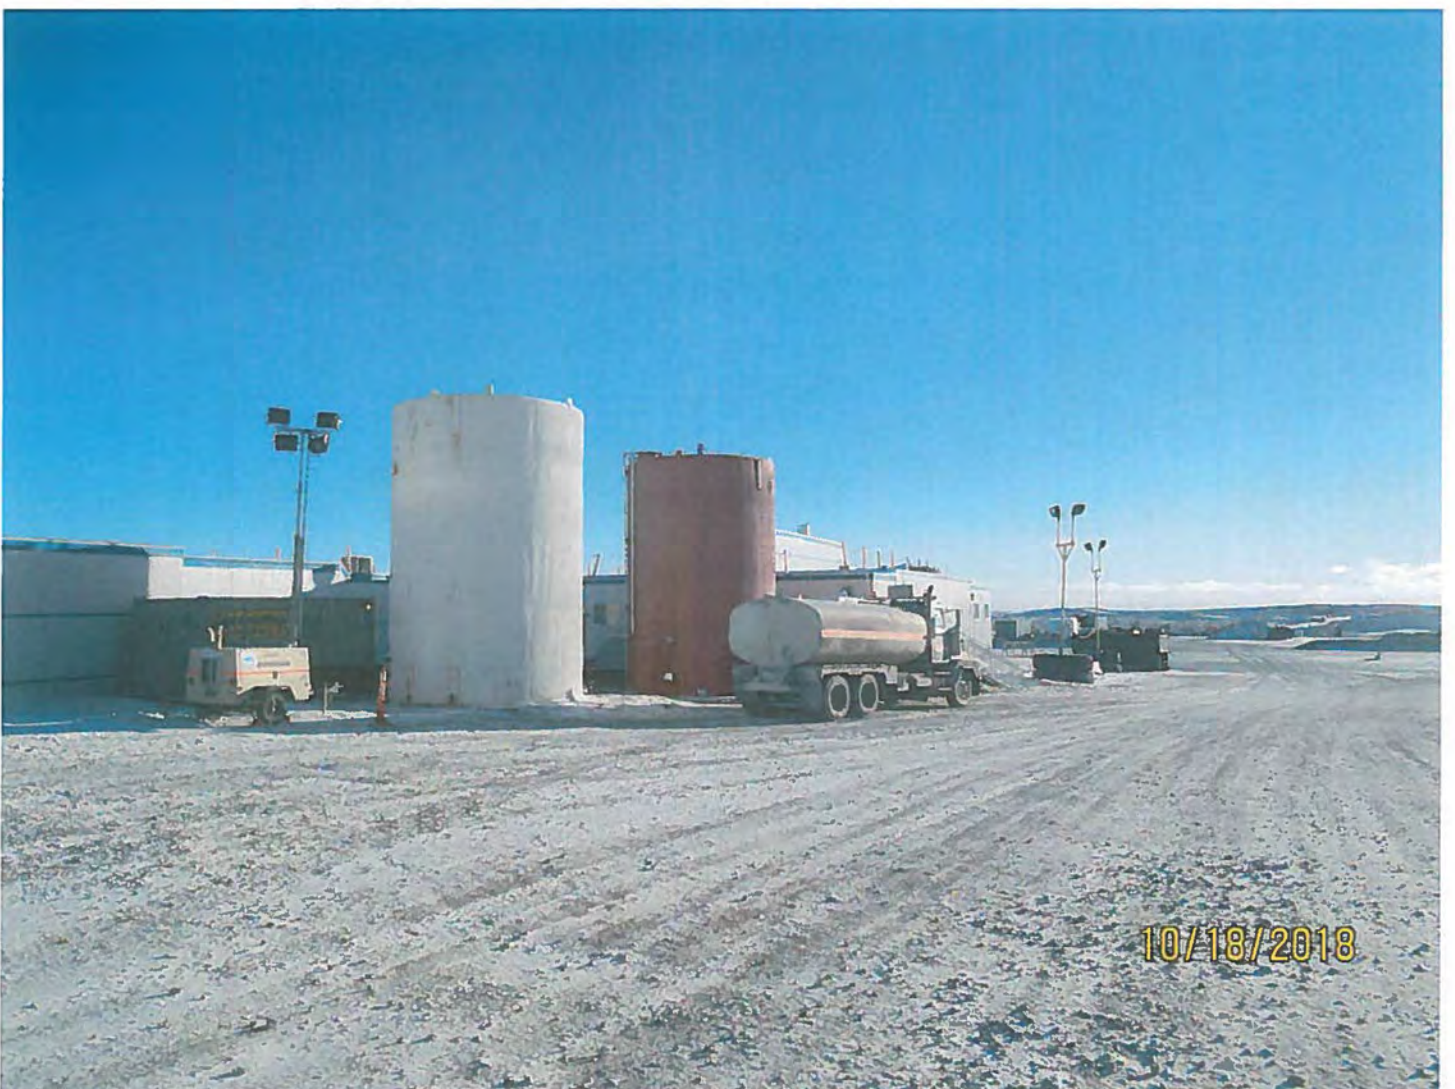
Photo #2 - W2017D0004 MUG Project

These tanks will be used to hold potable water (white) and fire suppression water (red).

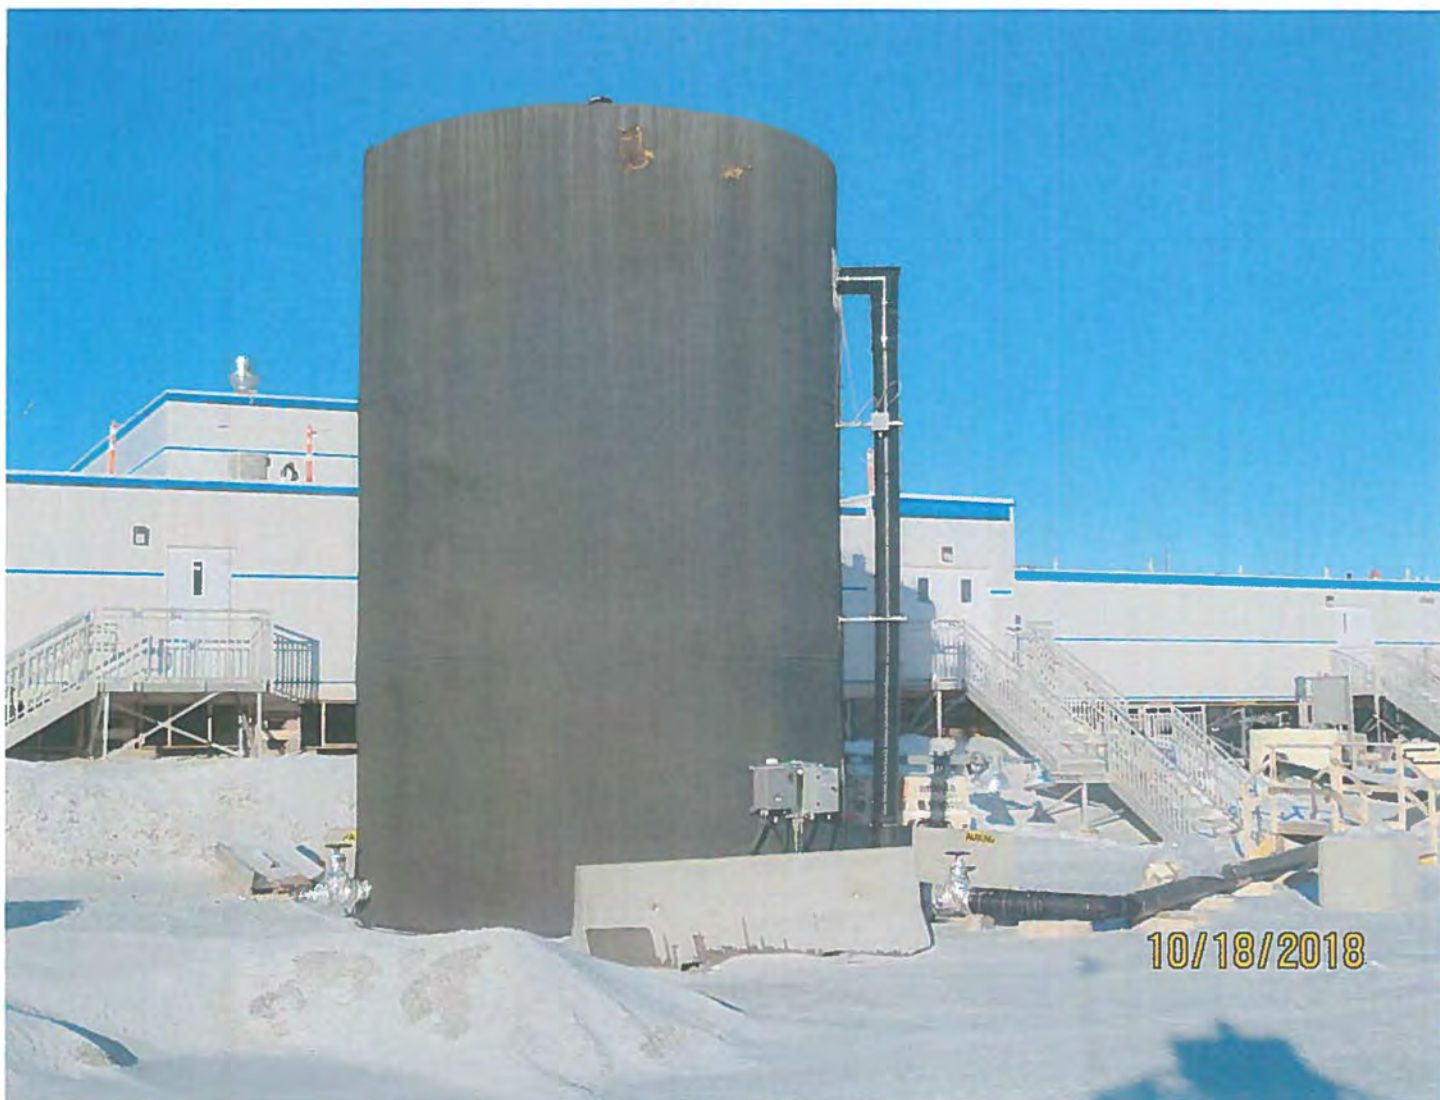
Photo #3 - W2017D0004 MUG Project
This sewage holding tank is located west of the new accommodations buildings.

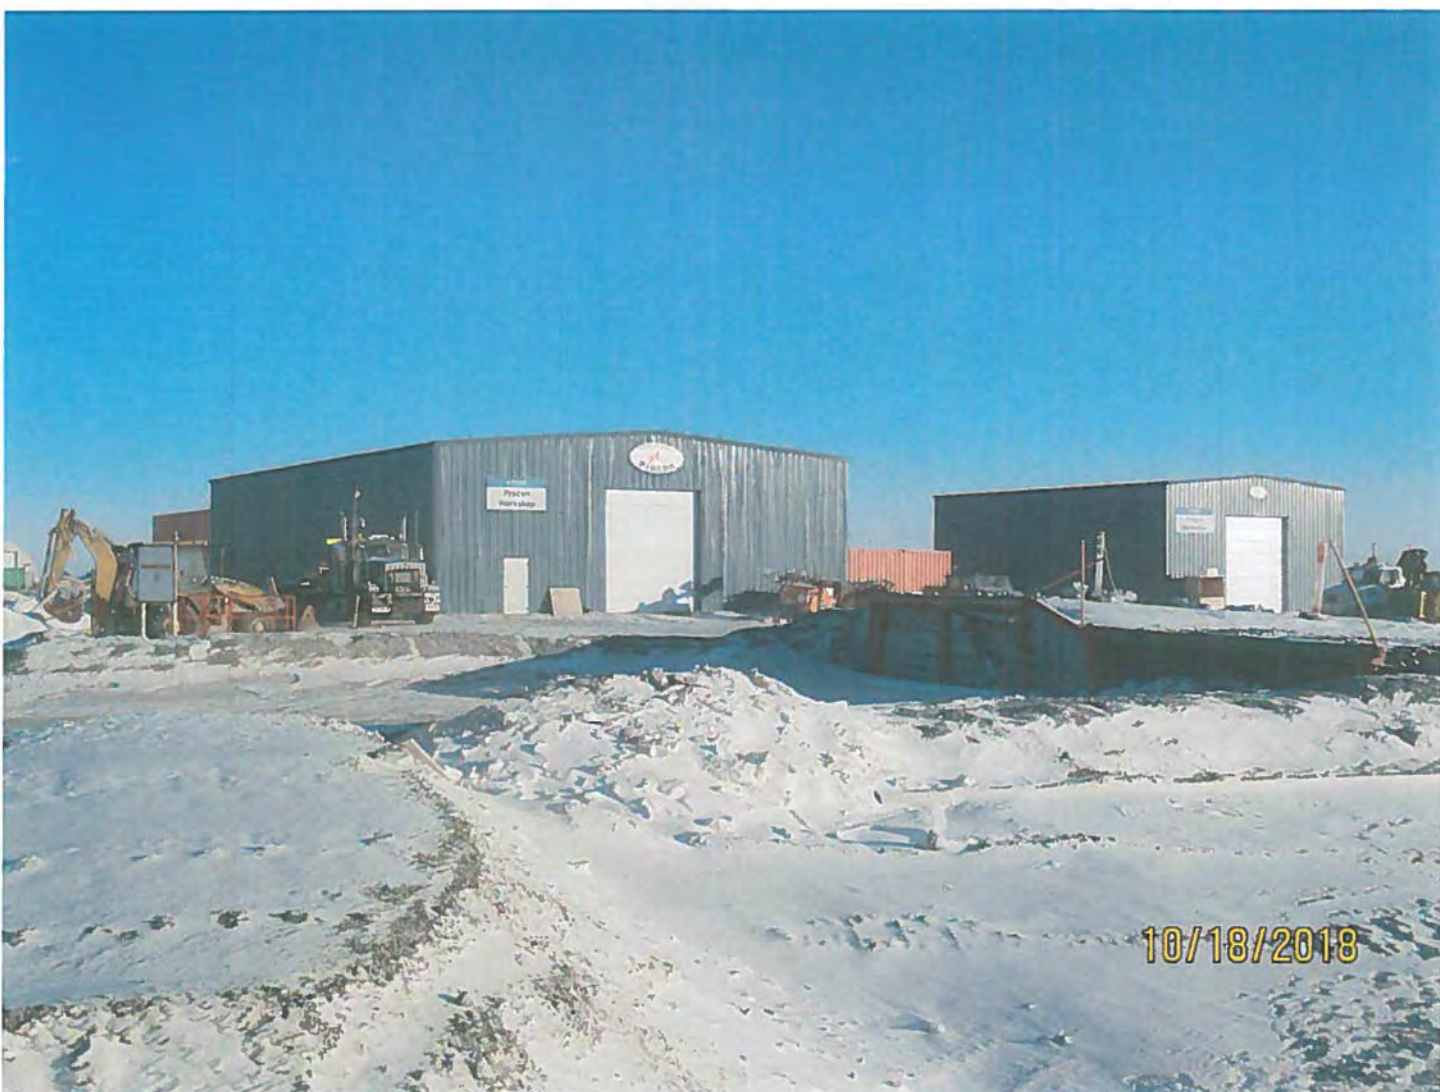
Photo #4 - W2017D0004 MUG Project
The welding shop (left) and cold storage building (right) are located on the west of the Misery Camp compound.

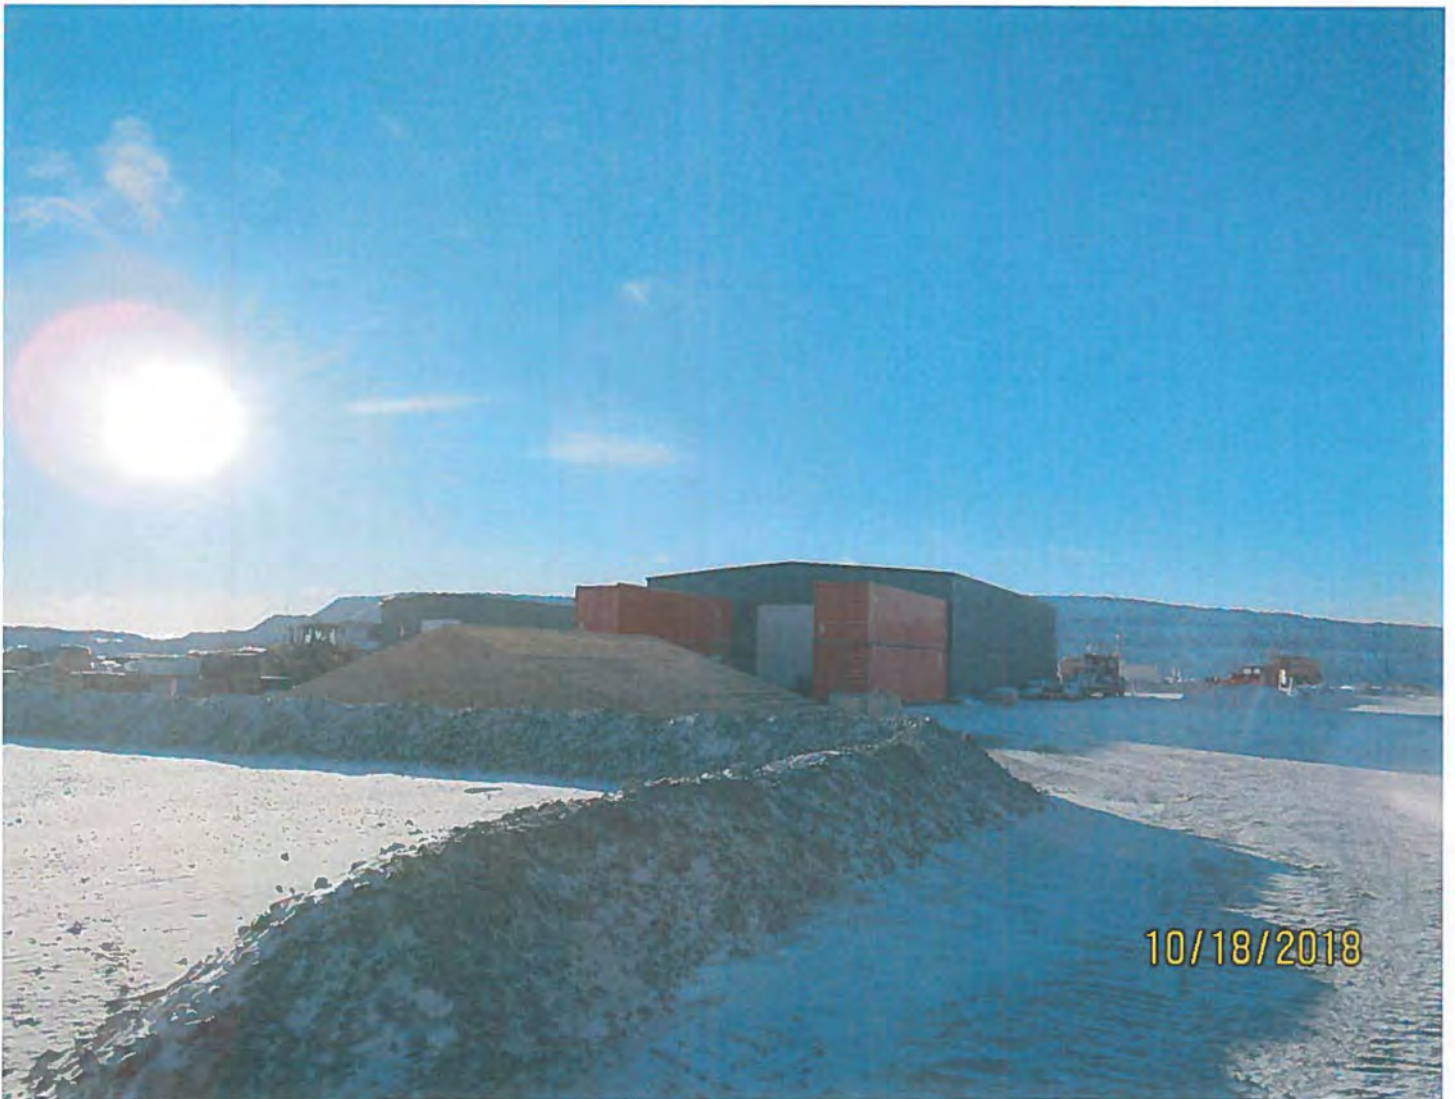
Photo #5 - W2017D0004 MUG Project

The camp welding shop was being expanded. Seacans and a roof can be seen in the photo.

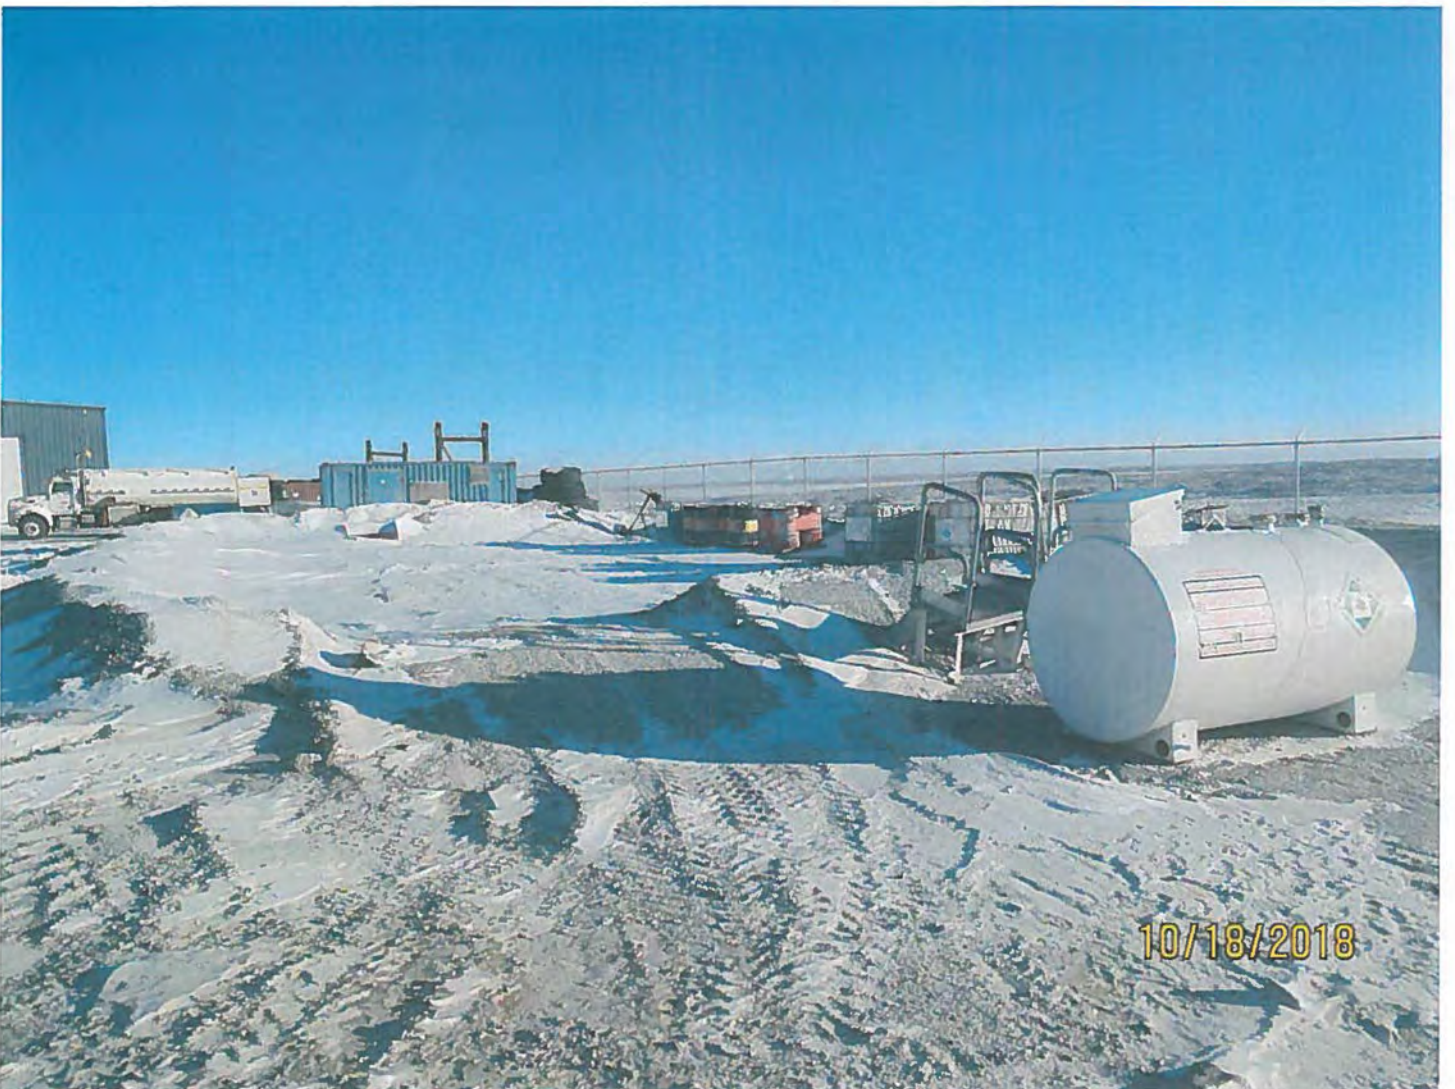
Photo #6 - W2017D0004 MUG Project

Items in the laydown north of the cold storage appeared to be properly staged and labeled.

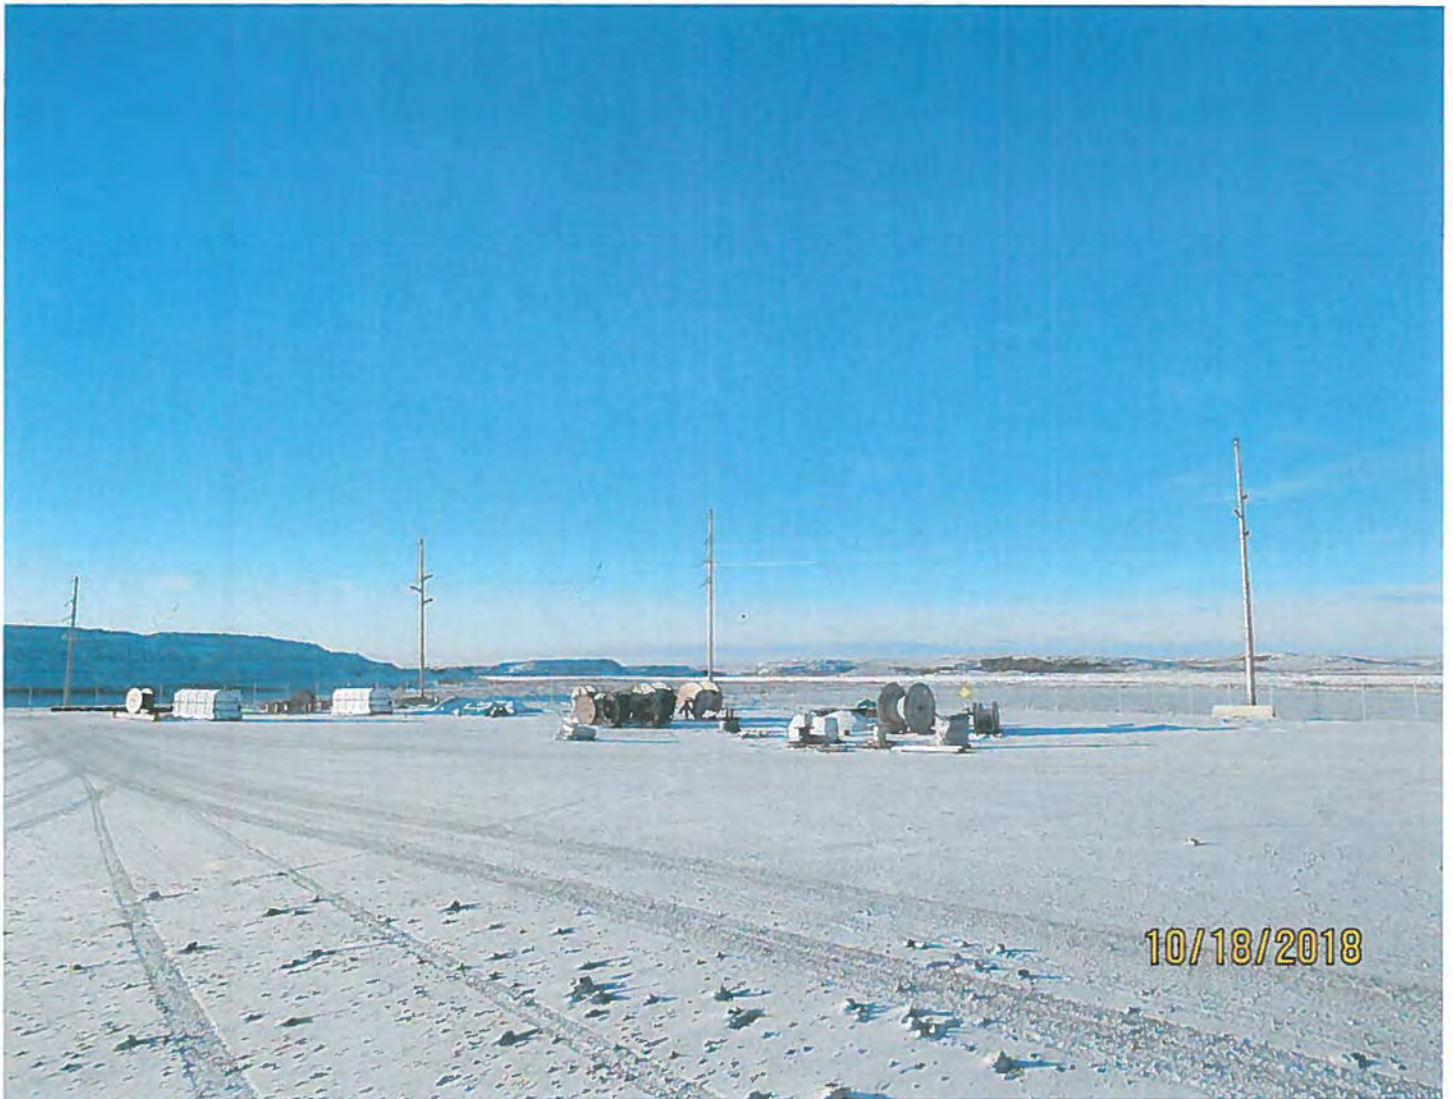
Photo #7 - W2017D0004 MUG Project
There were a minimal amount of materials staged in laydown in the northeast of the Misery Camp compound.

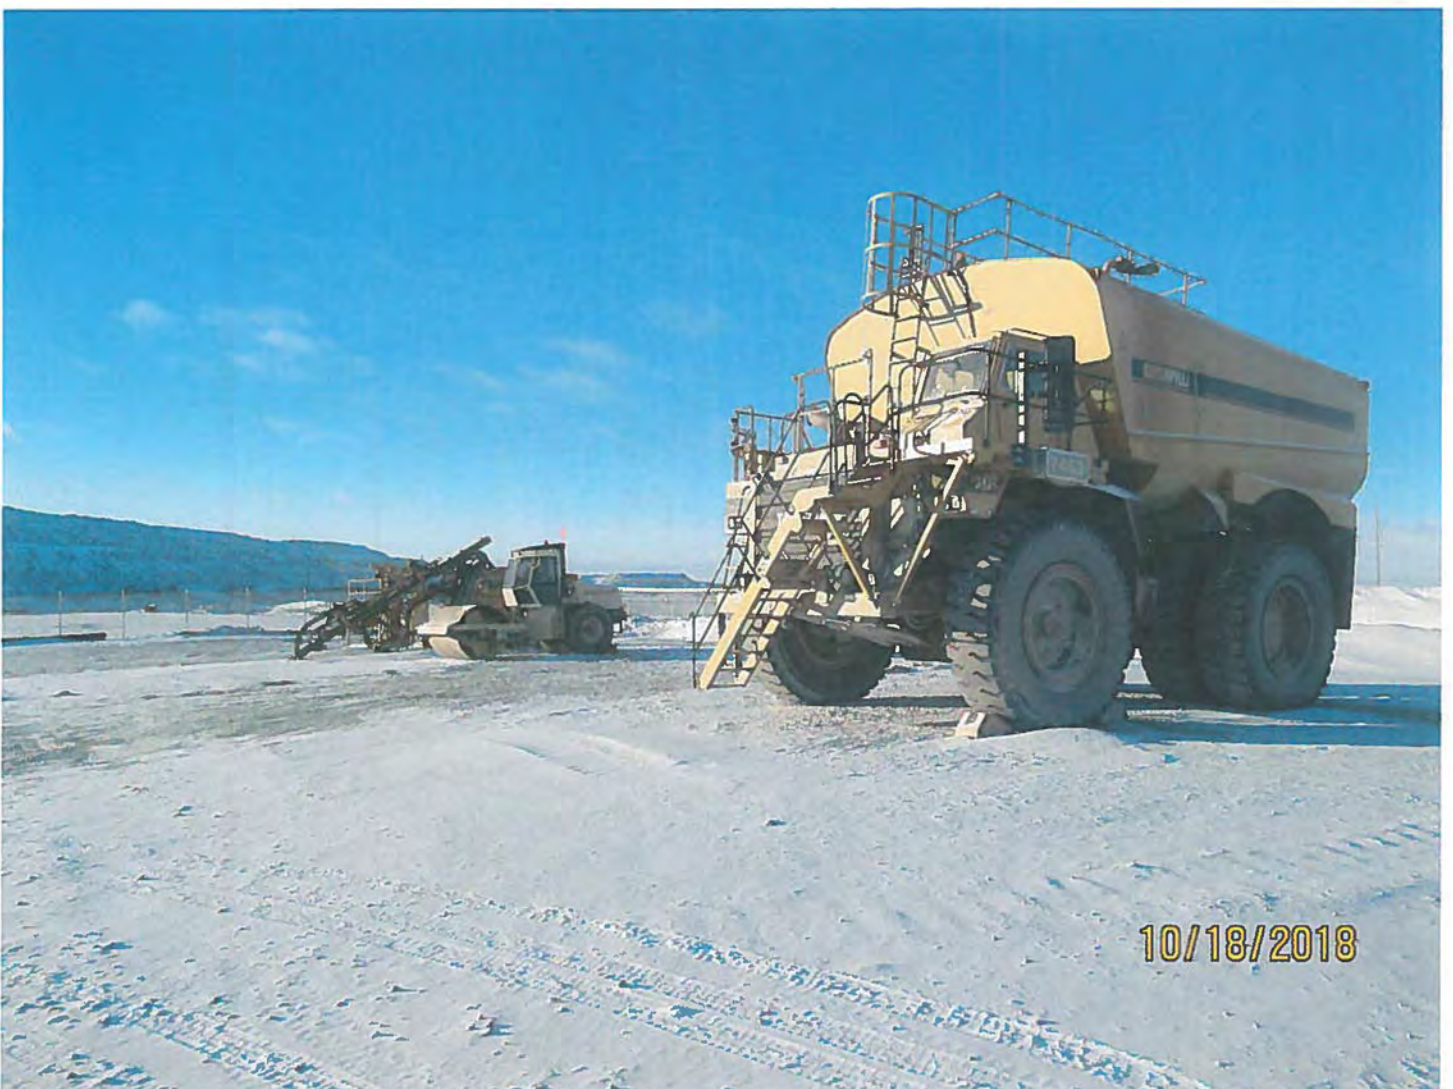
Photo #8 - W2017D0004 MUG Project
Looking north at the heavy equipment laydown.

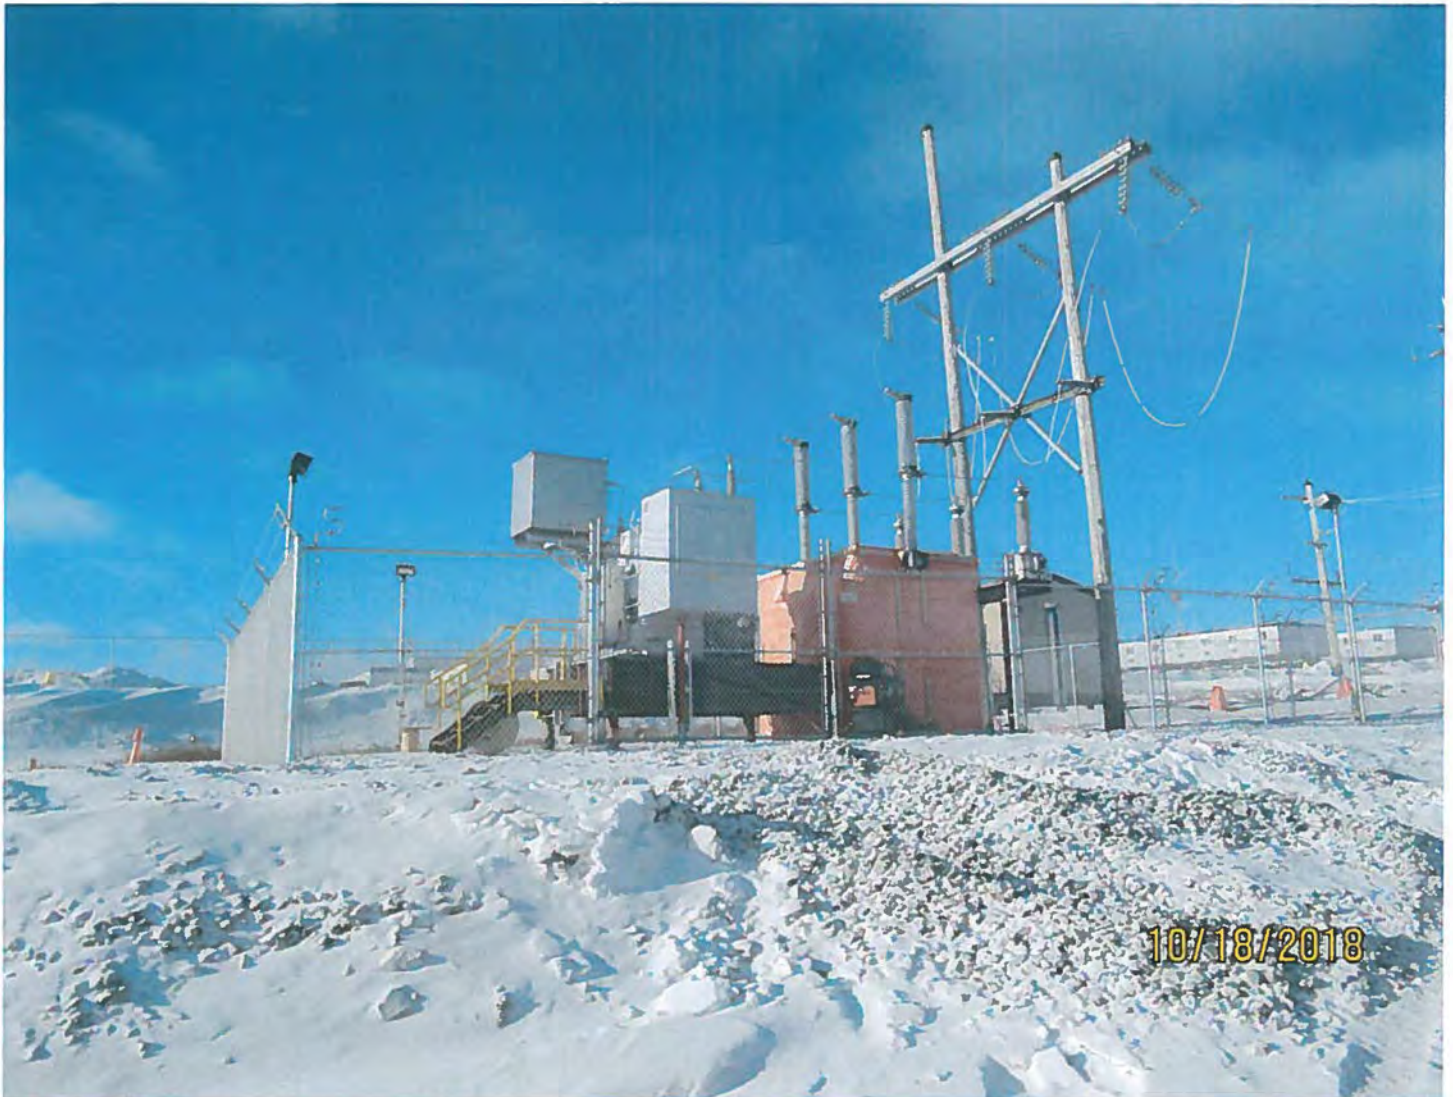
Photo #9 - W2017D0004 MUG Project
Electricity from the main camp reports to this transformer and is stepped down to five (5) kilovolts prior to use in the MUG Project.

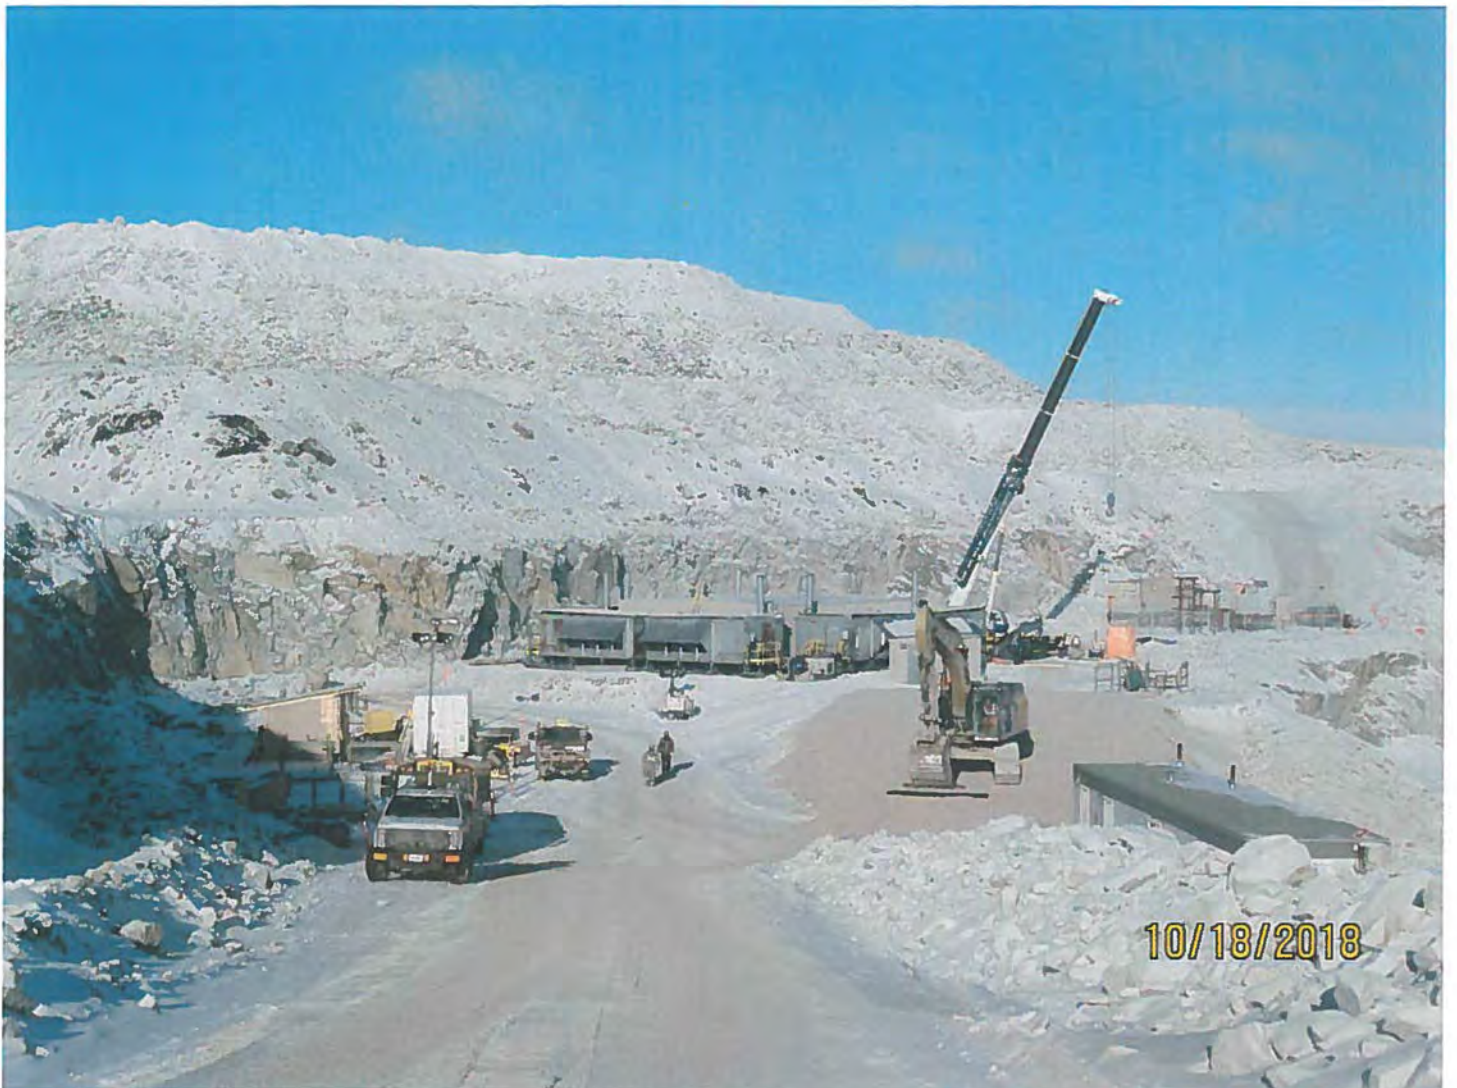
Photo #10 - W2017D0004 MUG Project
Construction of the FAR building and electrical transformer (far right) along the Misery Pit 440 Bench.

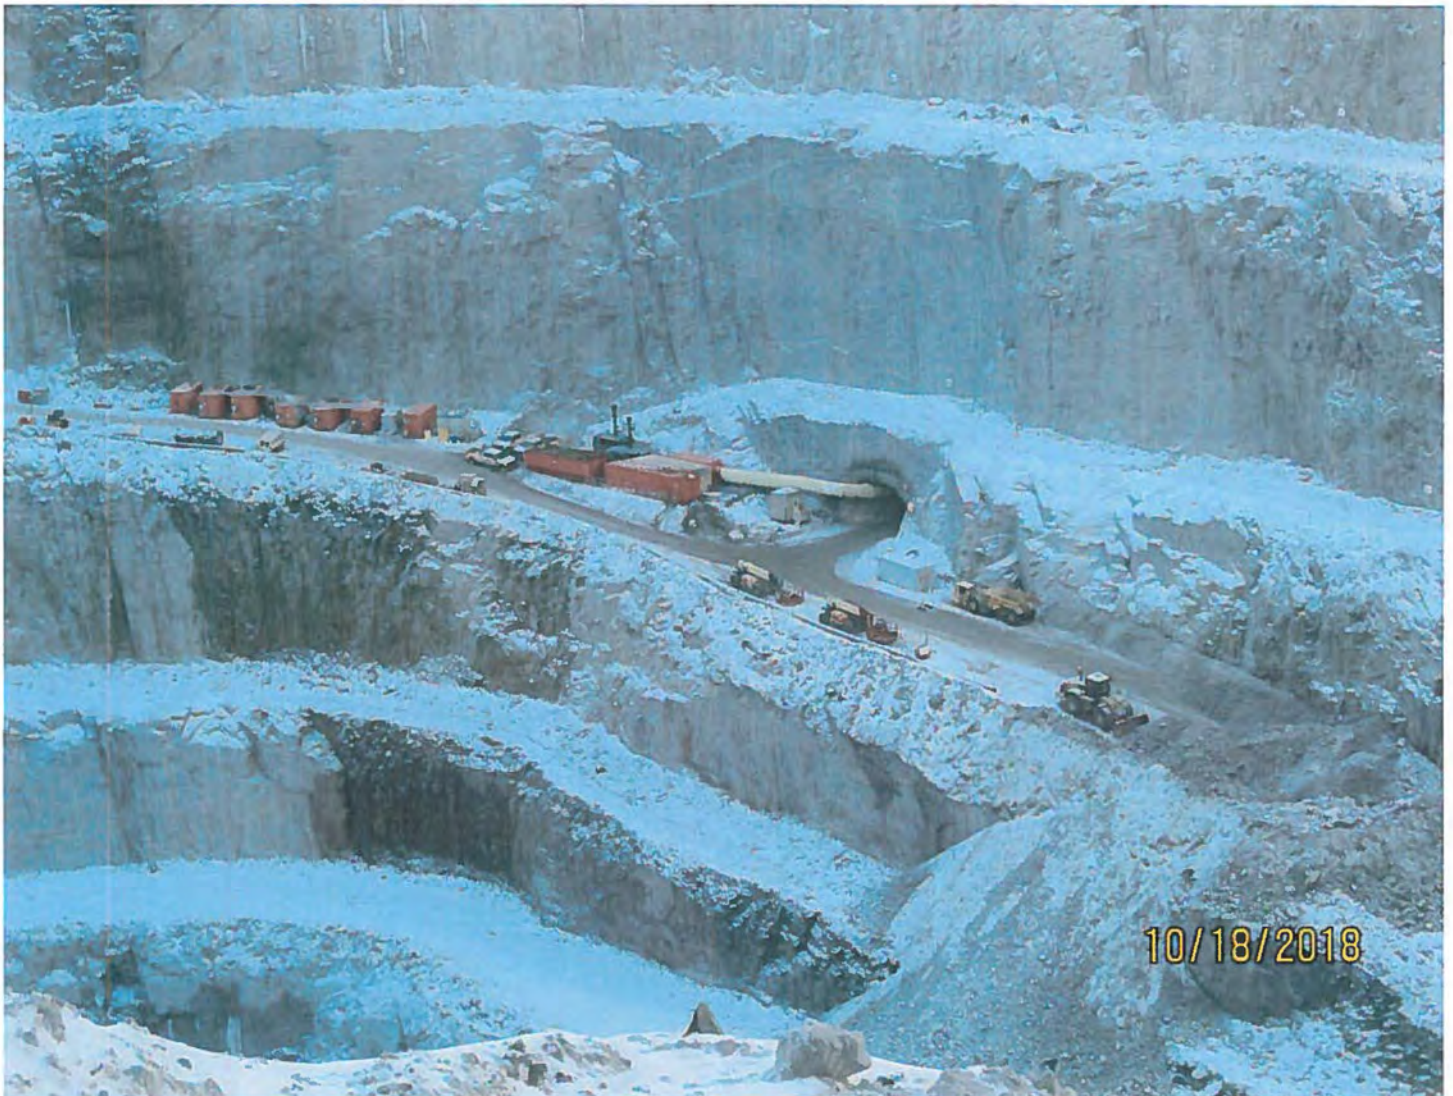
Photo #11 - W2017D0004 MUG Project
Looking down at the 2235 Portal. A rock disposal area into Misery Pit can be seen in the bottom-right of the photo.

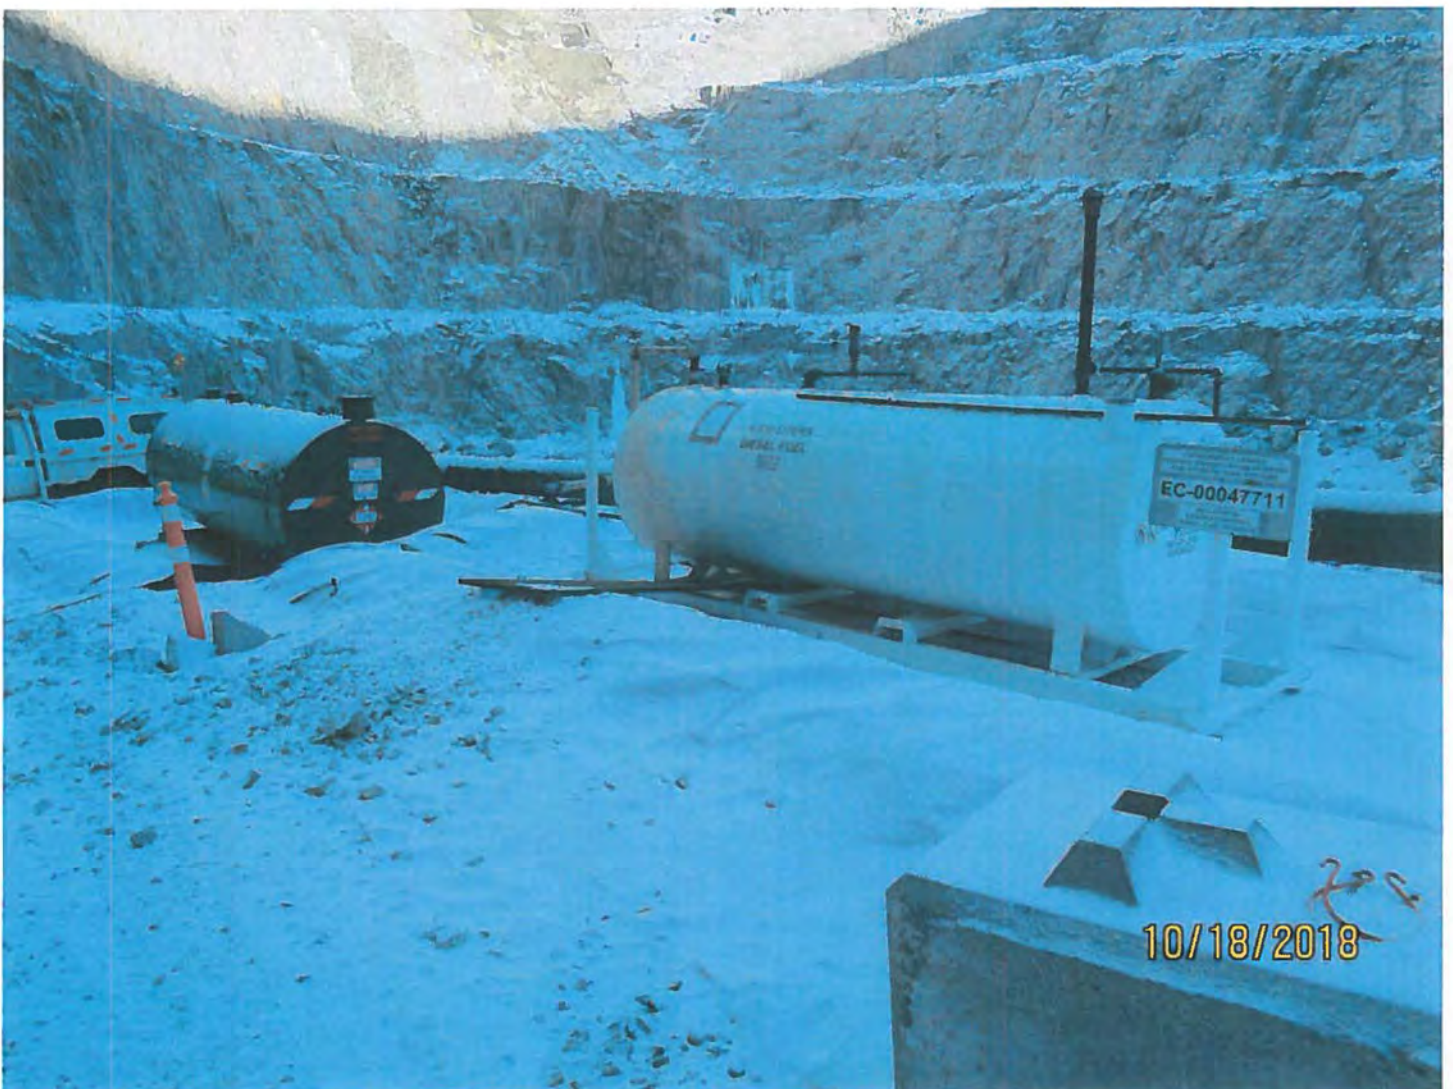
Photo #12 - W2017D0004 MUG Project
The 4,530 L tank staged on the ramp adjacent to the 2235 Portal (right) will be decommissioned & removed.

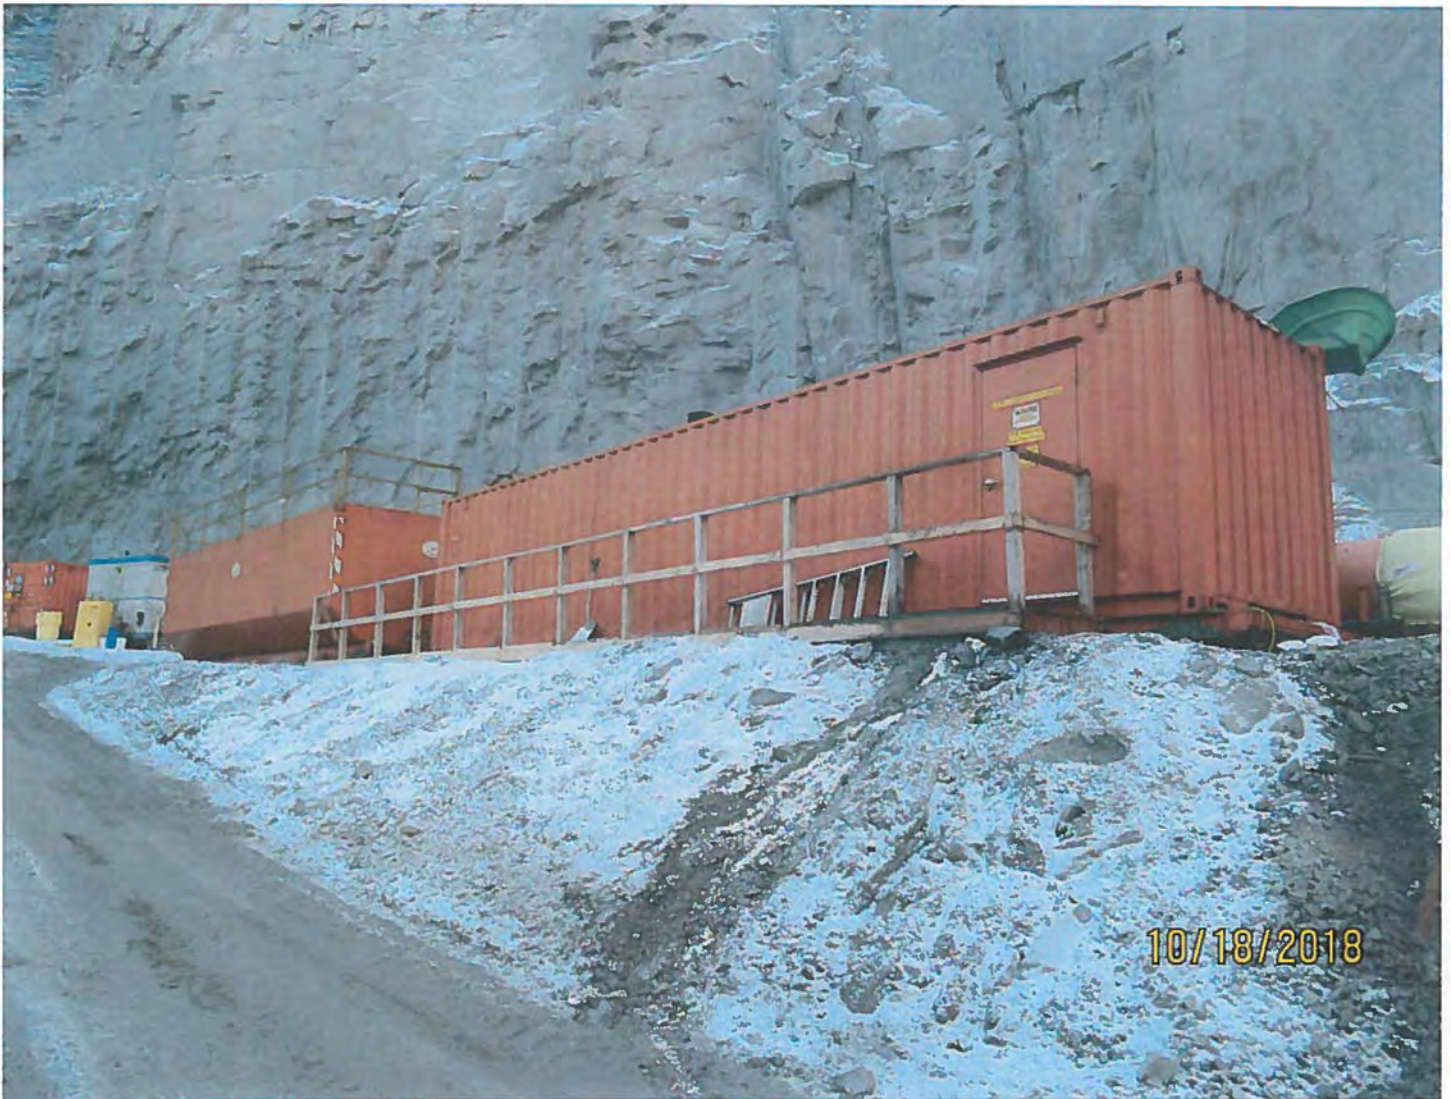
Photo #13 - W2017D0004 MUG Project
The mud (left) & brine (right) tanks used for underground water management activities.

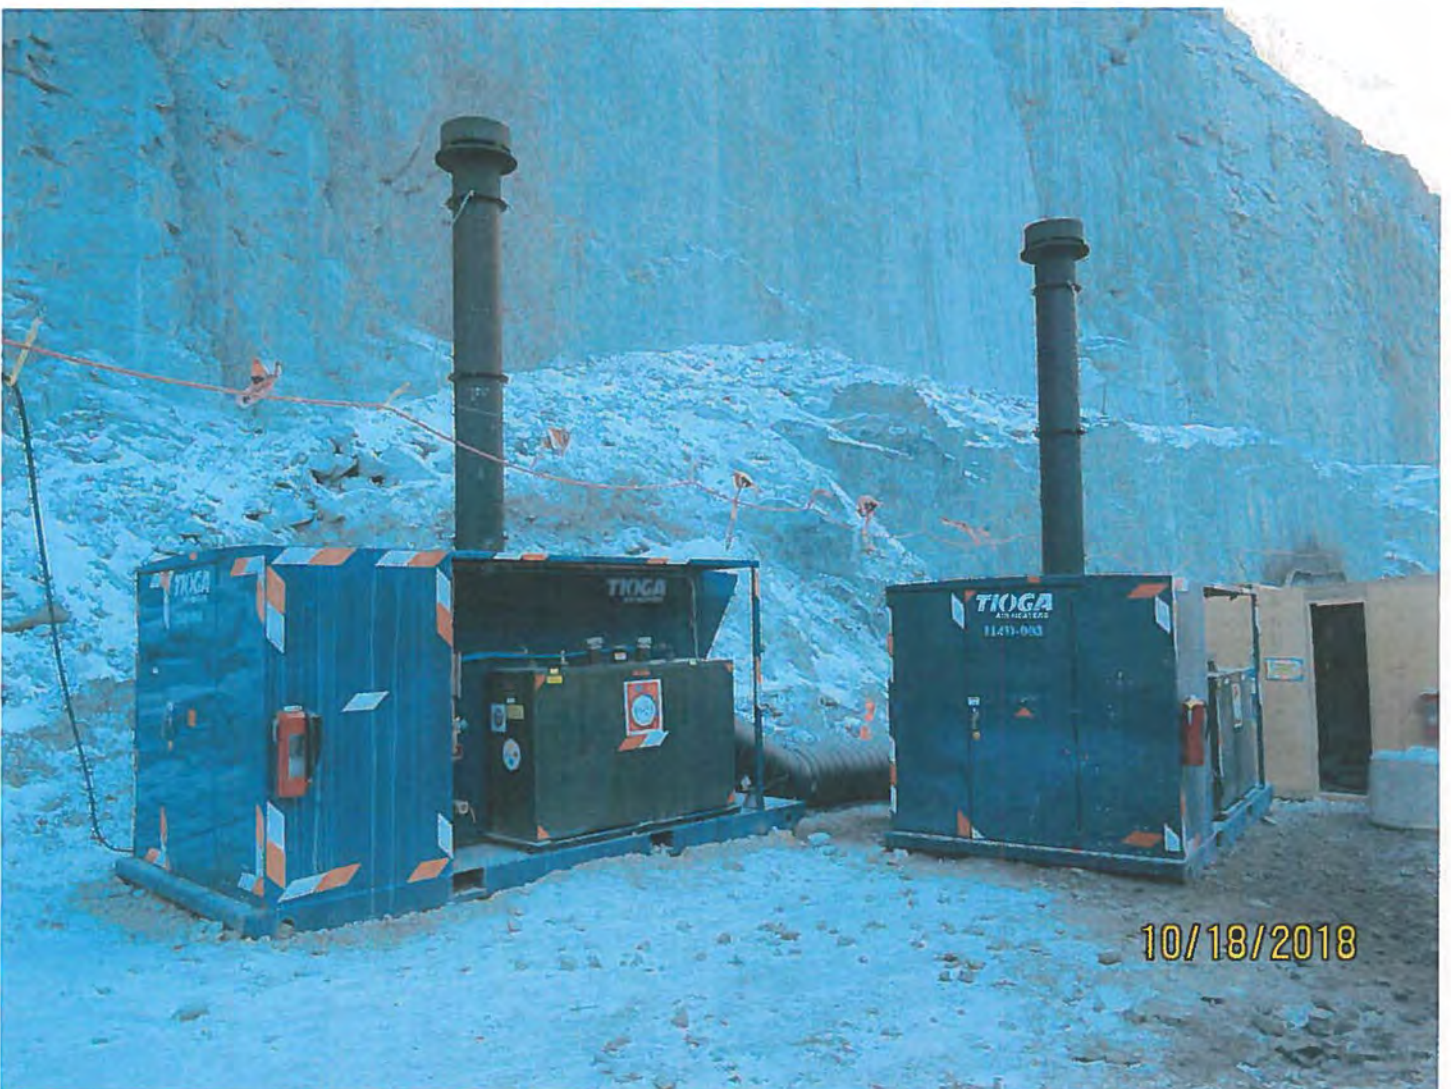
Photo #14 - W2017D0004 MUG Project
These heaters are used to heat the air that is being pumped into the underground.
