**Re: Land Use Permit W2017D0004
Mining & Associated Activities
Ekati Diamond Mine, Northwest Territories**

ENVIRONMENTAL INSPECTION REPORT

Permittee:	Dominion Diamond Ekati – Misery Underground	Inspection Dates: October 18 th , 2018
------------	---	---

Location(s) Inspected:	The Ekati Mine Misery Underground Project and Misery Camp expansion including site roads and laydown areas.
------------------------	---

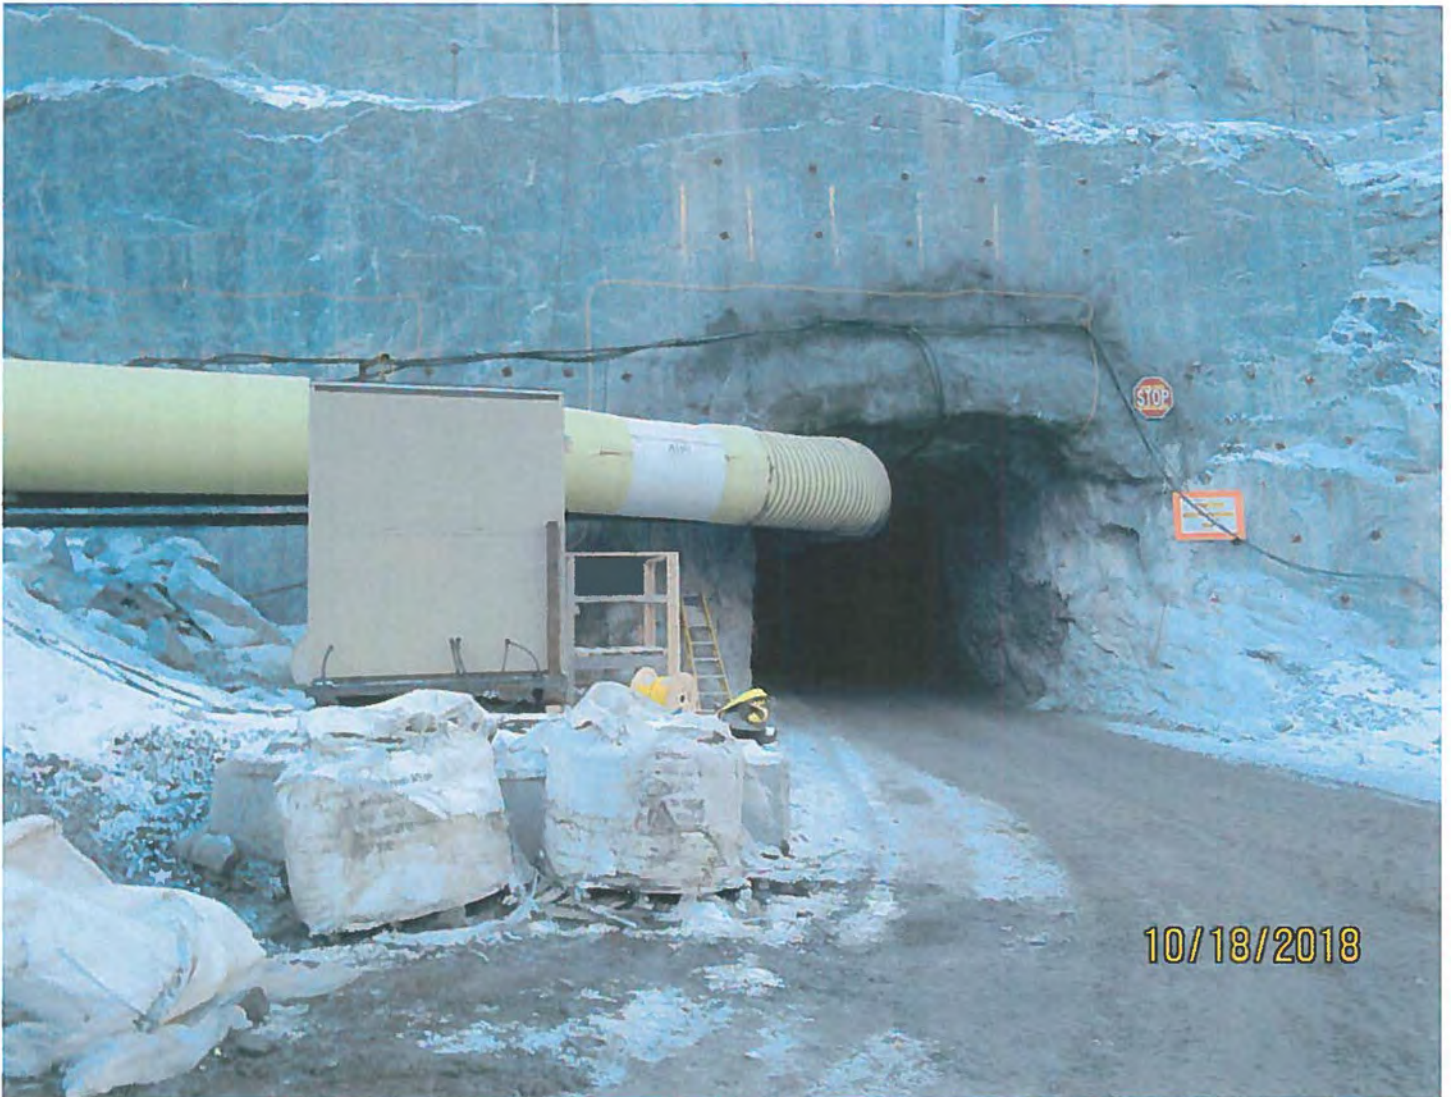
Photo #15 - W2017D0004 MUG Project
The fresh air vent tubing going into the 2235 Portal and staged sodium chloride used in underground operations.

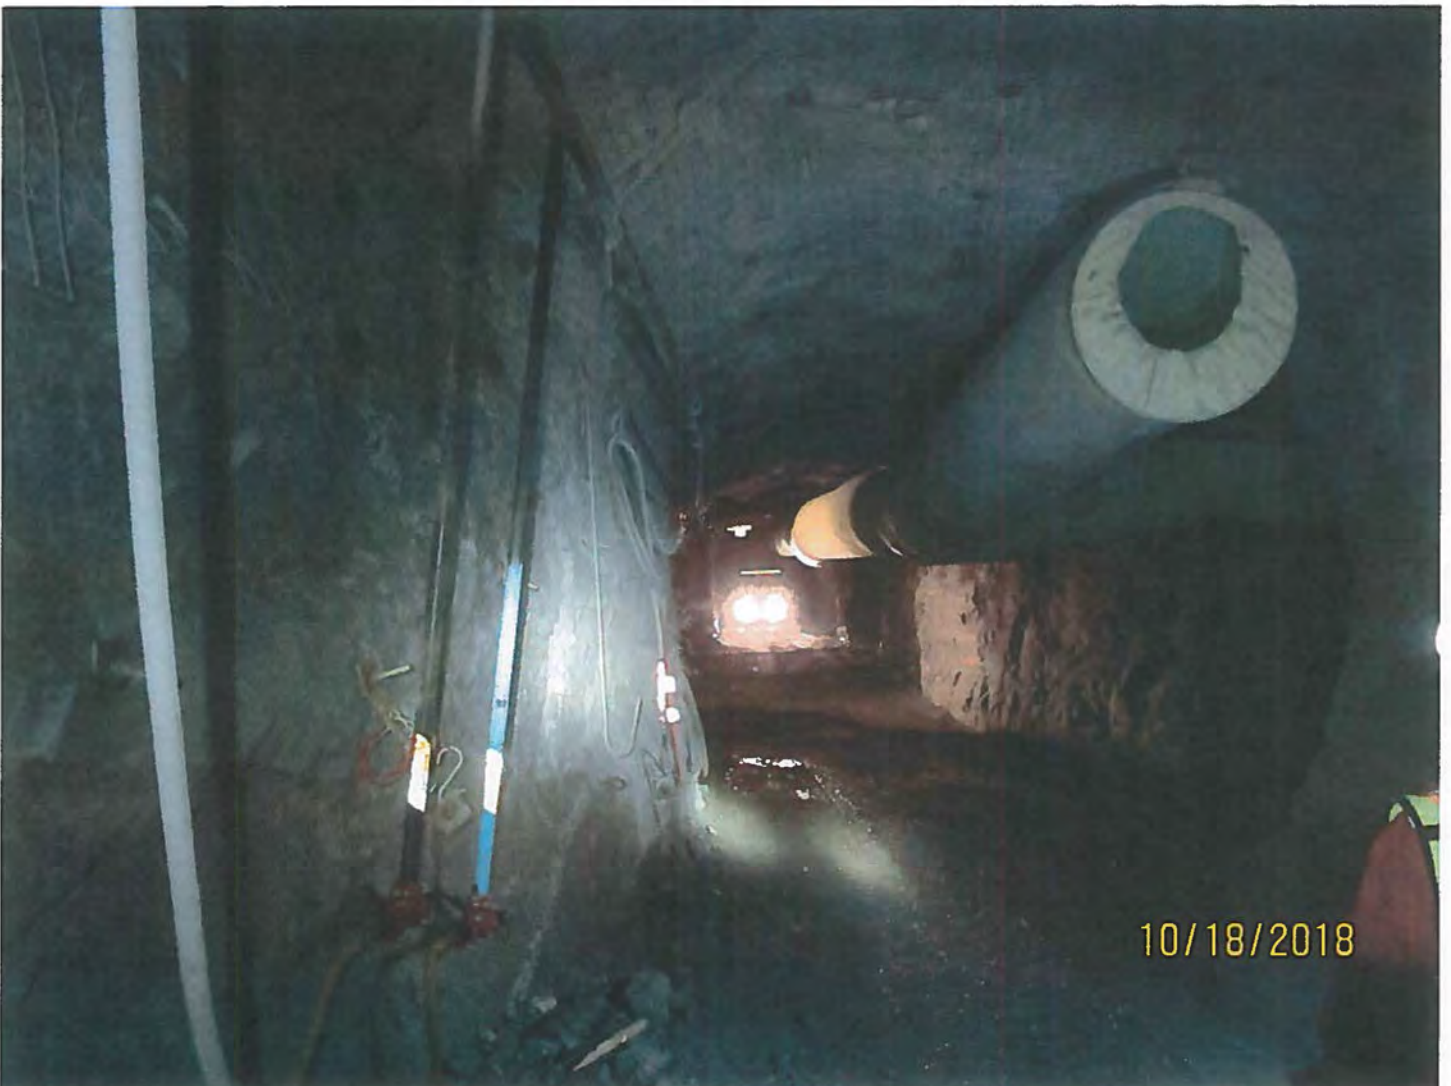
Photo #16 - W2017D0004 MUG Project
The vent tubing carrying warm air into the mine and water lines on left used in the underground water management.

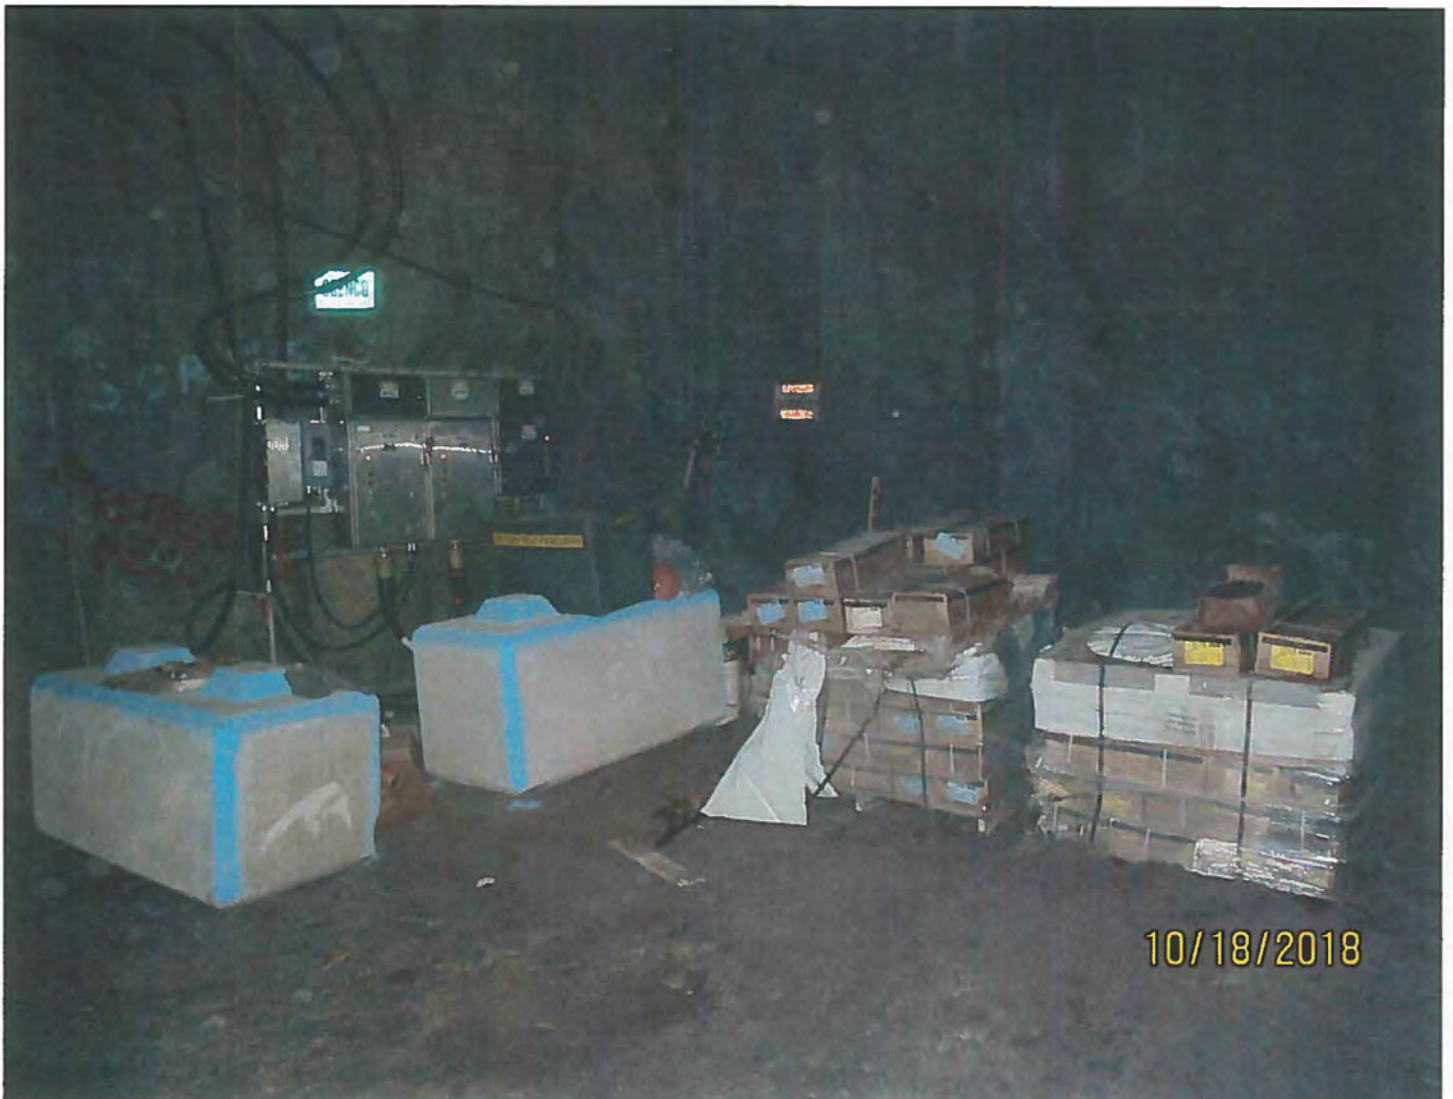
Photo #17 - W2017D0004 MUG Project
An underground electrical conduit station and epoxy used to cement bolts into place.

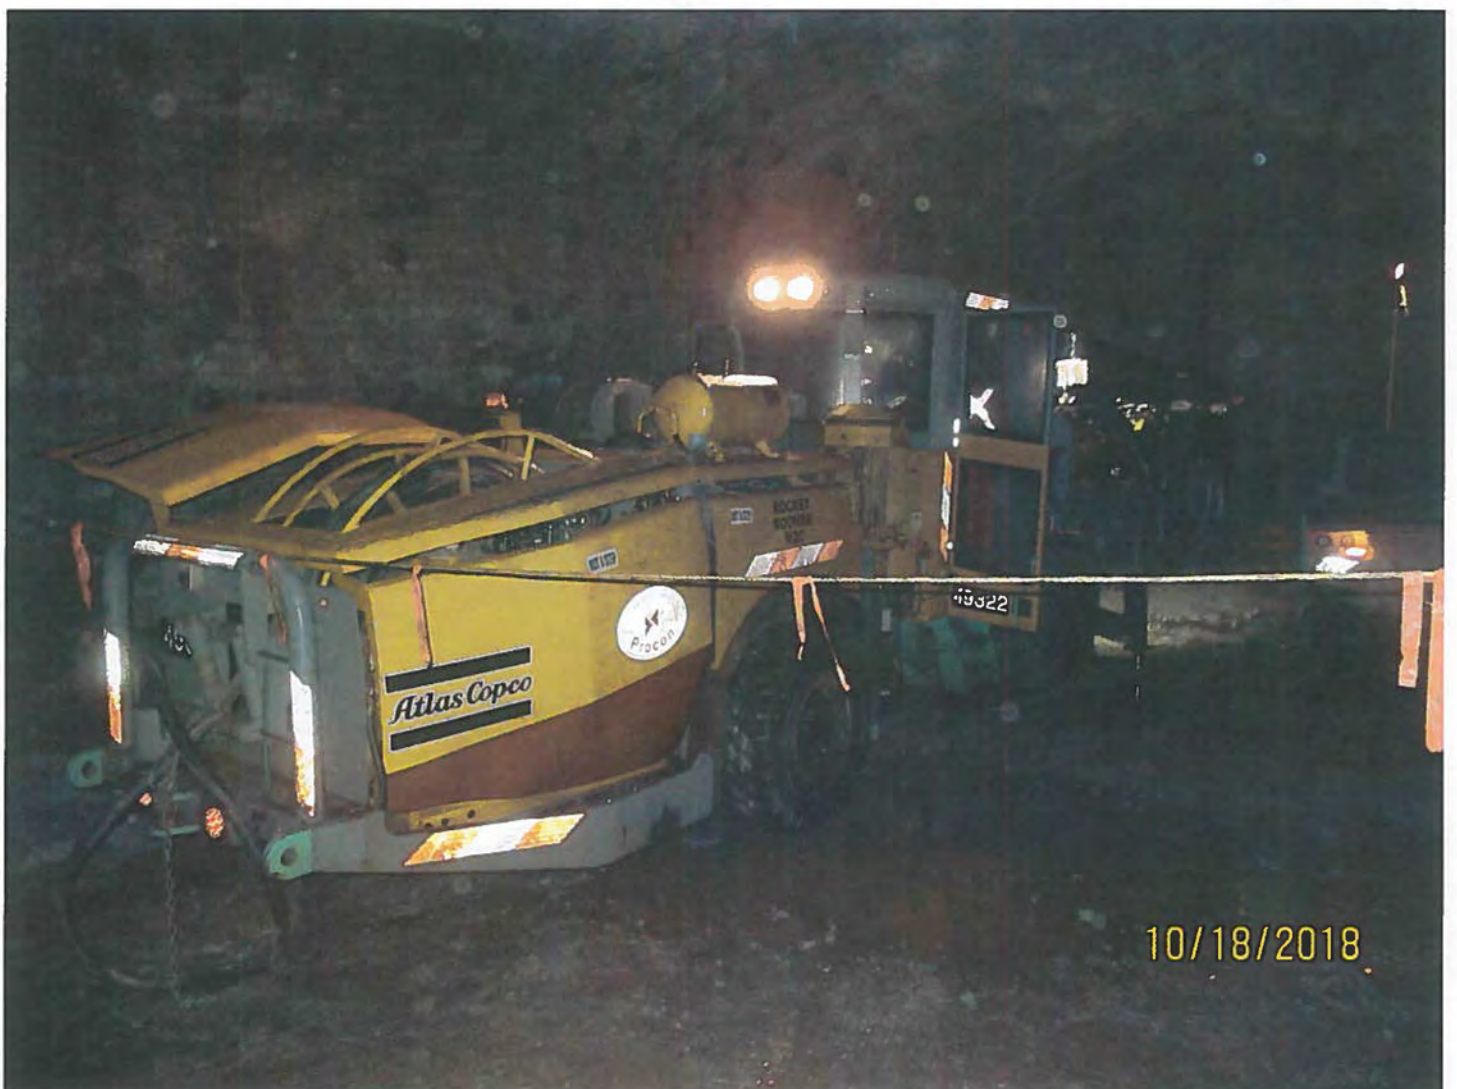
Photo #18 - W2017D0004 MUG Project
This AD 30 underground haul truck is refueled with the use of a mobile fuel truck.

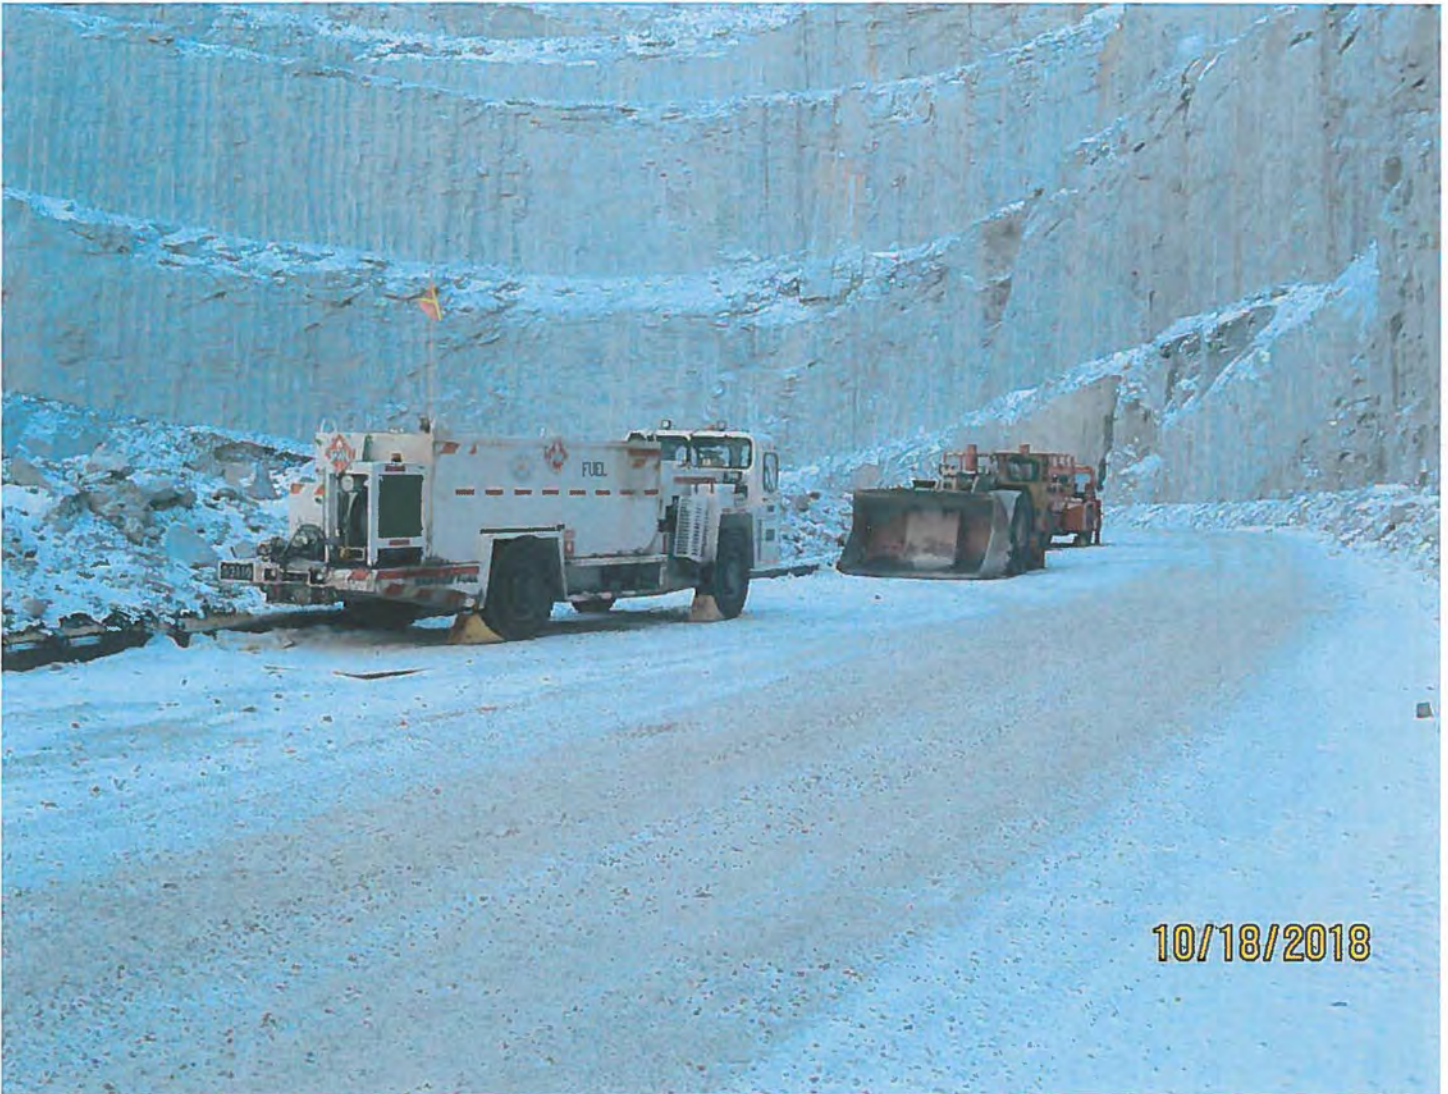
Photo #19 - W2017D0004 MUG Project
Underground heavy equipment staged on the ramp adjacent to the 2235 Portal.

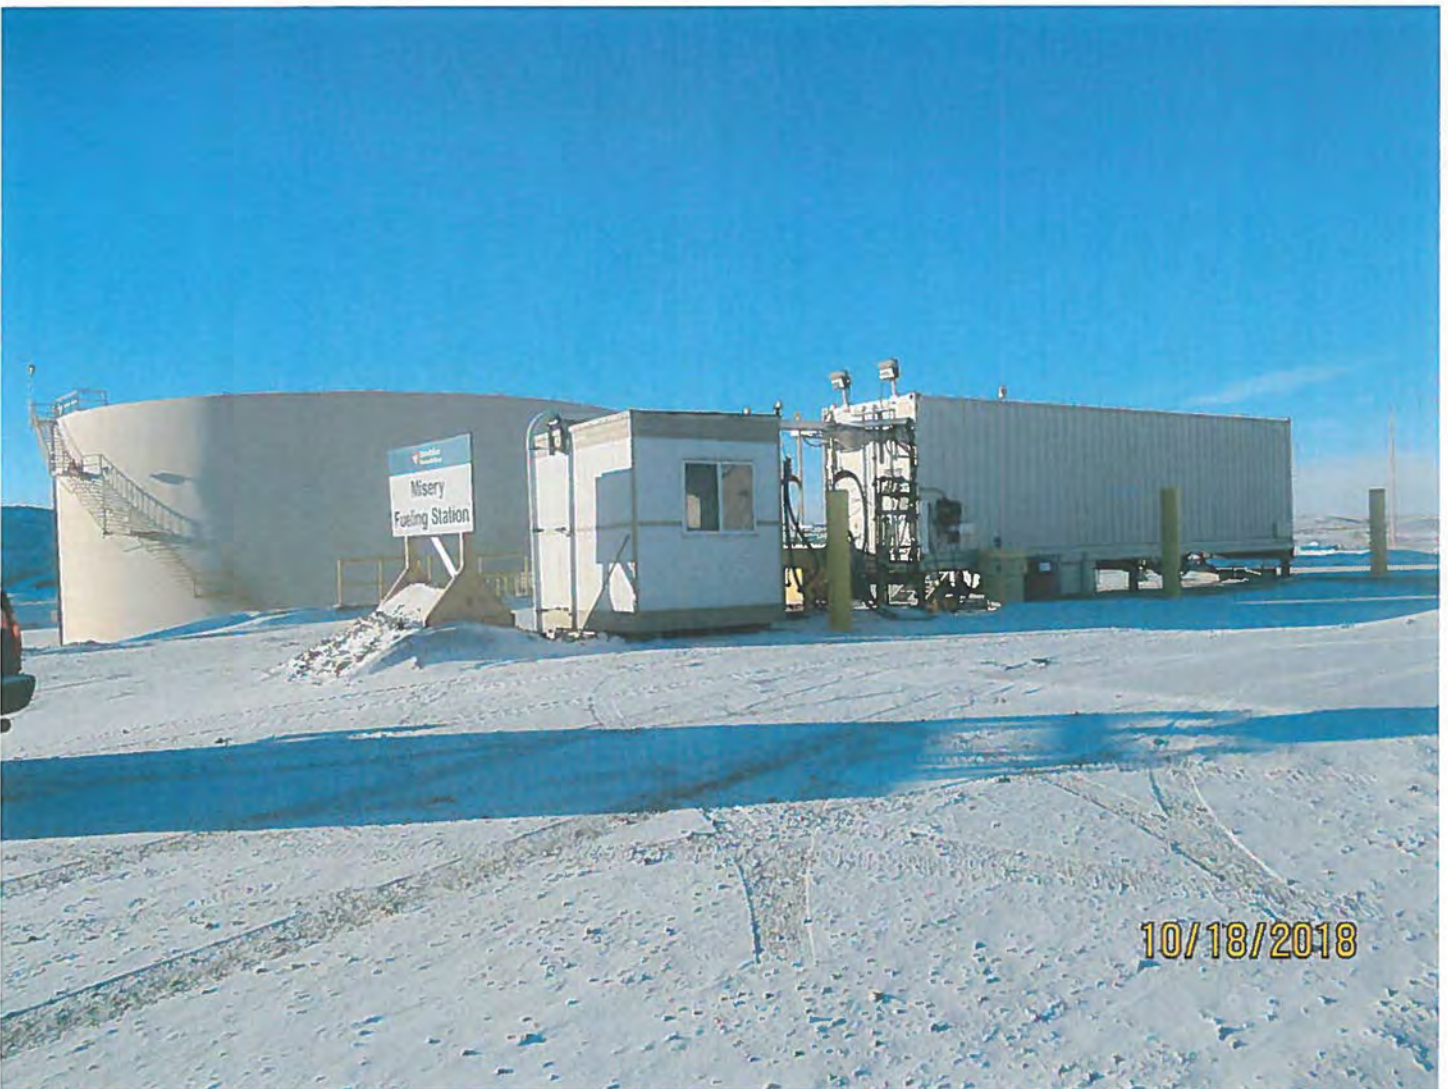
There is a fueling station adjacent to and south of the Misery bulk fuel storage tank (Photos #20 & #21). During the winter haul season, tanker trucks containing diesel fuel arrive onsite at Misery Camp and report to the fuel unloading station in Photo #22. Once here, the fuel trucks hook up at the station and fuel is transferred to the main fuel holding tank at the Misery Camp. It was noted the sumps at the fuel transfer stations are filling with snow and the Permittee must conduct regular weekly inspections of the sumps during the winter season to ensure there is adequate capacity available in the event of fuel spills. As with the underground, fuel transfers for above ground heavy haul trucks, equipment and machinery is completed with the use of mobile fuel trucks. As per Condition #32 of the permit, secondary containment must be used during all fuel transfers in the land use area.

Photo #20 - W2017D0004 MUG Project
Looking north at the Misery Camp fuel transfer station and bulk diesel tank.

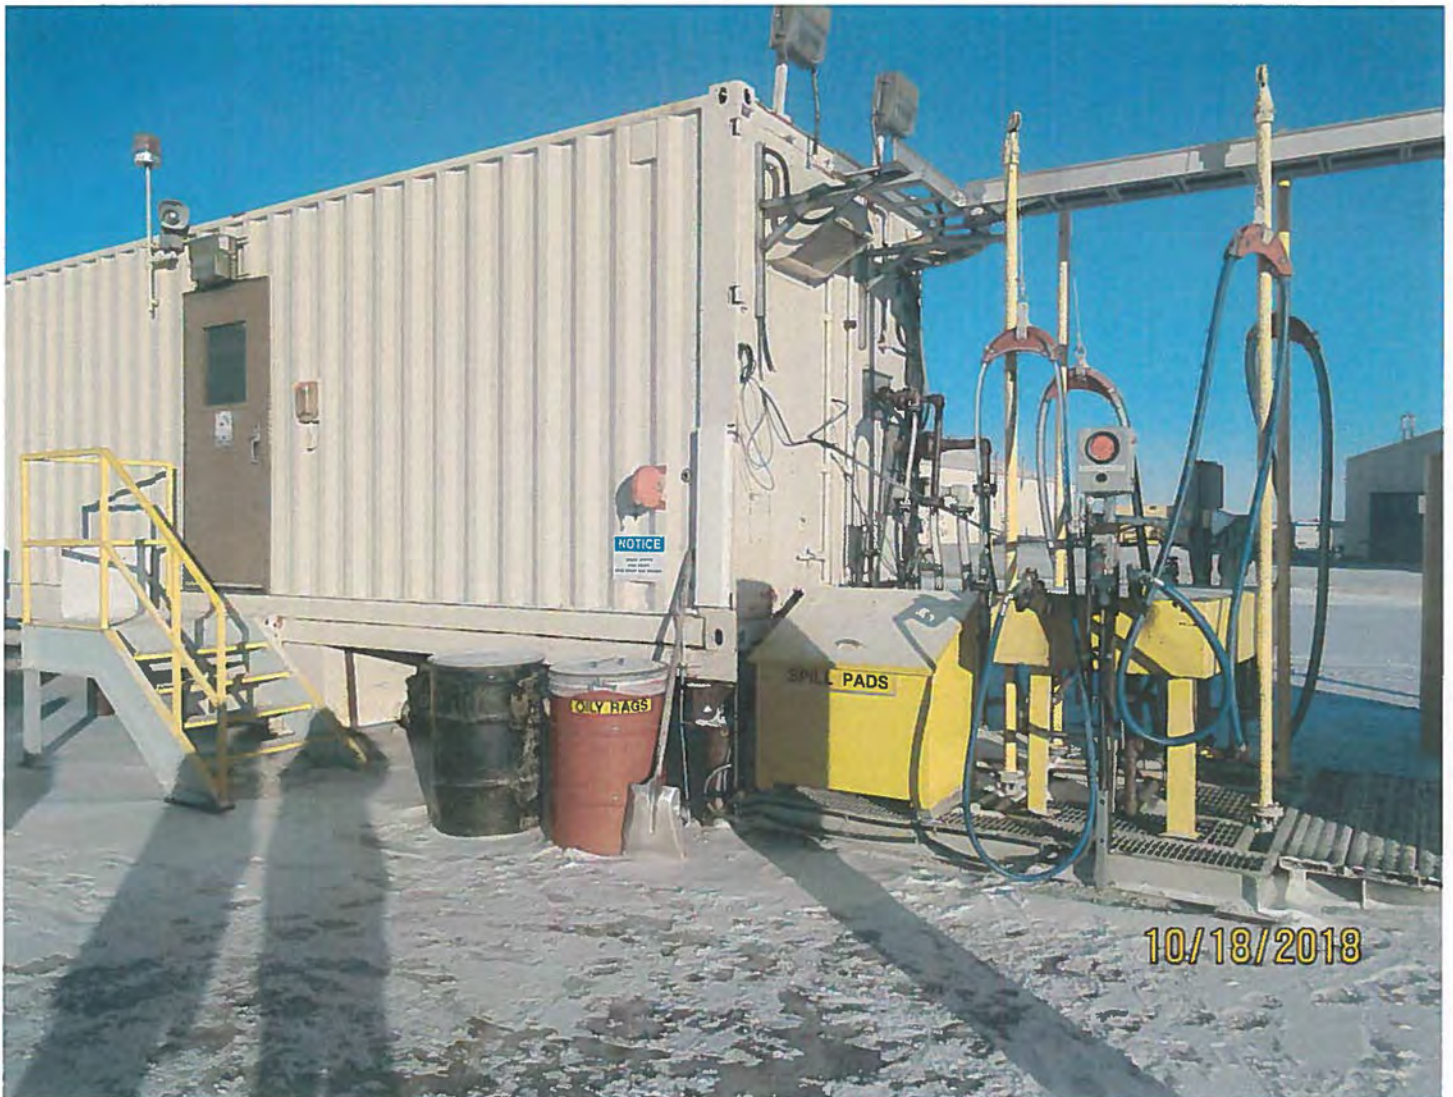
Photo #21 - W2017D0004 MUG Project
There were readily available spill reponse materials present at the station.

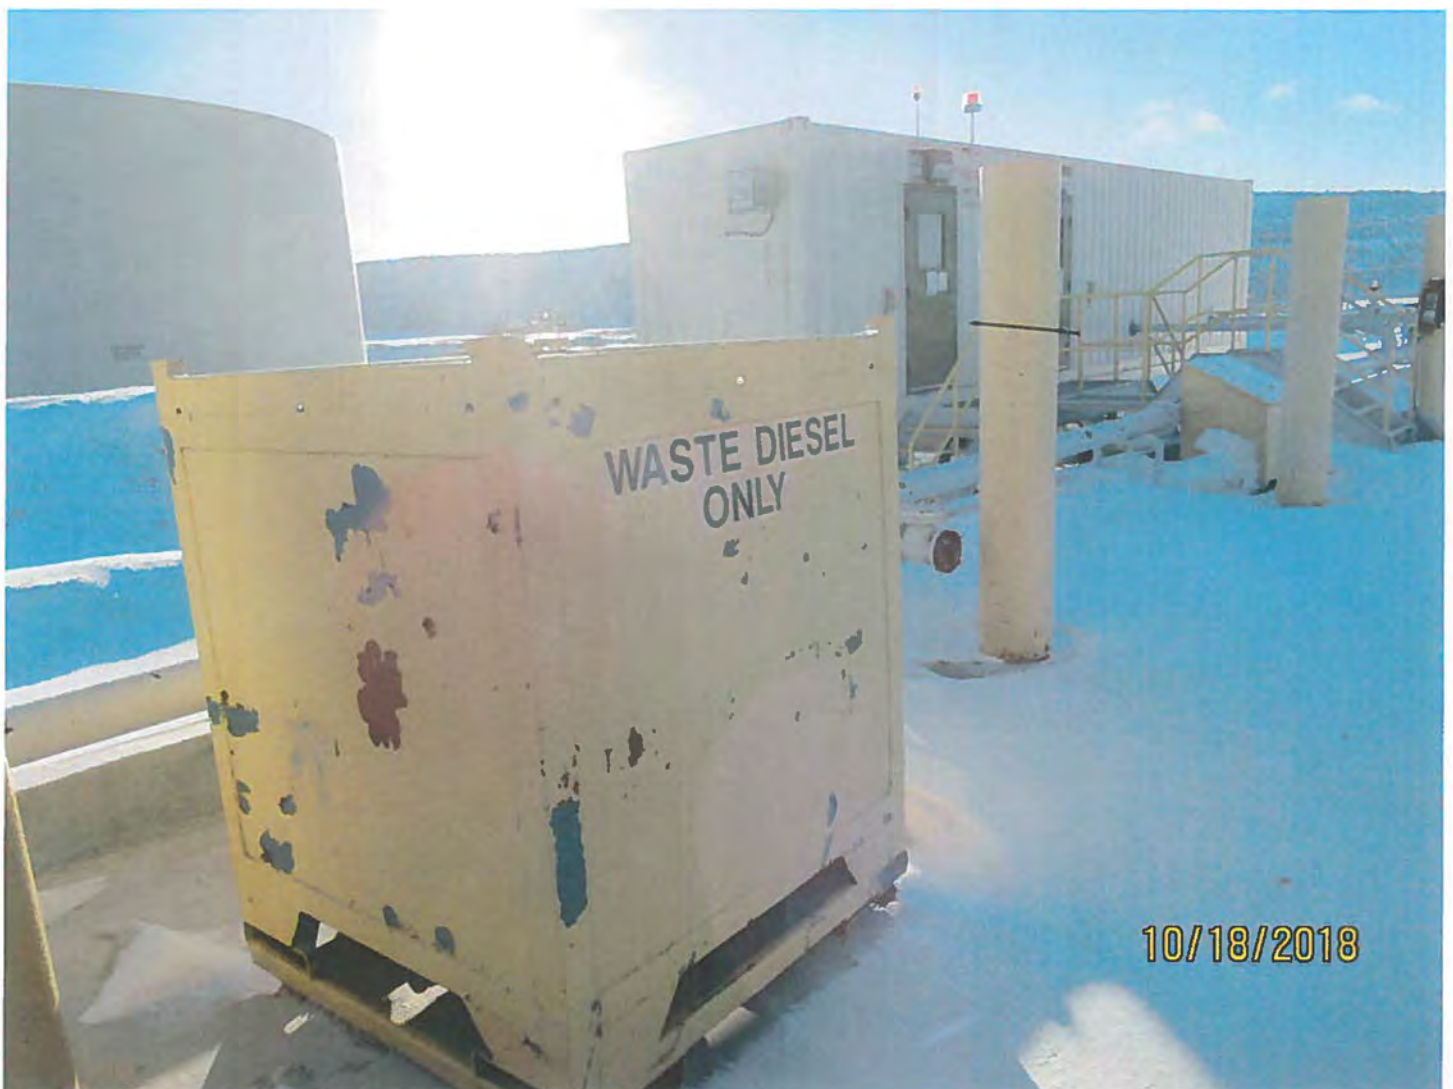
Photo #22 - W2017D0004 MUG Project
Waste diesel collected at the fuel offload station is placed in this holding container.

The Permittee must ensure secondary containment is used during all fuel transfers in the land use area to prevent hydrocarbon impacts to the environment (Condition #32). Secondary containment structures, including the sumps at the Misery Camp fuel transfer area, must be diligently monitored to ensure they are free of snow during the winter season and there is adequate capacity available in the event of spills (Condition #33).

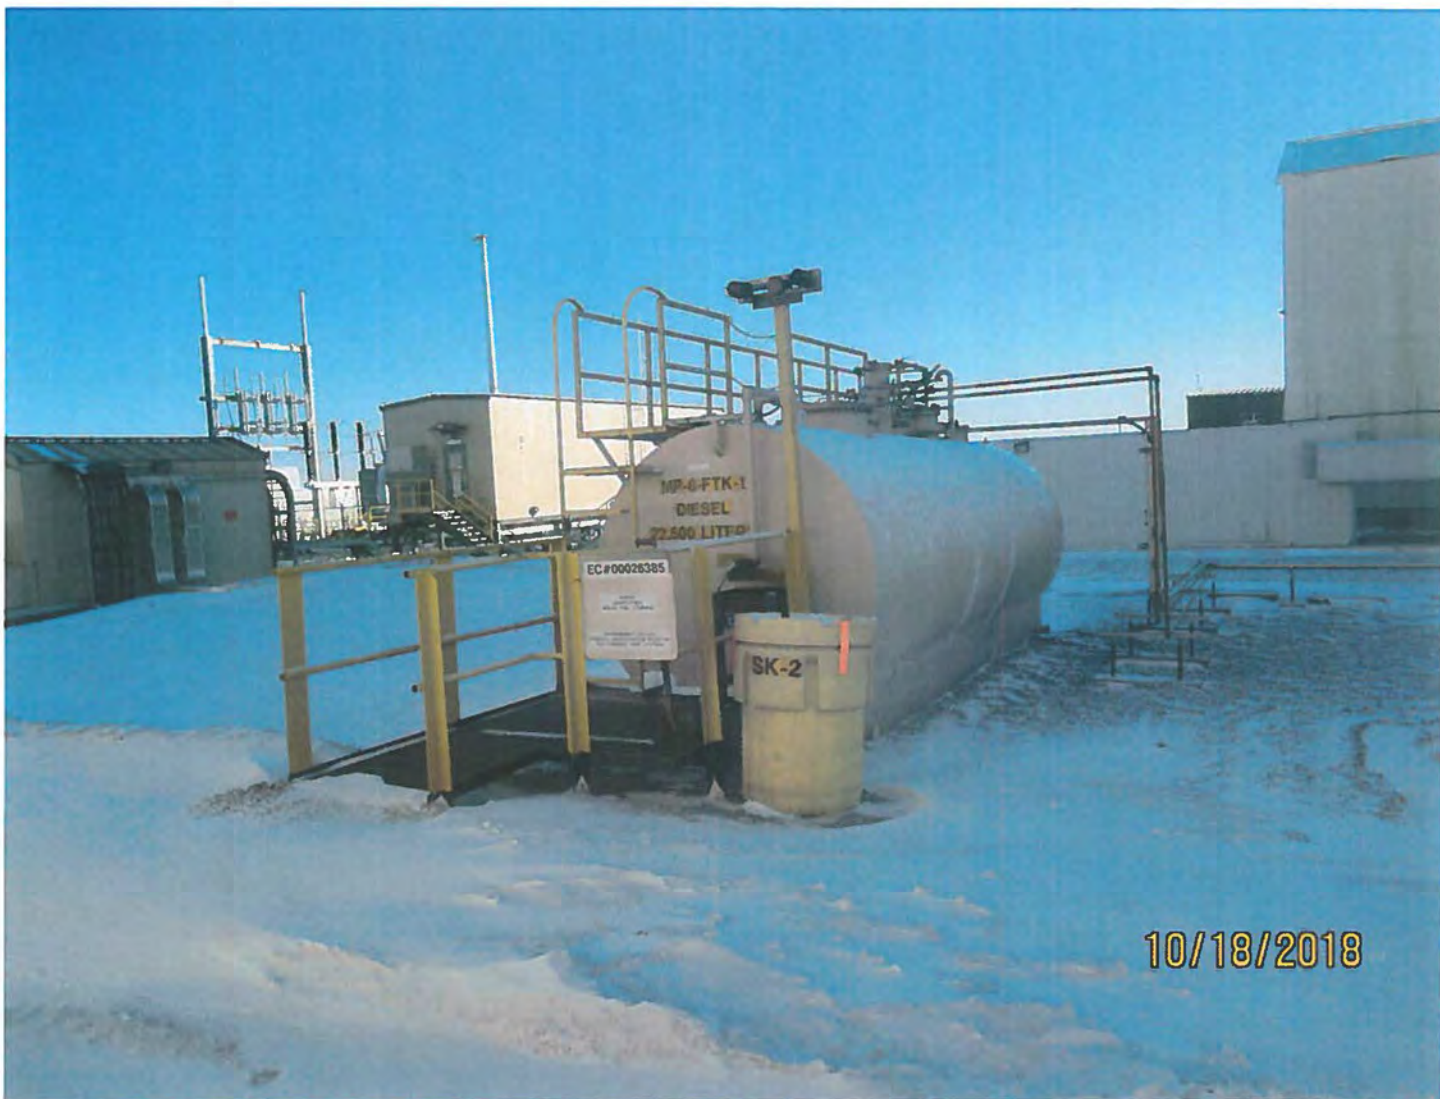
As seen in Photo #23, there are multiple fuel tanks of varying sizes in containment that are present throughout the Misery Camp and MUG Project. The Permittee must ensure secondary containment structures that are employed in the land use area are properly maintained to ensure adequate capacity is available (Condition #33). The Inspector noted there were readily available spill response materials present throughout the land use area and no further concerns were noted regarding fuel storage or handling.

Photo #23 - W2017D0004 MUG Project
An example of a fuel tank in containment with readily available spill response materials.

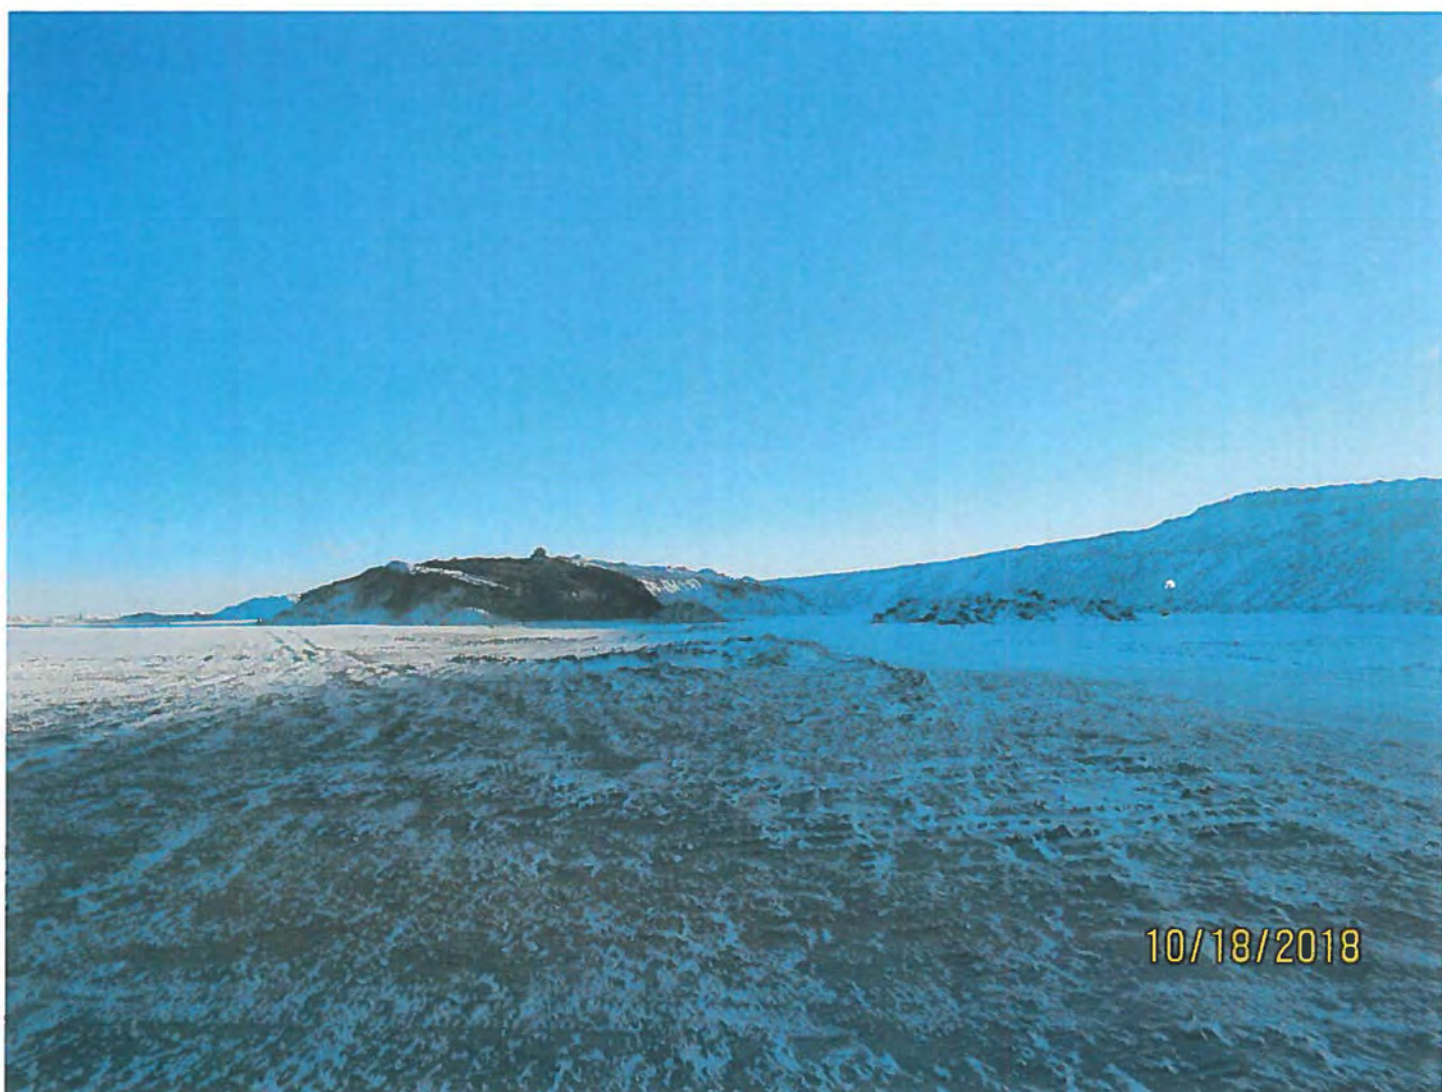
- The staged kimberlite in Photo #24 was being transported to the Ekati main process plant with the use of road trains on an ongoing basis
- There appeared to be no major hydrocarbon staining in the land use area including laydowns and along roadways
- Waste was being properly labeled and segregated prior to its disposal at the Ekati main camp
- A rock crushing operation was set-up north of camp

Photo #24 - W2017D0004 MUG Project
This stage kimberlite is being hauled to the Ekati main process plant on an ongoing basis.
