November 15, 2019

Subject: W2017D0004: Spill 2019429 Report

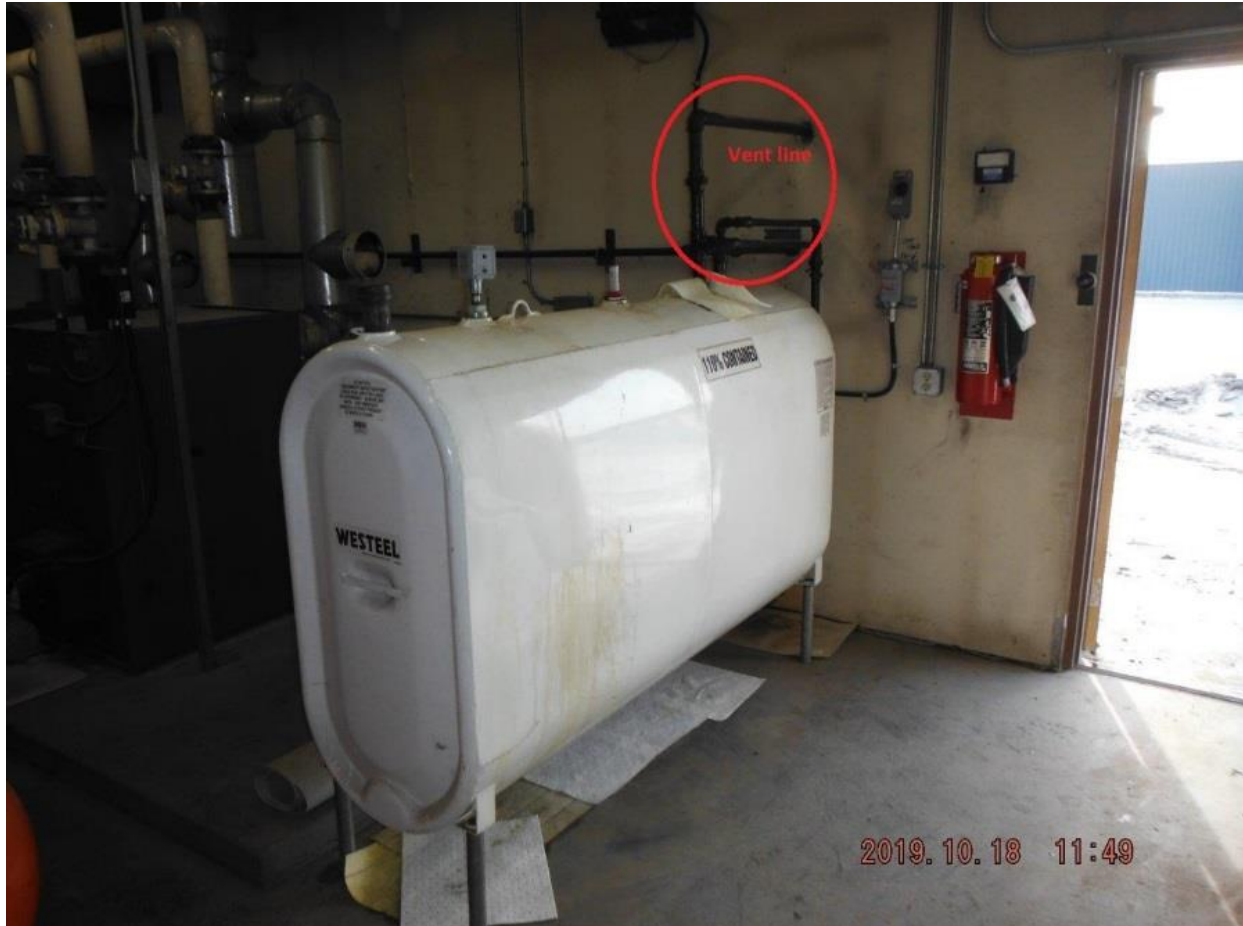
Figure 2. Day tank inside Misery Light Duty Shop

At 15:30 on October 17, 2019 a worker initiated a diesel transfer from a 4,500 L capacity storage tank (EC00001121) into a 1,135 L capacity day tank located inside the Misery Camp Light Duty Shop. The two tanks are connected by piping and the fuel is transferred using a small pump with a stated flow rate of 12.87 L/min. The operator continued to work in the area and monitor the status of the fuel transfer periodically. At 16:50 the operator noticed that the day tank had exceeded capacity and diesel had travelled up the vent line and spilled outside of the building. Dominion estimates that the tank was overflowing for approximately 9 minutes and spilled 117 L before the flow was stopped.

- Dominion conducted an investigation of the spill, and concluded that the return line needed to be adjusted so that it would work properly in the event of a future overflow.
- The spill was entered into the Dominion First Priority Enterprise (FPe) incident management software and reviewed at all Safe Shift Meeting across site.
- Dominion used information such as the pump flow rate, estimated day tank volume prior to fill-up, and total transfer time to create an approximate spill volume of 117 L.

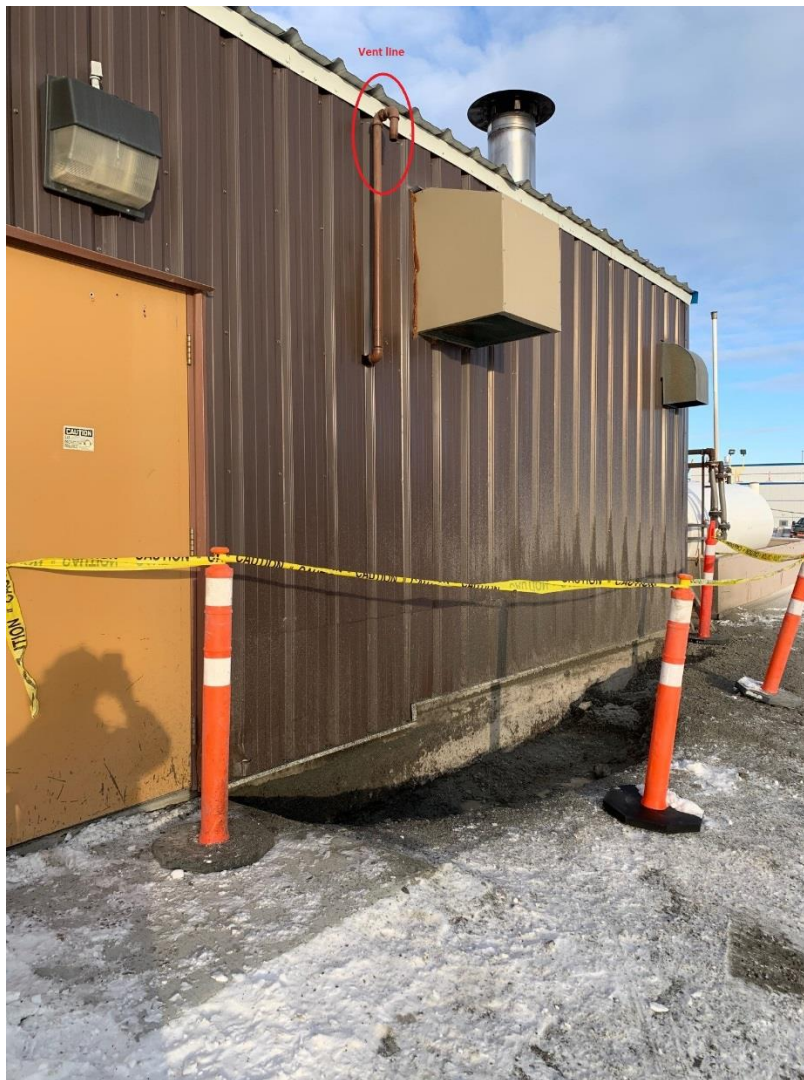
Figure 3. Vent line and spill excavation outside of Light Duty Shop

- 1) The operator was not solely focused on monitoring the fuel transfer. The fuel transfer took a total of 80 minutes, so the operator attempted to perform other tasks in the area while the transfer was taking place.
- 2) The day tank is equipped with a 1" diameter return line which is meant to prevent overfills and return fuel directly to the outdoor storage tank when the day tank is filled to capacity. However, due to the small diameter of the return line and presence of several elbows in the piping, the fuel took the path of least resistance when it overfilled and ran directly up the vent line and out onto the ground outside of the shop (see Figure 3).

The Spill Contingency Plan was initiated, and the worker shut off the fuel transfer pump and contacted their Team Leader immediately. Absorbent pads were placed outside of the building to capture all free-standing diesel. The Site Services team used shovels to excavate the contaminated gravel near the building. Equipment was used to scrape up the contaminated gravel running down the hill outside of the building. As per Dominion’s Hydrocarbon-Impacted Materials Management Plan, fine-grained material (<4 cm) was taken to the landfarm for treatment, and large-diameter material (>4 cm) was taken to Zone S for disposal. Clean-up was not initiated immediately due to the presence of underground electrical cables in the area. The area was assessed prior to clean up to ensure the safety of personnel performing the work.
