**Re: Land Use Permit W2018W0001
Wood Cutting Operation
Km 185.2 of Highway #3, NT**

ENVIRONMENTAL INSPECTION REPORT

Permittee:	JR Enterprises	Inspection Date – October 8 th , 2024
------------	----------------	--

Location(s) Inspected:	The woods operations camp at Km 185.2 of Highway #3.
------------------------	--

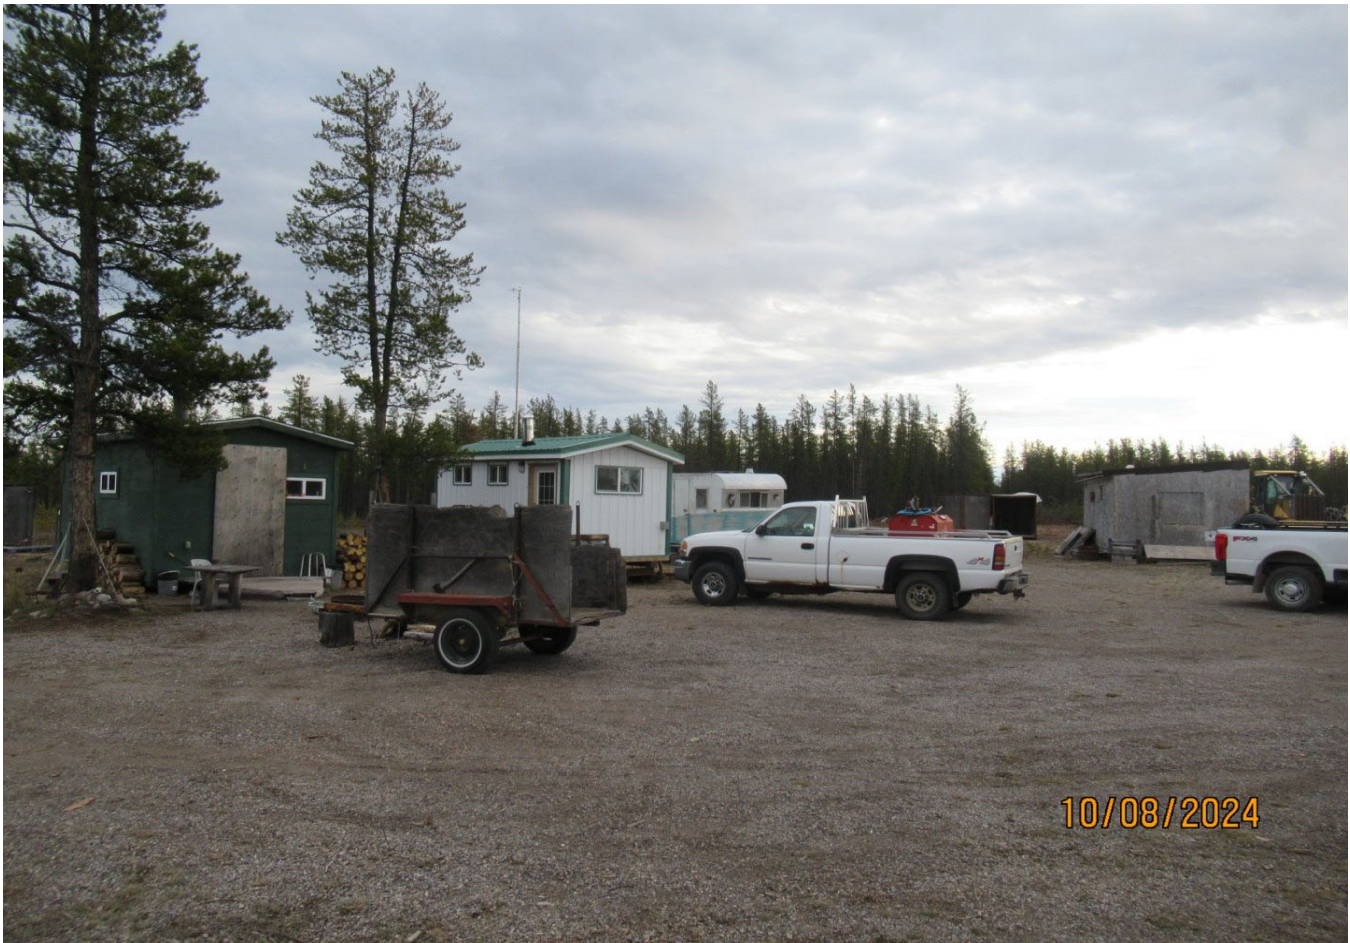
The Km 185.2 camp, located on the east side of Highway #3 was inactive during the inspection and the only change at the camp since the previous inspection was the addition of a second skid camp module (Figure 1 & 2). The previously noted concerns at the campsite have been satisfactorily addressed by the Permittee and this cooperation is appreciated.

Figure 1
Looking east at the camp buildings.

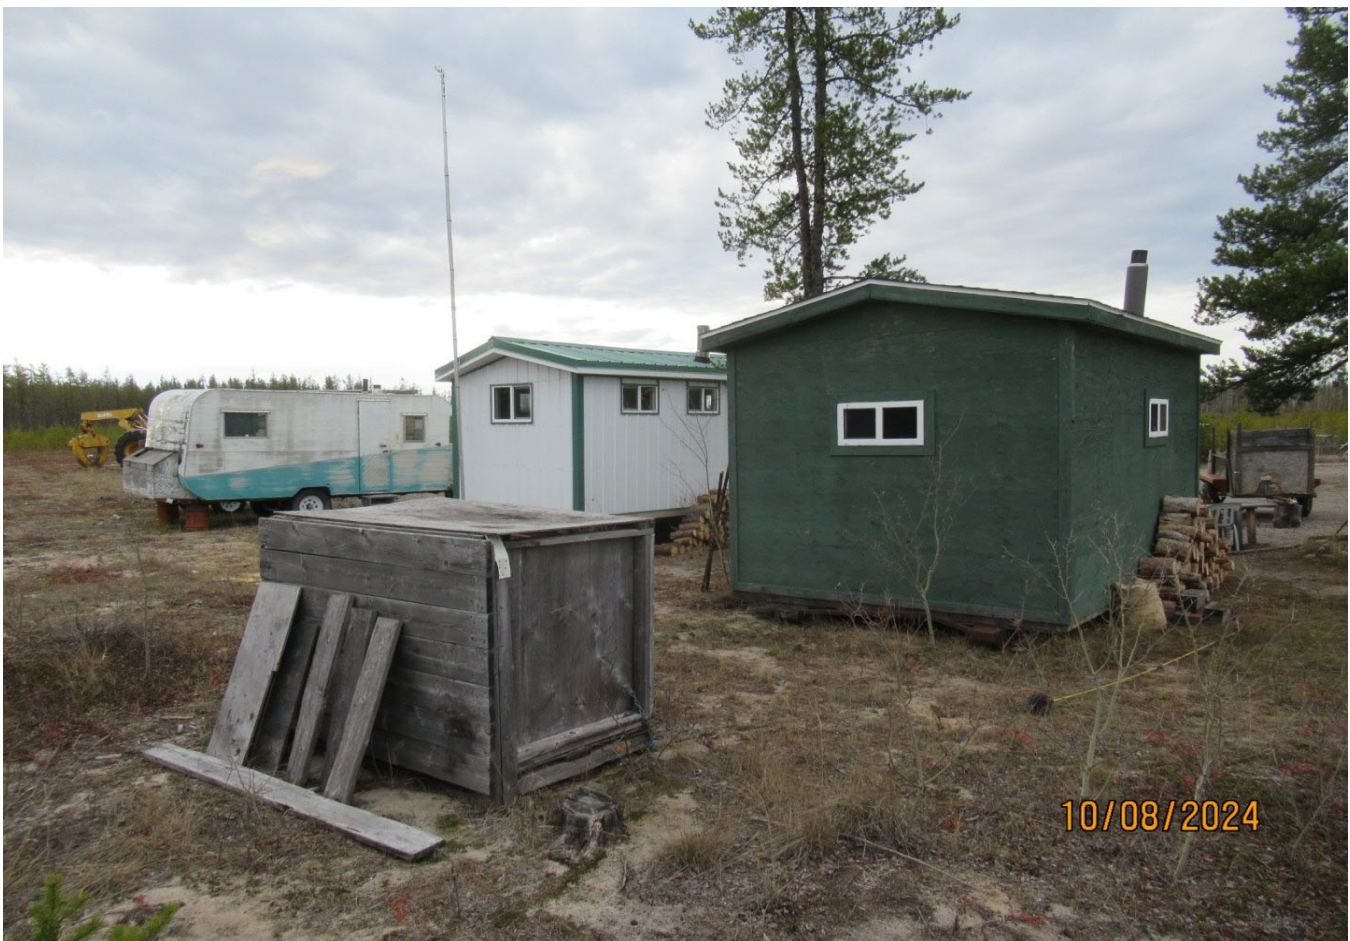
Figure 2
Another view of the buildings on site.

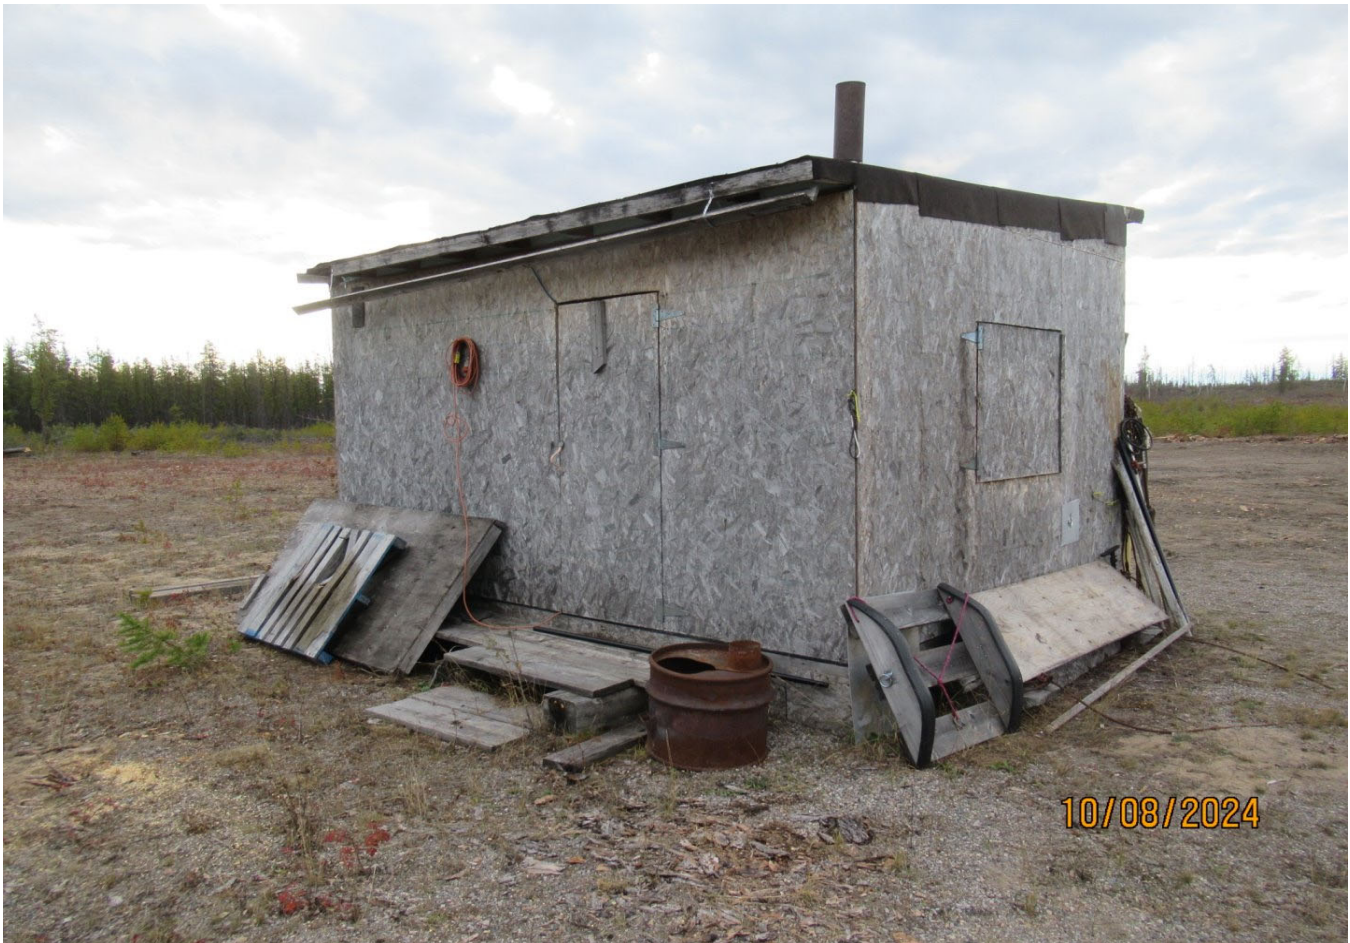
Other camp buildings can be viewed in Figures 3 through 6 and no major concerns were noted since the following was observed.

Figure 3
Shop on the south side of the campsite.

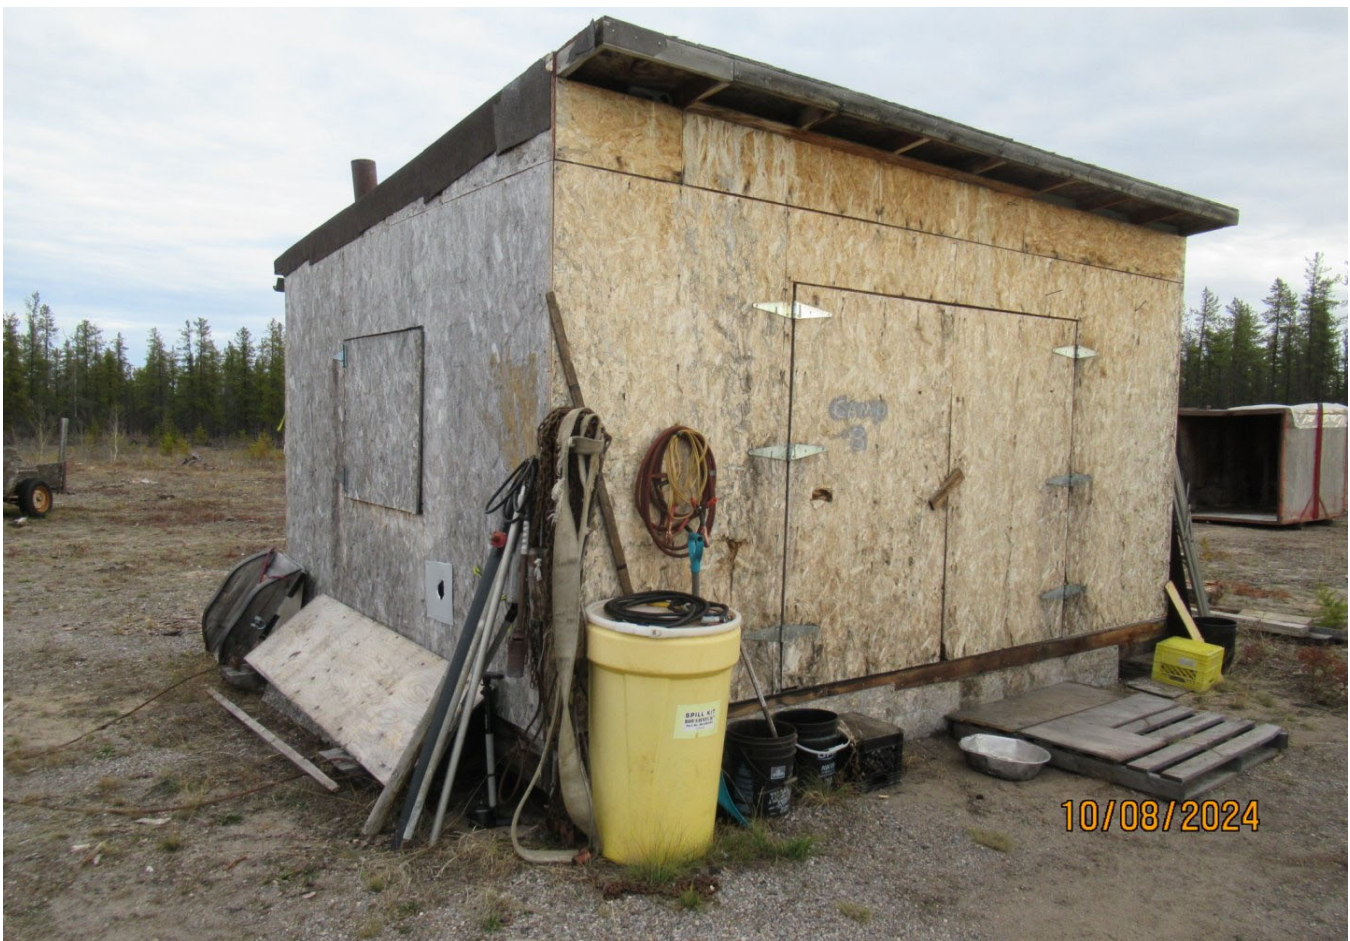
- A spill kit is present on the south side of the shop (Figure 4).
- Items that were stored on the west side of the campsite (Figure 5) appear to have been removed from the land use area and this practice of ongoing removal must continue to prevent accumulation on site.

Figure 4
Another view of the shop and a spill kit is present in a highly visible location.

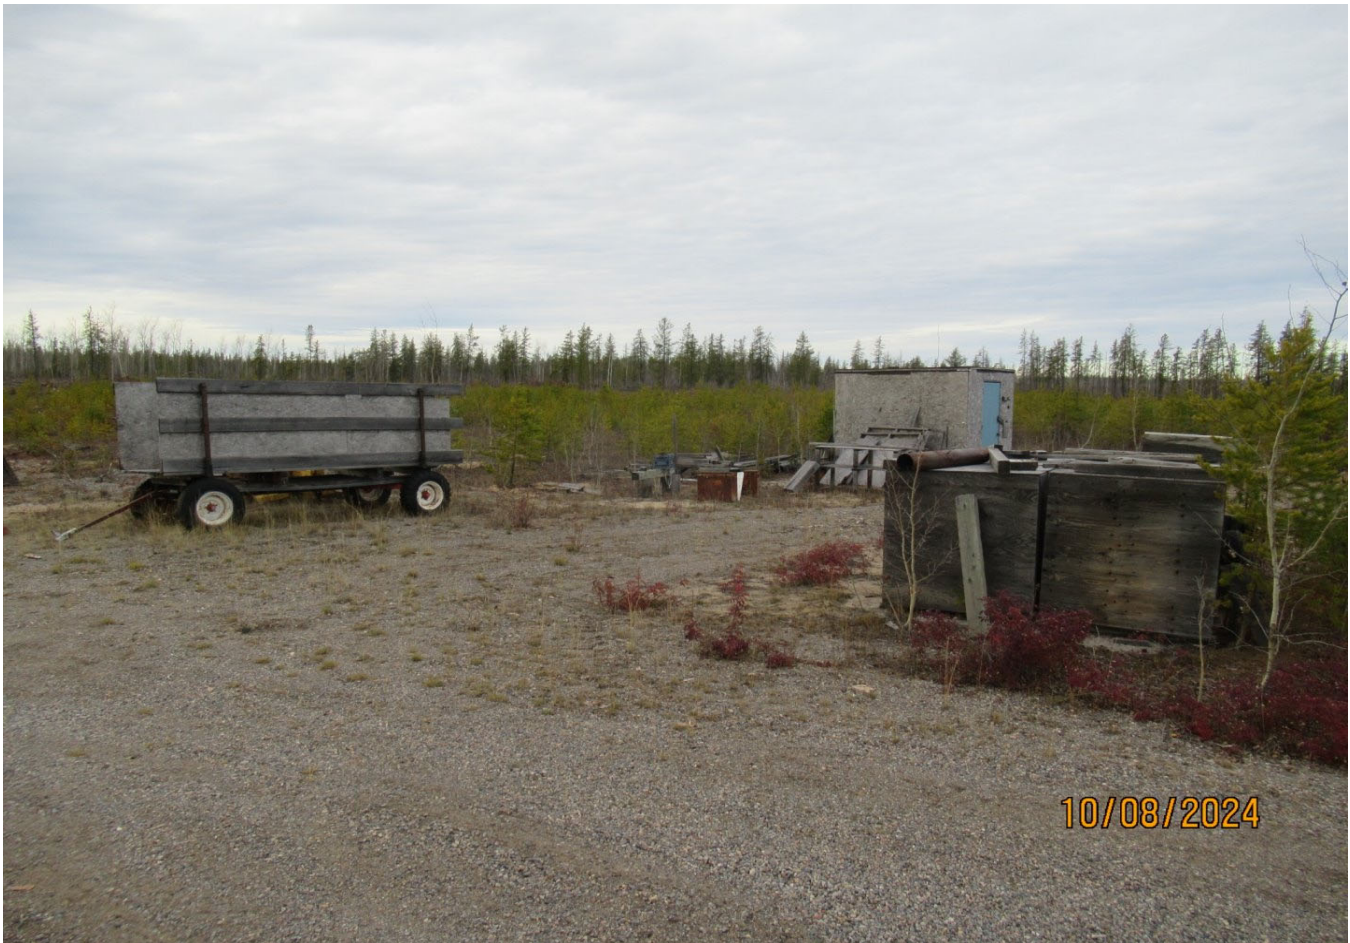
Figure 5

A building has been relocated from this area and some items removed.

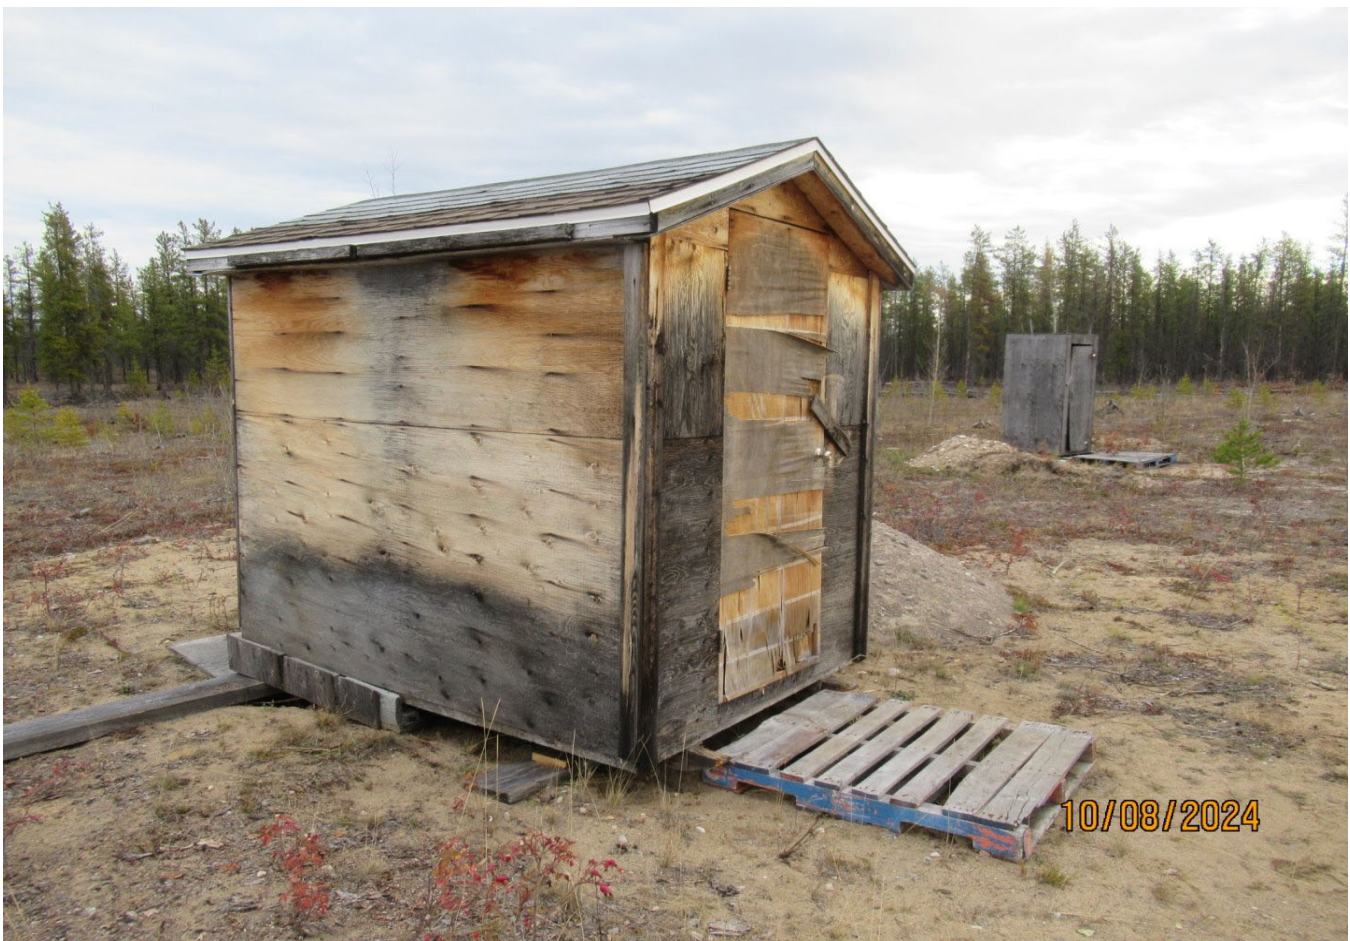
Figure 6

- Pit privies (Figure 6) are in use for sewage disposal and sump capacity was sufficient below both privies.
- The location where old/derelict vehicles were stored can be viewed in Figure 7 and once again, the Permittee's cooperation to address this previously noted concern is appreciated by the Inspector.

Pit privies on the north side of the campsite. Capacity was sufficient under both privies.

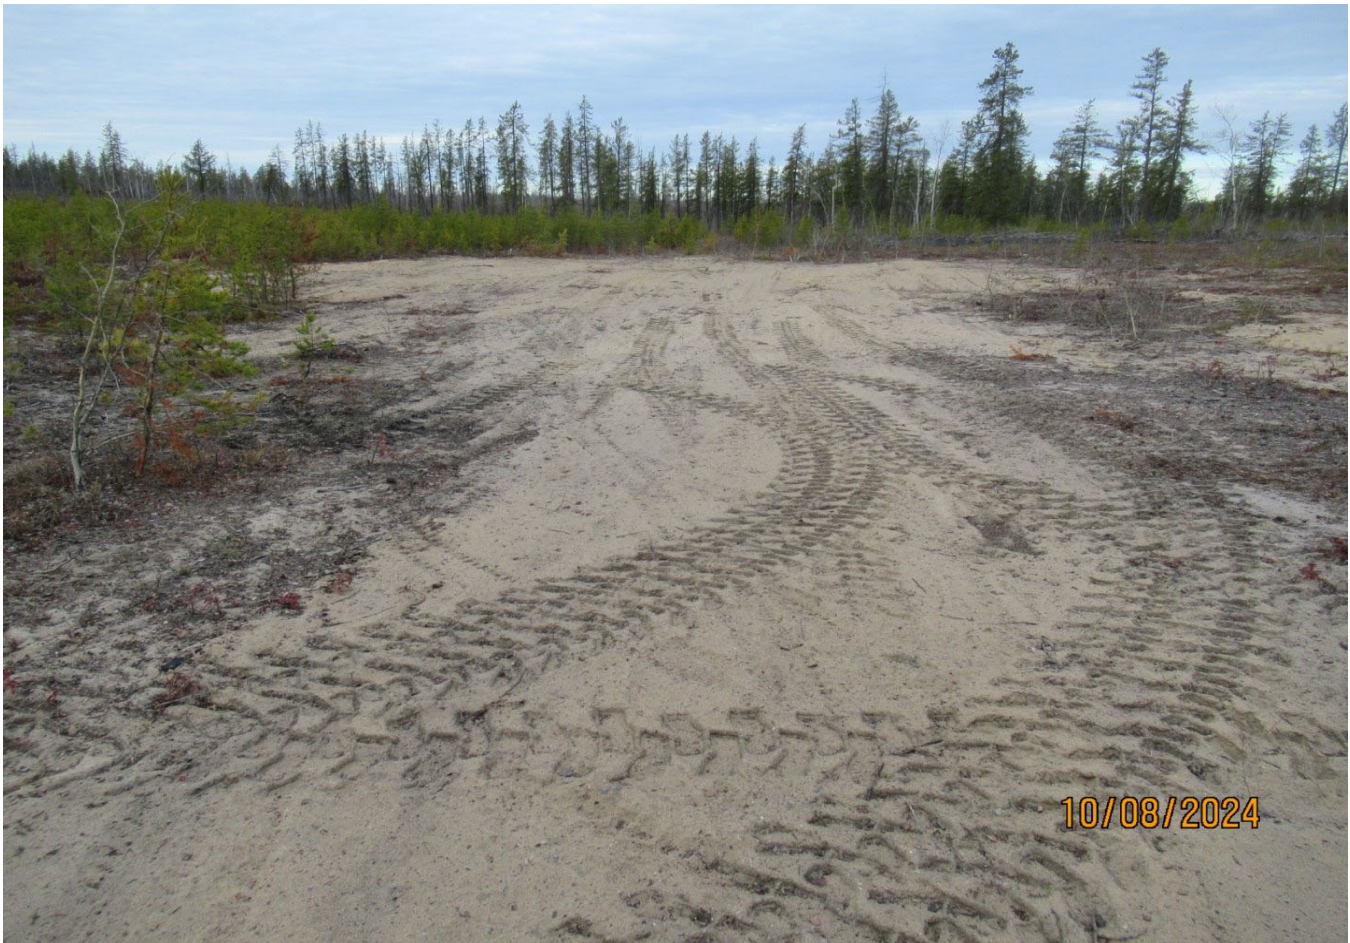
Figure 7

Old vehicles have been removed from this location as requested during the last inspection.

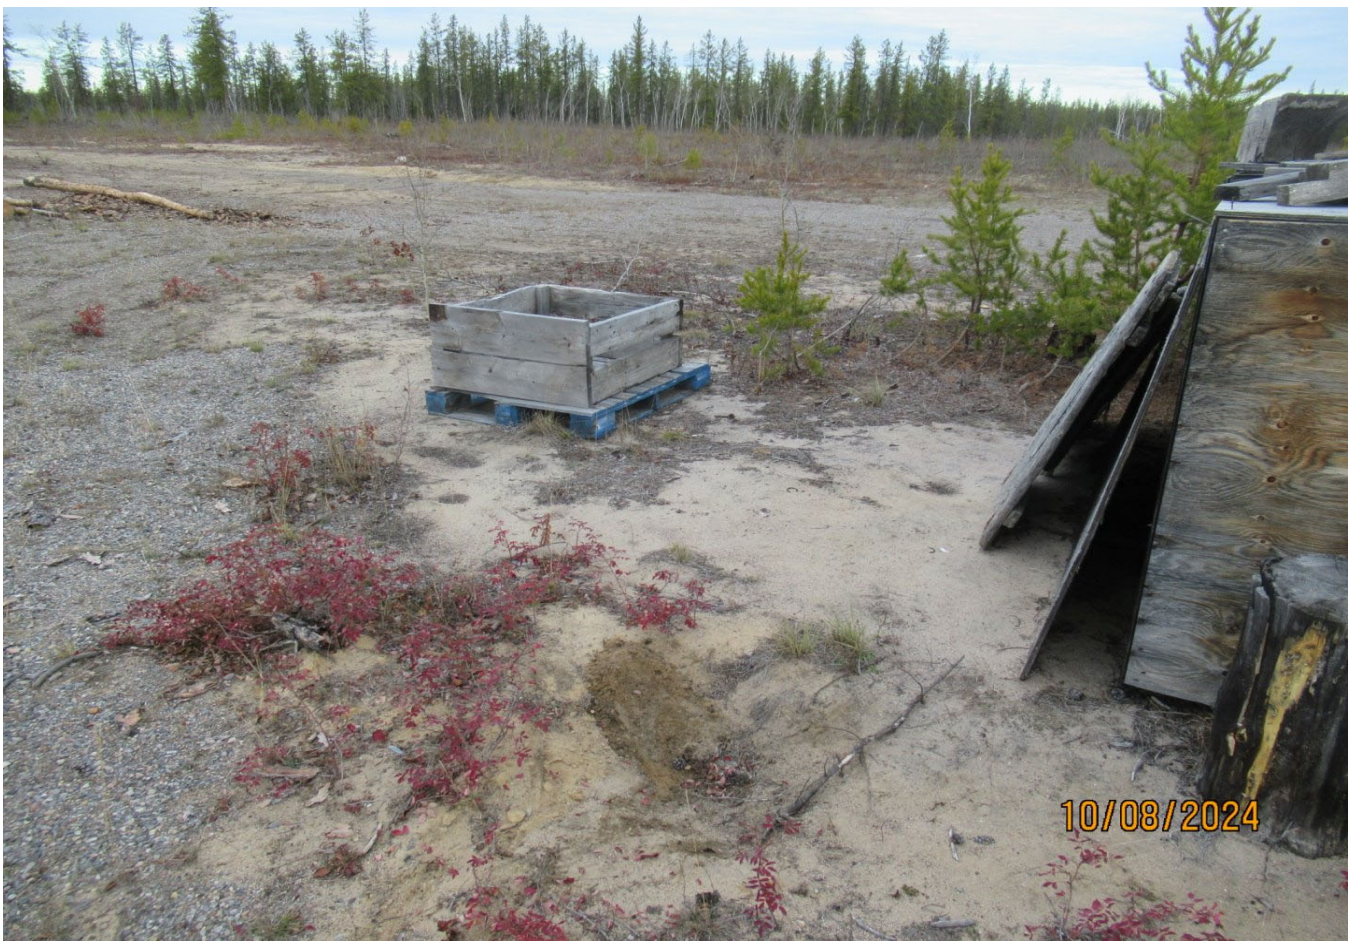
Figure 8

- All of the fuel drums that were located on the west side of the campsite (Figure 8) have been removed and no obvious hydrocarbon spills were observed.

Previous location of the fuel cache. No hydrocarbon impacted soils were observed.

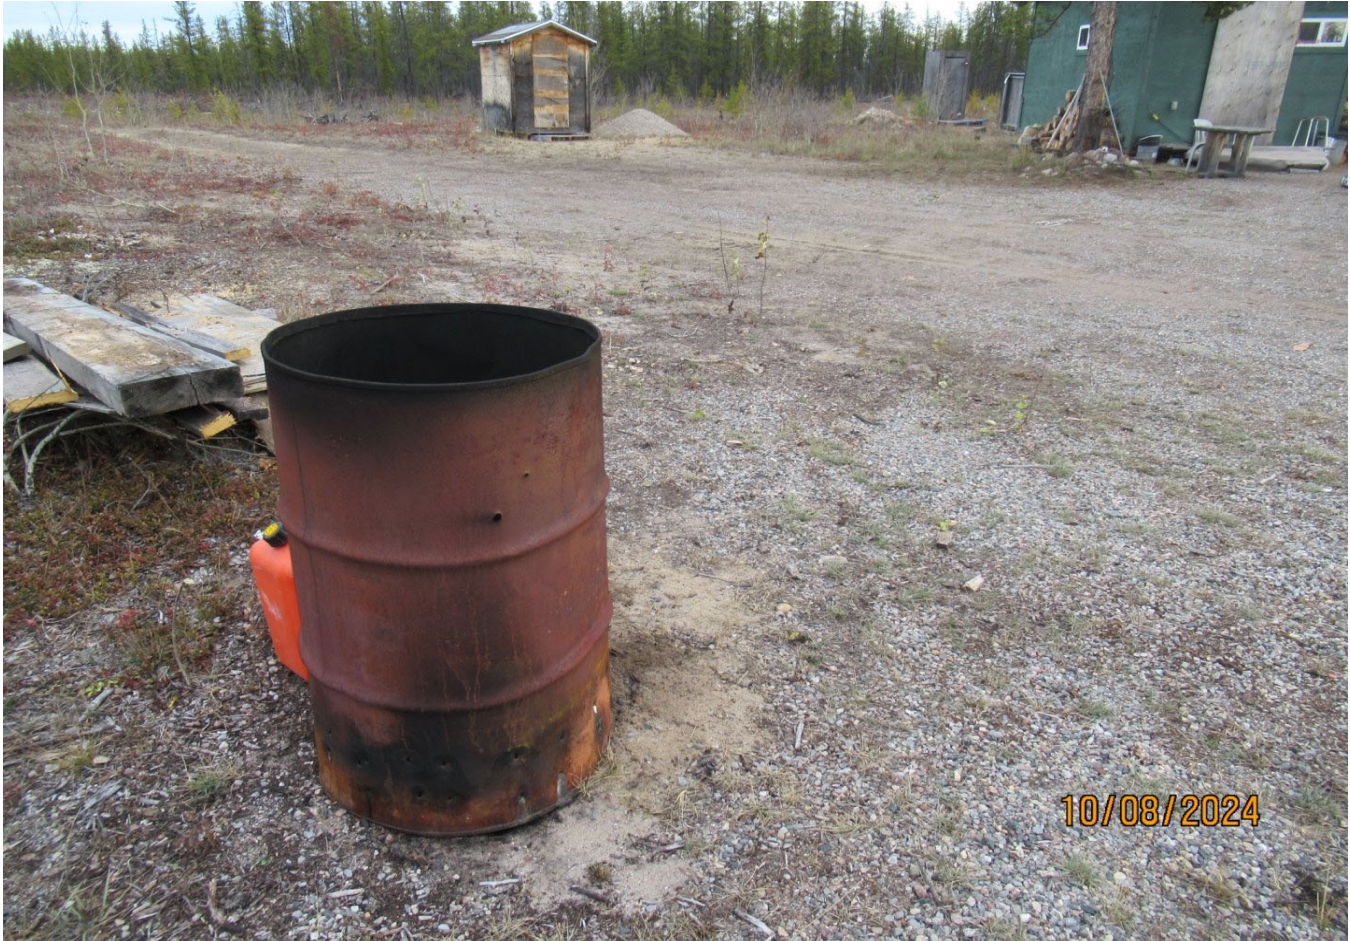
Figure 9

Burn barrel is in use and only items that can be burnt are paper, cardboard, and untreated lumber. Accelerants must not be used for the burning of waste.

- A burn barrel is in use (Figure 9) and as a reminder, the only items that can be open burned are paper, cardboard, and untreated lumber. All other waste must be securely stored and shipped offsite for proper disposal at a licensed facility in Yellowknife. Also, the use of accelerants (hydrocarbons) for the burning of waste is an unacceptable practice and the Permittee must refrain from doing this.

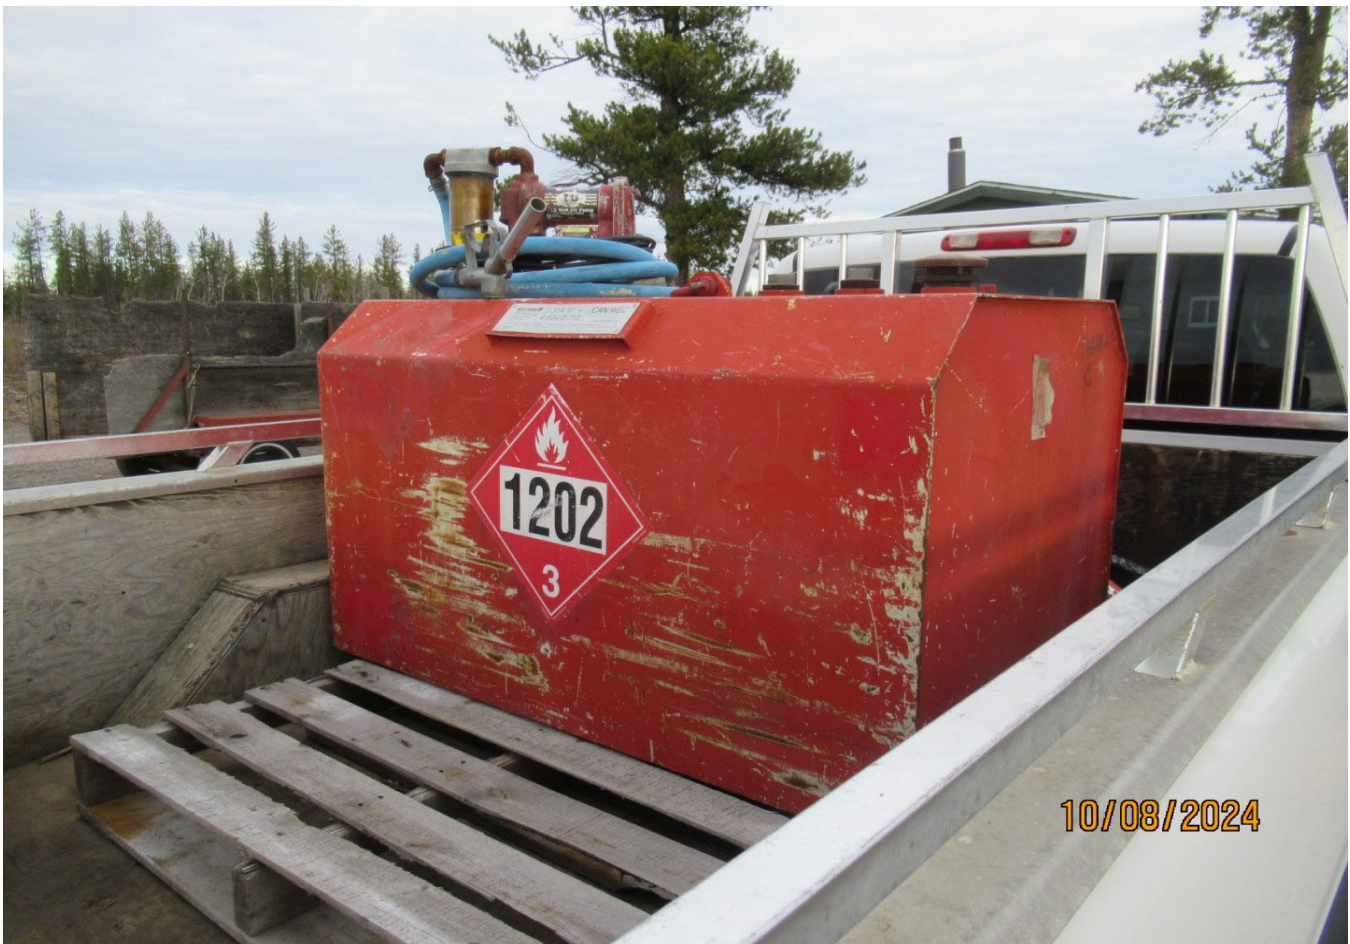
Figure 10

- The only fuel container observed in the land use area is the tidy tank in the back of a pickup (Figure 10). No concerns were noted with fuel storage or handling.

Tidy tank in use for the refueling of equipment throughout the land use area.

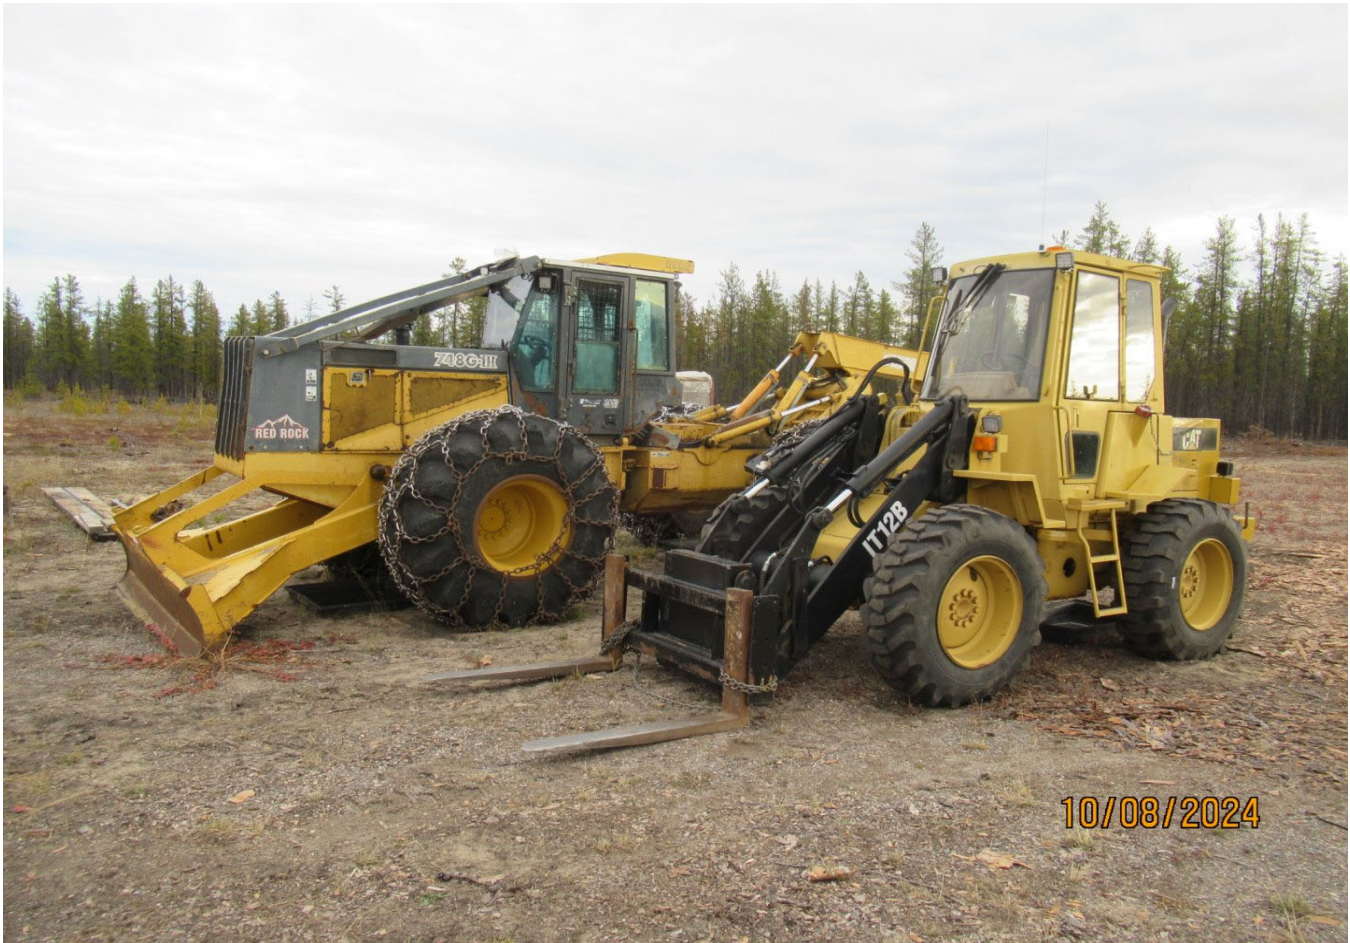
Figure 11

Parked equipment had drip trays present. Trays must be routinely monitored and maintained with proper disposal of impacted water/snow and hydrocarbons.

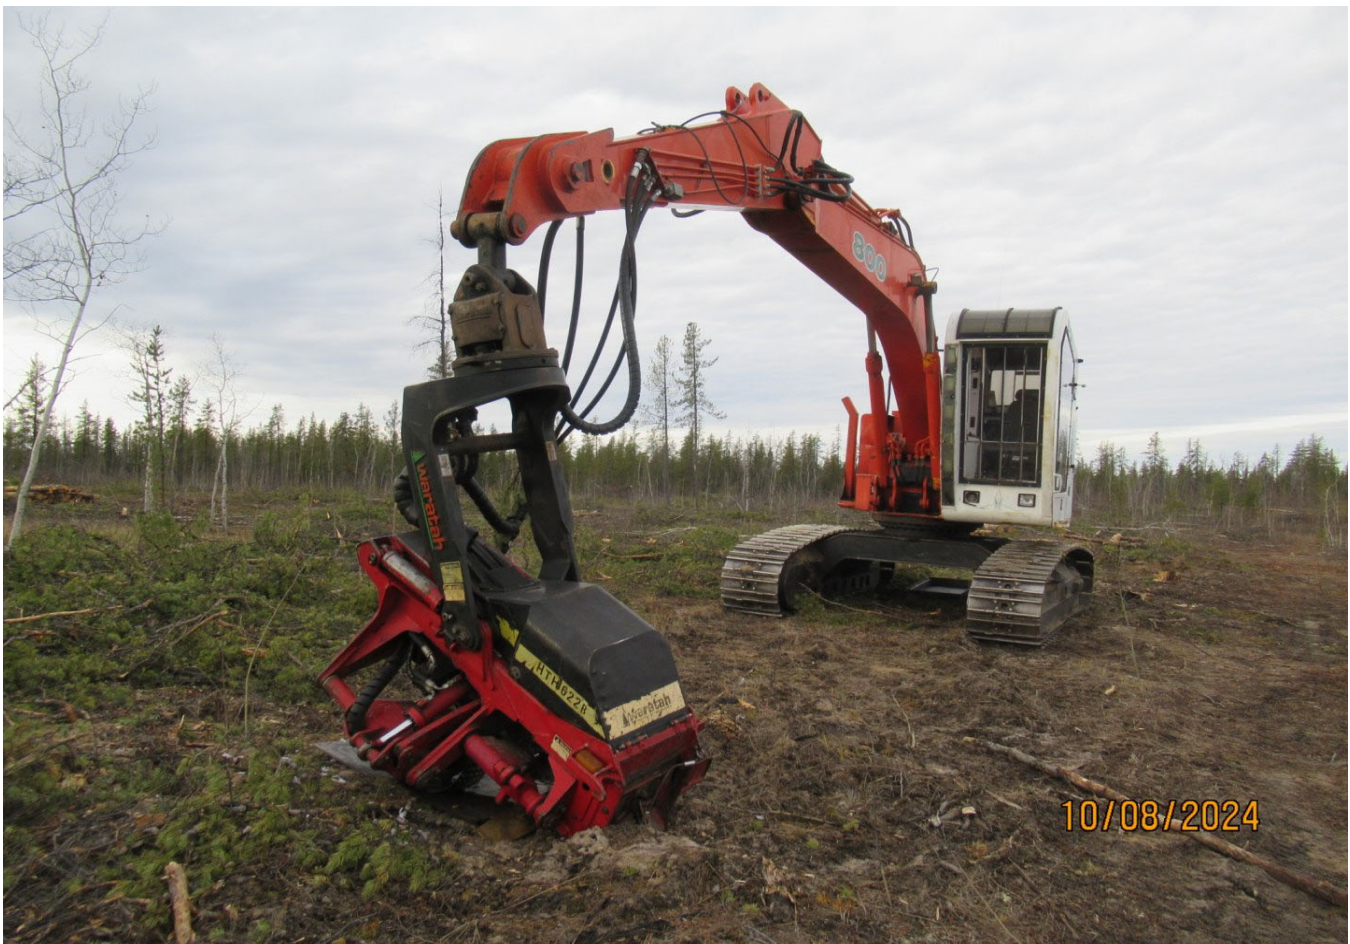
Figure 12

Harvester for the felling, de-limbing, and topping of trees.

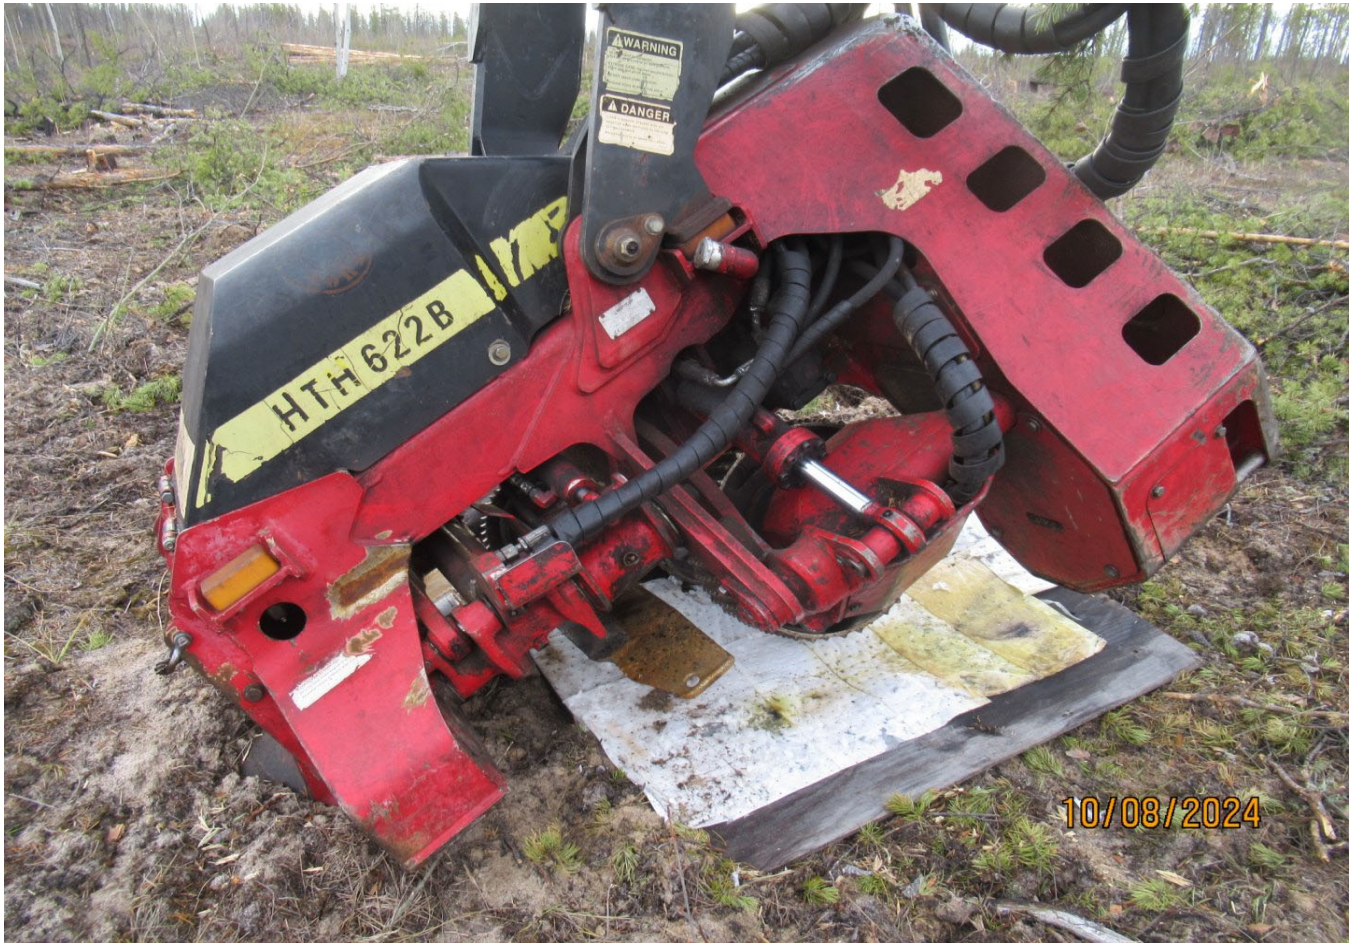
Figure 13

Drip board in use below the head of the harvester. Repairs of persistent leaks must be conducted at the earliest opportunity.

- All parked equipment had drip trays (Figure 11 through 13) present. As per Condition #28, at the very earliest opportunity, repairs to the head of the harvester must be conducted if a persistent hydraulic leak is present. Until repairs can be conducted, the drip board must be diligently monitored and hydrocarbon absorbent matting changed out once saturated.

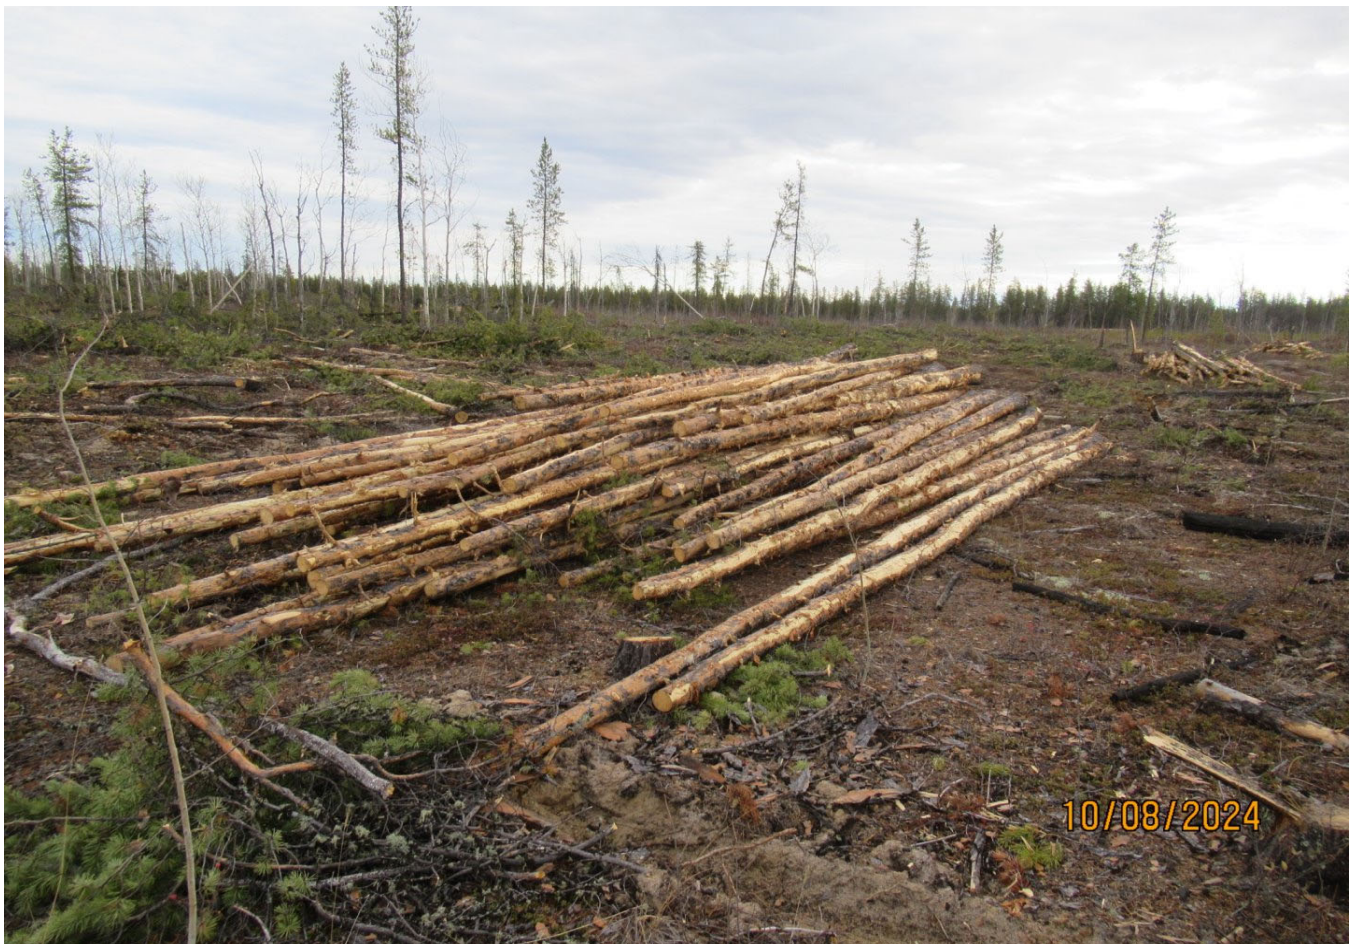
- Felled and bunched trees can be viewed in Figure 14 and stump height & tree top disposal appeared satisfactory throughout the portion of the cut block inspected.

Example of felled and stacked trees in the wood lot.
