**Re: Land Use Permit W2020X0005
Miscellaneous - Remediation
Rayrock Remediation Project, NT**

ENVIRONMENTAL INSPECTION REPORT

Permittee:	CIRNAC – Contaminants and Remediation Division	Inspection Date: February 6 th , 2025
------------	--	--

Location(s) Inspected:	Winter Roads.
------------------------	---------------

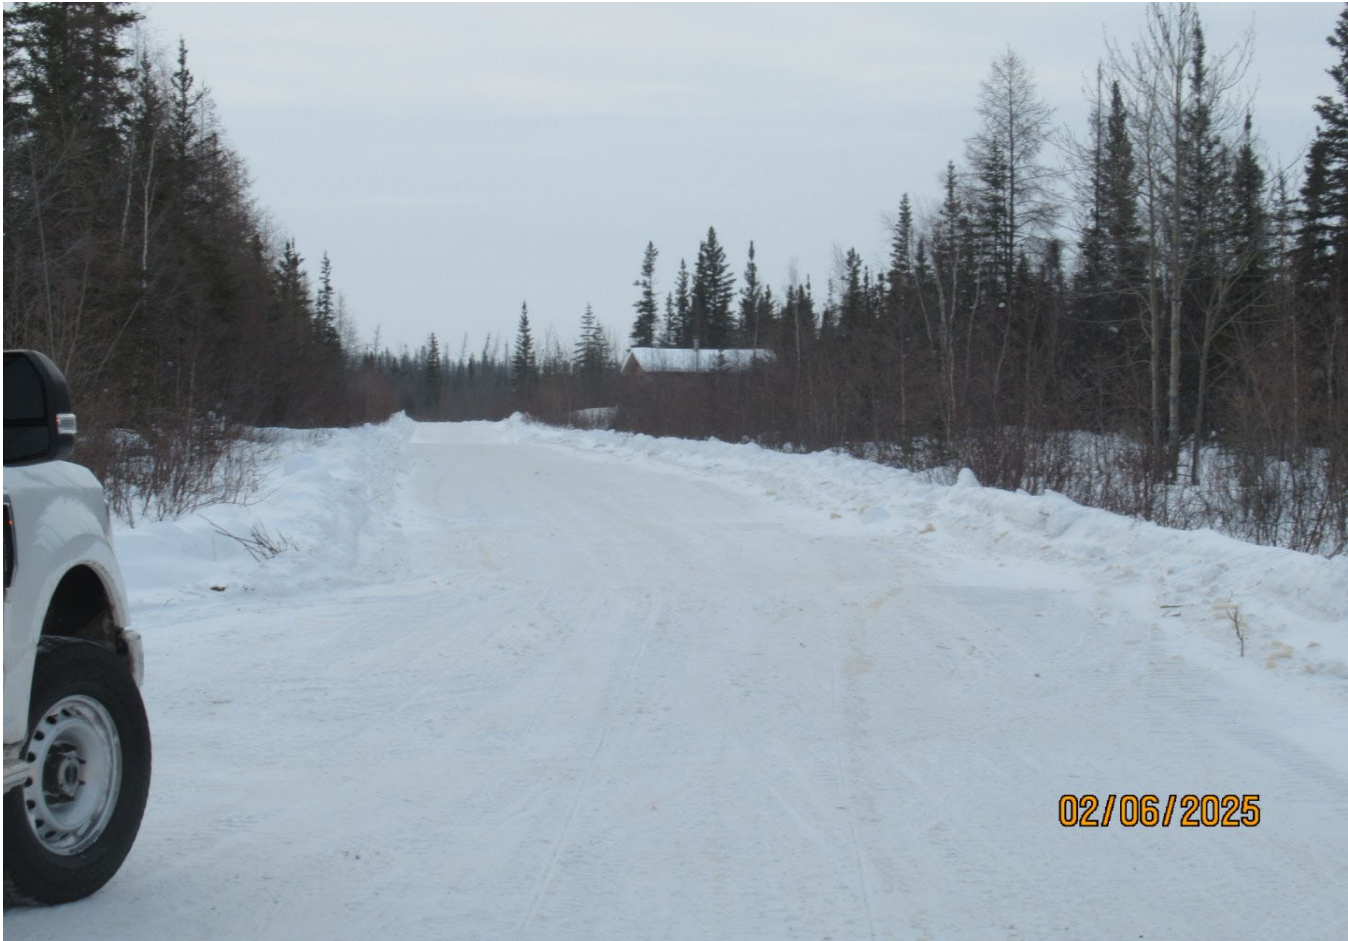
Figure 1

Km 0 of the Sun Main Winter Road. Looking south along the alignment.

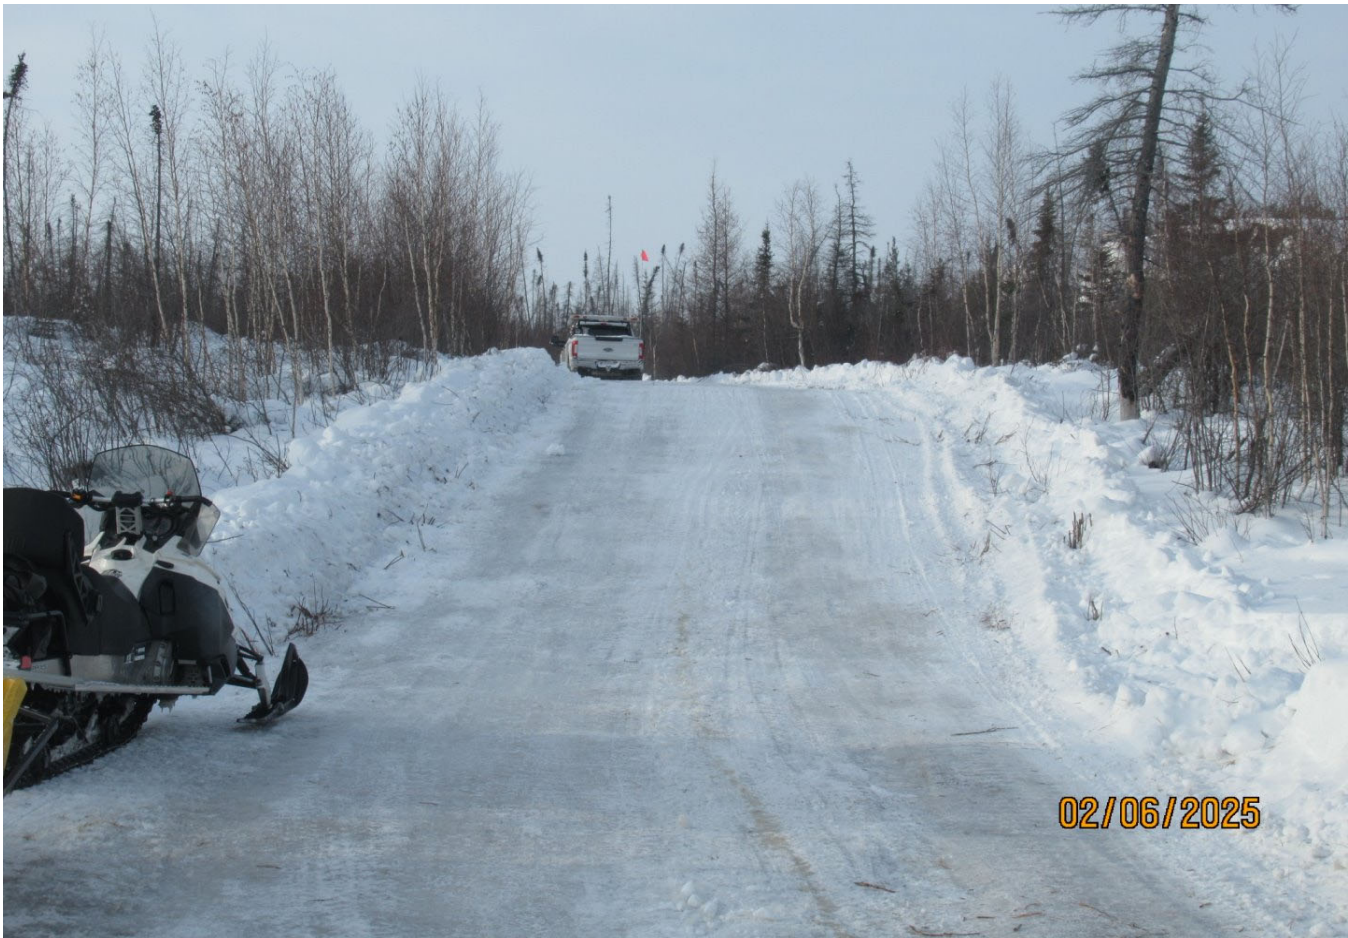
Figure 2

Example of the initial icing of a portage on the Rayrock winter road.

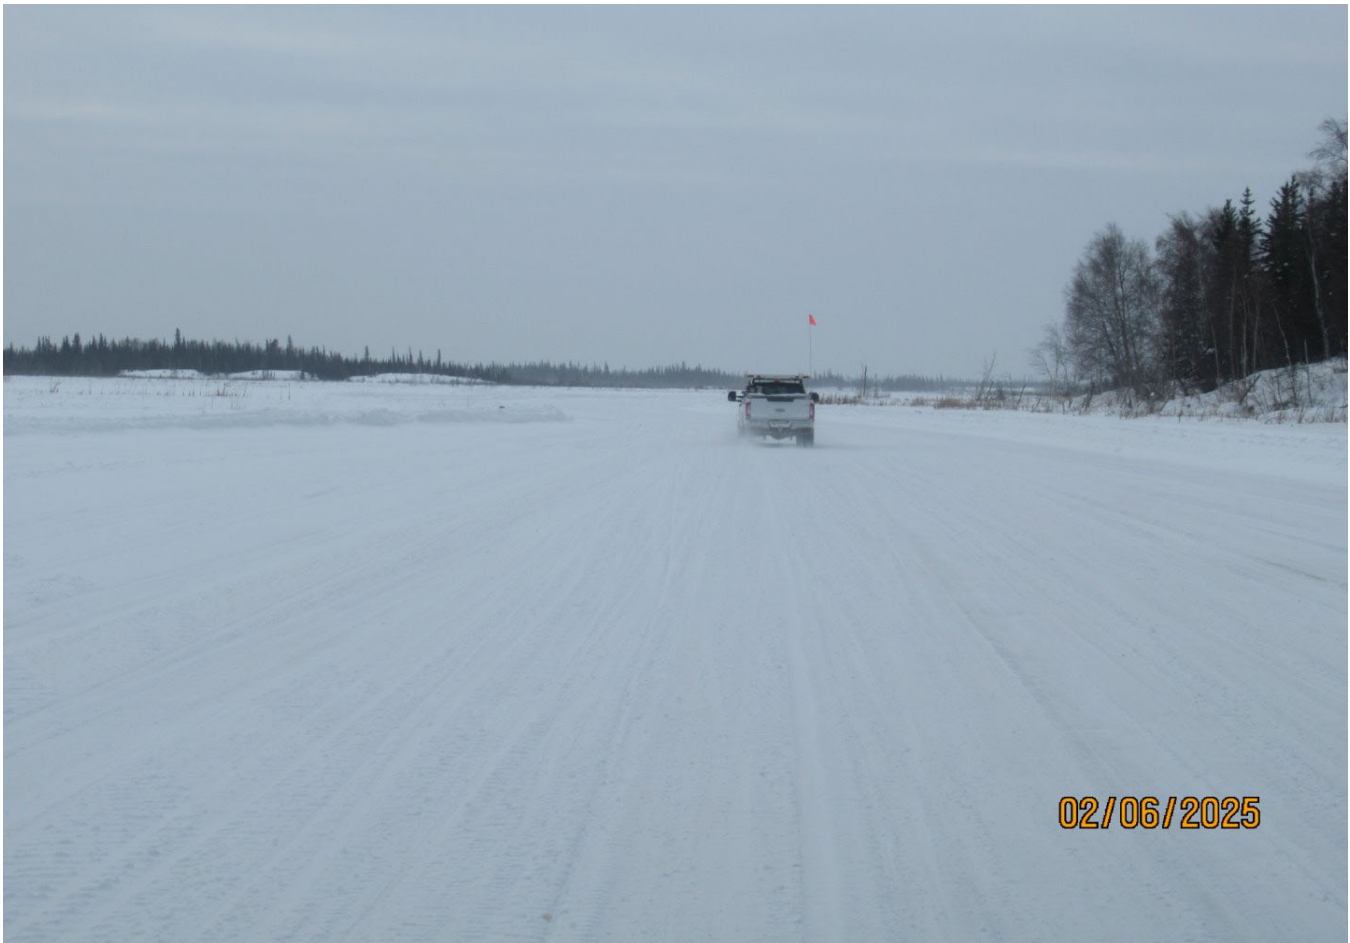
Figure 3

Ice surface of Rat lake has been cleared to width. Looking southwest.

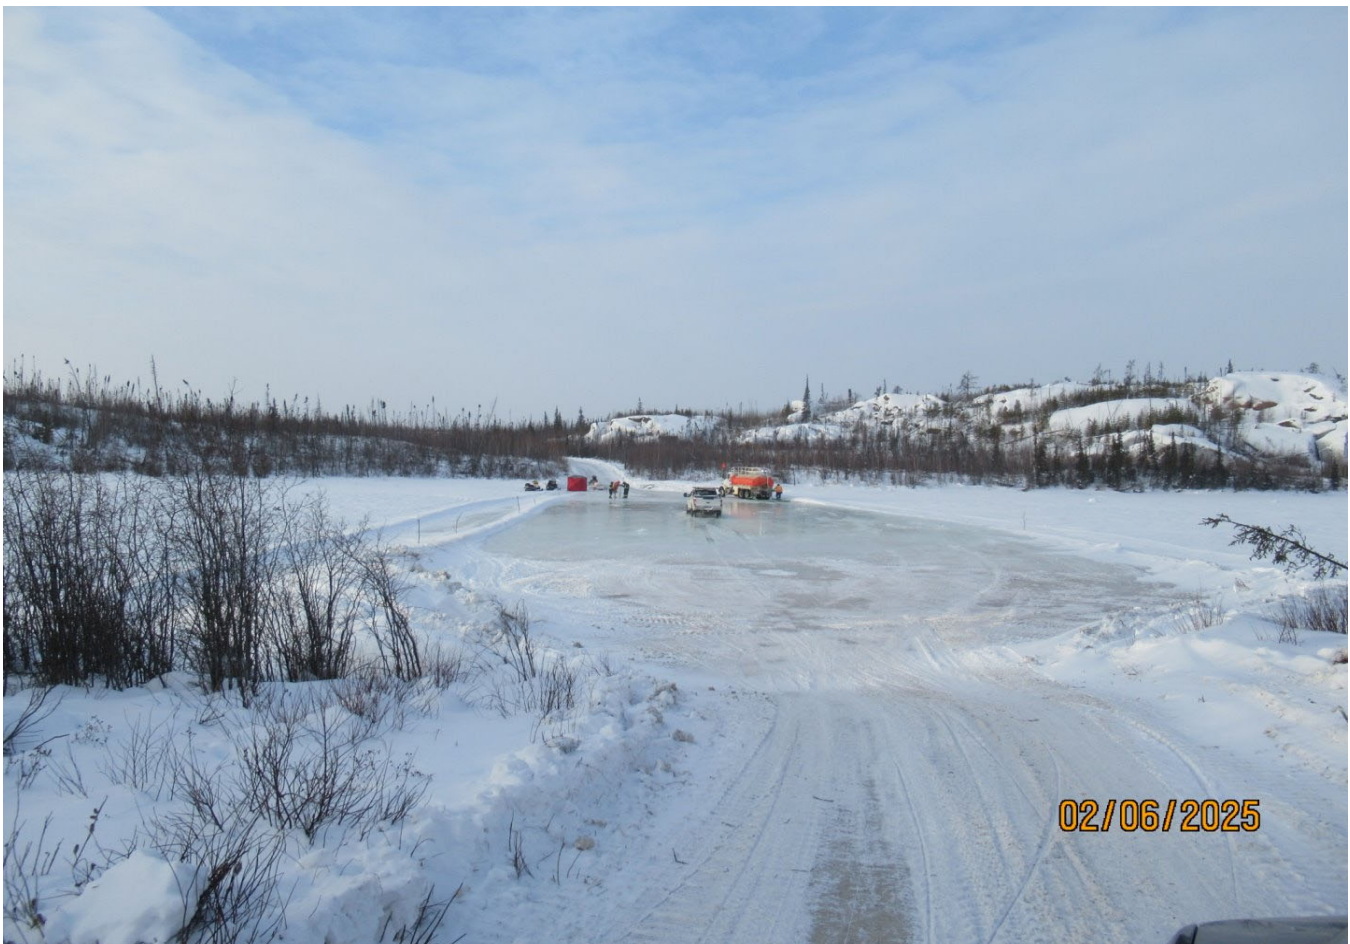
Figure 4

The Emile River ice crossing is being flooded to grow ice to allow for the movement of freight and fuel onto the Rayrock Property.

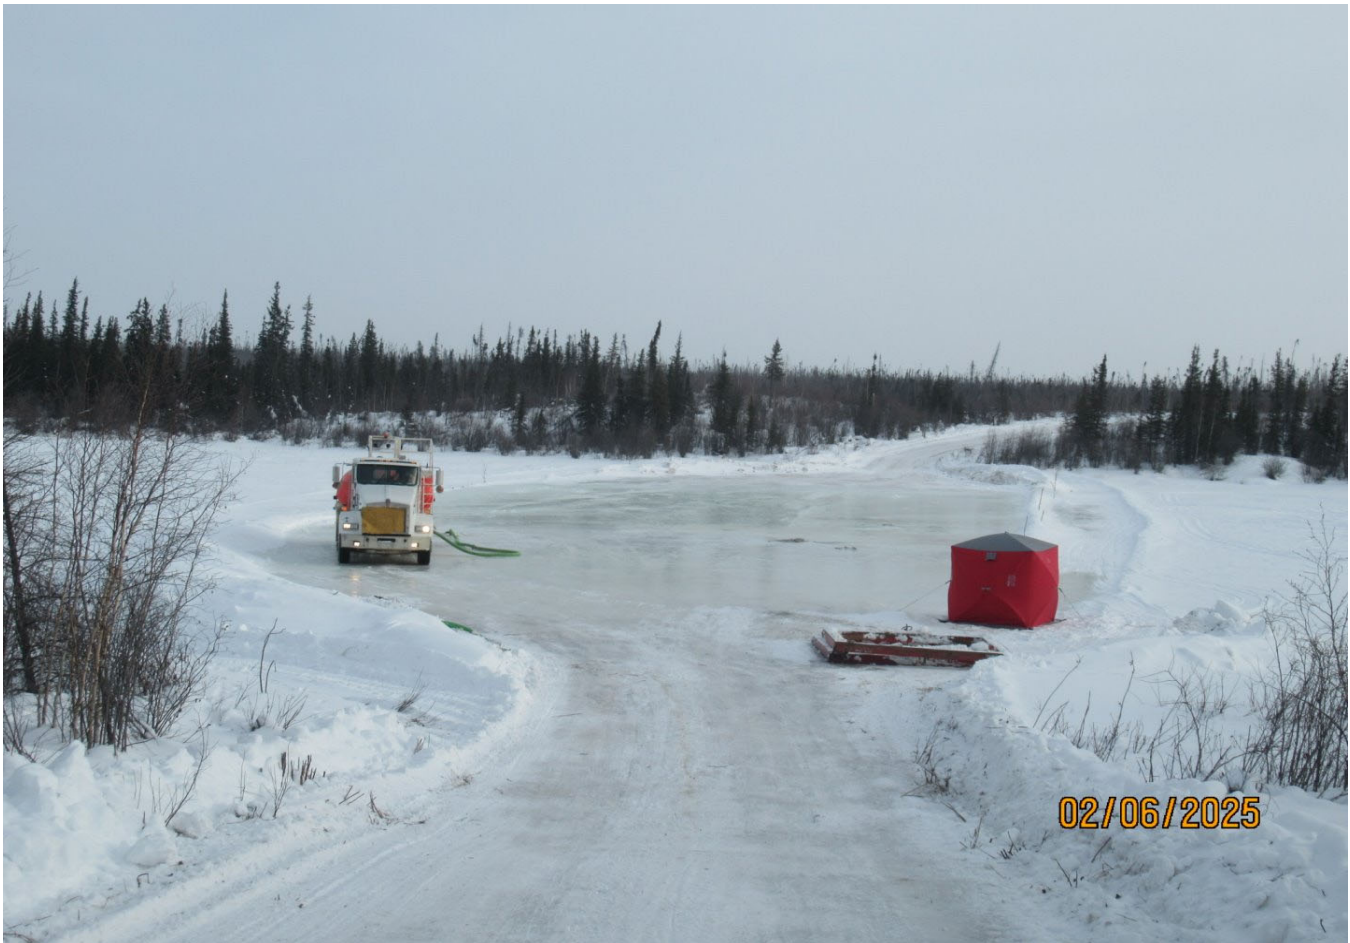
Figure 5
Looking east at the Emile River ice crossing.

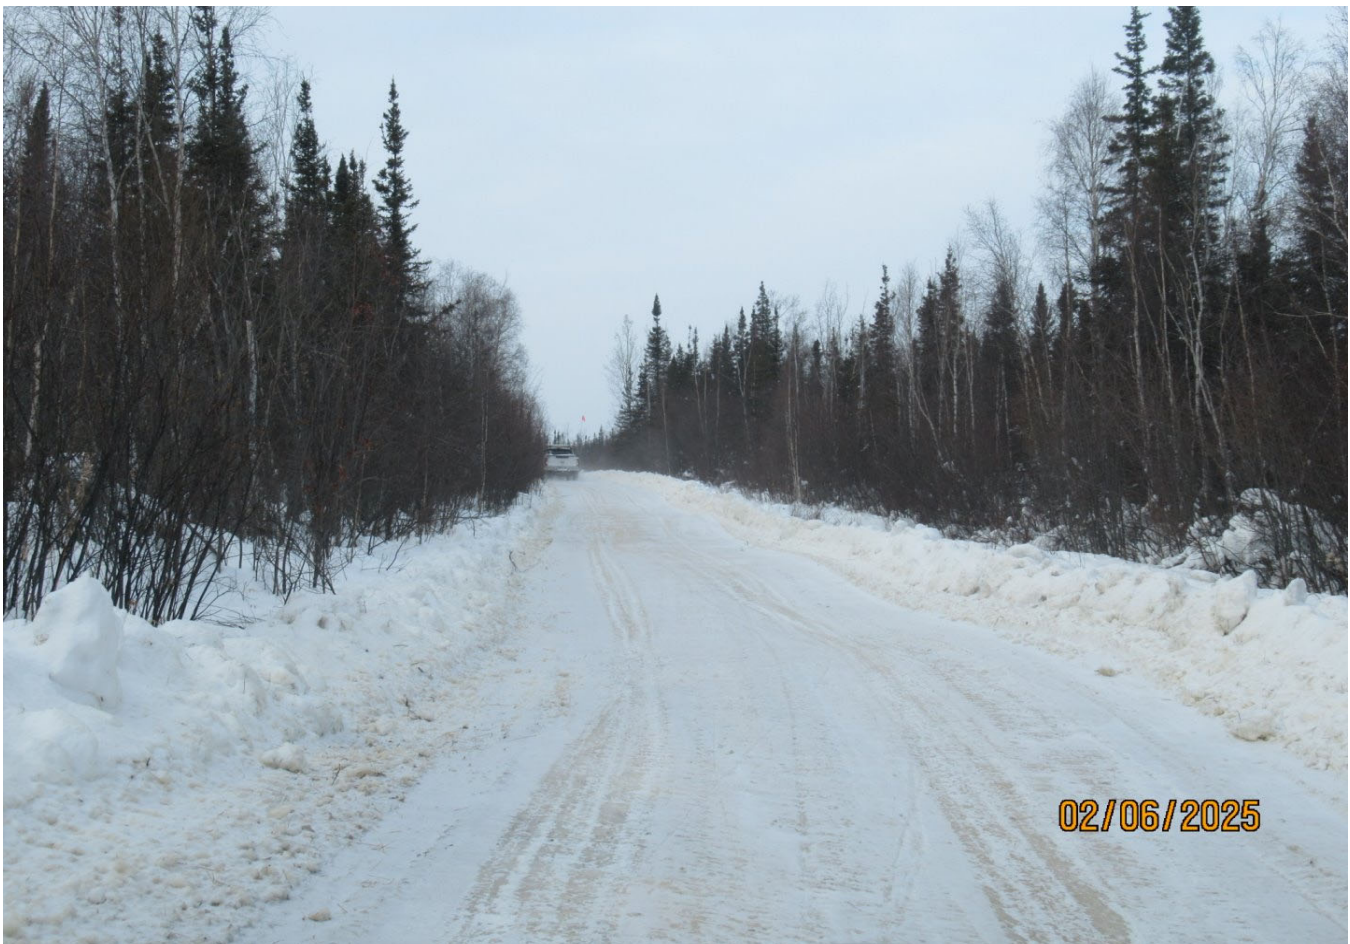
The Inspector is pleased to report that initial icing of portages (Figure 6 through 8) was sufficient to meet the requirements of Condition #22 but as a reminder, and prior to the movement of freight, fuel, and the sand haul to Sunmain, icing from shoulder-to-shoulder must be completed during final grooming activities. This practice will ensure the underlying ground surface is protected at all times and prevent early deterioration of the portages if land use operations progress late into the Spring.

Figure 6
Example of a portage with initial icing completed. Final grooming must be completed to ensure icing from shoulder-to-shoulder of the right-of-way.

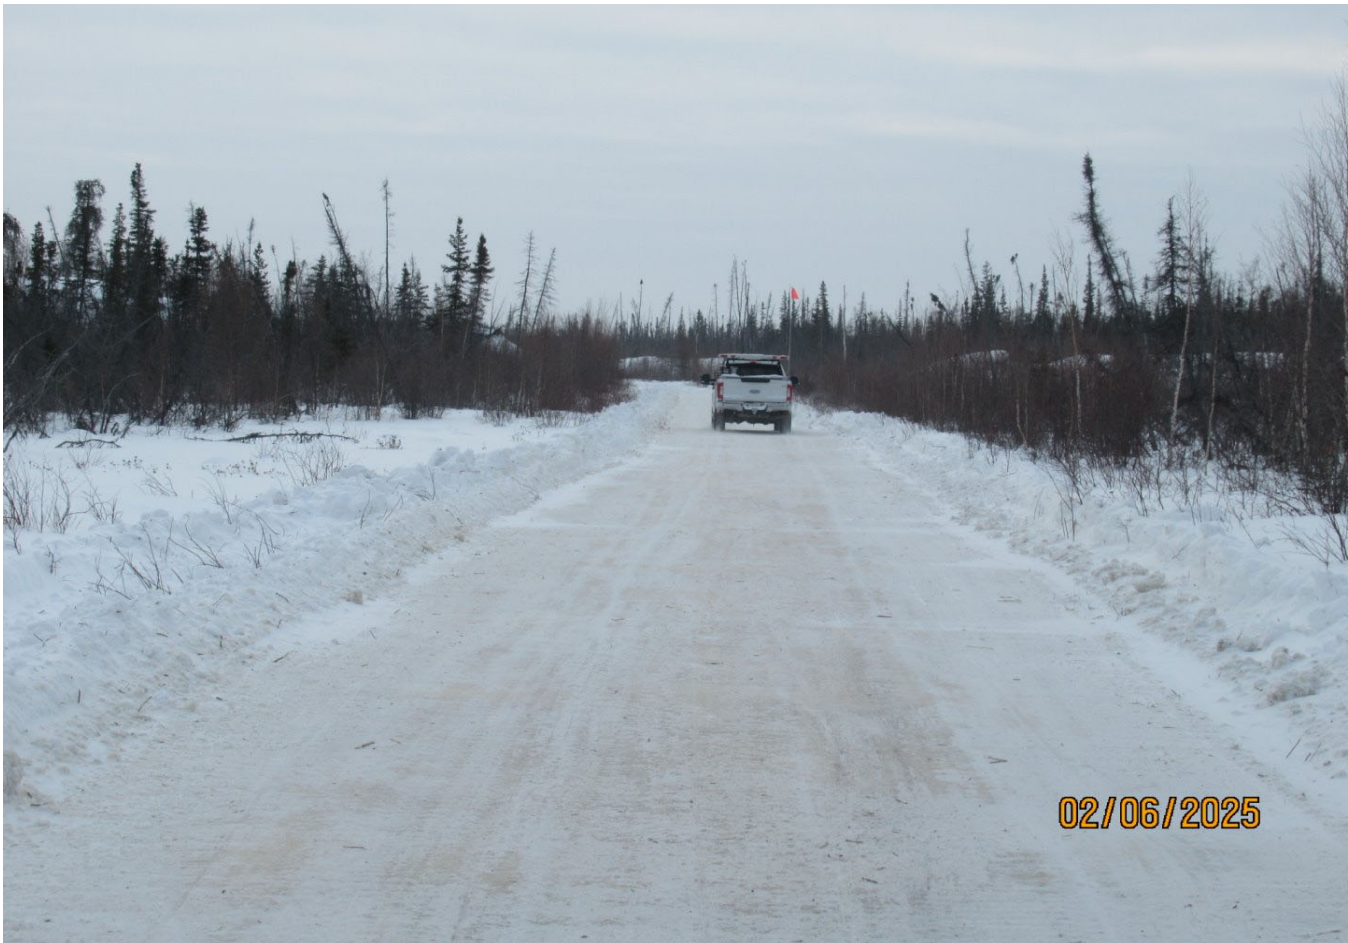
Figure 7

Another example of a portage with initial icing completed on the Sunmain Winter Road.

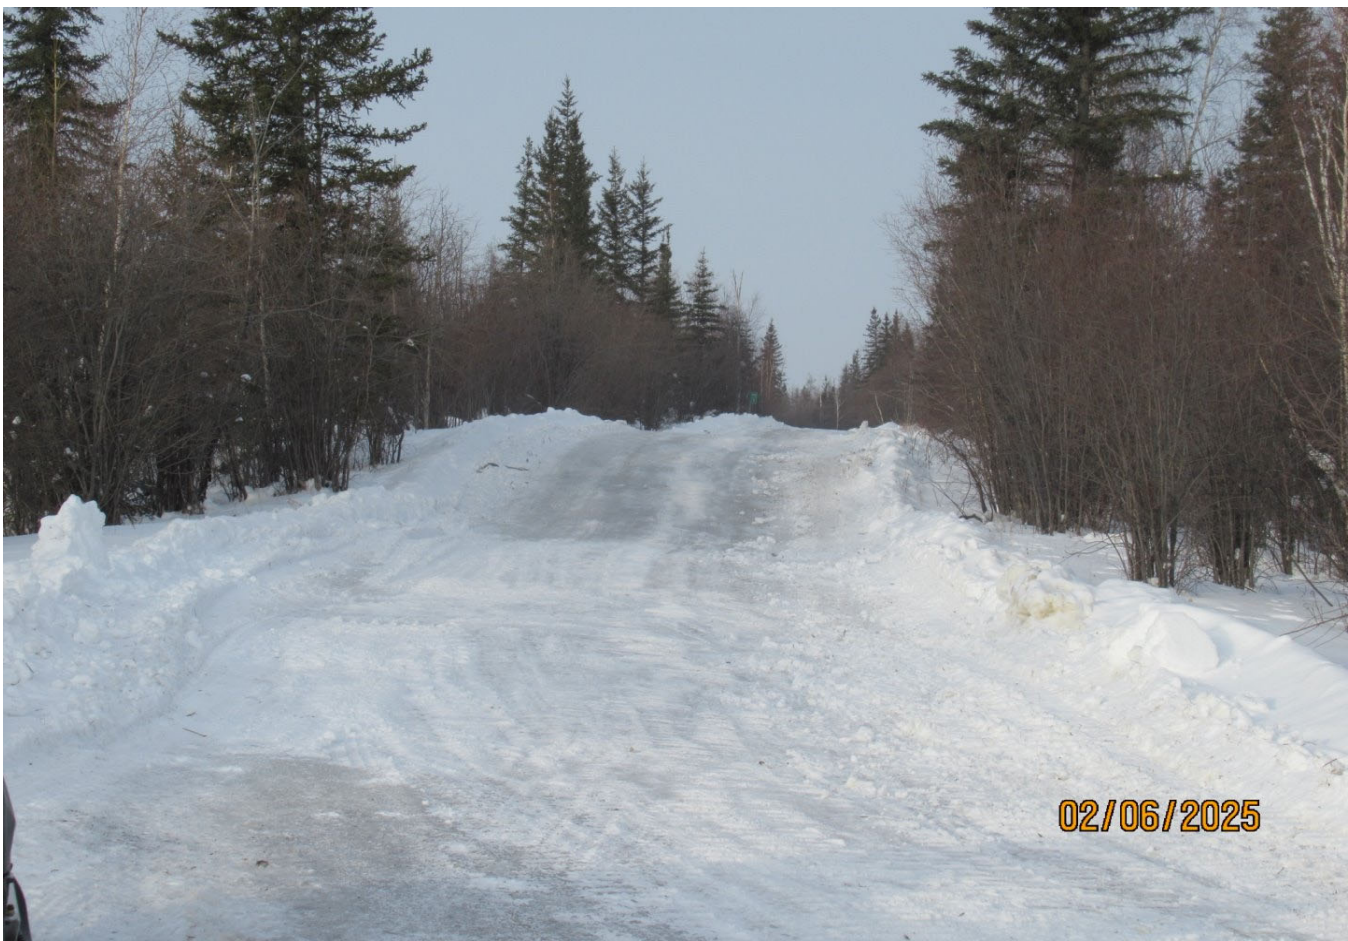
Figure 8

Looking north along the second portage of the Rayrock Winter Road.

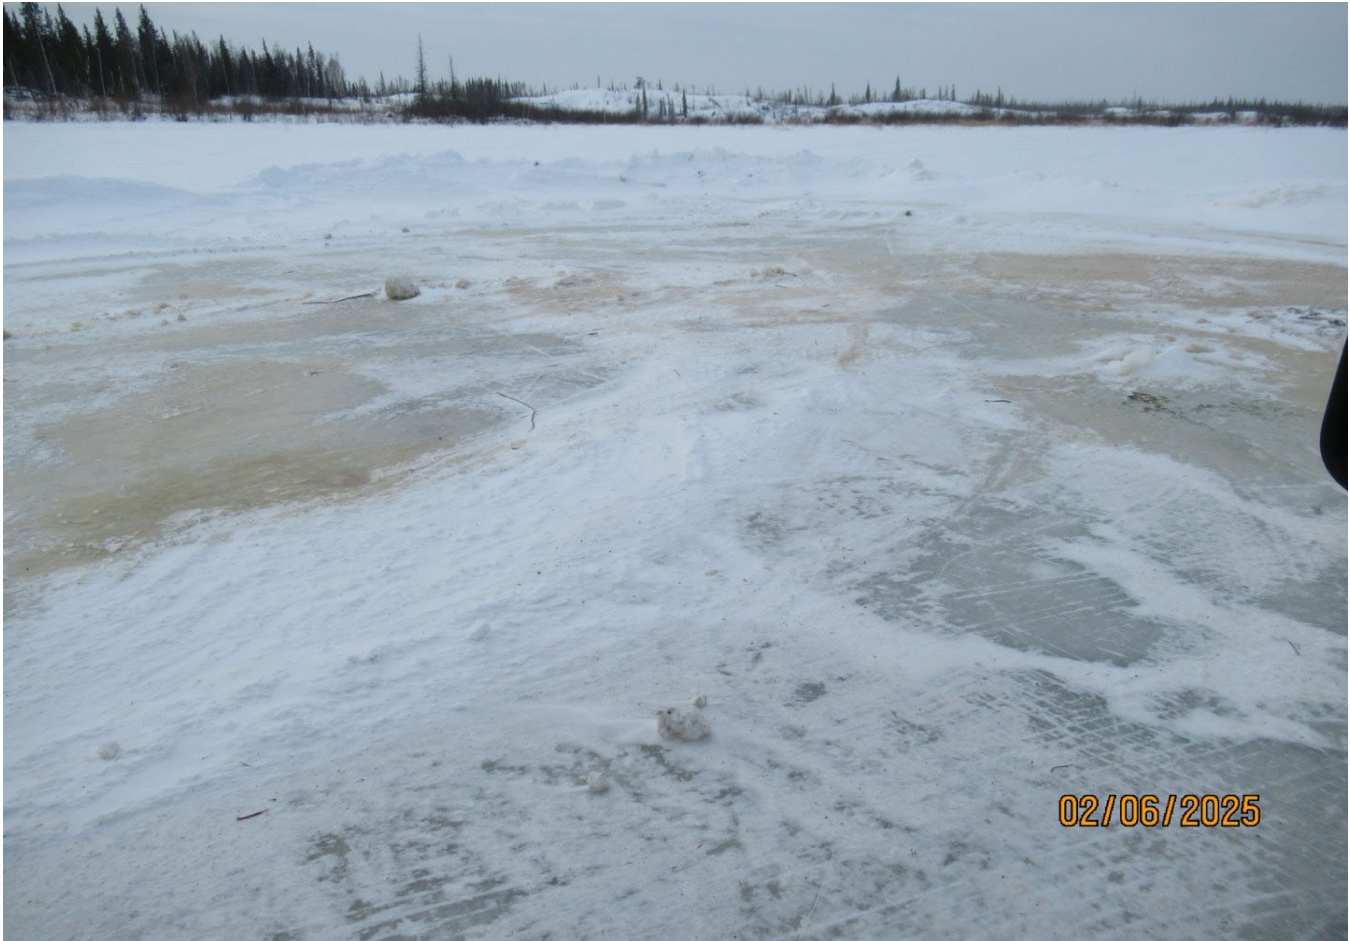
Figure 9

Water is being sourced from various watercourses along the Sunmain Winter Road and one location can be viewed in Figure 9. As seen in this figure, no obvious hydrocarbon or glycol spills were observed on the ice surface and it is anticipated that diligent monitoring & cleanup of small spills will be conducted on an ongoing basis if observed. This practice will ensure compliance with Condition #66 (Fuel Containment).

Water source along the Sunmain Winter Road. No obvious hydrocarbon or glycol leaks were observed.

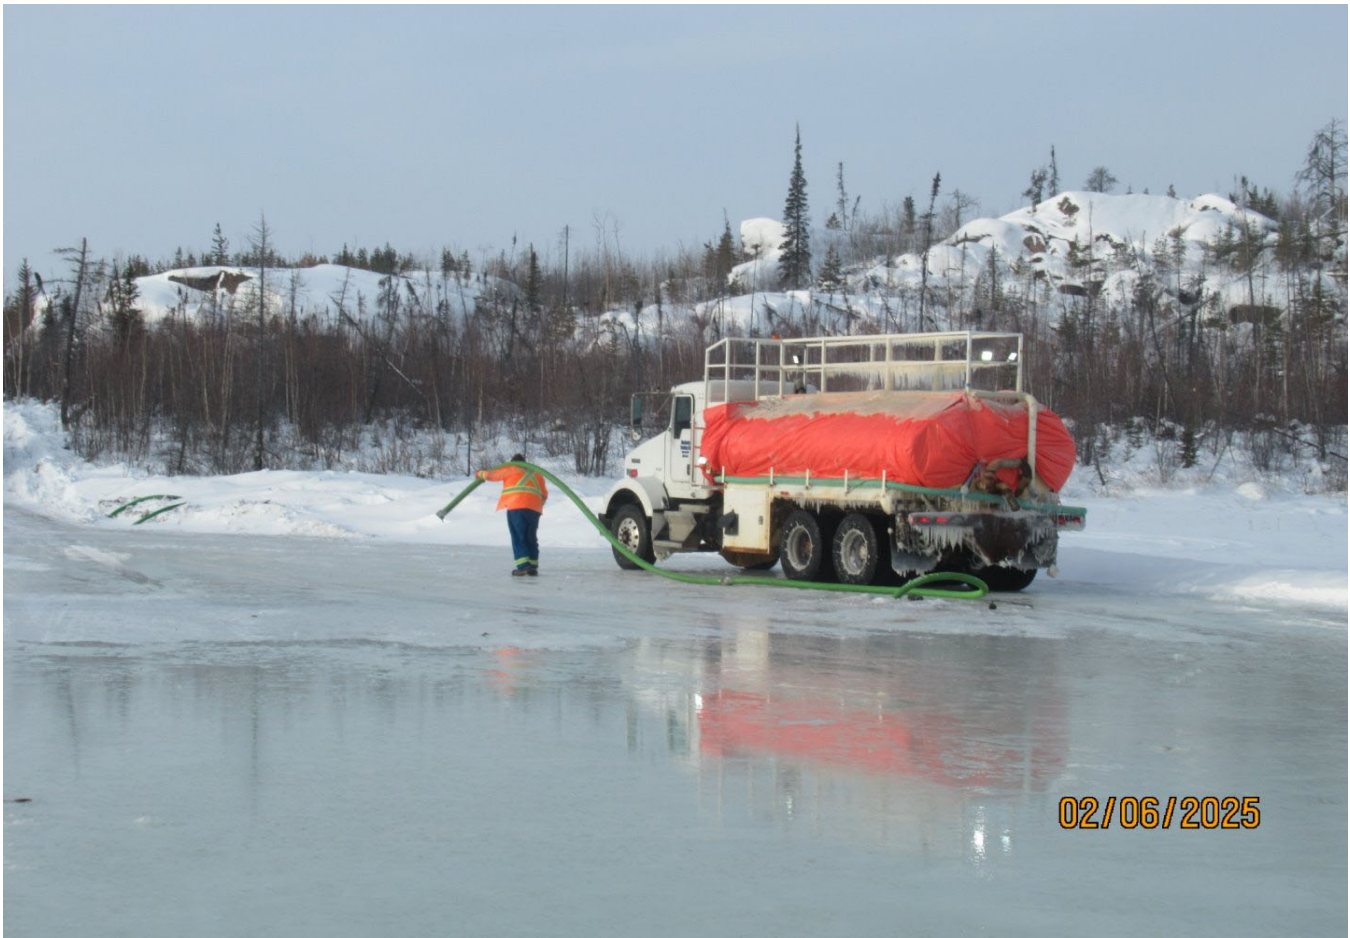
Figure 10

One of two water trucks active on the southern sections of the Rayrock Winter Road.

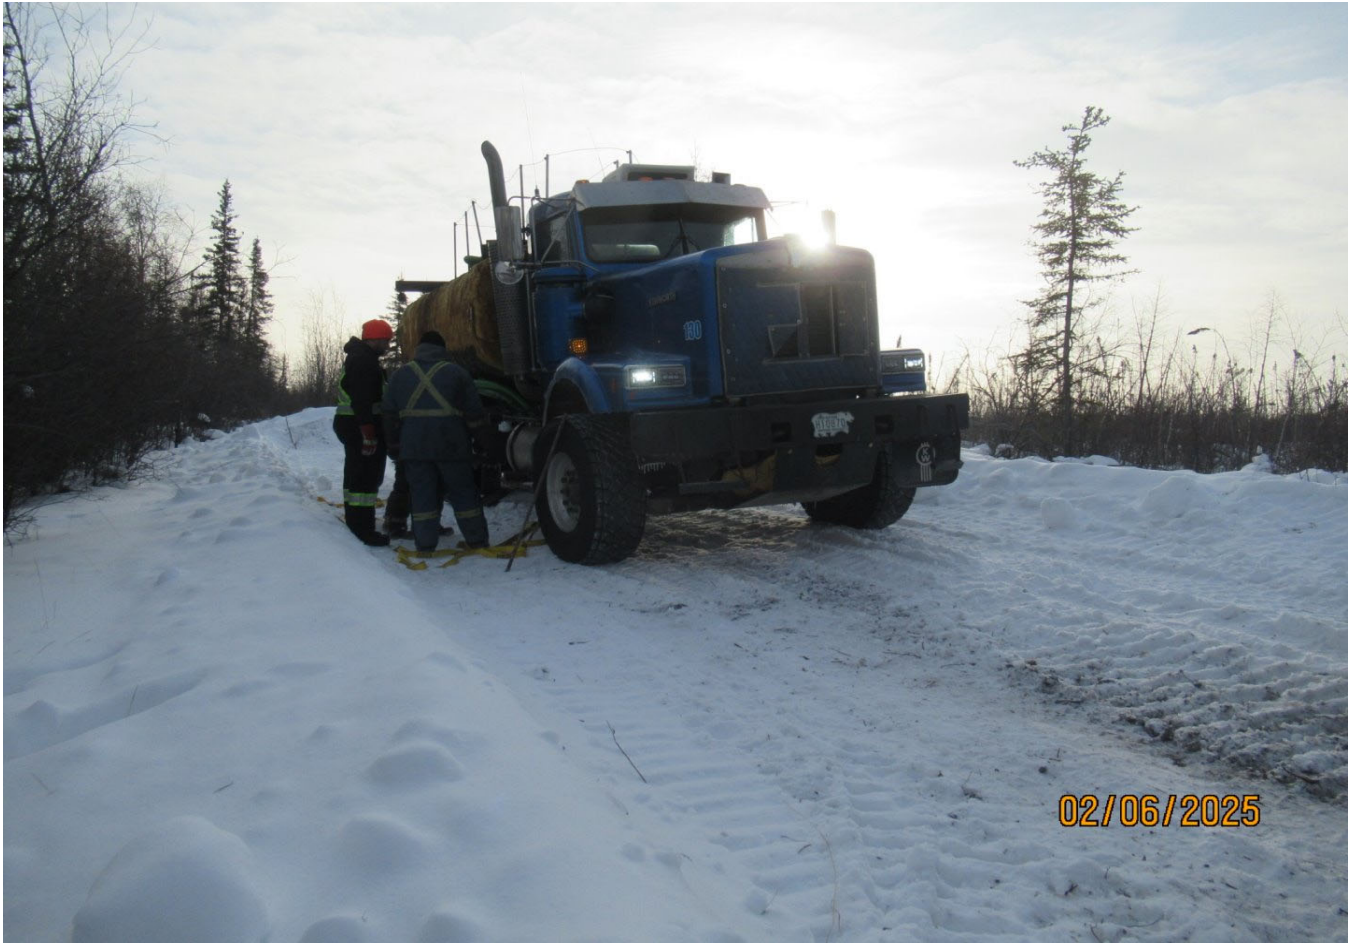
Figure 11

Second water truck observed working on the Rayrock Winter Road.

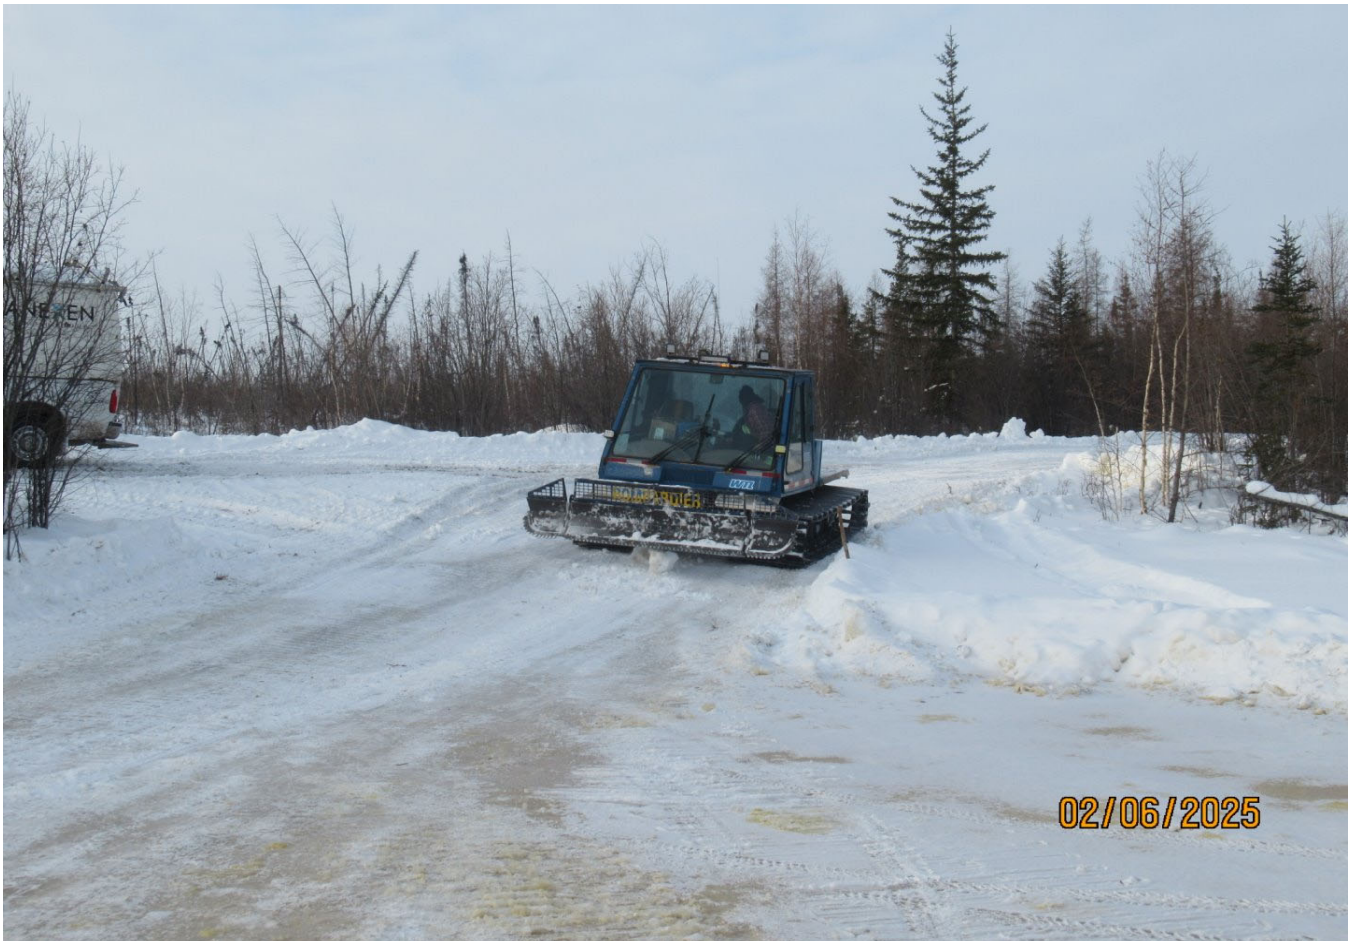
Figure 12

Snowcat actively ploughing snow on the southern sections of the Rayrock Winter Road.

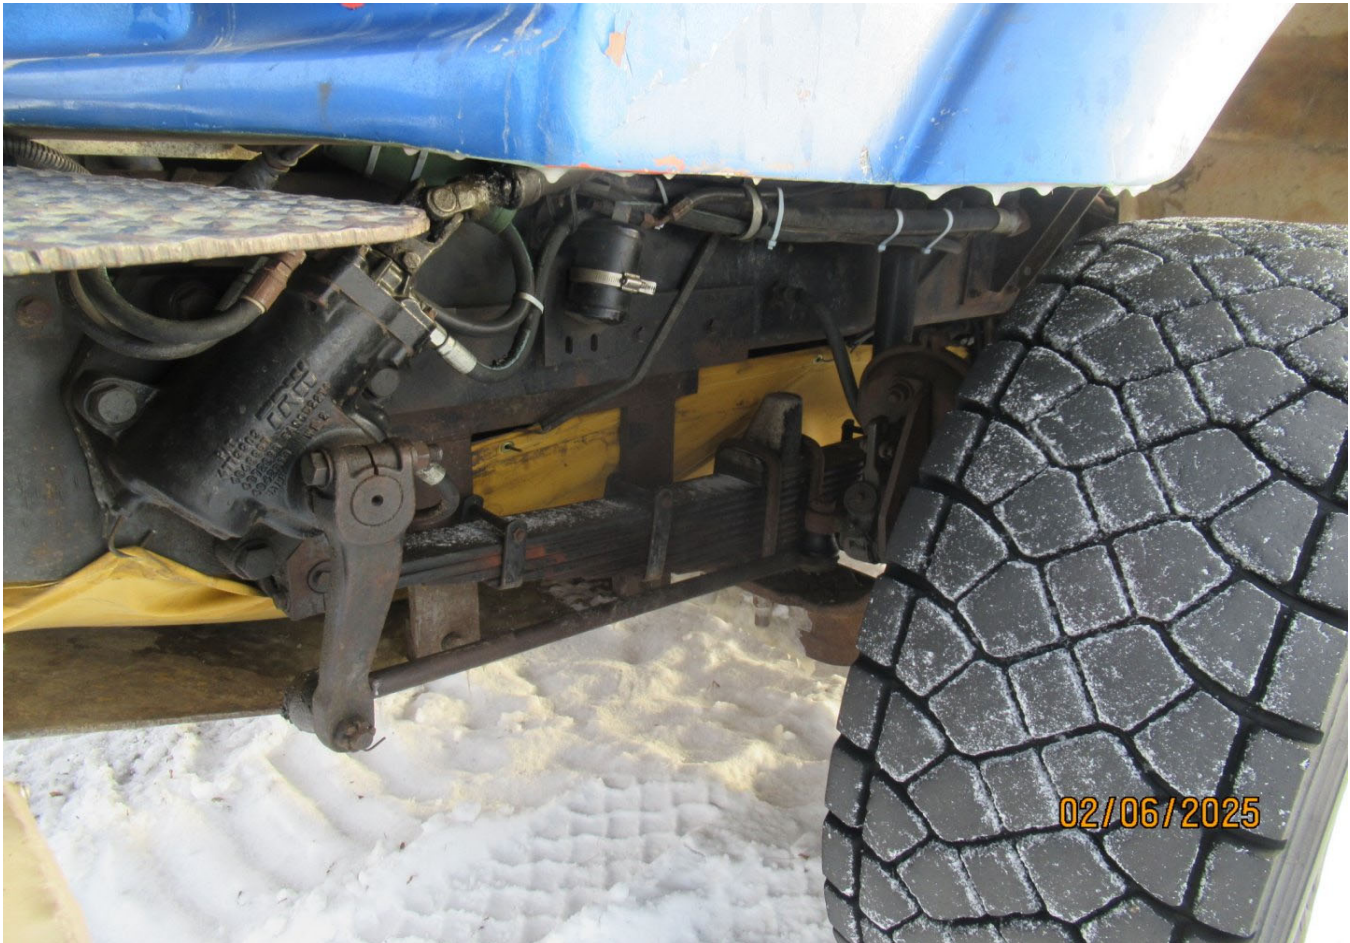
Figure 13

Water truck equipped with a belly tarp to contain potential leaks. Belly tarps must be maintained at all times.

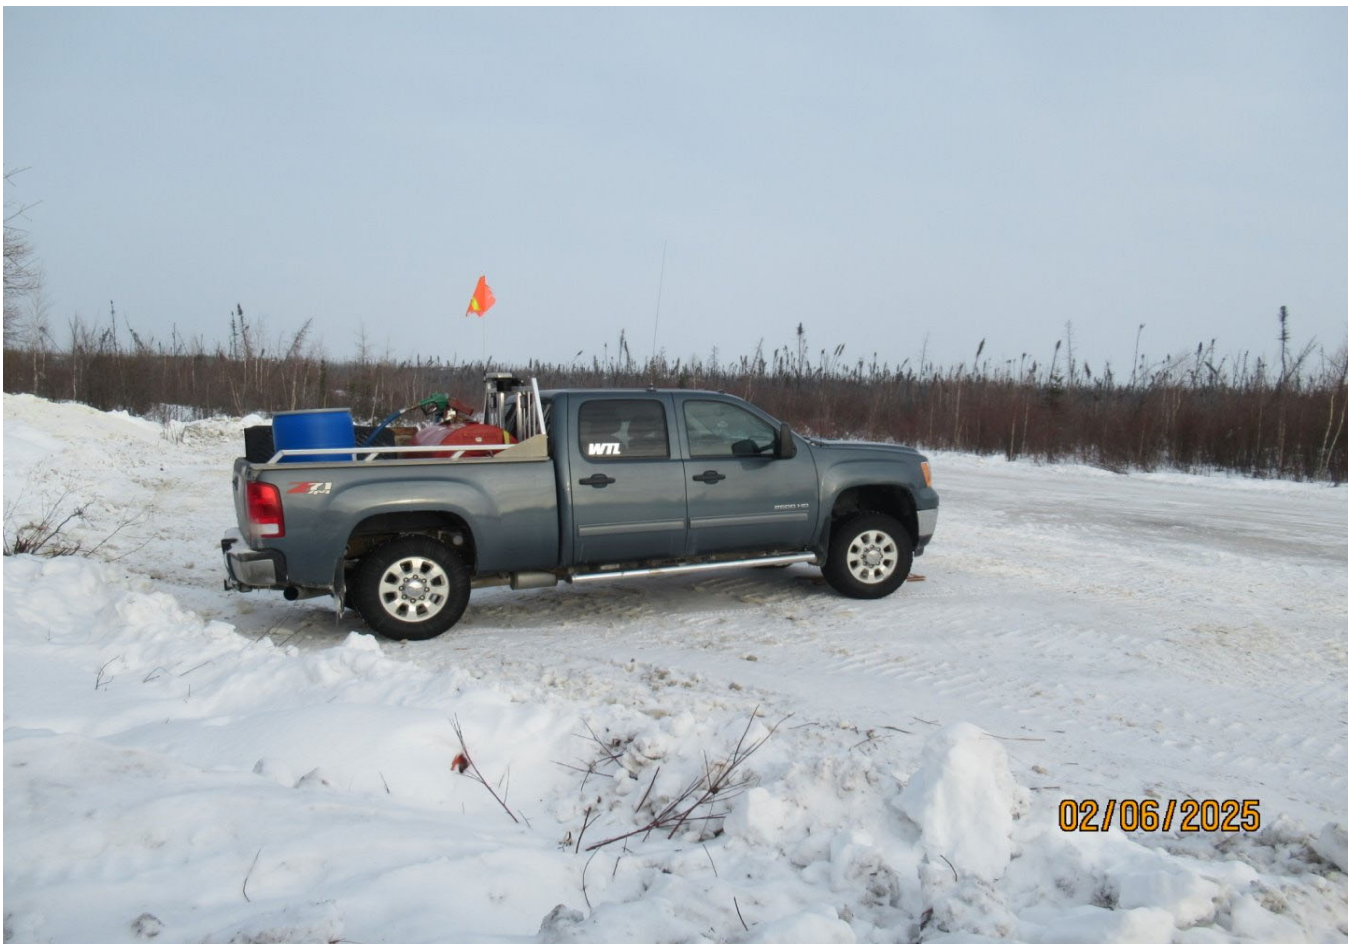
Figure 14

Pickup parked at the Km 0 laydown of the Rayrock Winter Road. Spill kit was present.

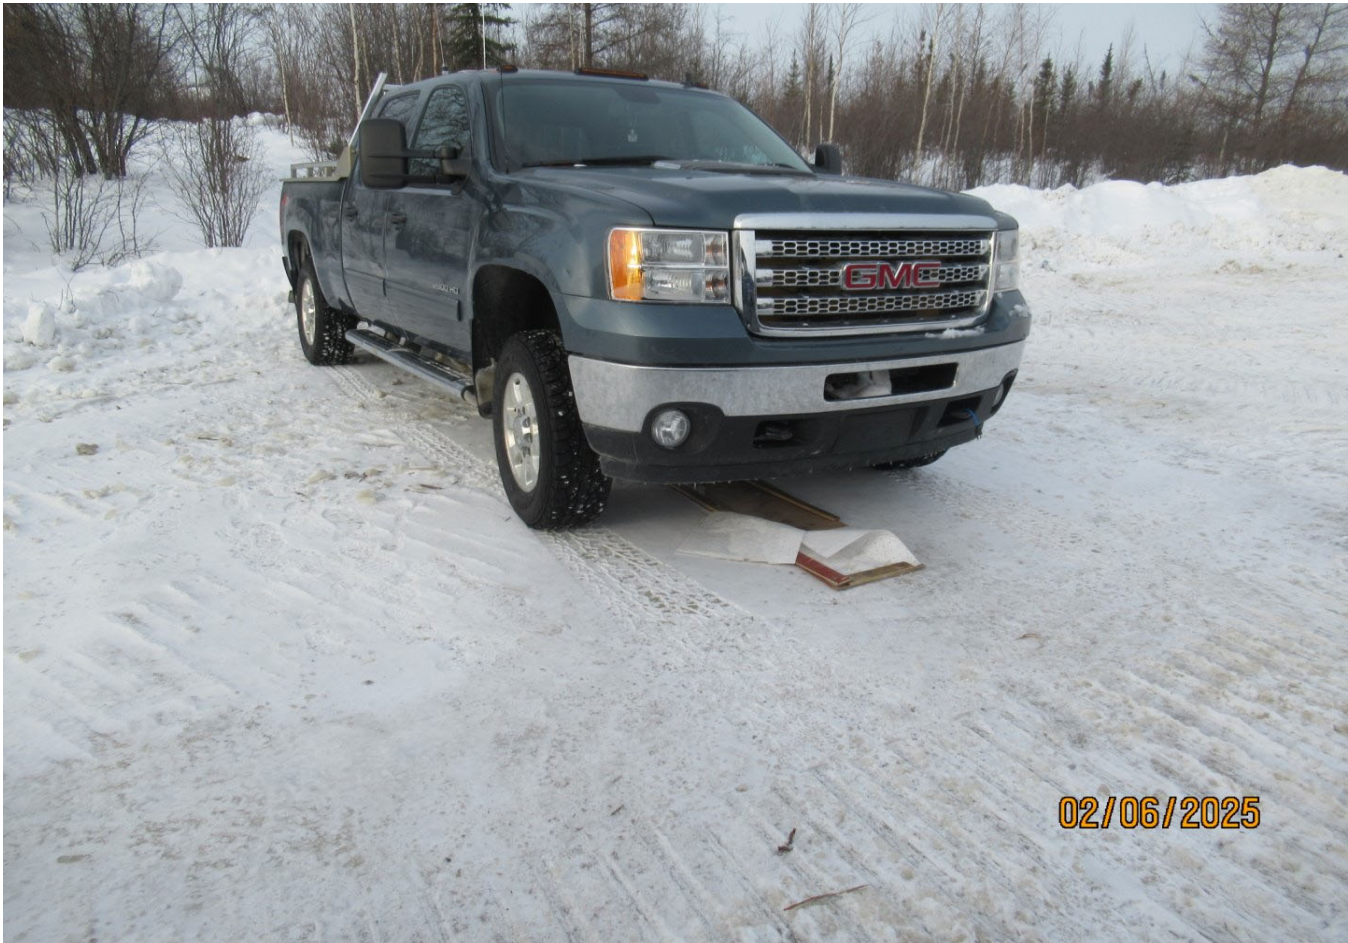
The only concern noted was with the drip board viewed in Figure 15 under the parked pickup in the Km 0 laydown of the Rayrock winter road. The hydrocarbon absorbent matting has been ripped off the board and it must be resecured to ensure effectiveness. This concern was discussed with Mr. Weatherby upon completion of the inspection and will be immediately addressed.

Hydrocarbon absorbent matting must be secured to drip boards to ensure they are effective at containing potential leaks from vehicles.

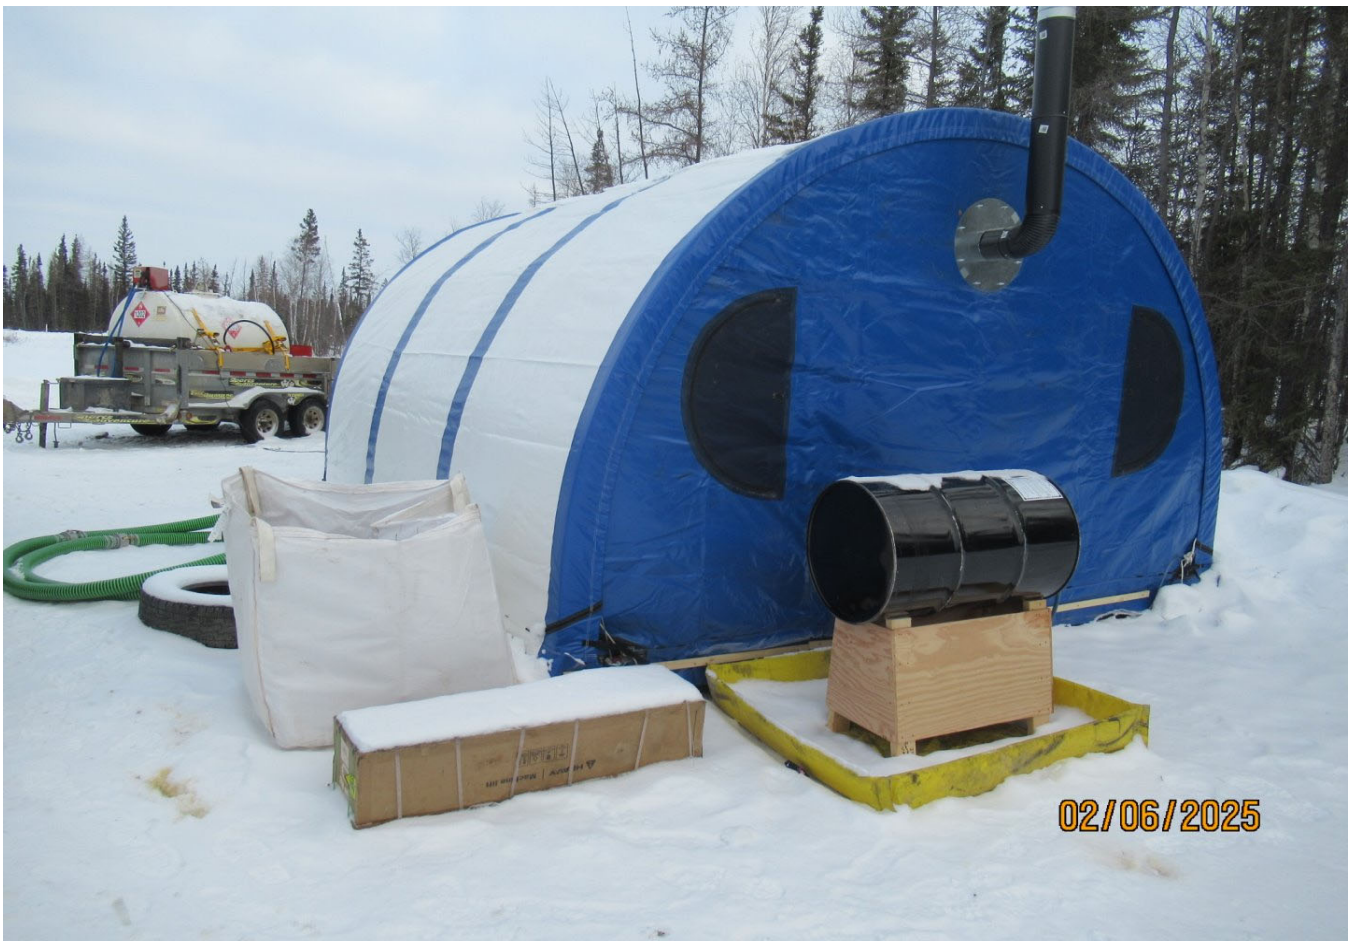
Figure 16

Weather haven camp set up at Km 0 of the Sunmain Winter Road.

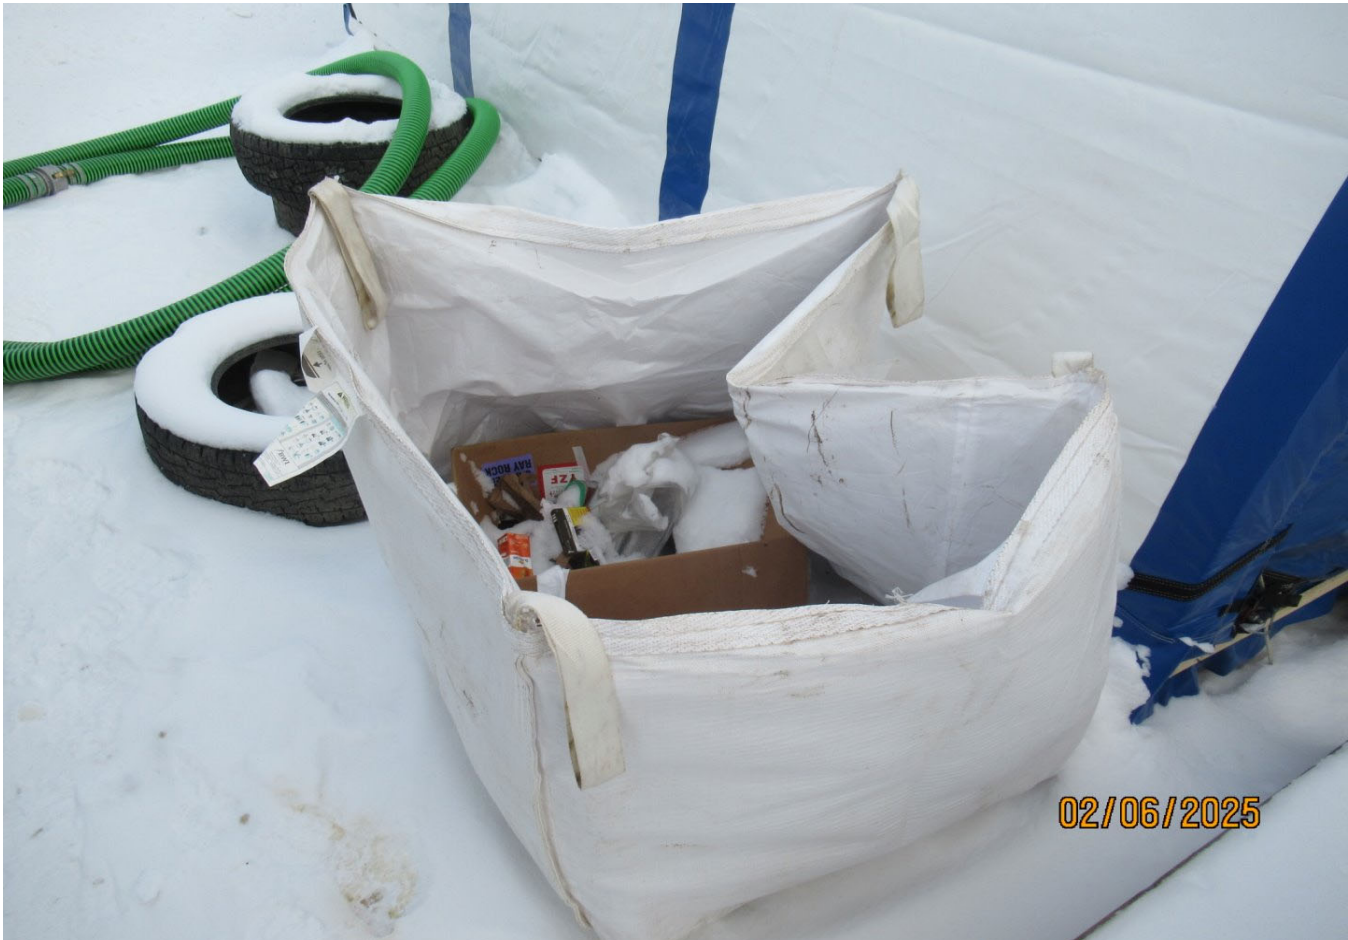
Figure 17

Mega bag for the storage of combustible items at the Km 0 camp. Waste is being returned to Rayrock for proper disposal as per the approved Waste Management Plan.
