**Re: Land Use Permit W2020X0005
Miscellaneous - Remediation
Rayrock Remediation Project, NT**

ENVIRONMENTAL INSPECTION REPORT

Permittee:	CIRNAC – Contaminants and Remediation Division	Inspection Date: February 6 th , 2025
------------	--	--

Location(s) Inspected:	Winter Roads.
------------------------	---------------

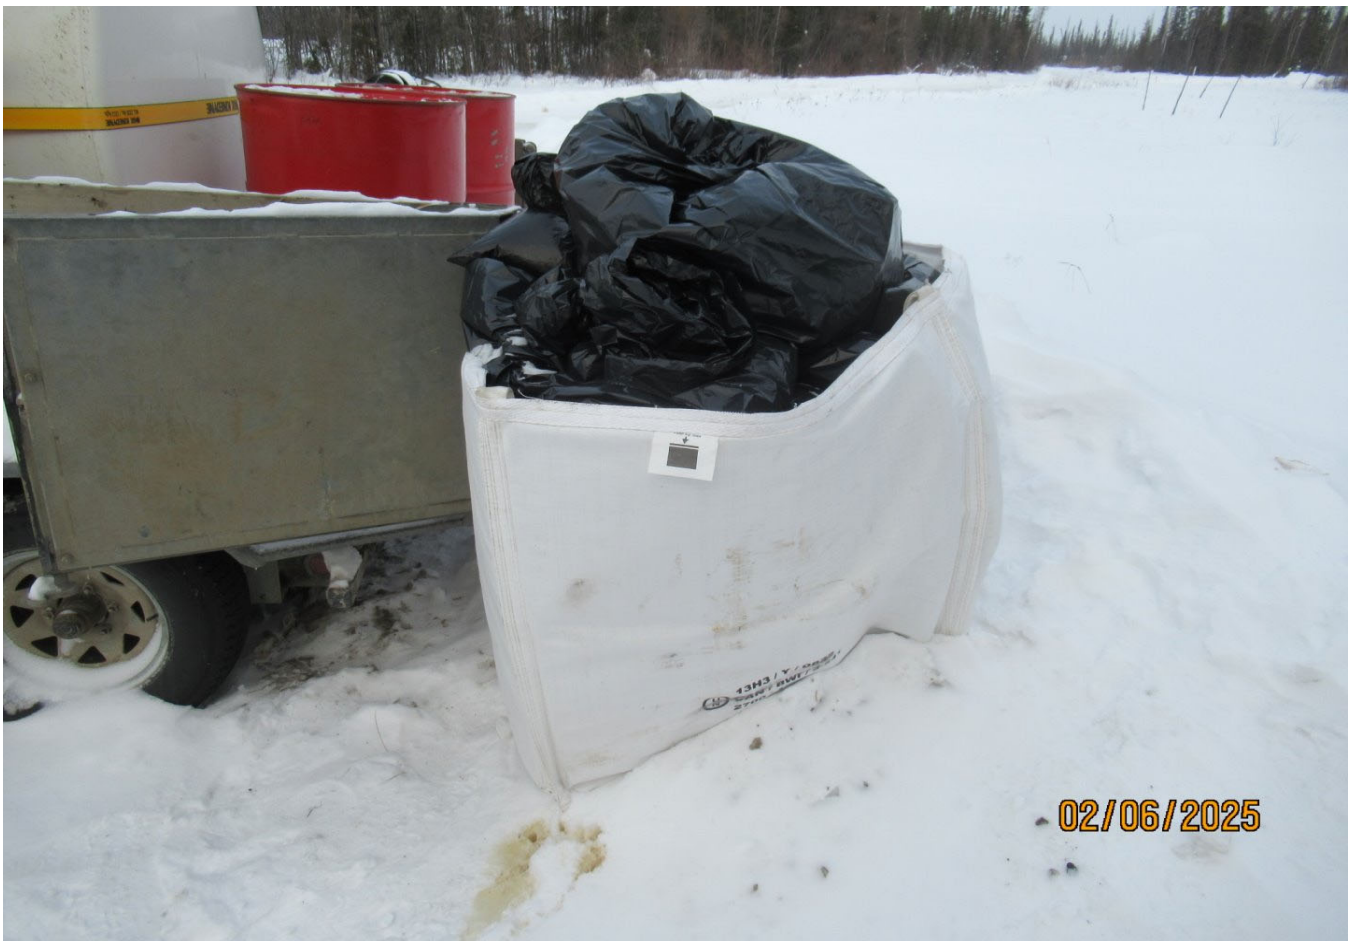
Figure 18

Honey bags are in use for sewage. Bags are being removed for proper offsite disposal.

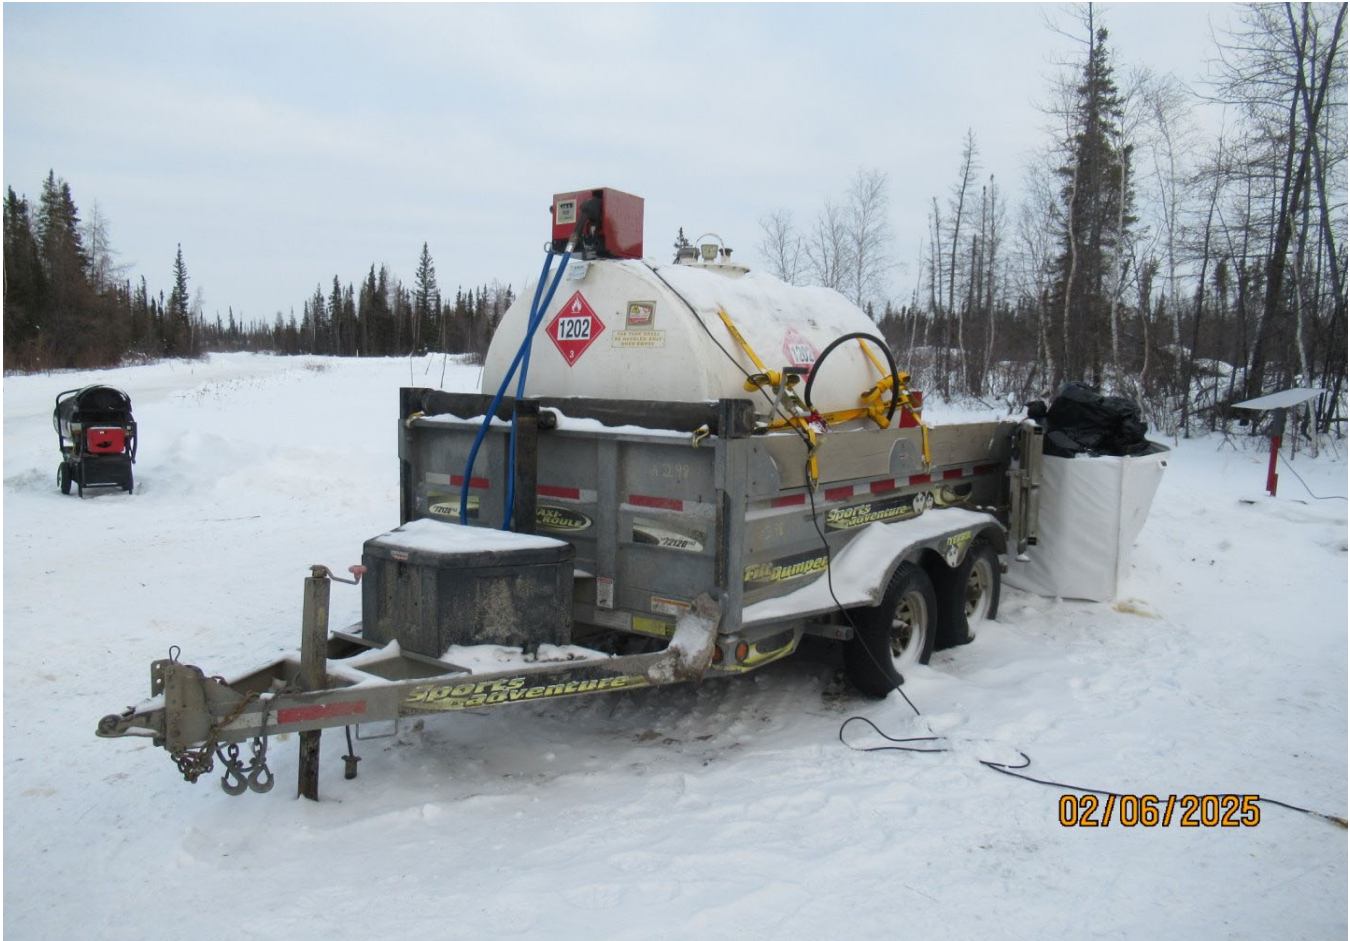
Figure 19

Envirotank positioned at the camp. No concerns were noted with fuel storage or handling.

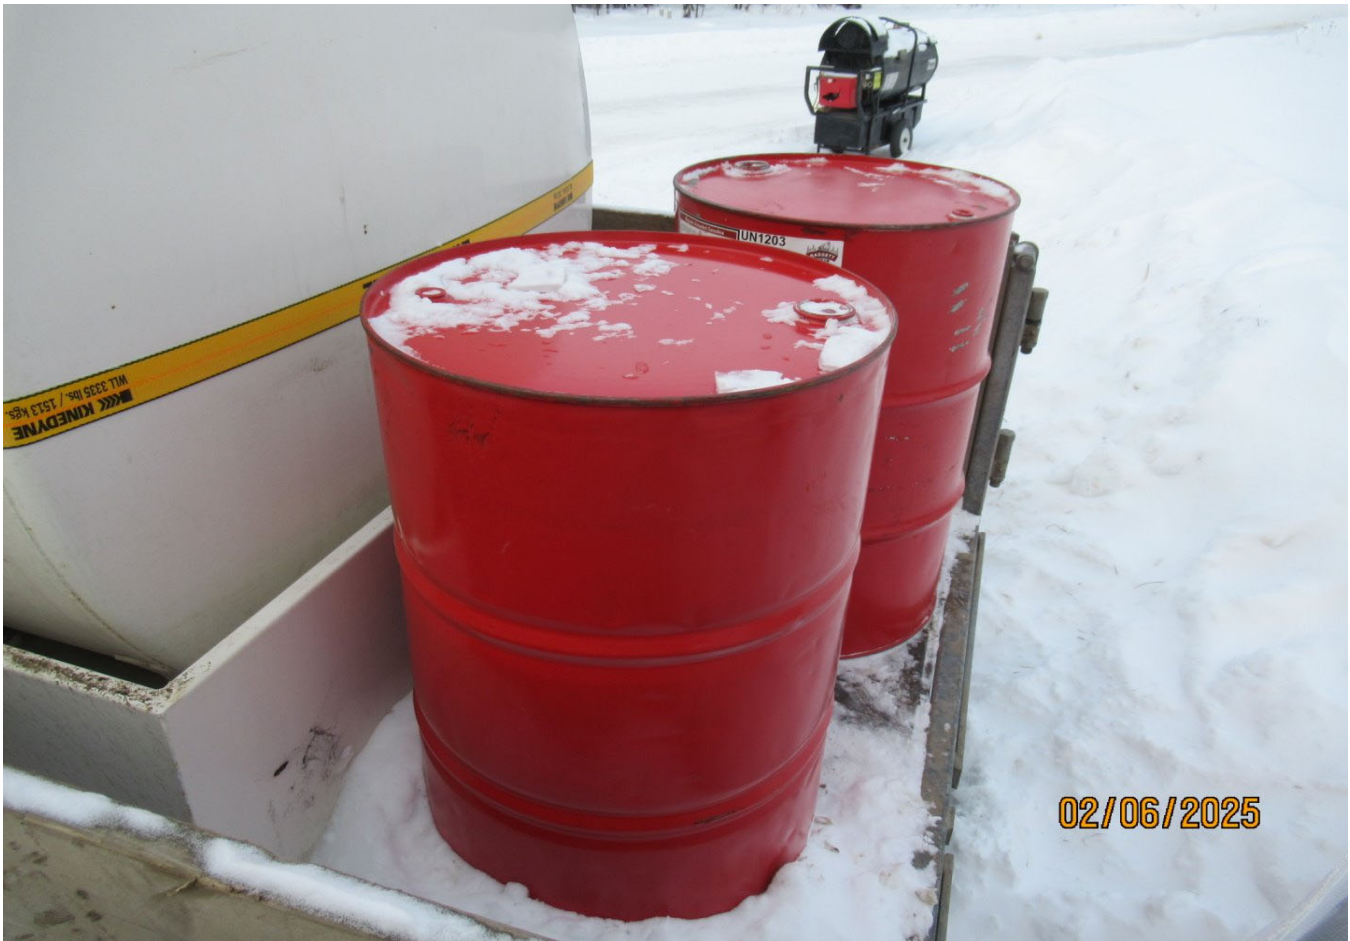
Figure 20

Gasoline drums are being stored upright on a trailer. No concerns with fuel storage were noted.

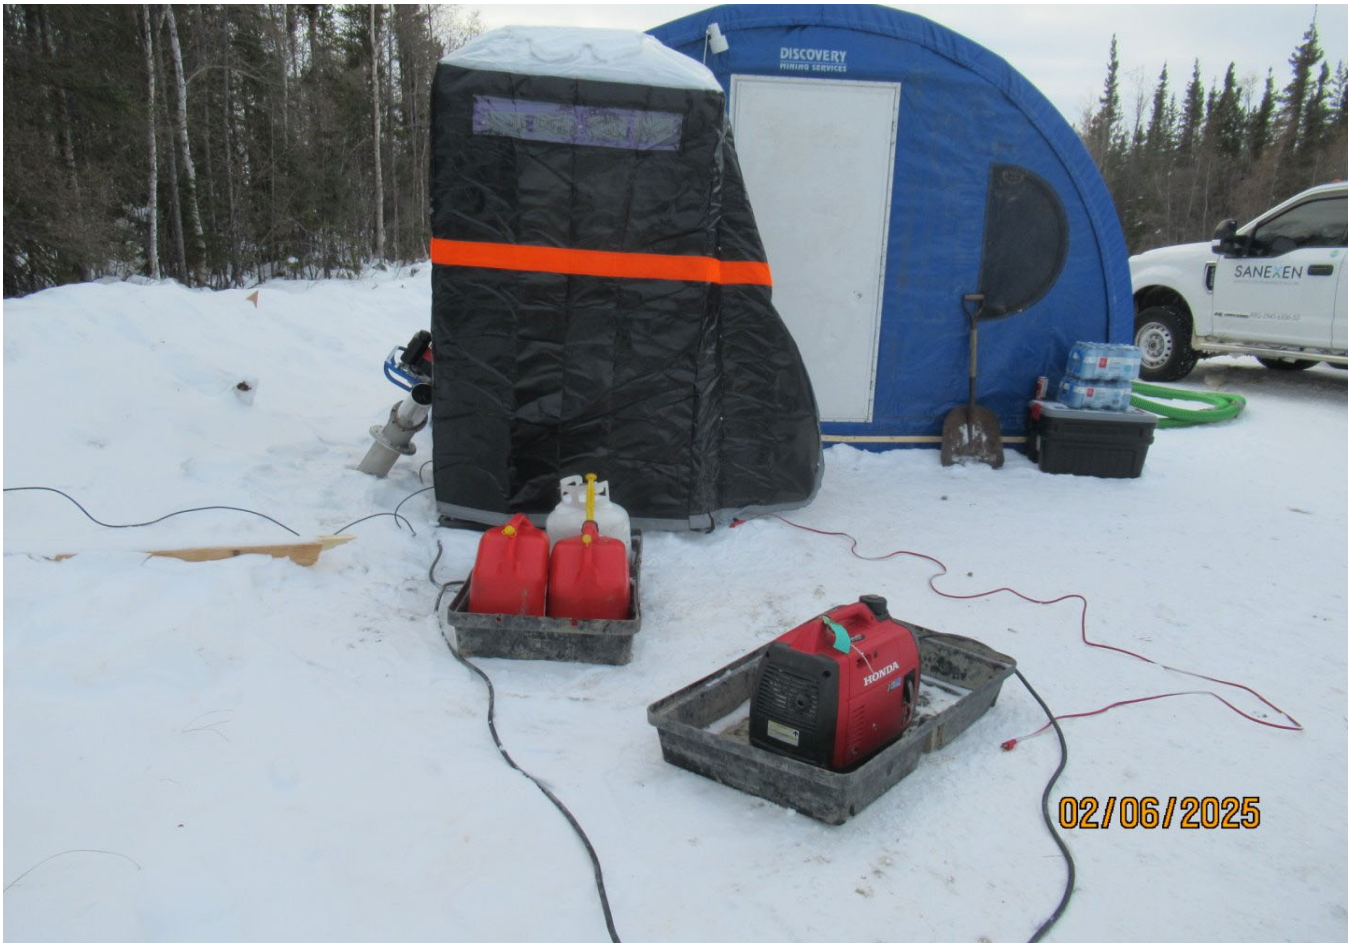
Figure 21

Hydrocarbon containers and ancillary equipment is stored in secondary containment.

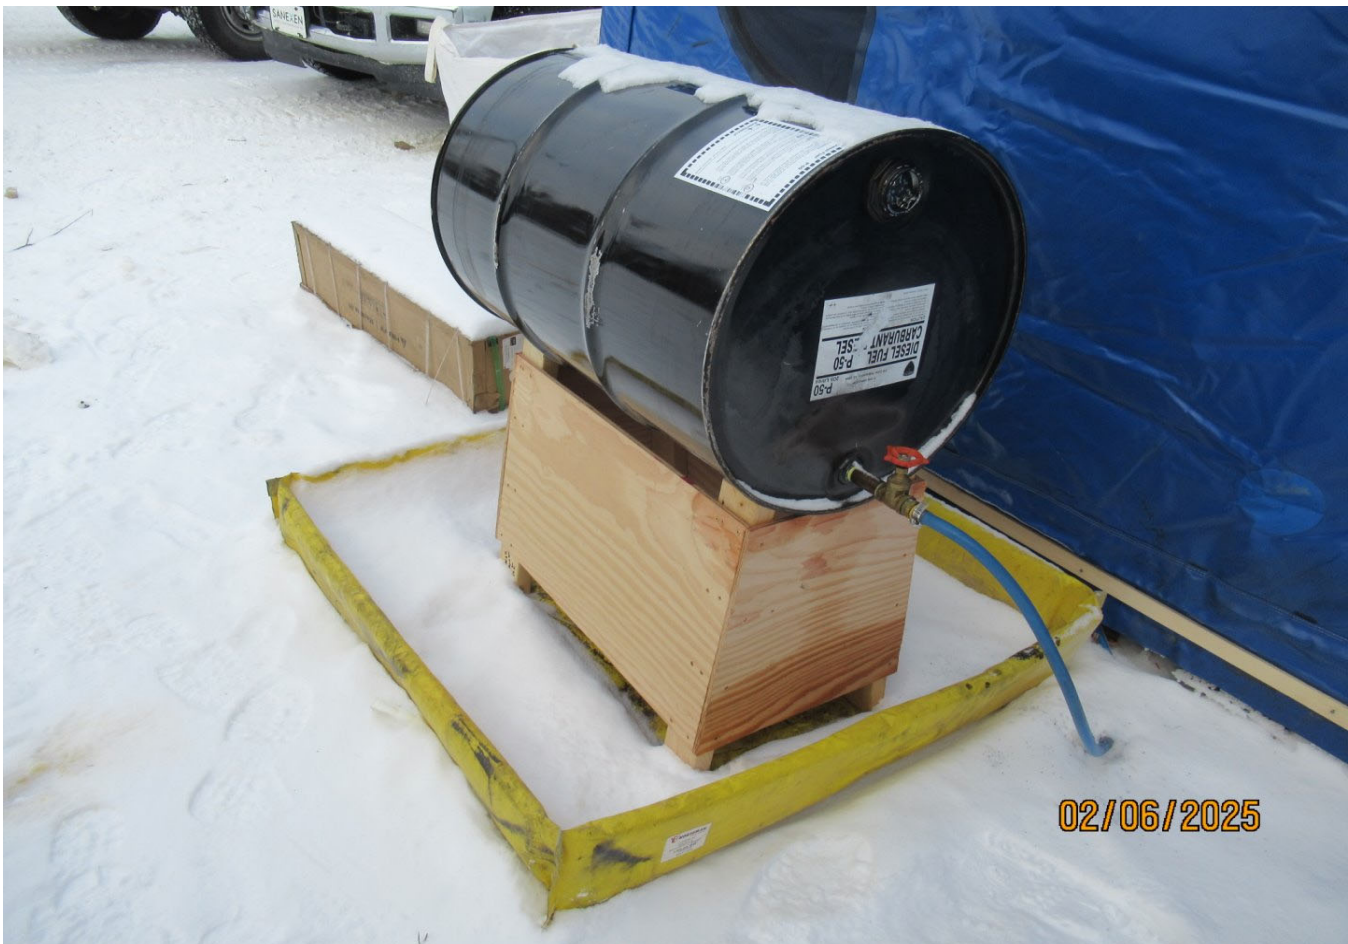
Figure 22

The only concern noted was with the active diesel fuel drum viewed in Figure 22. Secondary containment is not effective. Typically, the area of concerns on an active drum is from the fittings or spills during refueling operations. The Inspector discussed the requirement for the Permittee to wrap the fittings with hydrocarbon absorbent matting, place a five gallon pail with absorbent matting & weight below the fittings to catch drips from re-fueling, properly dispose of the snow currently contained in the yellow instaberm and remove the instaberm since it poses a false sense of security since it currently is ineffective, and is a safety concern for personnel.

Secondary containment is ineffective. The Contractor must wrap the fittings with absorbent matting and place a five gallon pail under the fittings of active drums.
