RE: Land Use Permit W2021C0009 – Nighthawk Gold Corp Colomac Project – Colomac Mine – Inspection – CIRNAC Federal Lands

INSPECTION DATE – June 24th 2024

ENVIRONMENTAL INSPECTION REPORT (W2021C0007)

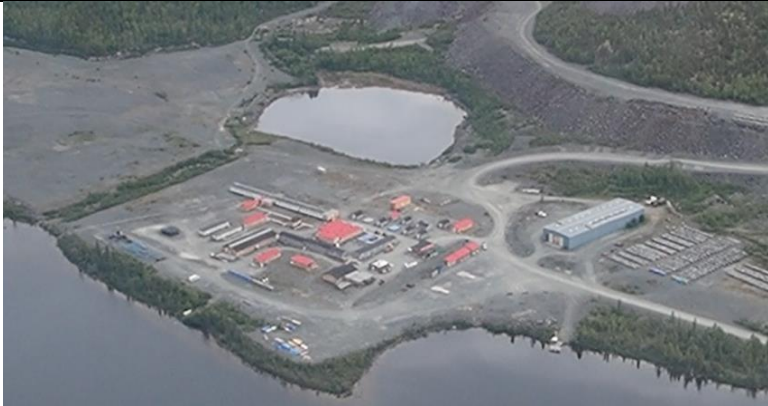
The site was overall very well managed, clean, and organized. The inspectors conducted an aerial overview of the camp operations, drill locations, and runway before landing at the site (Photo #1). Upon landing, the following observations were made: all in-use fuel at the site was appropriately stored in dry secondary containment (Photo #2). Waste management was handled effectively, with waste sorted appropriately and contained to prevent interaction with wildlife. Kitchen garbage (Photo #3) was divided into recyclables, burnable, and non-burnable categories, all within secure containment.

Photo #1: Aerial overview of the Nighthawk exploration camp.

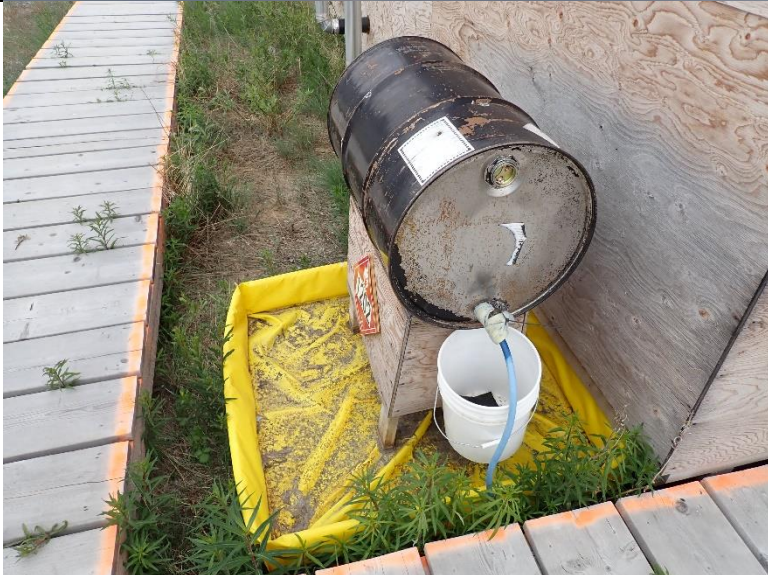
Photo #2: Fuel drum appropriately placed in secondary containment.

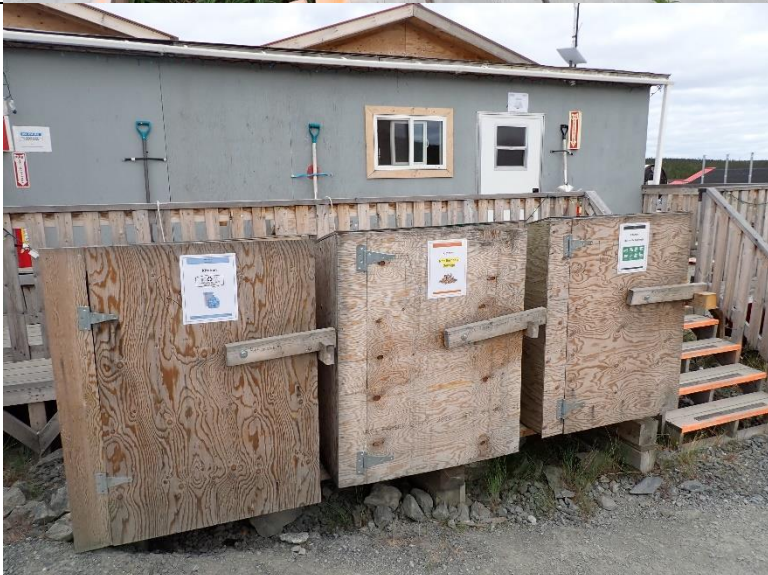
Photo 3: Kitchen waste disposal area, sorted by disposal type, and securely stored to prevent wildlife access.

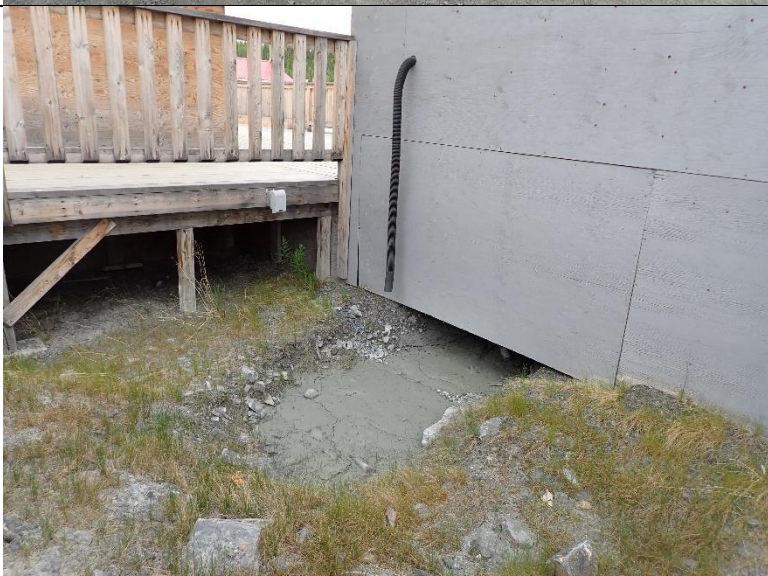
The inspectors visited the core processing building, where drilled core samples are split. One half of each sample is tested, while the other is labeled and archived. During the core-splitting process, water and waste material from the cutting process are deposited into a sump located outside of the building (Photo #4).

Photo #4: Grey water sump from core cutting building

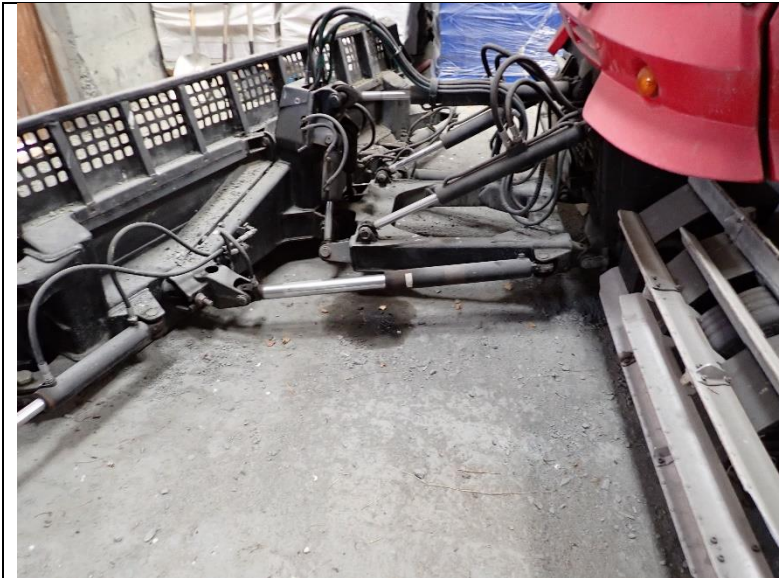
Heavy equipment on site was generally stored indoors, with drip trays or other secondary containment methods used where necessary. However, several pieces of machinery in the "Big Blue" warehouse showed minor hydrocarbon leaks, resulting in staining on the floor (Photo #5). The inspector reminded the permittee that, as per Condition #76 of the land use permit, any machinery stationary for more than two hours must be placed on a haz-mat or drip tray, or be sufficiently diapered to prevent any potential spills.

Photo #5: Heavy equipment located in Big Blue warehouse, with hydrocarbon drip staining occurring.

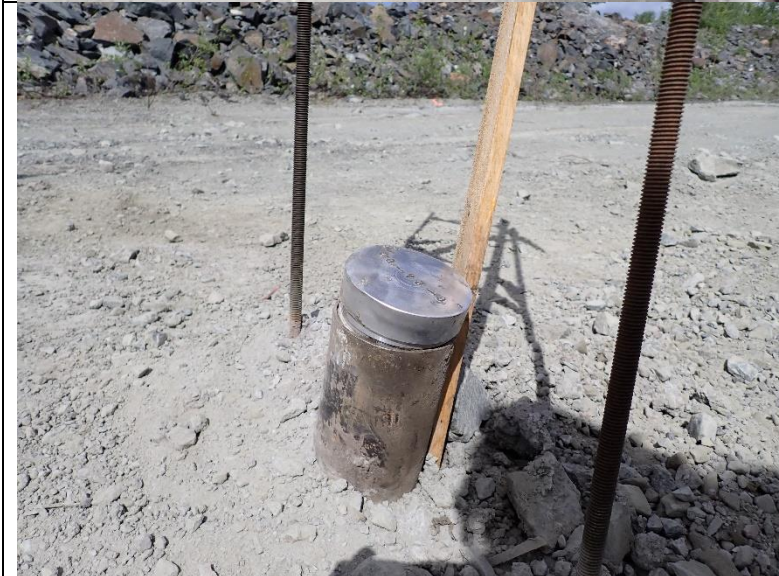
The inspectors also reviewed the drill sites that had been completed since the last inspection. The drill locations were remediated to the inspector's satisfaction, with no evidence of drilling grease or other contaminants found at the sites (Photo #6). There was no active drilling on federal lands at the time of the inspection.

Photo #6: Overview of one of the 2024 drill locations. No issues with grease or staining associated with drilling practices were observed this inspection.

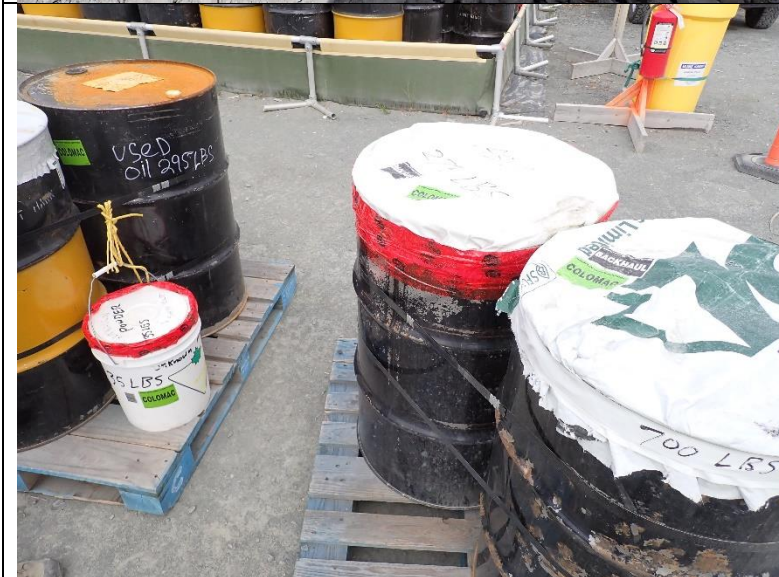
Waste material, including used oil, was being stockpiled for removal near the airstrip. However, several drums containing waste liquids were stored in a location without adequate secondary containment (Photo #7). The inspector reminded the permittee that these materials should be stored within secondary containment berms to reduce any risk to the environment as per the waste management plan. Other fuel storage areas were well-organized, with appropriately sized berms in place, and spill kits and safety equipment were stored nearby (Photo #8). Additionally, dry waste, including scrap steel, was stored in barrels and placed near the runway for removal on the next scheduled cargo flight (Photo #9).

Photo #7: Waste material accumulated to leave site. Liquid wastes and potentially spillable waste should be stored in secondary containment.

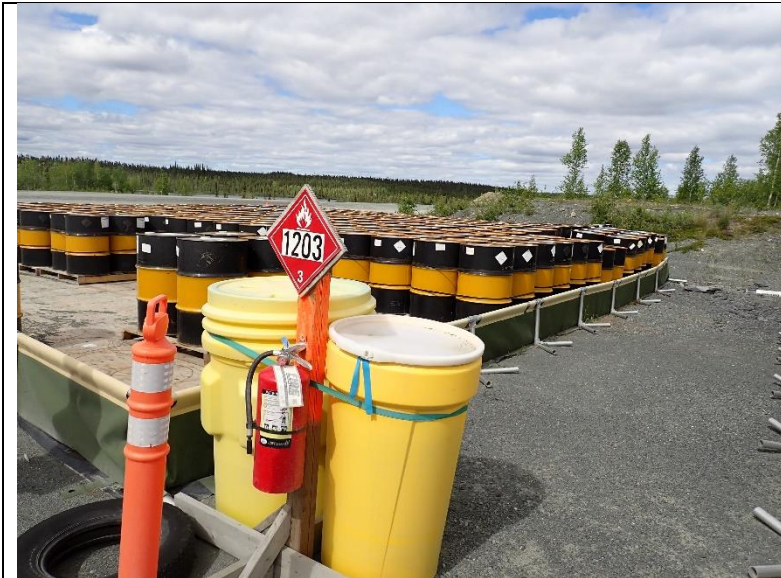
Photo #8: Close up of fuel storage located near the airstrip and spill kits located nearby.

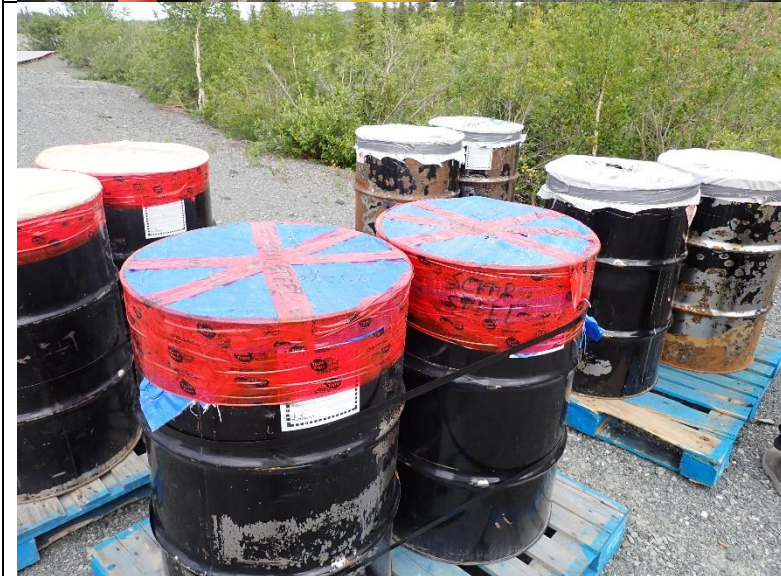
Photo #9: Additional waste packaged up for removal sitting alongside the airstrip.

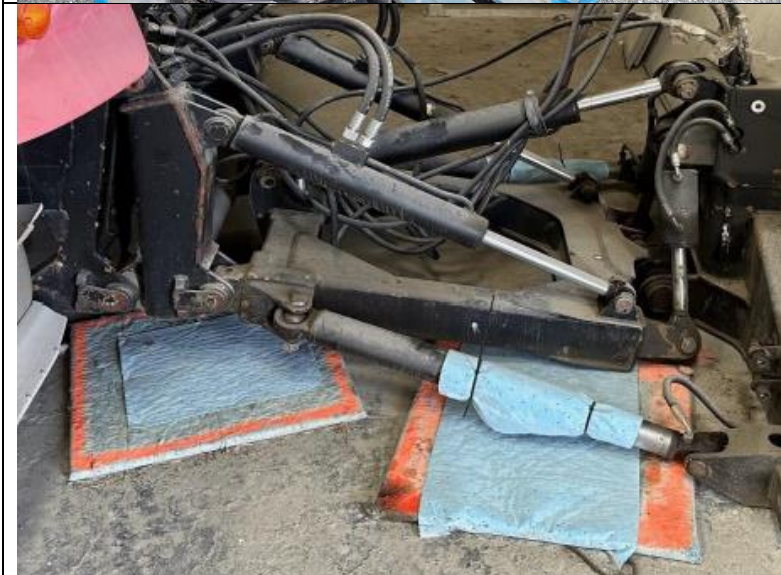
Photo #10: Photo submitted by on-site staff to demonstrate compliance of updated secondary containment measures applied to machinery.

July 1, 2024 Update: Concerns raised regarding management of small leaks noted from machinery have been addressed (Photo #10). On-site staff submitted photos to the inspectors to demonstrate compliance.
