**Re: Land Use Permit W2016E0004 and W2021E0007
Road Construction (TASR) and Whati Access Road
Tlicho All Season Road (TASR) Alignment from ~Km 196, Highway #3 to Whati, NT**

ENVIRONMENTAL INSPECTION REPORT

Km 19.5 Shop Complex – Land Use Permit: W2016E0004

Whati Access Road Rehabilitation Project – Land Use Permit: W2021E0007

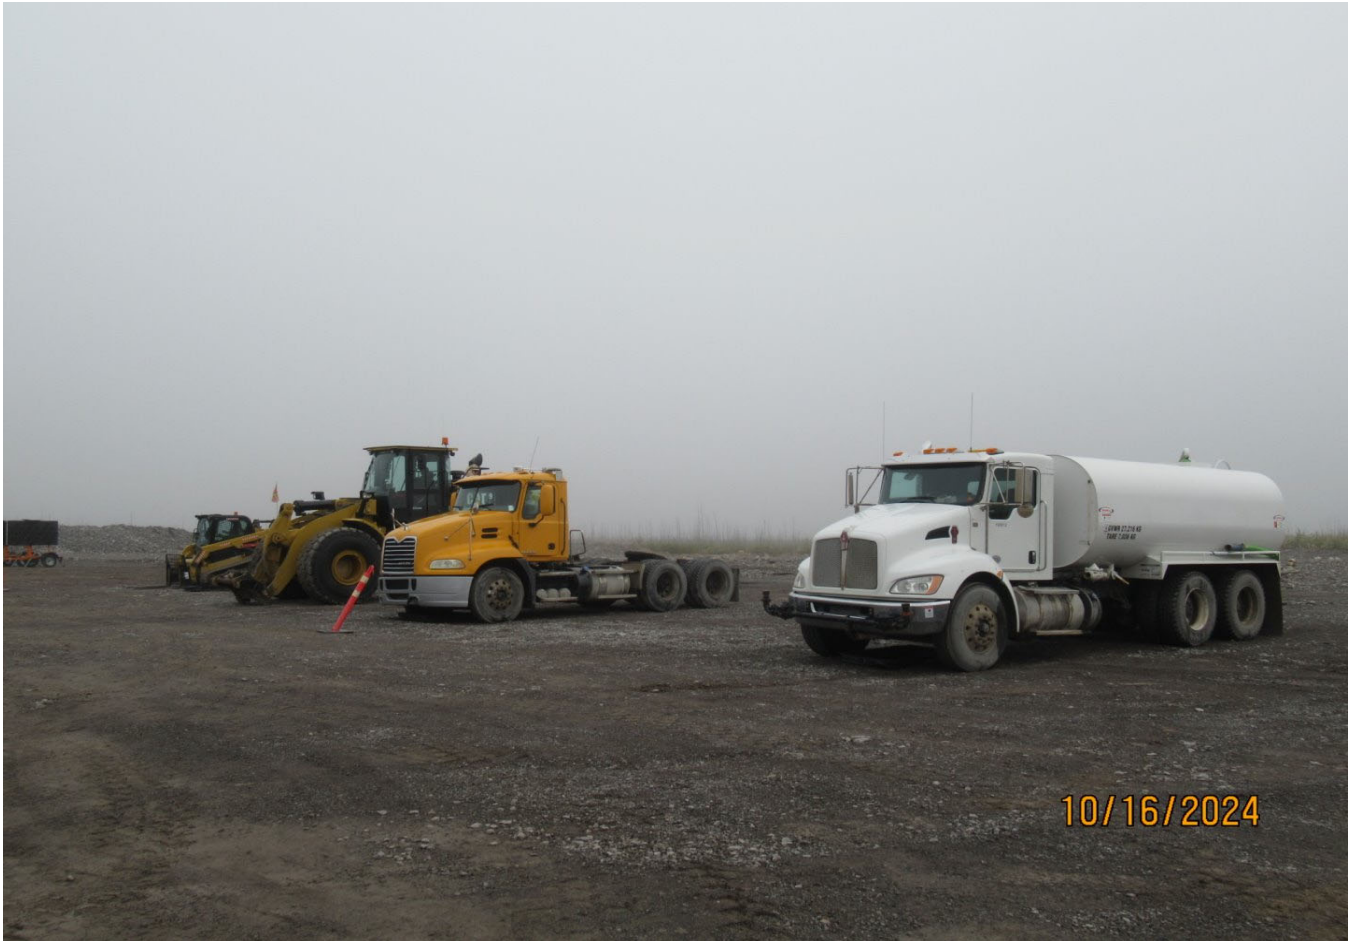
Figure 3

All parked vehicles and equipment had drip trays present.

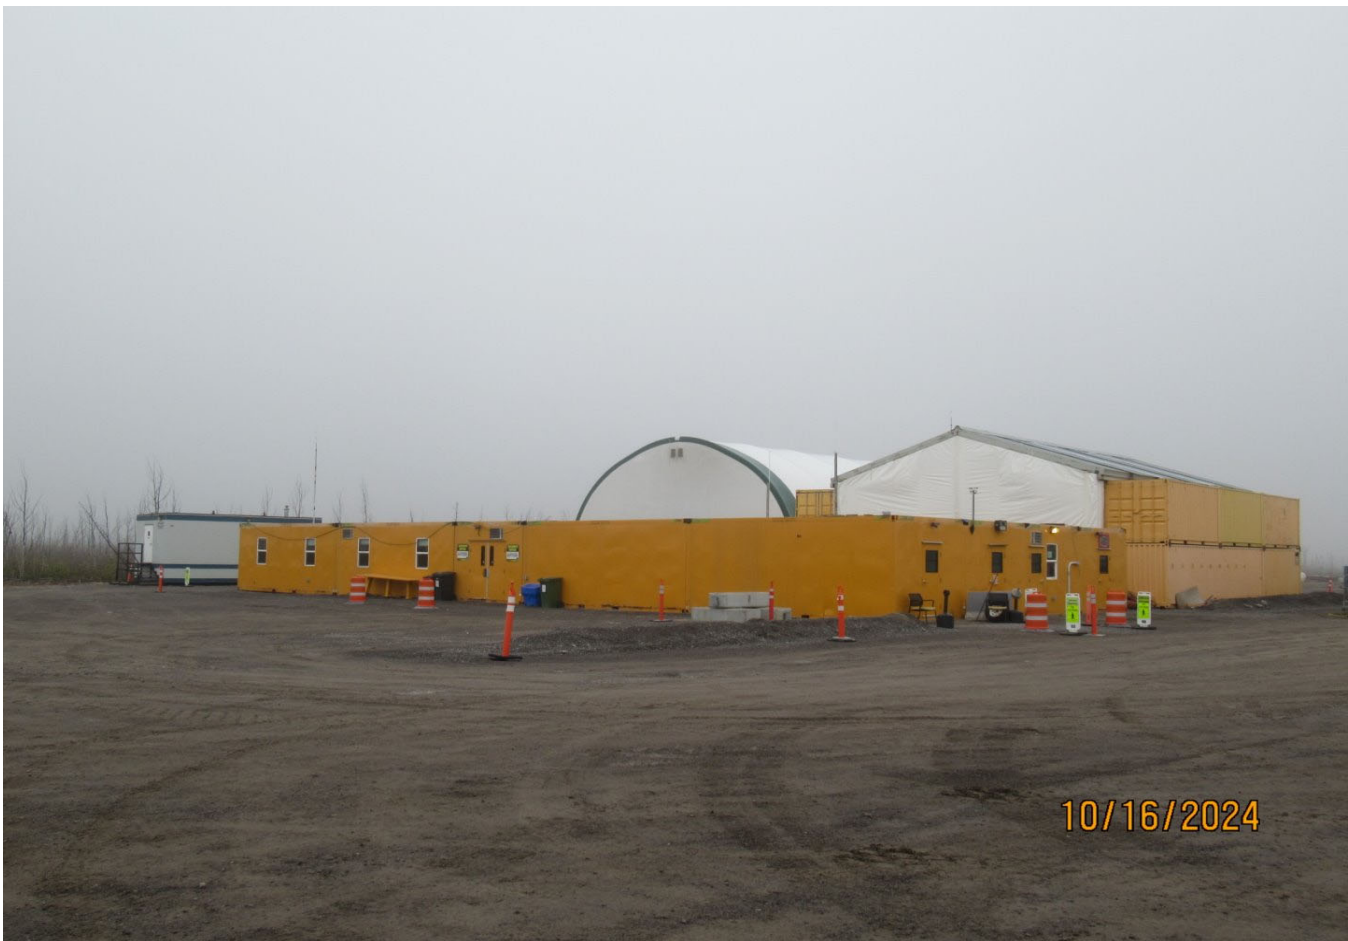
Figure 4

Looking north at the Km 19.5 shop complex. The eighteen (18) office connex units will be decommissioned and demobilized from the land use area at the very earliest opportunity.

Please provide the undersigned Inspector notification once the ATCO trailers and new propane generators are operational, and when known, the proposed schedule for the removal of the existing infrastructure discussed above.

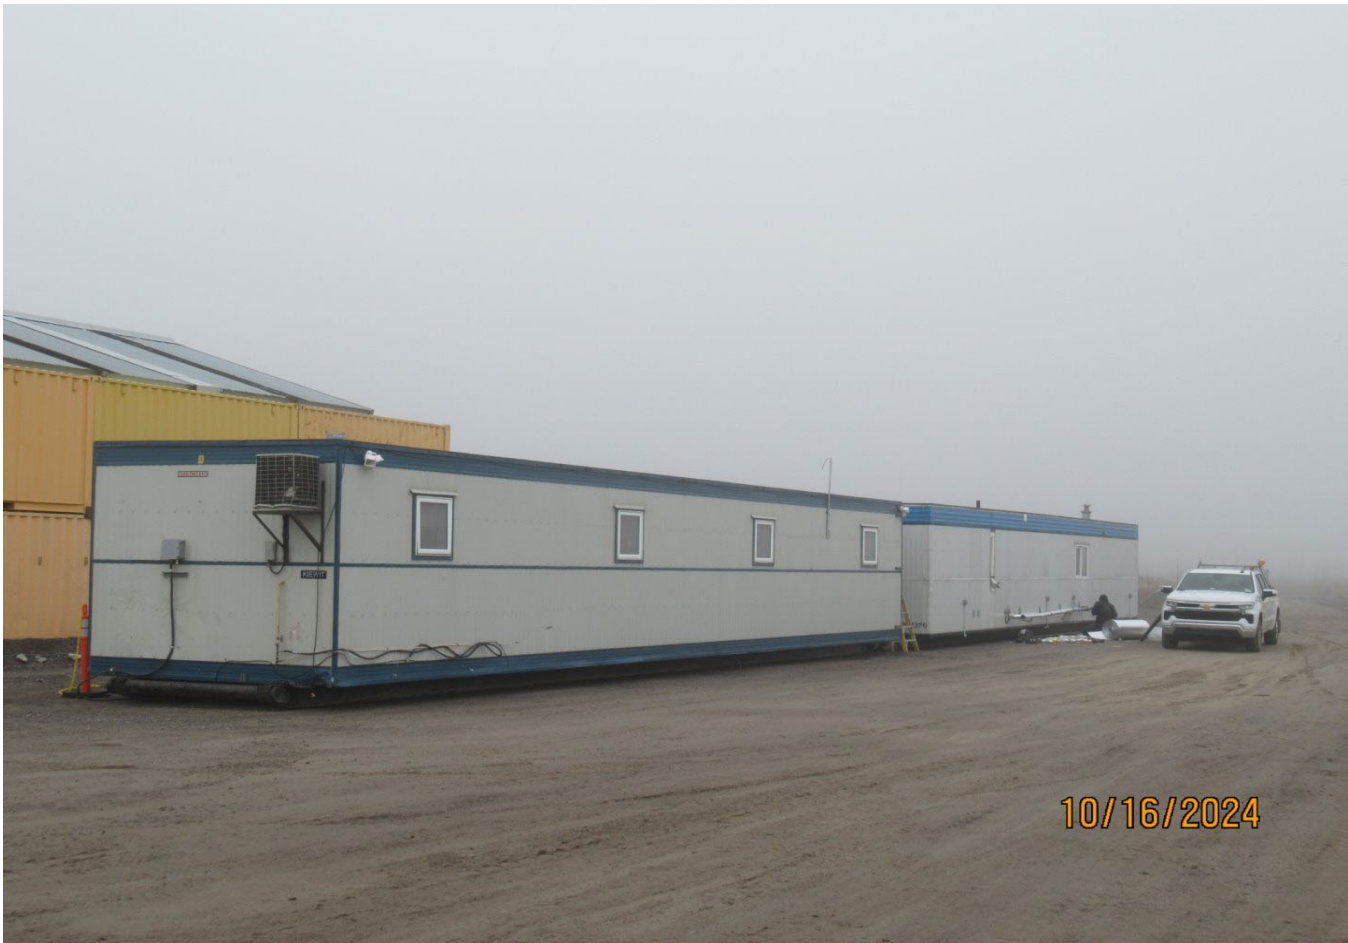
Figure 5

Two ATCO trailers are being installed to replace the eighteen office connex units.

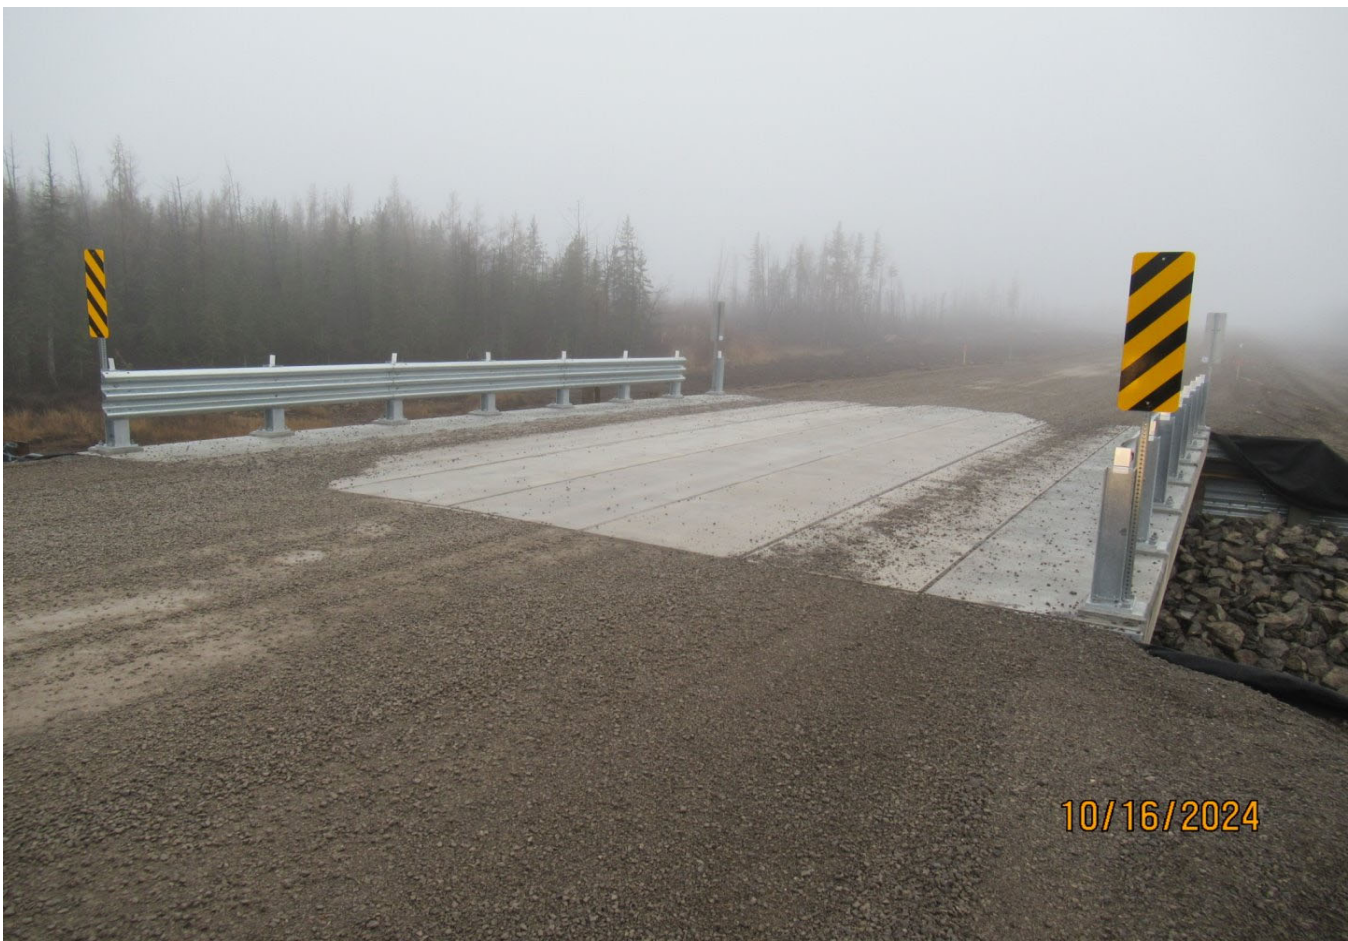
Figure 6

At the time of the inspection, all equipment had been demobilized from the land use area and restoration along the access road was complete. As part of this land use operation, a bridge (Figure 6) was installed at Km 0+540 of the Whati Access Road and no immediate concerns were observed. The final task required for environmental protection of a watercourse was the placement of rip rap on the slopes of the bridge abutments (Figure 7 & 8). Sourced rock appeared to have minimal fines with the exception of the one area viewed to the left of Figure 8.

Newly installed bridge at Km 0+540 of the Whati Access Road. Looking southwest at the bridge.

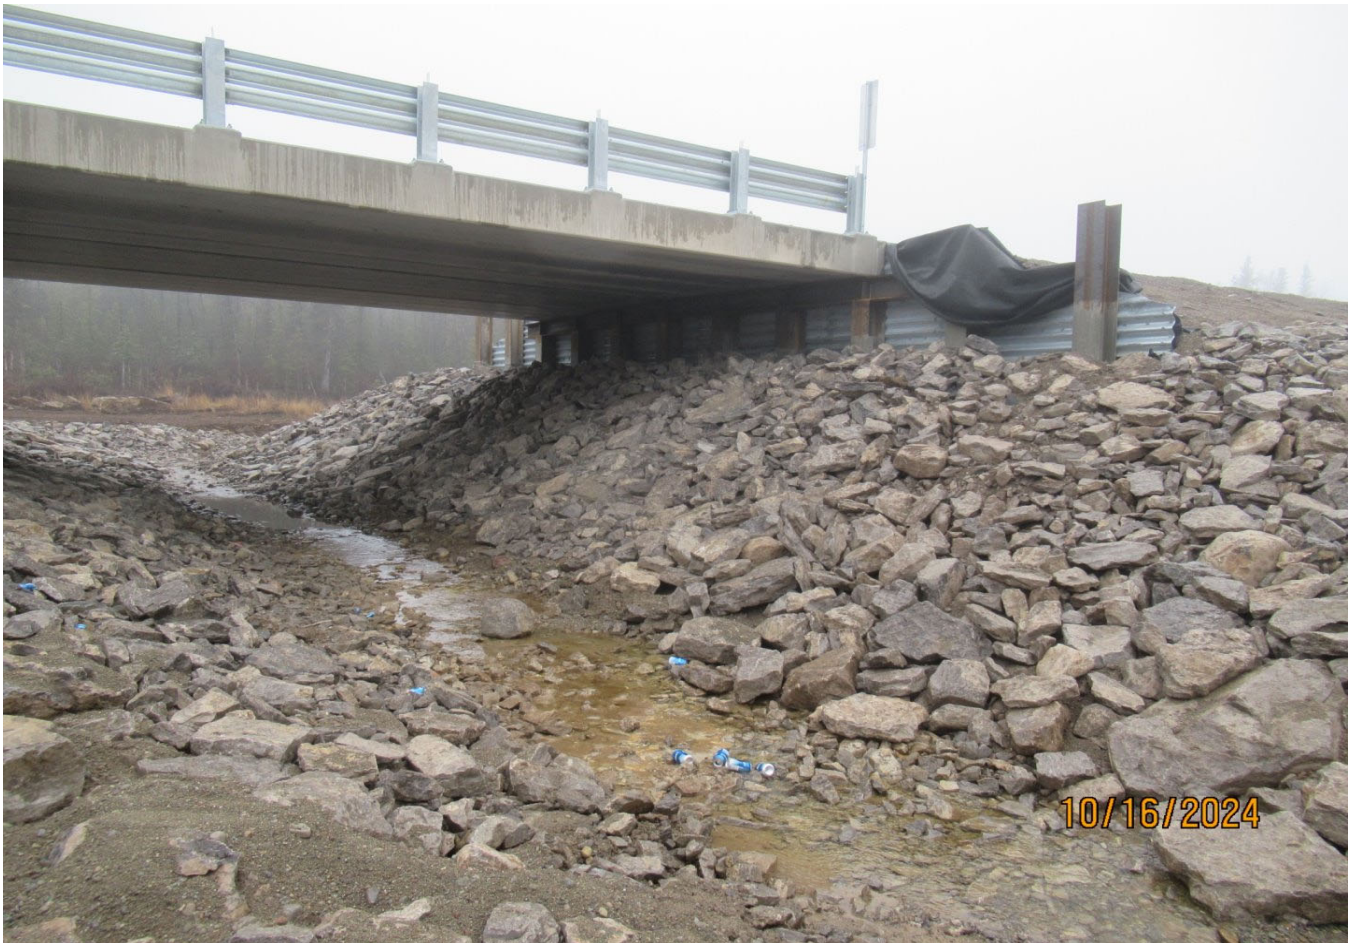
Figure 7

Rip rap on the west abutment. Material appeared to have minimal fines present.

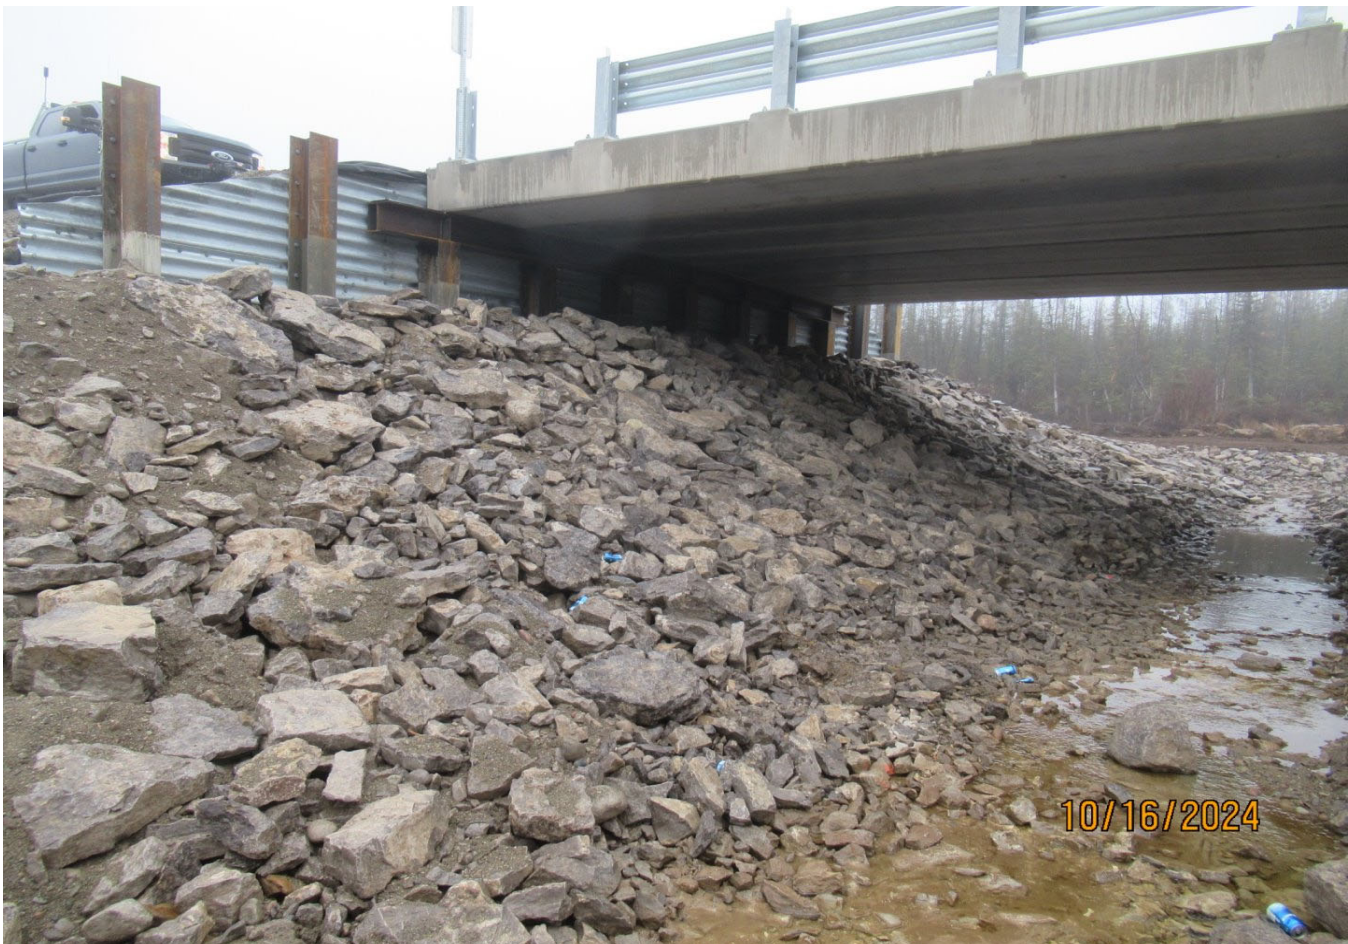
Figure 8

Another view of rip rap below the bridge. Some "fines" were present on the east abutment but they should not pose any immediate environmental concerns.

The Permittee must ensure this area is diligently monitored during high precipitation events and at spring freshet, and if any erosion or sedimentation concerns are observed, or may occur, the Inspector must be immediately notified with measures to be implemented provided.

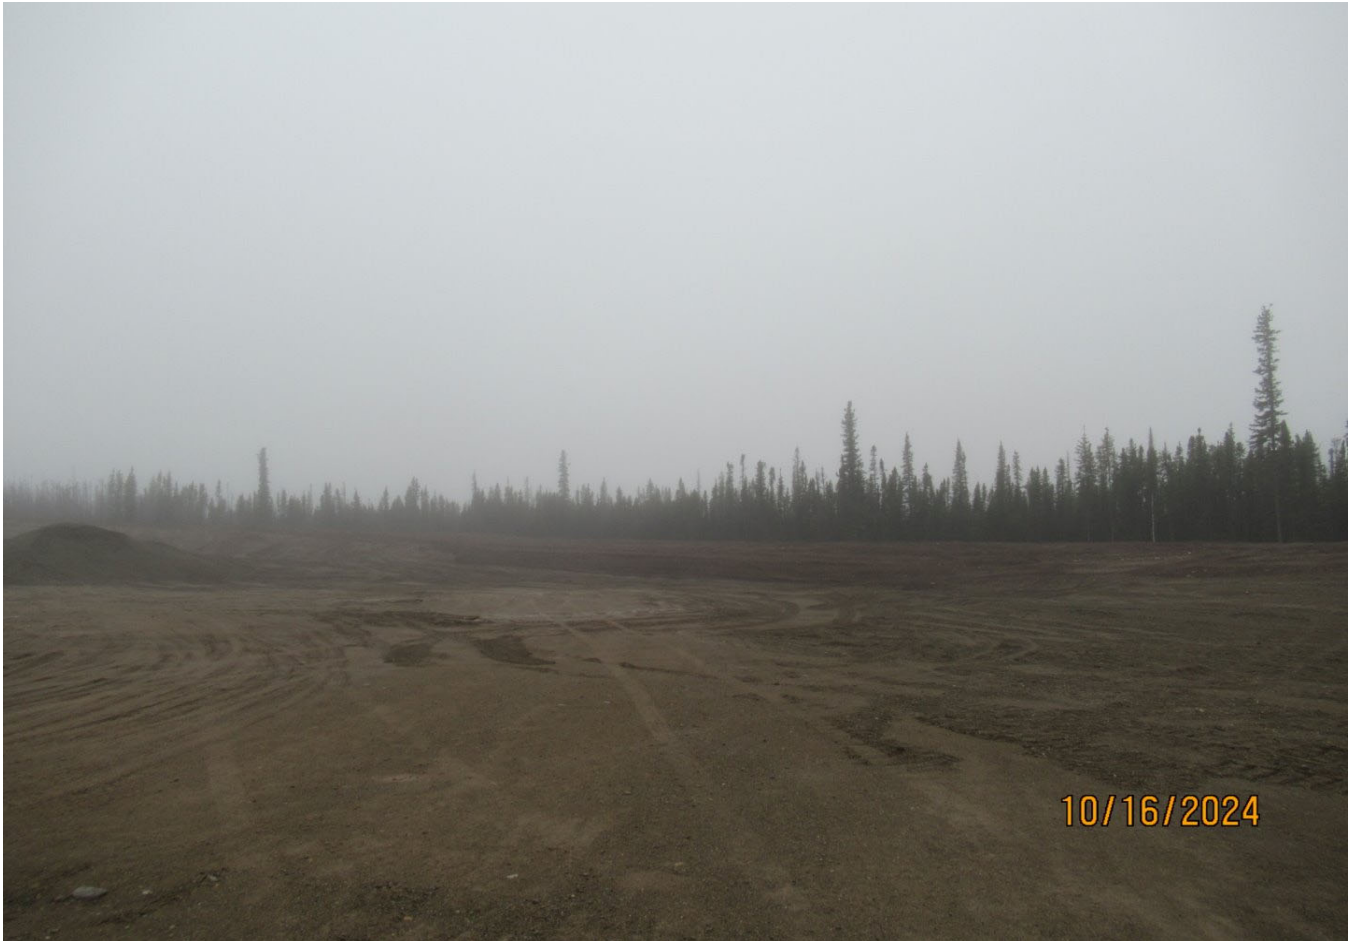
Figure 13

Community quarry reclamation was discussed with the Contractor (Rowe's Construction) during this land use operation, and as seen in Figure 11 through 13, reclamation appeared satisfactory. The active working faces were contoured, dozer tracks will create microclimates & seed catches, no windrows of overburden or trees were observed, and the quarry floor appears to have been graded to drain.

North side of the quarry and no windrows of trees or overburden were observed.

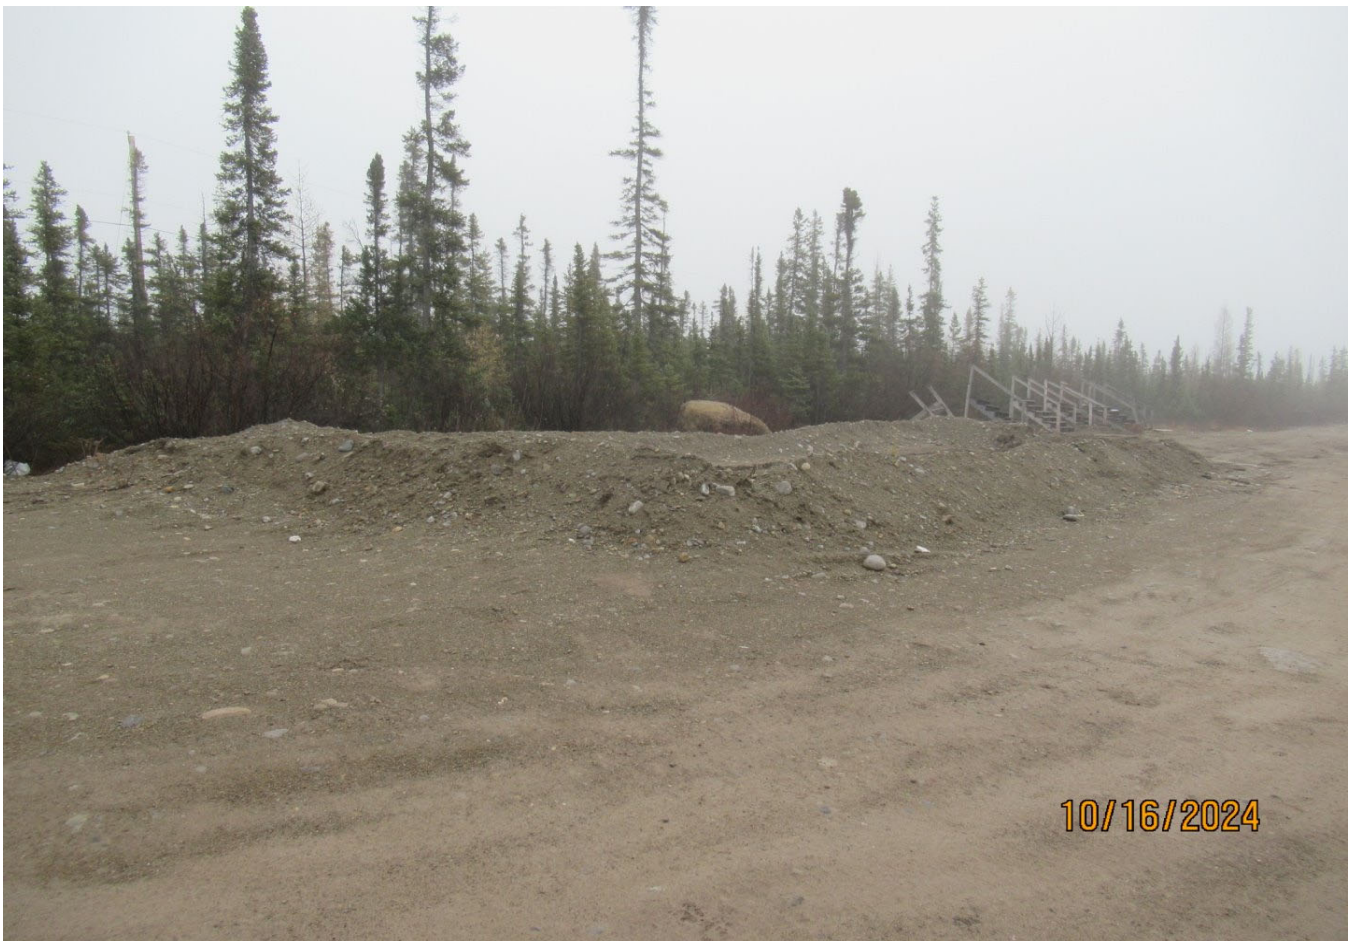
Figure 14

The final area inspected was the previous location of the 90,000 Litre envirotank (Figure 14) in the community of Whati. No obvious hydrocarbon spills were observed and therefore it appears that fuel storage & handling was acceptable throughout this land use operation.

Previous location of the 90,000 Litre fuel tank in the Community of Whati. No hydrocarbon spills were observed.
