**Re: Land Use Permit W2021F0010
Winter Road & Campsites
Whati/Gamètì Junction to Wekweètì, NT**

ENVIRONMENTAL INSPECTION REPORT

Location(s) Inspected:	Campsites at Km 0 of the Wekweèti Winter Road and north end of Portage 208.
------------------------	---

Permit: W2021F0010

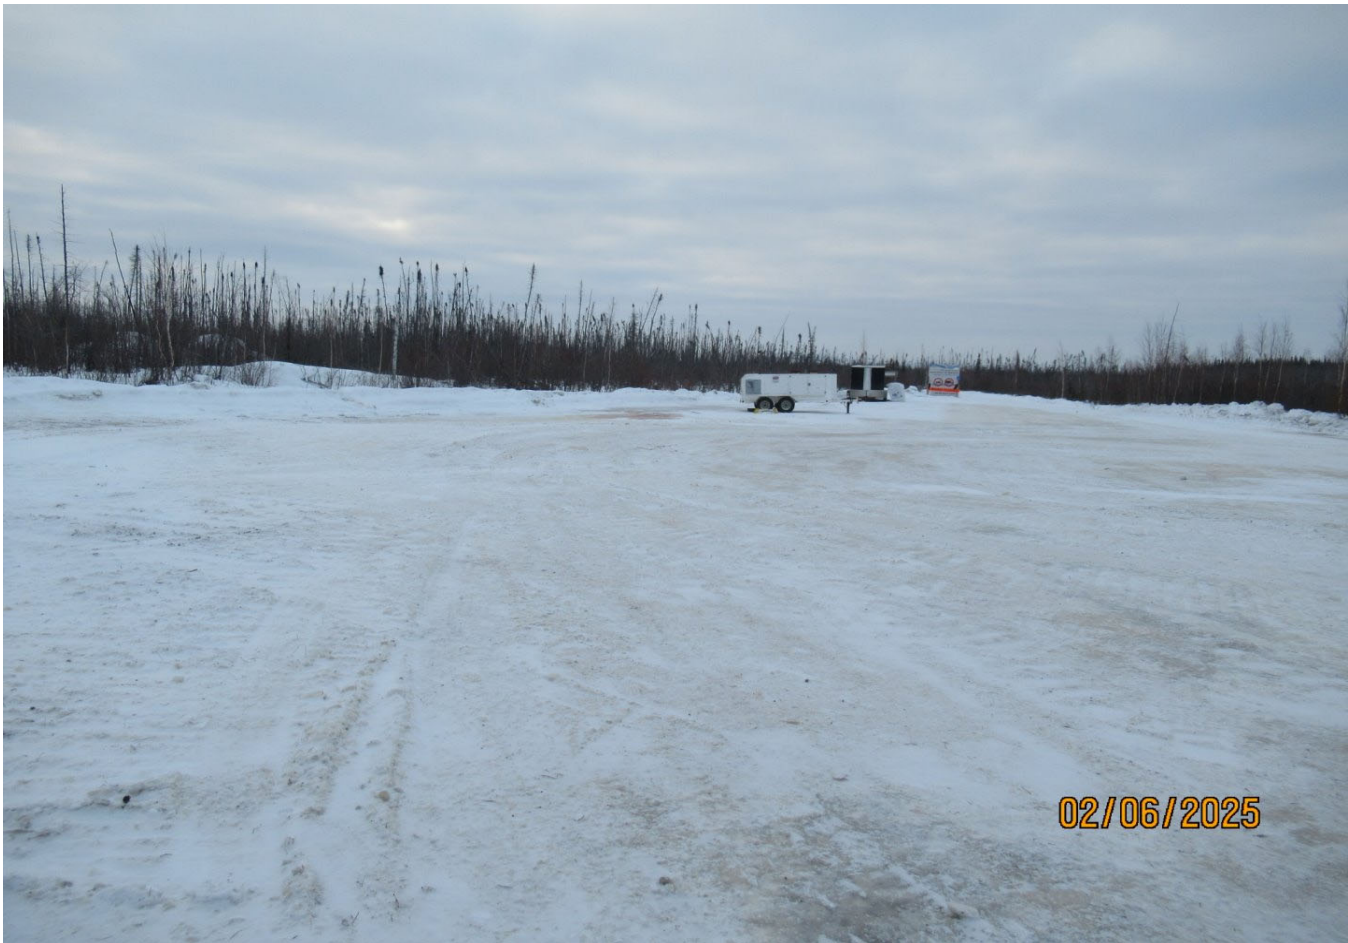
The Inspectors were informed by Mr. Lloyd Woloshyn (Contractor) that the Aurora Telecom Services (ATS) camp was demobilized from the Km 0 campsite and re-established on the north end of Portage 208 on January 30th, 2025. Figure 1 is looking south along the Km 0 campsite and the Inspector is pleased to report that no obvious hydrocarbon or glycol spills were present on the ground surface, and therefore no concerns were noted.

Looking south at the remaining items at the Km 0 campsite.

Although nothing obvious was observed, diligent monitoring by the Permittee/Contractor must occur into the Spring as the ice pad that was established below the camp infrastructure & equipment laydown melts out.

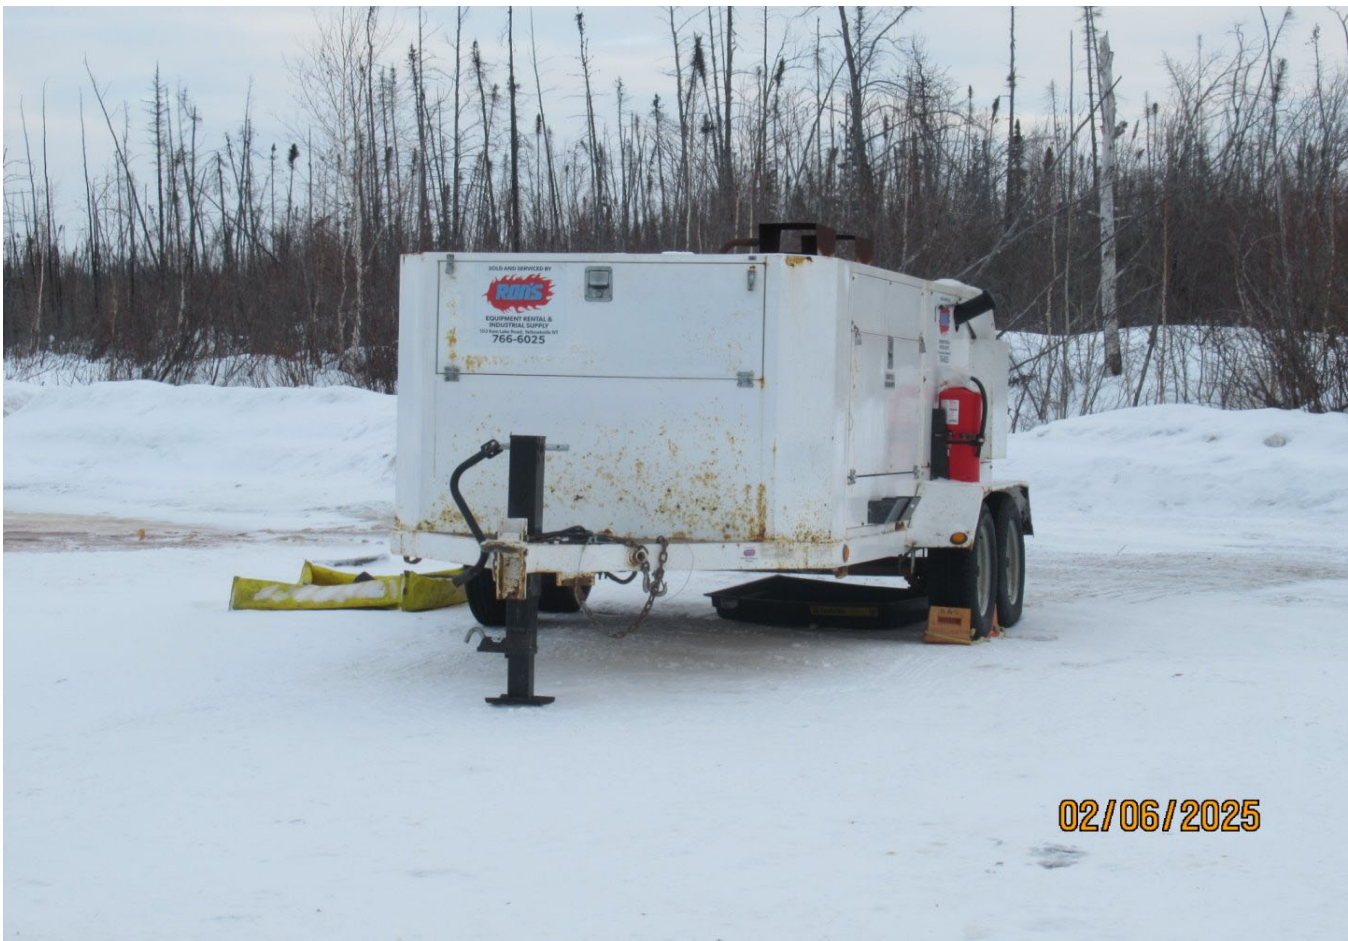
Figure 2

Items remaining on site are the oil fired heater generator (Figure 2), an enclosed trailer which is housing water hoses & a spill kit (Figure 3), and a poly lined mega bag that contained spent hydrocarbon absorbent matting & impacted snow (Figure 4 & 5) that will be removed to KBL Environmental Ltd. for proper disposal.

Secondary containment is present below this piece of ancillary equipment that remains at the Km 0 campsite.

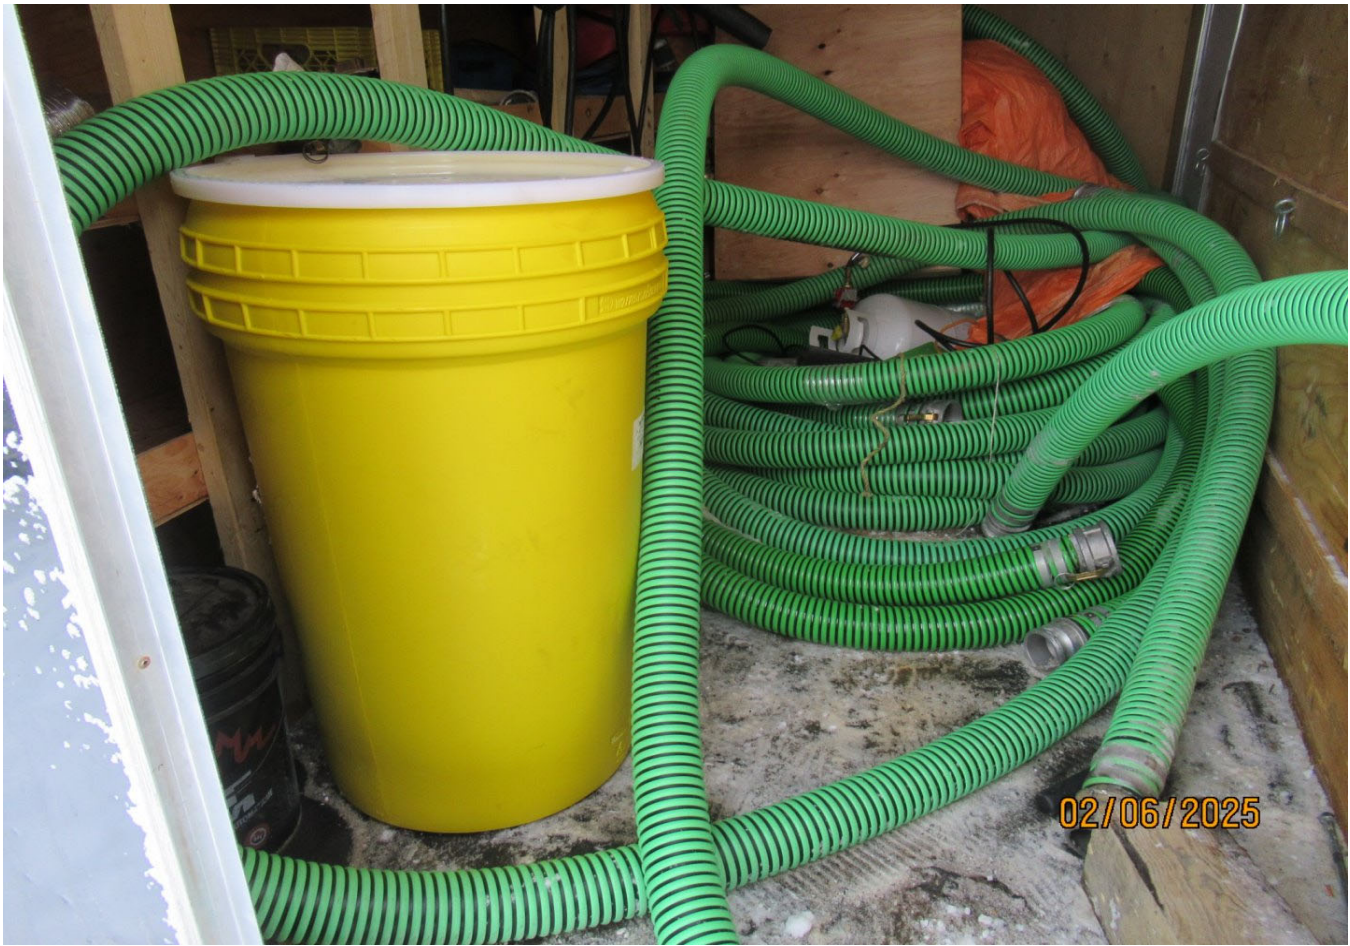
Figure 3

Spill kit inside the enclosed trailer that is currently parked at the Km 0 campsite.

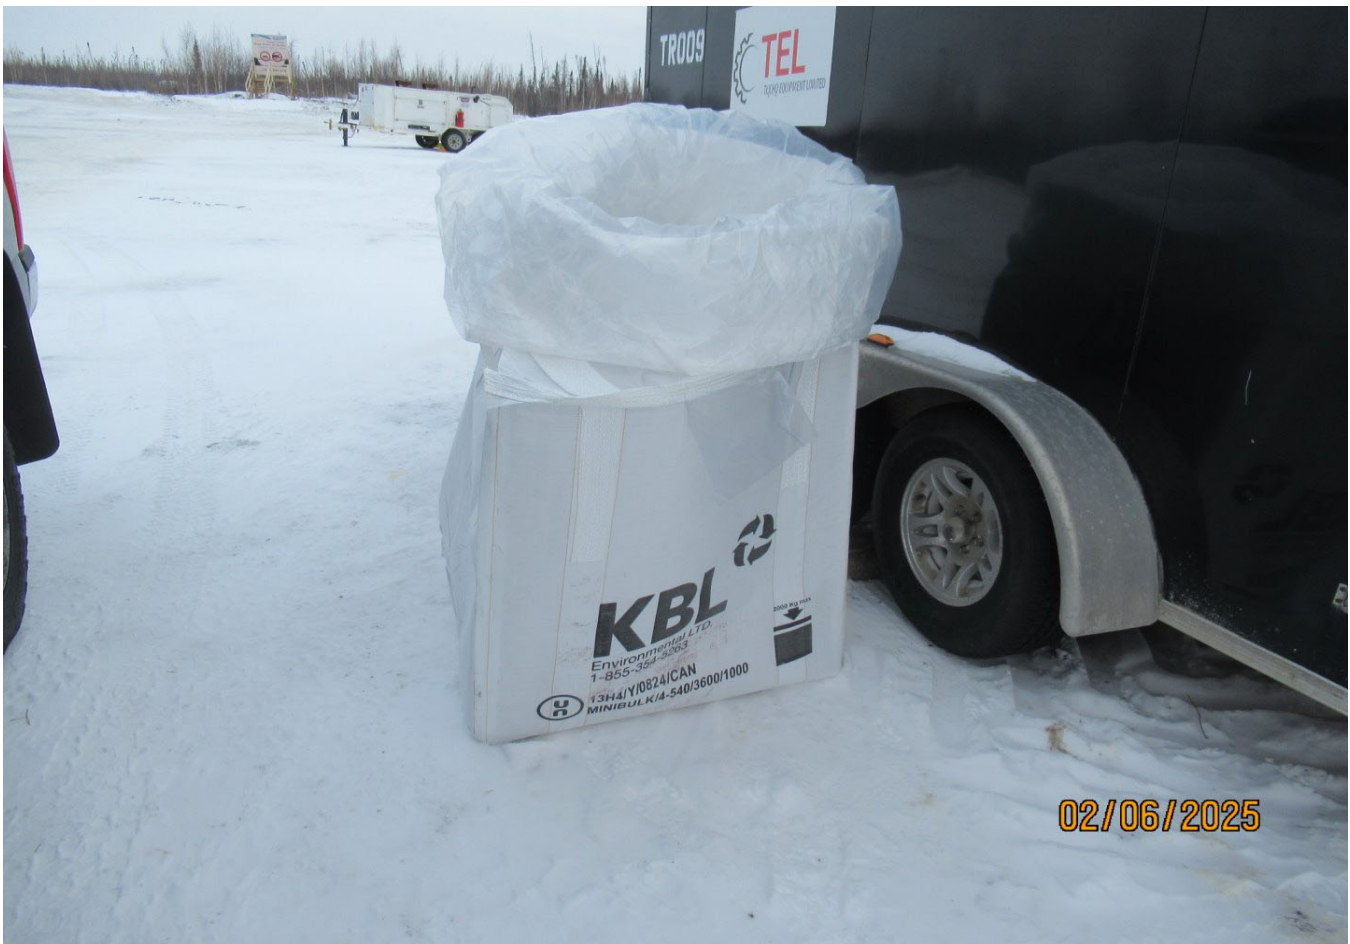
Figure 4

Poly lined mega bag for the collection and secure storage of hydrocarbon impacted snow until it can be removed for proper offsite disposal.

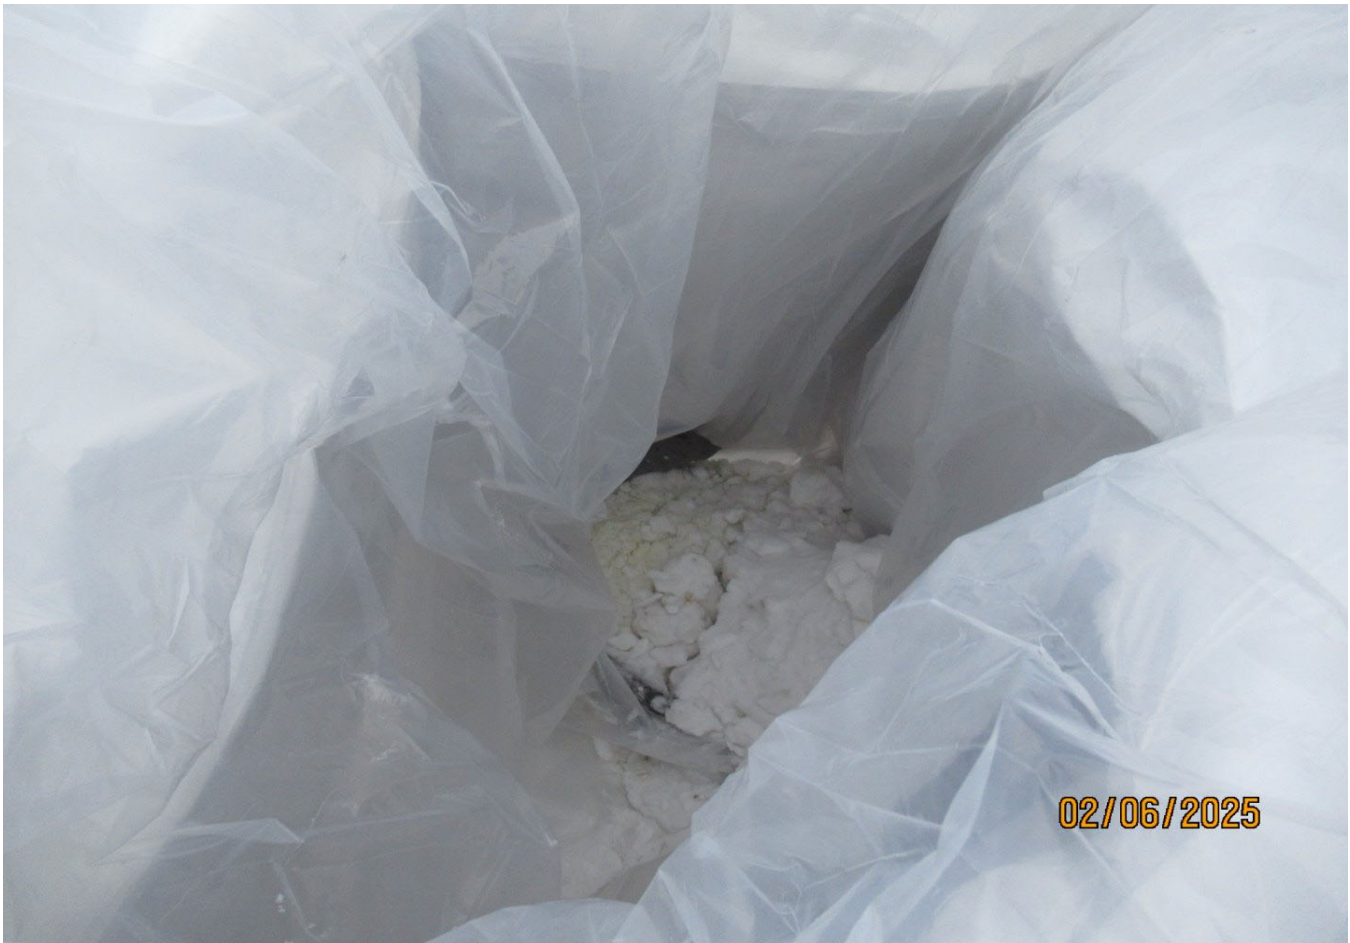
Figure 5
Impacted snow and absorbent matting inside the mega bag.

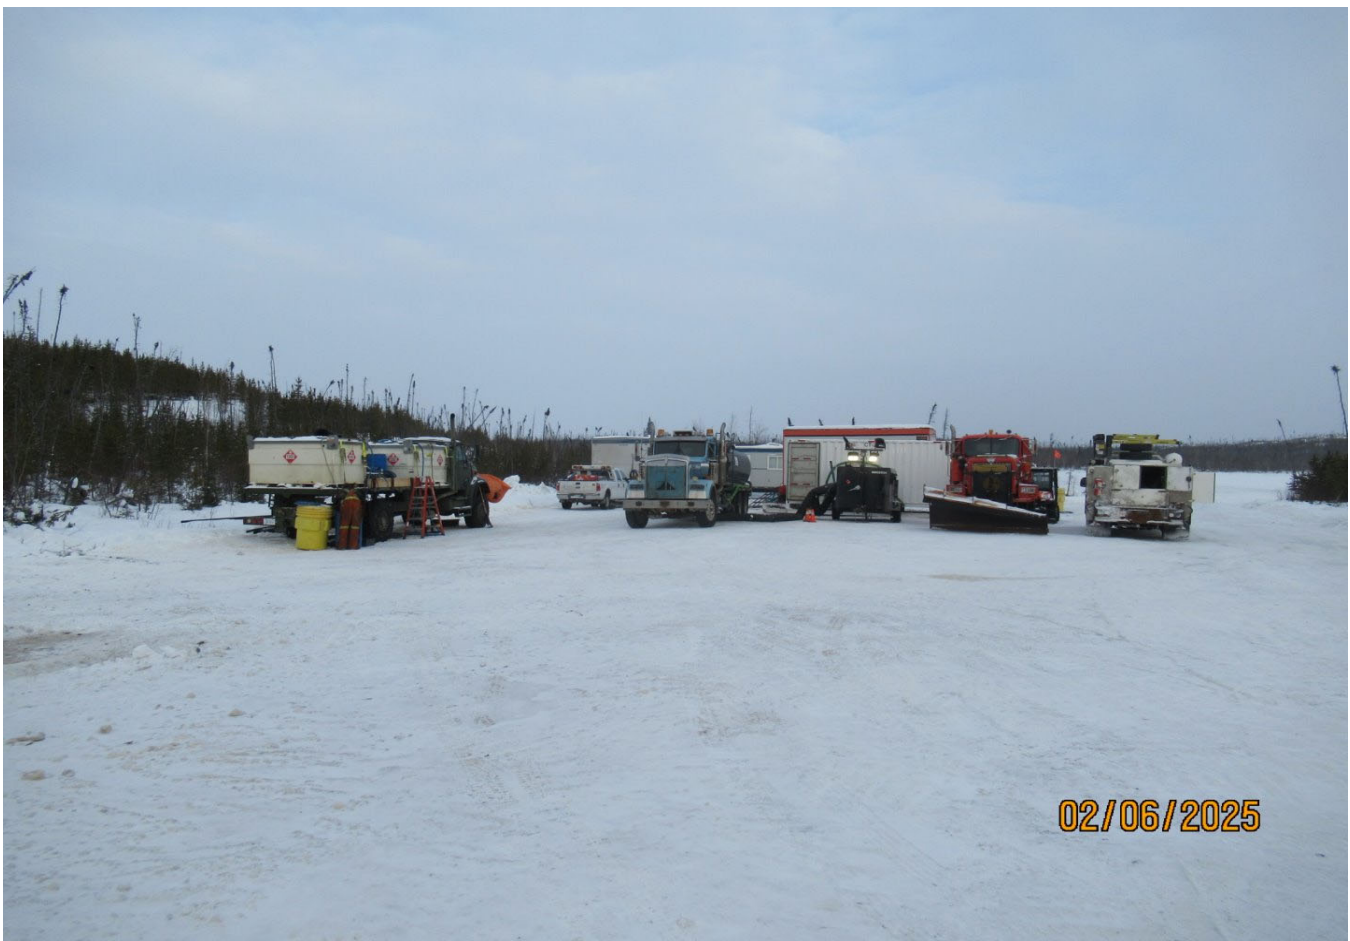
Camp infrastructure, fuel, vehicles, and equipment at the newly established campsite on the north end of Portage 208 can be viewed in Figure 6. All findings of the inspection were discussed with the ATS mobile mechanic, and prior to the completion of the inspection, all concerns were satisfactorily addressed.

Figure 6
Looking northeast at the P208 campsite.

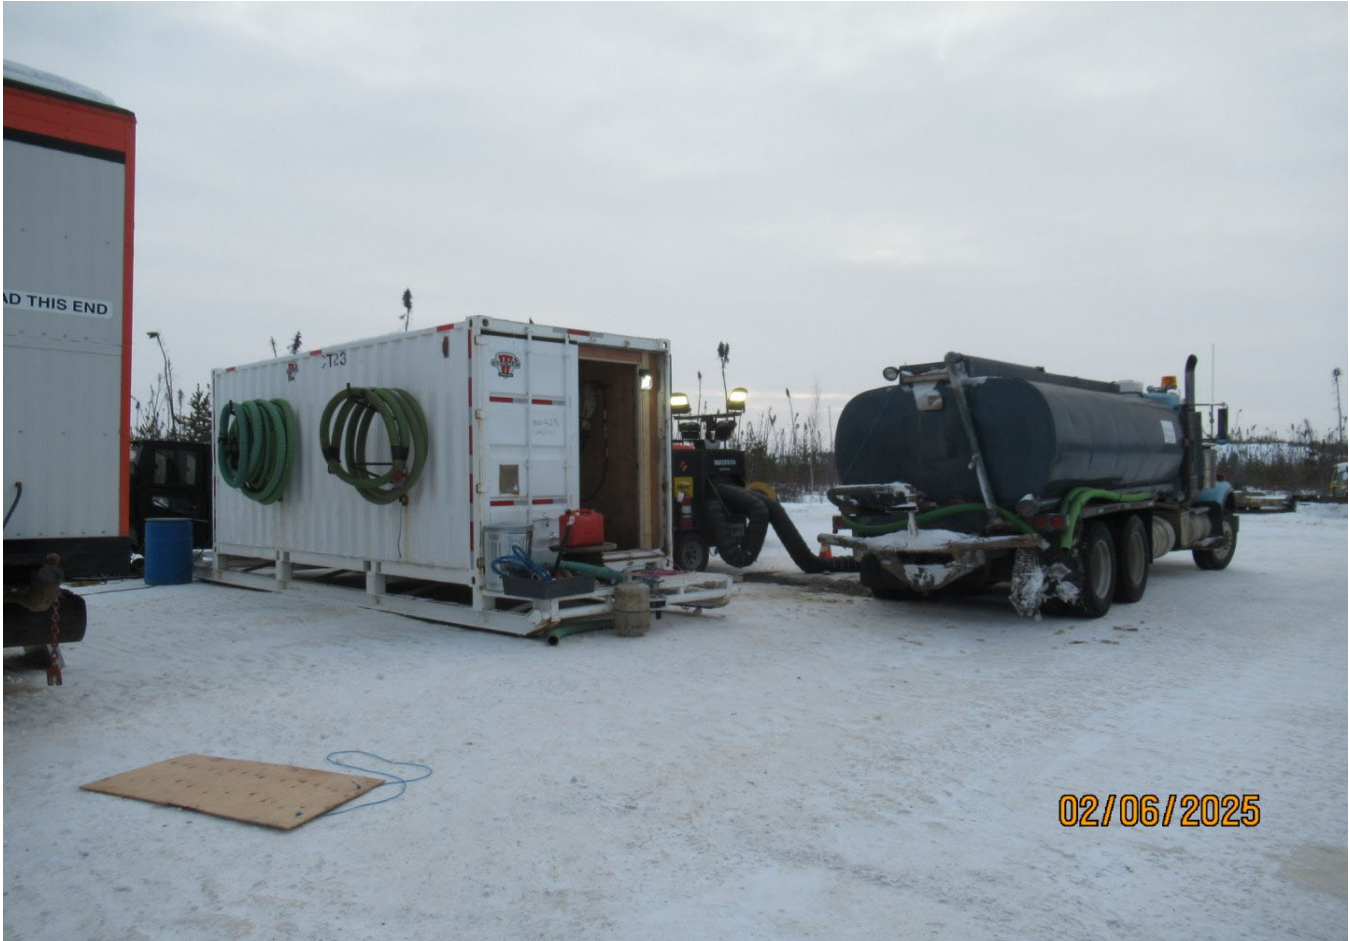
- Pails of oils and lubes are being securely stored in the seacan viewed in Figure 7 which will drastically reduce the potential for a spill to occur.
- All domestic garbage is being stored in the parts seacan and to prevent accumulation, it is being taken off site for disposal at a licensed facility on a regular basis.

Parts seacan is also being used for the secure storage of domestic waste until proper offsite disposal occurs.

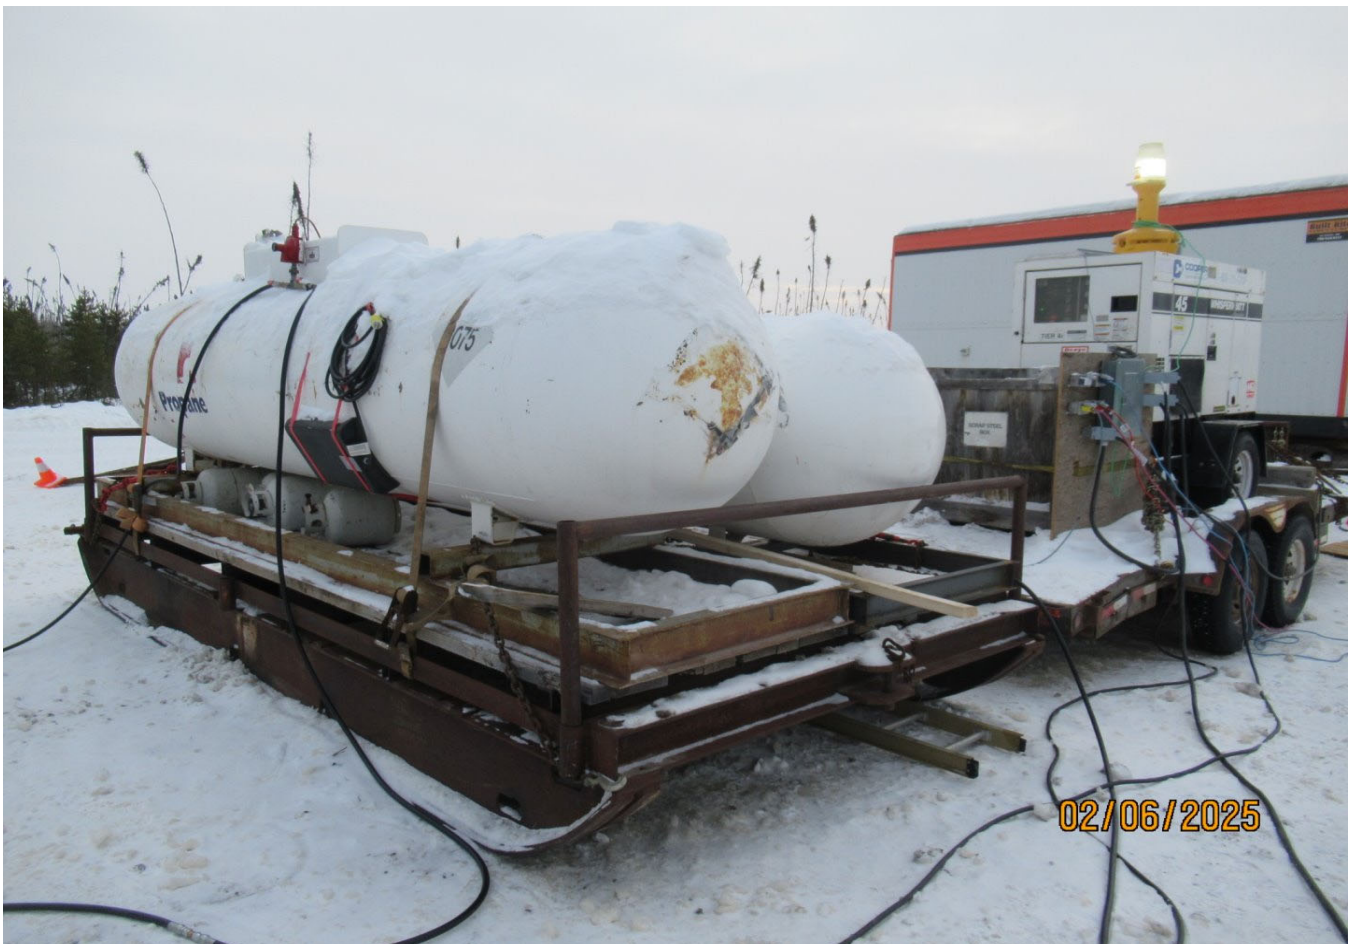
Figure 8

- Secondary containment was in place below the generator viewed in Figure 8.
- All parked vehicles and equipment had a form of secondary containment present (Figure 9 & 10).

Propane skid and camp generator.

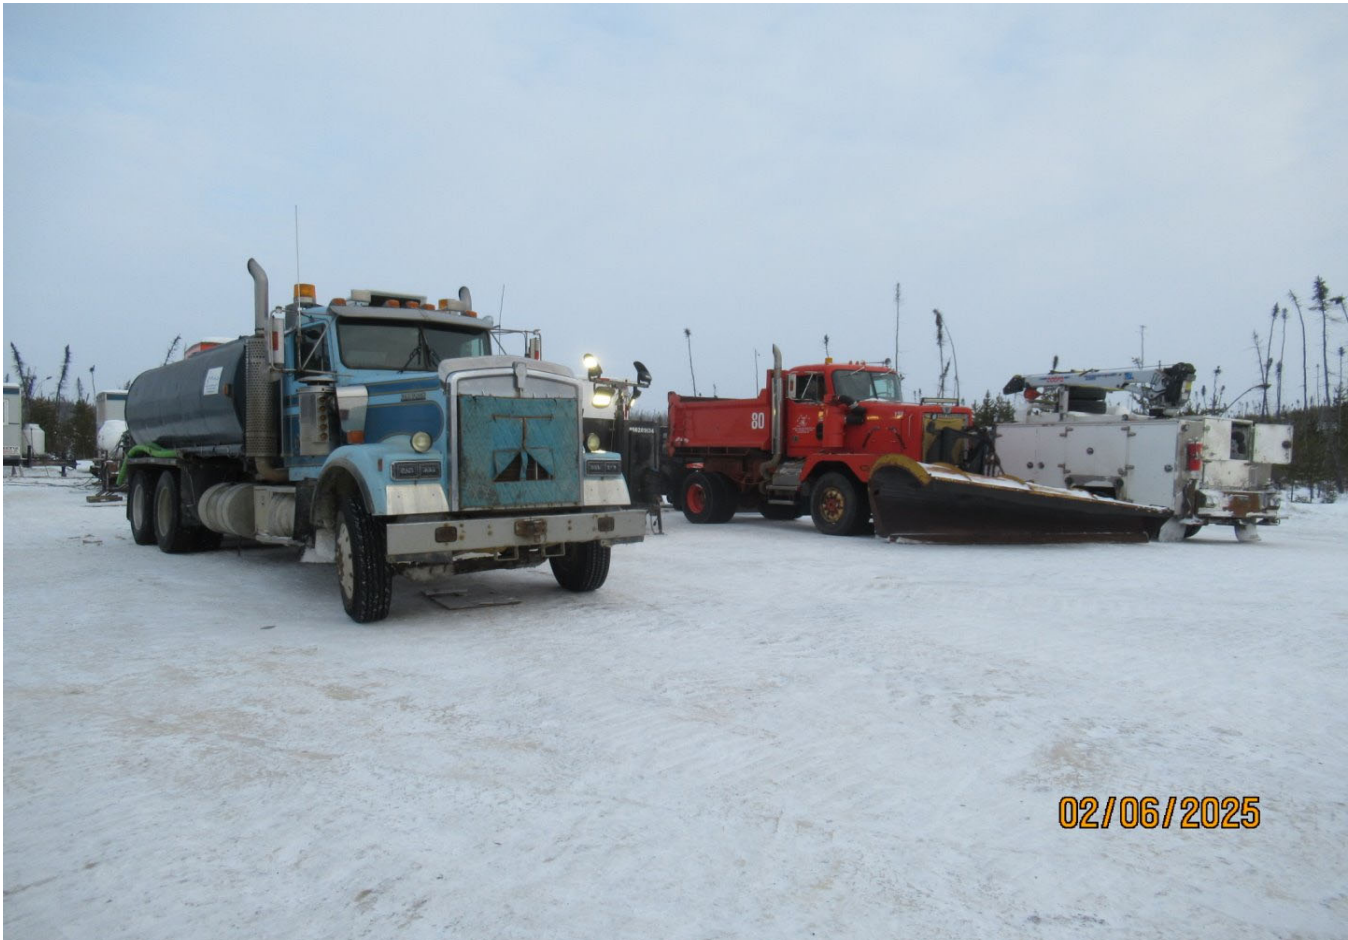
Figure 9

Parked equipment at the P208 campsite. All equipment and vehicles have a form of secondary containment present.

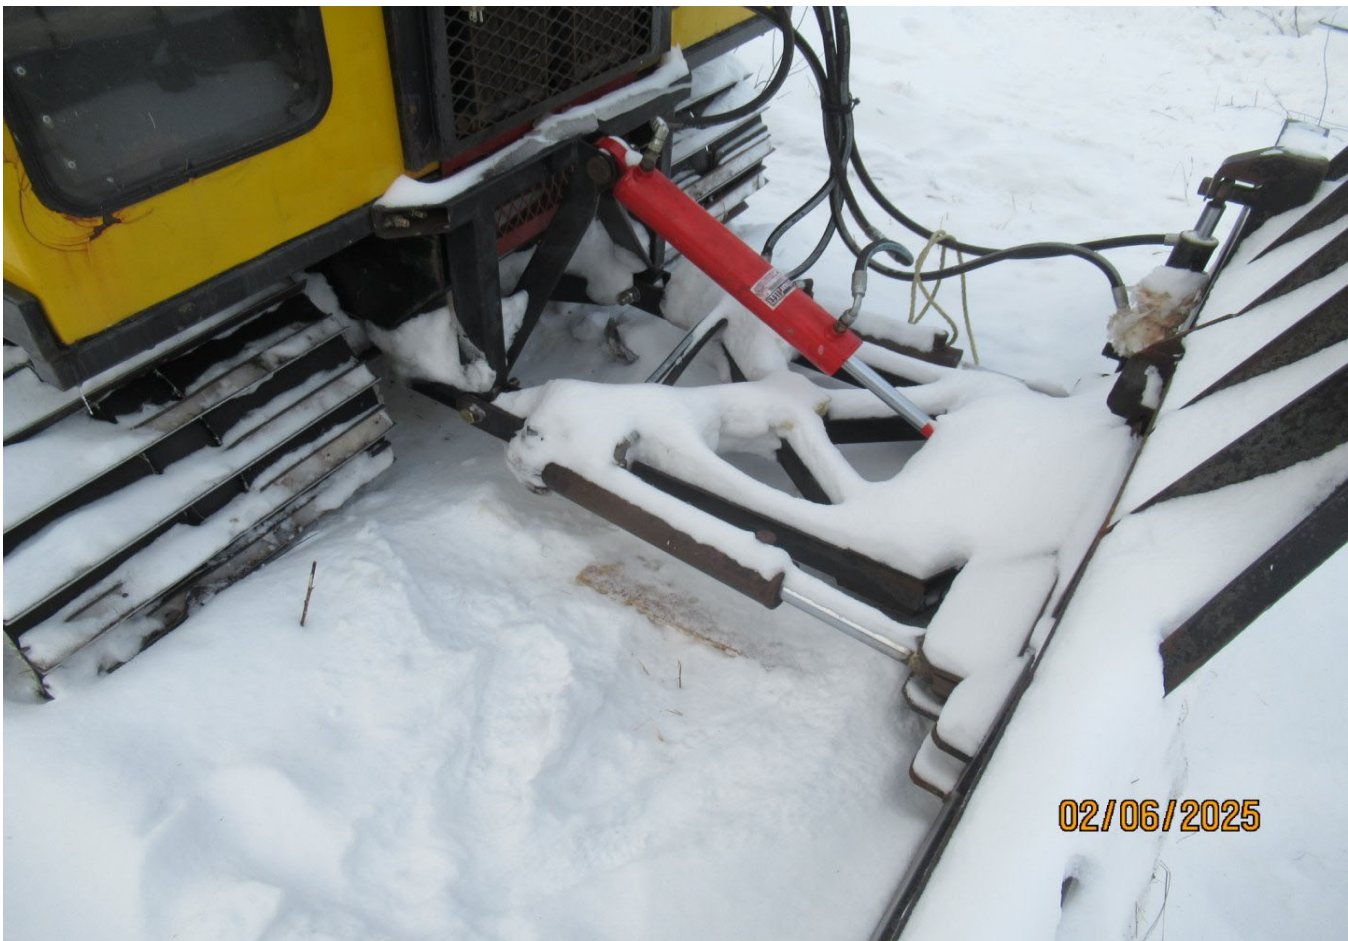
Figure 10

Drip board is present under the hydraulic lines of the skidozer.

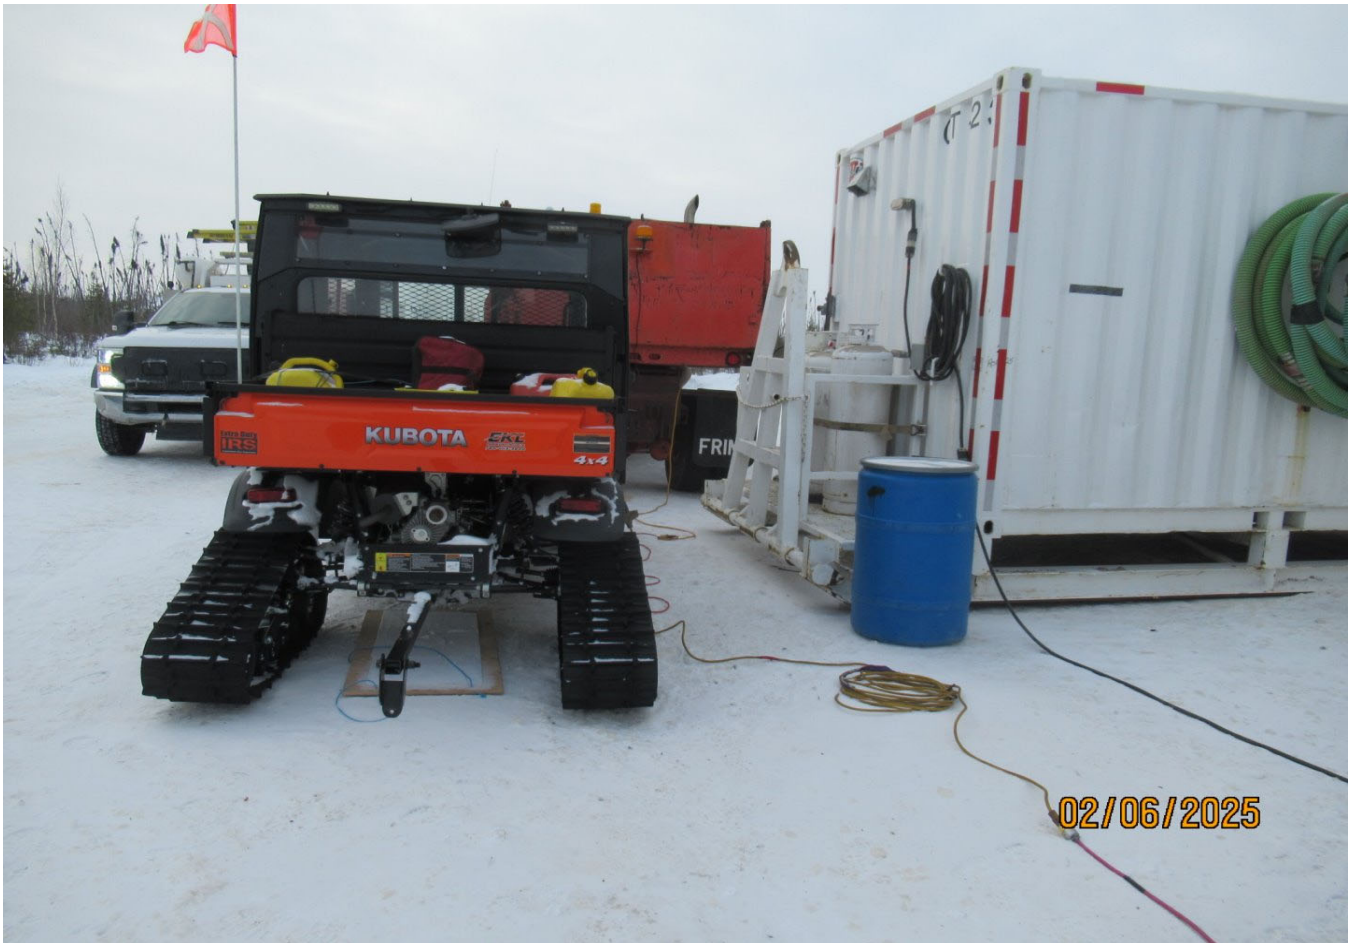
Figure 11

Spill kit adjacent to the parts seacan and the Kubota has a drip board present.

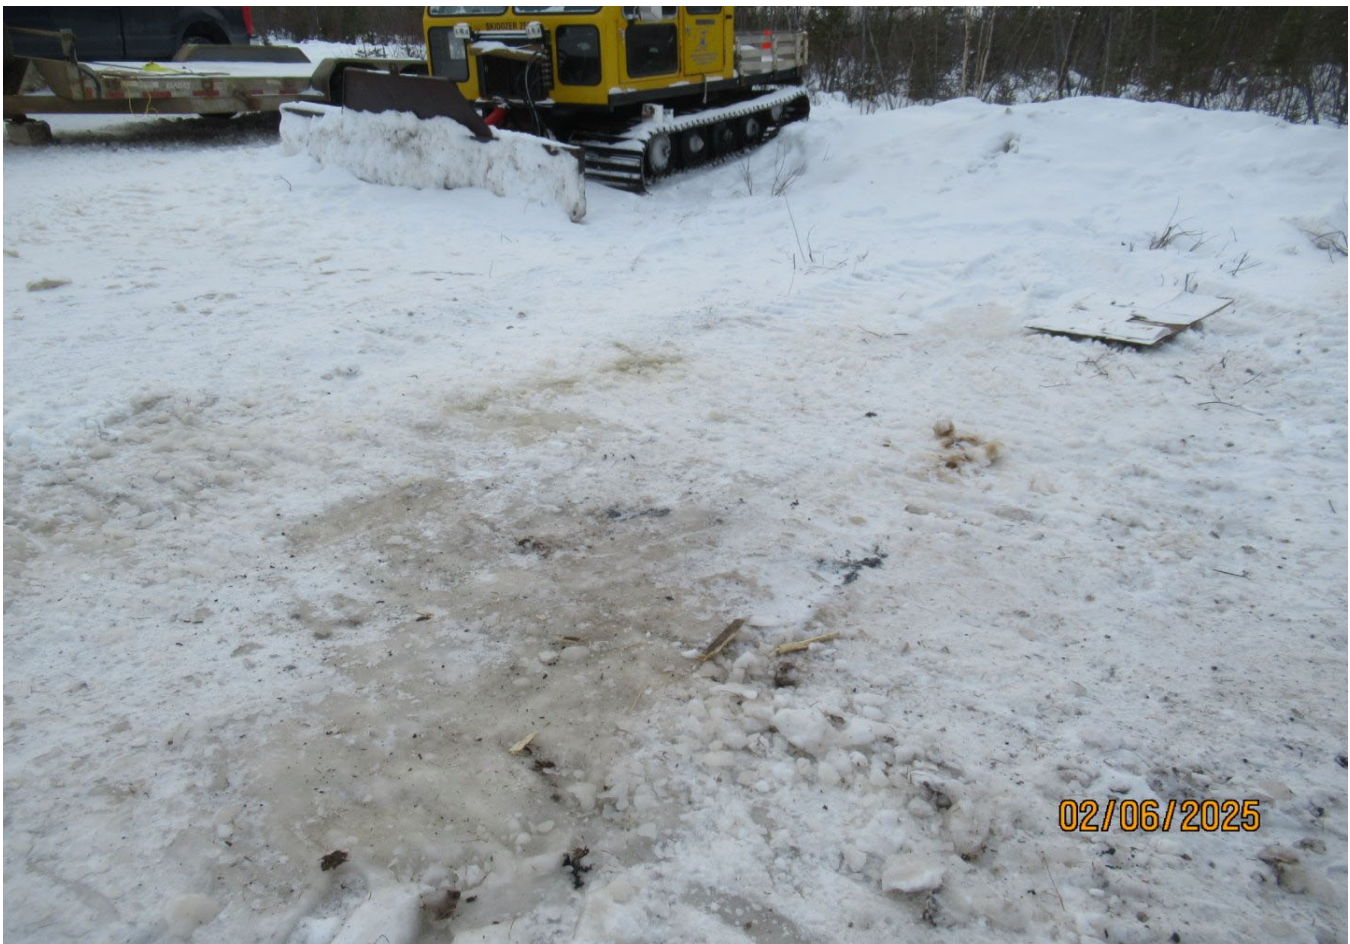
Figure 12

- Spill kits and spill response materials are readily available throughout the campsite (Figure 11).
- A few small hydrocarbon "drips" were observed on the south side of the campsite and can be viewed in Figure 12. Ongoing maintenance to equipment/vehicles and cleanup of all small spills must continue for the remainder of this land use operation.

A few small drips from equipment were observed on the south side of the P208 campsite. Ongoing cleanup and proper offsite disposal must occur.

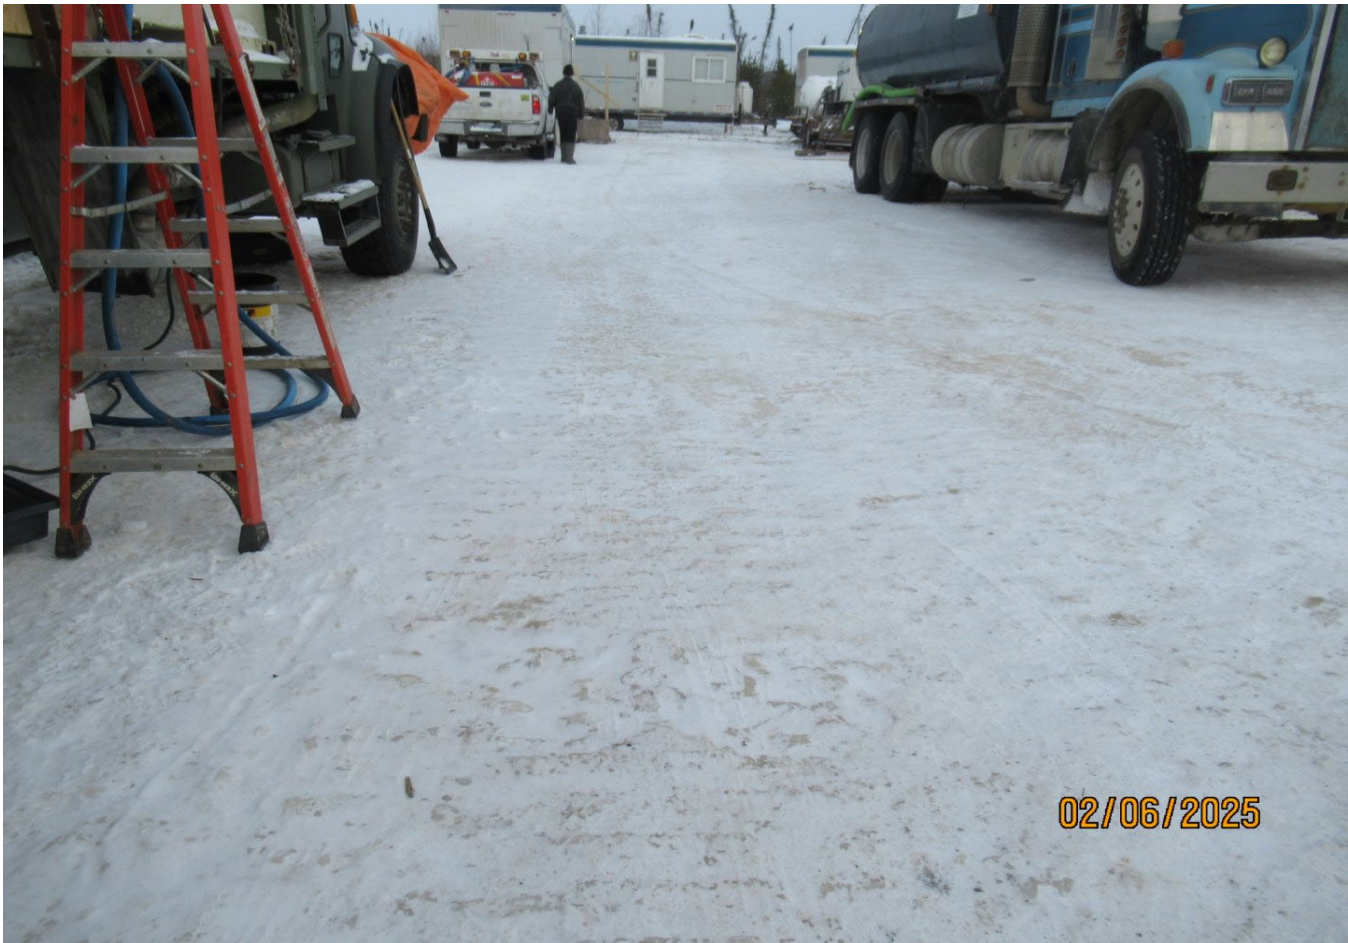
Figure 13

- Prior to the placement of the camp infrastructure and parking of equipment, the campsite was watered in to protect the ground surface and to also provide a medium that would allow hydrocarbon/glycol spills to be thoroughly cleaned up without impacting underlying soils.

The campsite was iced in prior to positioning of the camp modules & other items.

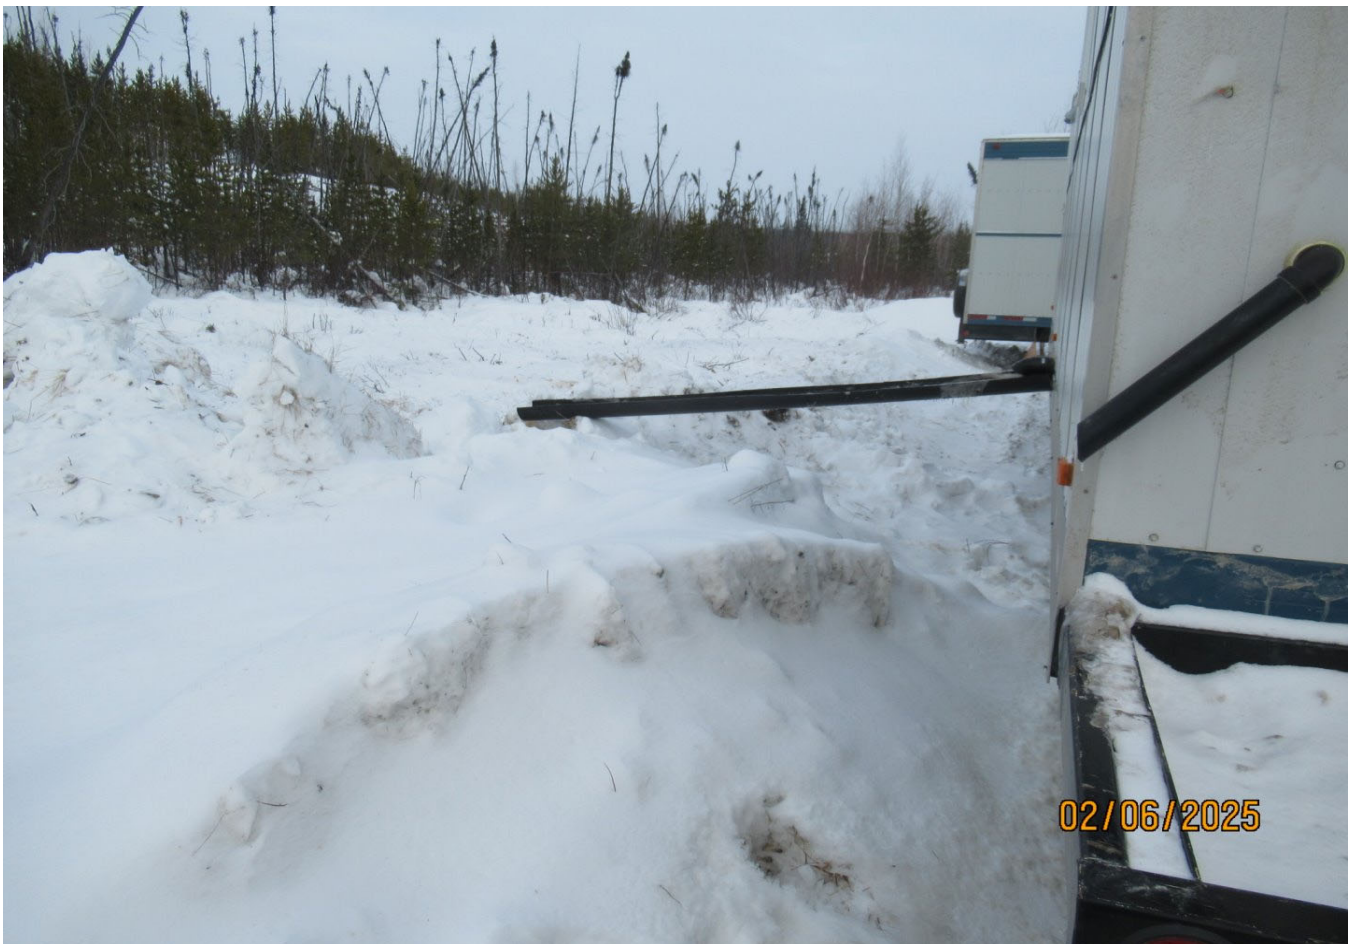
Figure 14

Domestic wastewater is being directed into a natural depression that is setback a sufficient distance from the nearest watercourse.

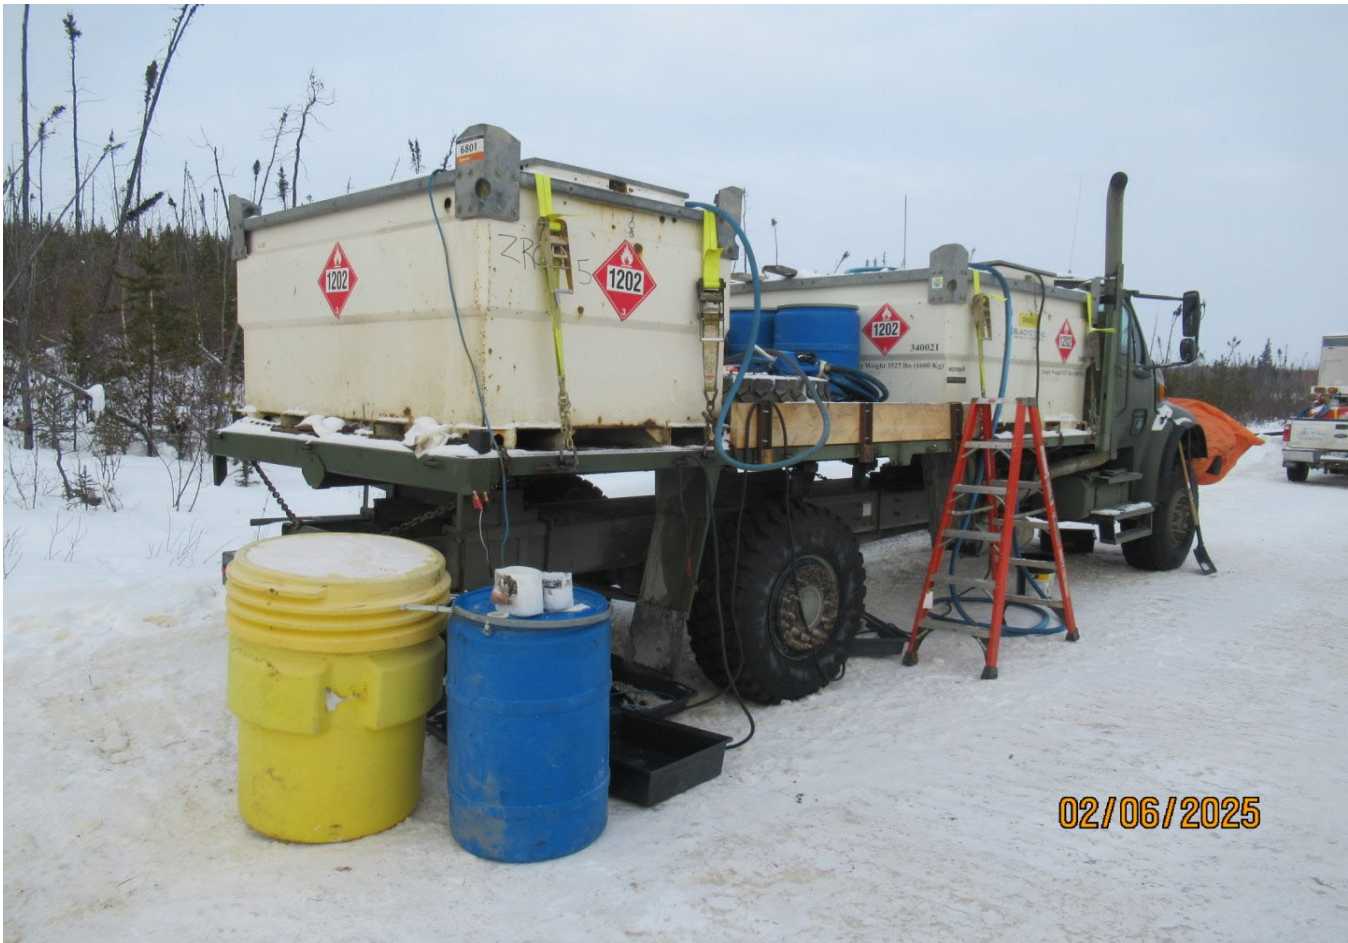
- Domestic wastewater is being deposited in the adjacent forest a sufficient distance from the nearest watercourse (Figure 14).
- No concerns were noted with fuel storage or handling at either of the refueling stations viewed in Figure 15 & 16. It should also be noted that two cut off oil jugs were left open on top of the blue barrel viewed in Figure 15 and once discussed with the ATS mechanic, they were poured into a sealed pail for secure storage until offsite disposal occurs.

Transcube fuel containers. No concerns were noted with fuel storage or handling.

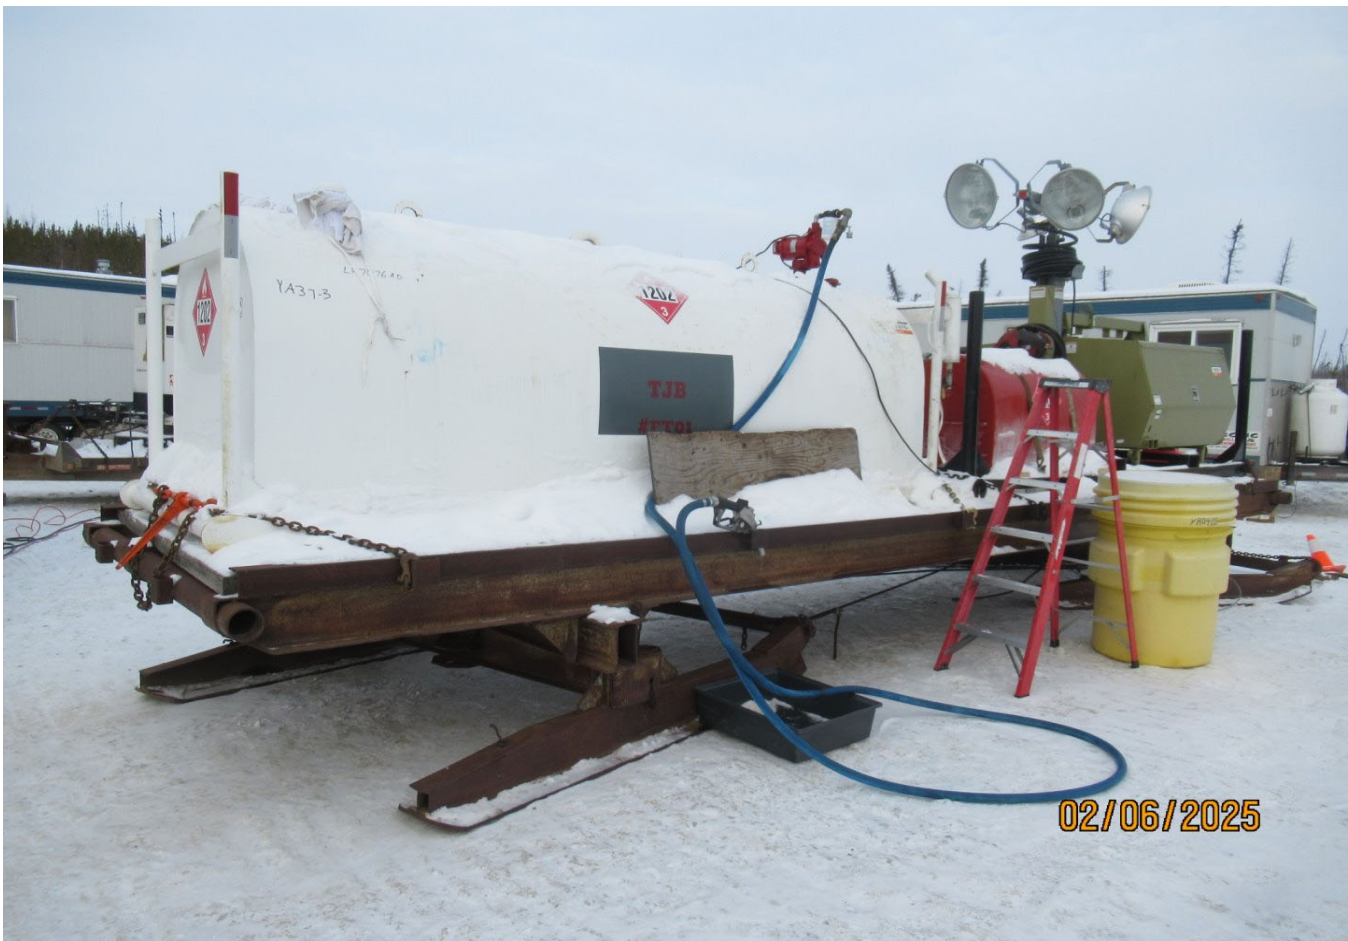
Figure 16

Second refueling station at the P208 campsite. Fuel handling appears satisfactory as no spills were observed.
