**Re: Land Use Permit W2021Q0011  
Quarrying / Winter Roads / Camps  
Snare Forks to Kilometre 12 of the Wekweètì Winter Road, NT**

## ENVIRONMENTAL INSPECTION REPORT

Permittee:	NWT Power Corporation	Inspection Date – February 24 <sup>th</sup> , 2022
------------	-----------------------	----------------------------------------------------

Location(s) Inspected:	The 12.3 km winter road from the Wekweëti winter road (Km 12) to the Snare Forks Hydro Facility.
------------------------	--------------------------------------------------------------------------------------------------

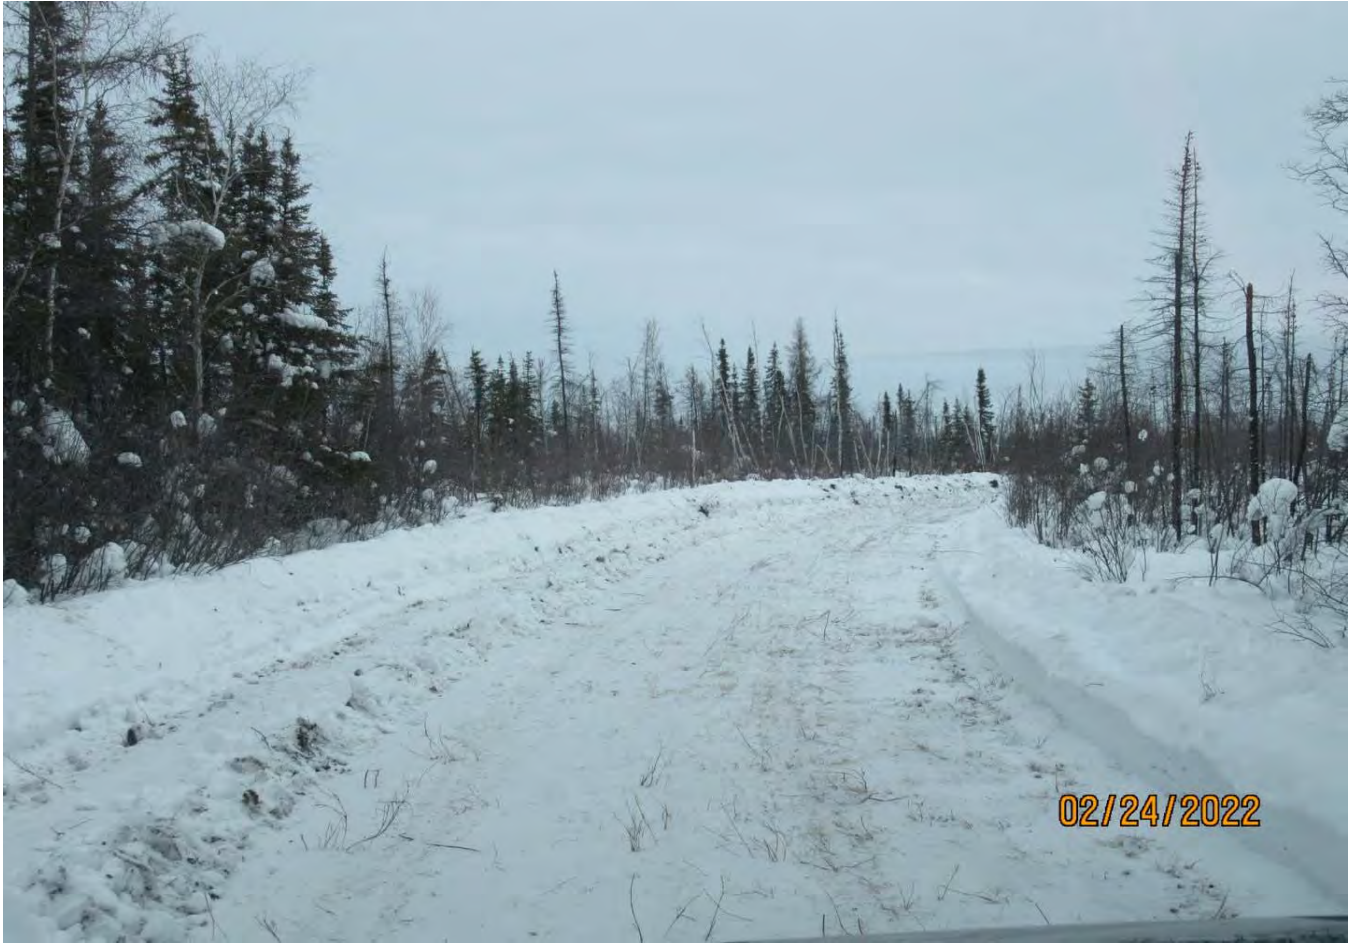
**Figure 1**

As seen in Figure 1 & 2, the initial snow clearing of the portage was complete but unfortunately the Inspectors were very disappointed with the blade work of equipment operators since damage to the underlying ground surface (duff layer) was observed. The Contractor is therefore non-compliant with Condition #20 of the land use permit.

The initial clearing of snow has been completed.

Another area of concern was where equipment cleared pullouts adjacent to the winter road and once again, excessive damage to the duff layer was observed (Figure 3 through 6). The two aforementioned concerns were discussed with Mr. Fraser & Mr. Bloomstrand and the Inspectors were informed that better care will be taken with the blades/bucket of equipment and no further damage will occur.

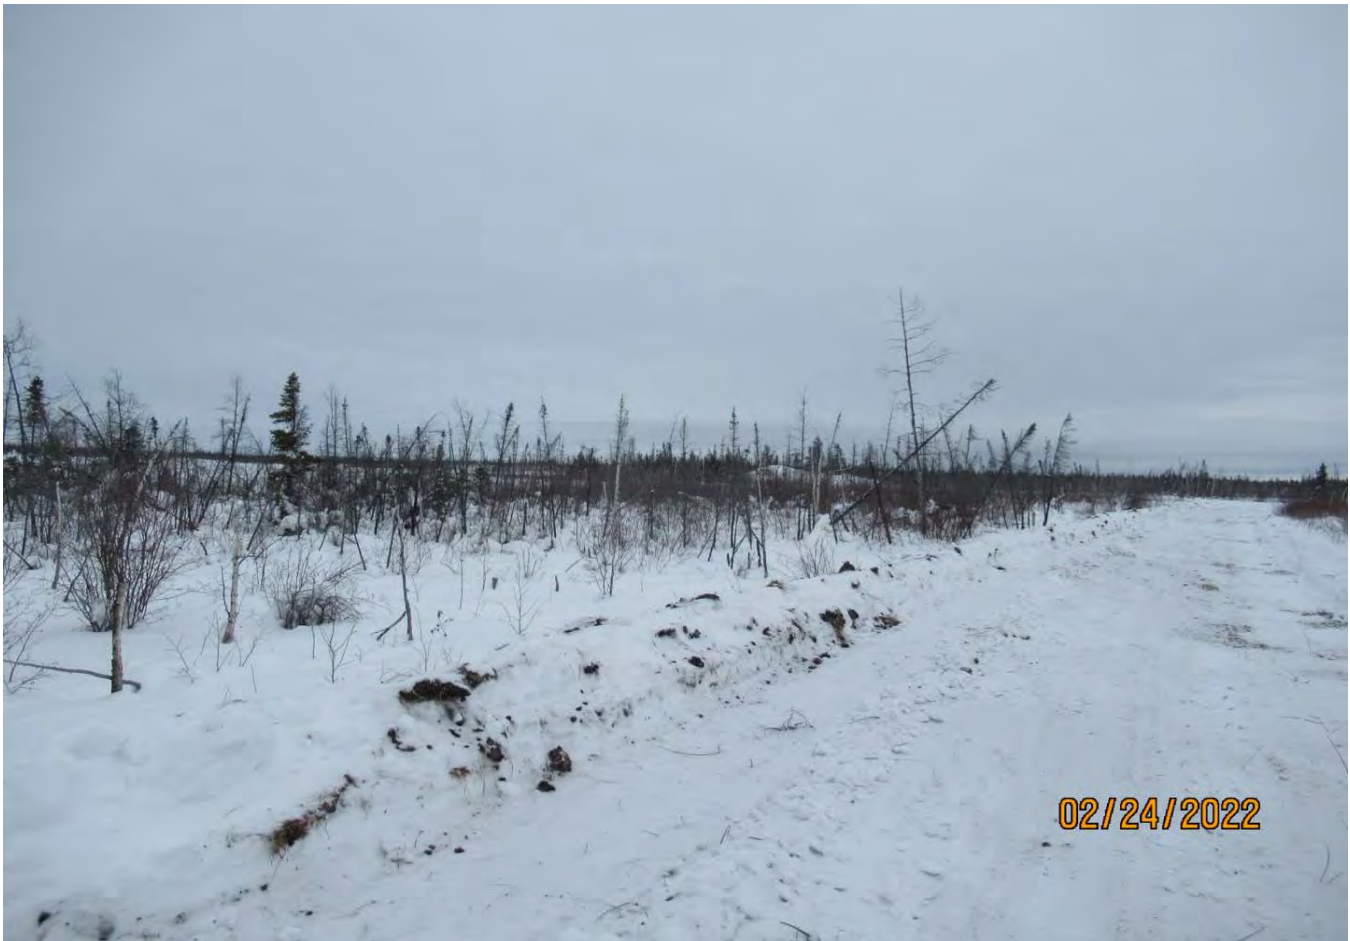
**Figure 2**

The underlying ground surface was disturbed in numerous locations along the winter road.

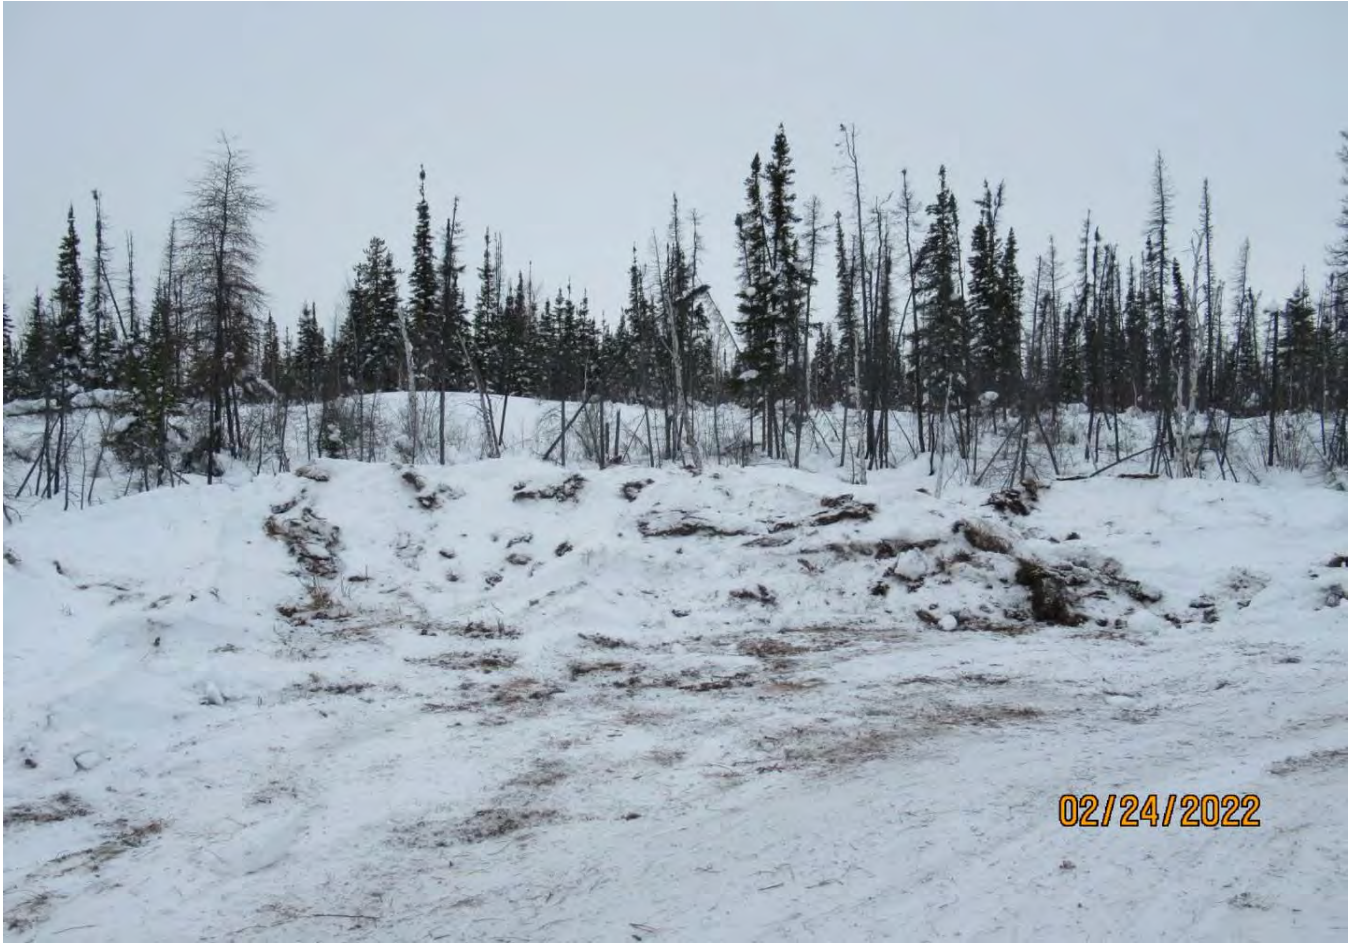
**Figure 3**

**Example of a cleared turning around with rolled organics.**

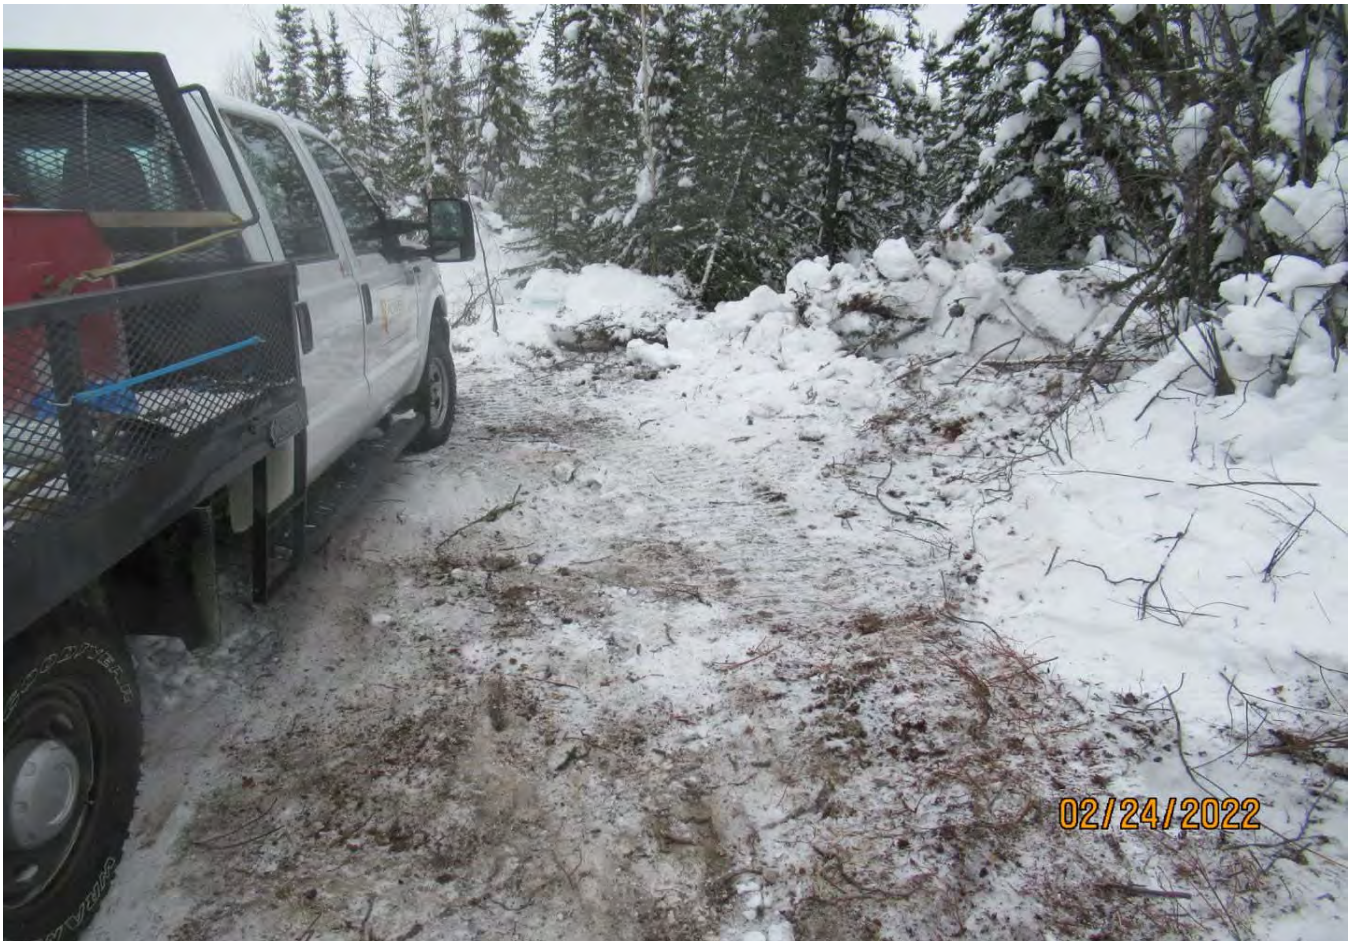
**Figure 4**

**Another pullout with disturbance.**

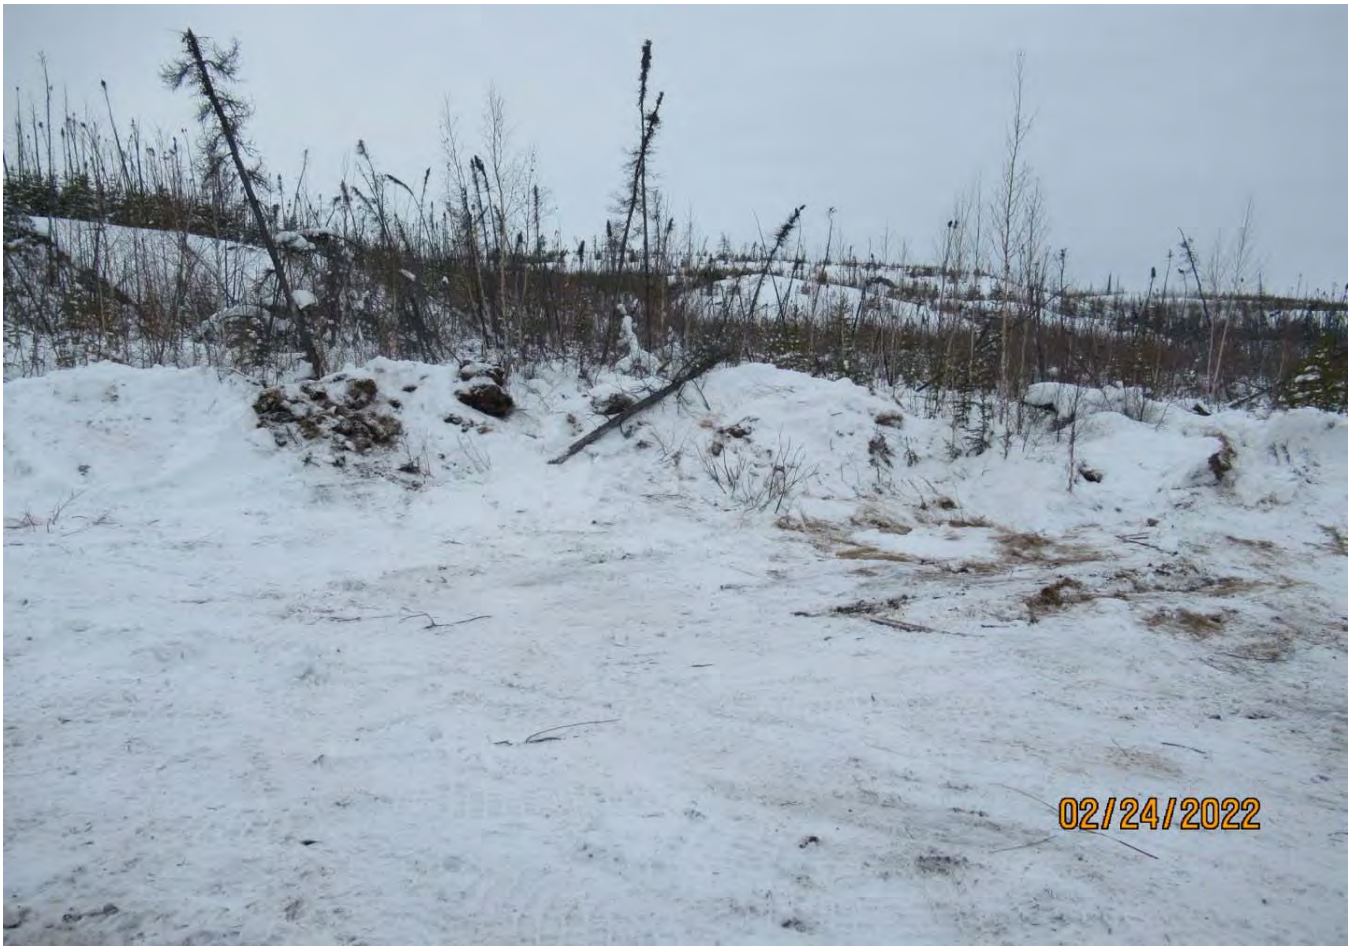
**Figure 5**  
Another pullout with disturbance.

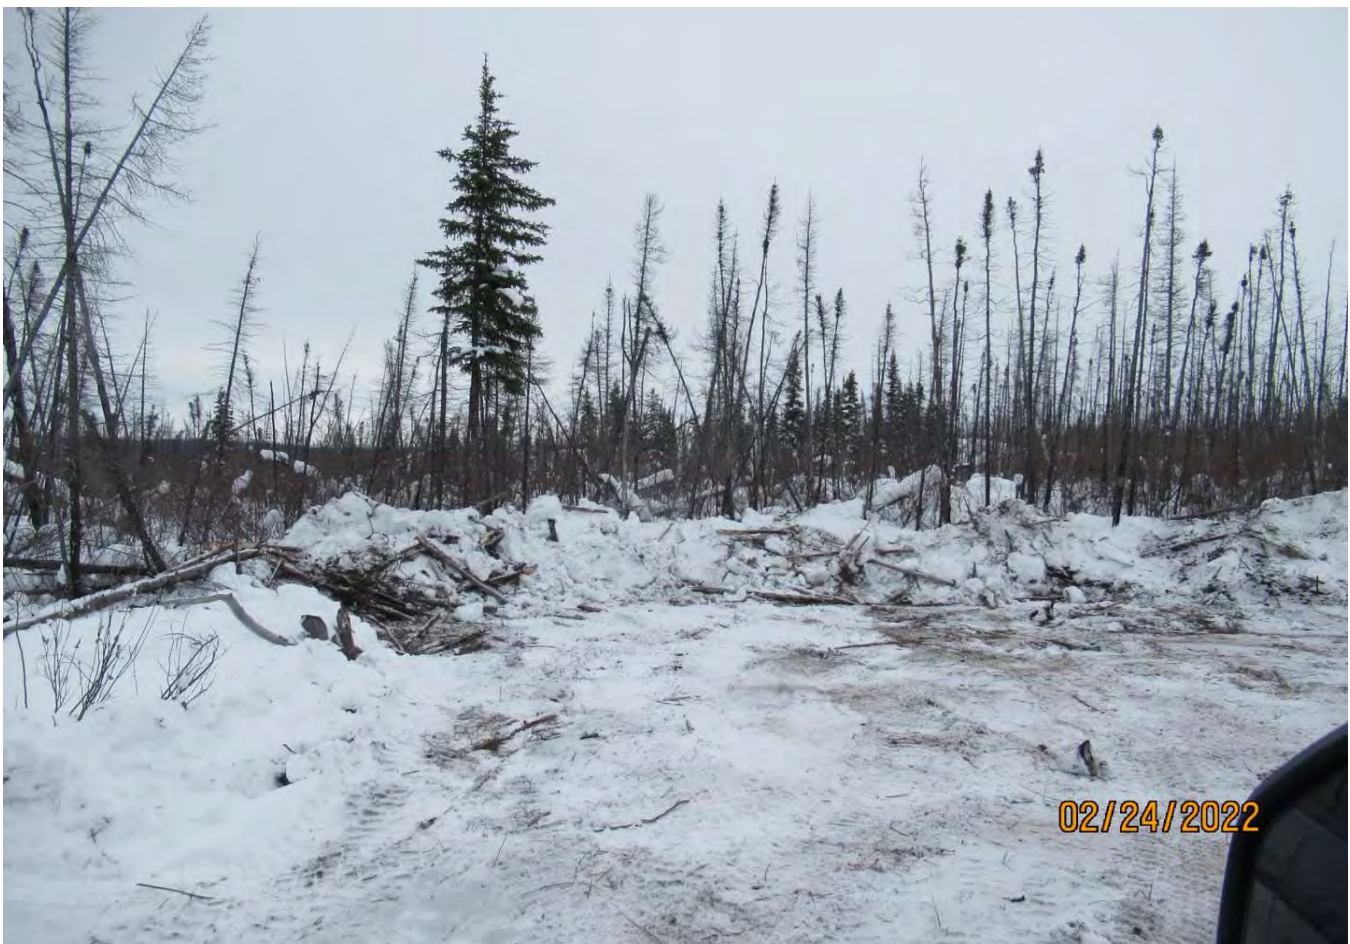
**Figure 6**  
Another area with disturbance.

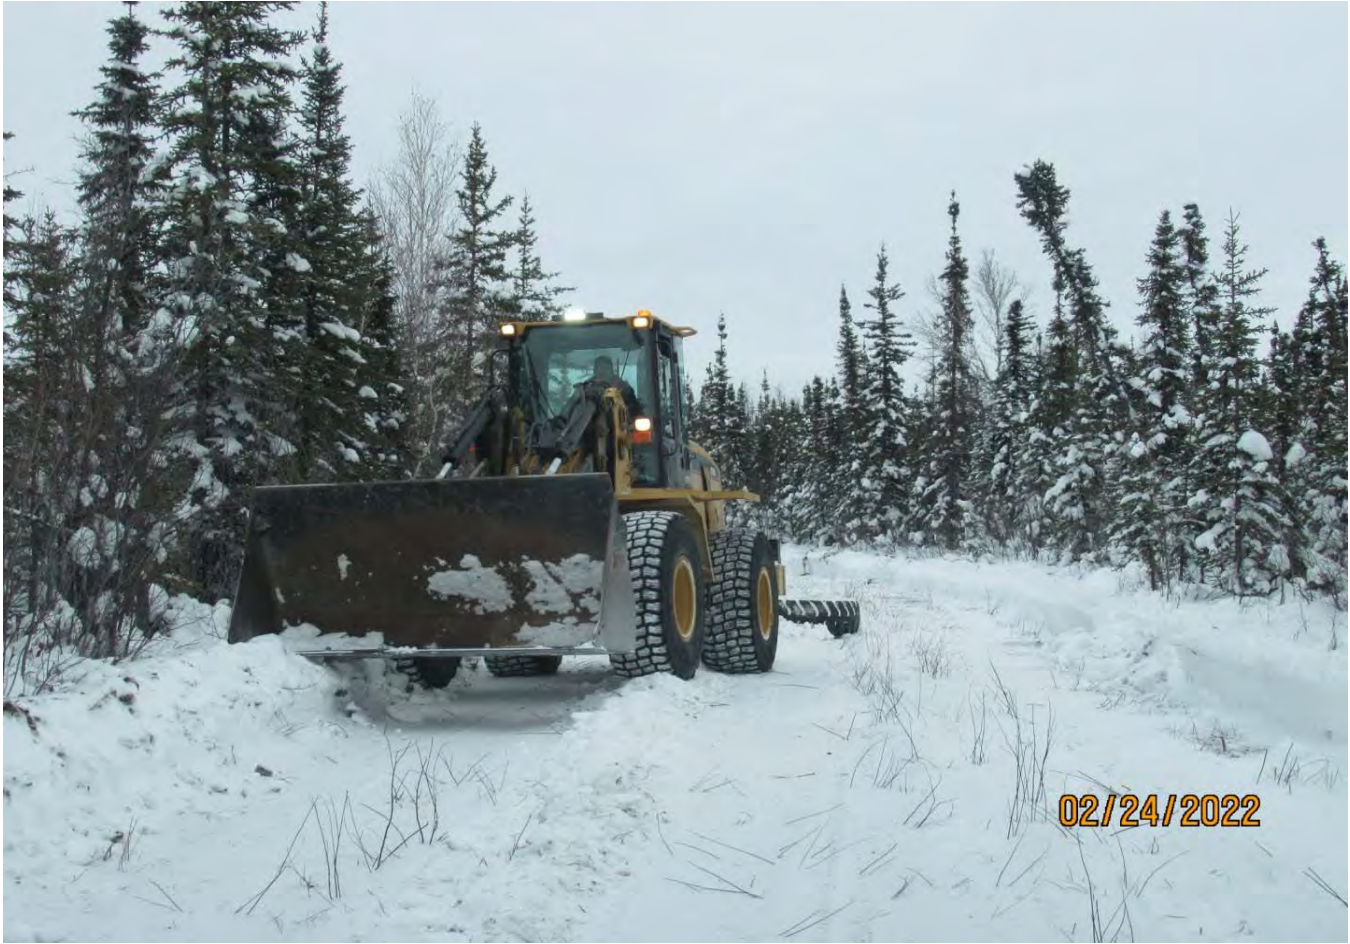
**Figure 7**

Equipment in use for this land use operation is a loader with a drag (Figure 7), a water truck (Figure 8) and a grader (Figure 9). All equipment appeared to be operating cleanly as no obvious hydrocarbon leaks or spills were observed. It also appears that the Contractor is complying with Condition #48 of the permit and drip boards are being placed under parked equipment.

A loader with a tire drag was dragging the portages.

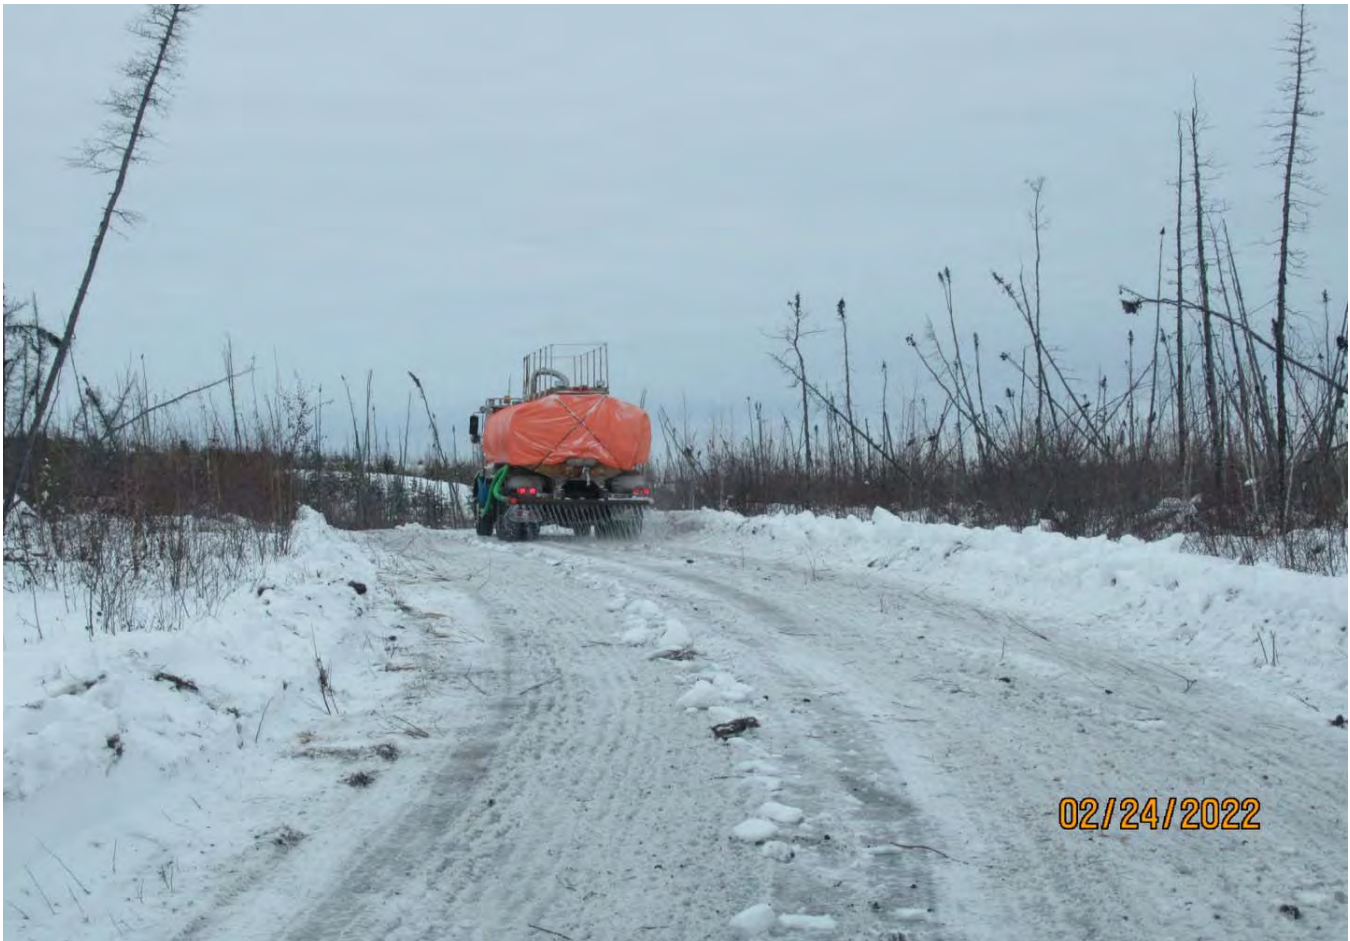
**Figure 8**

A water truck was actively watering the last 4.5 kilometres of the winter road.

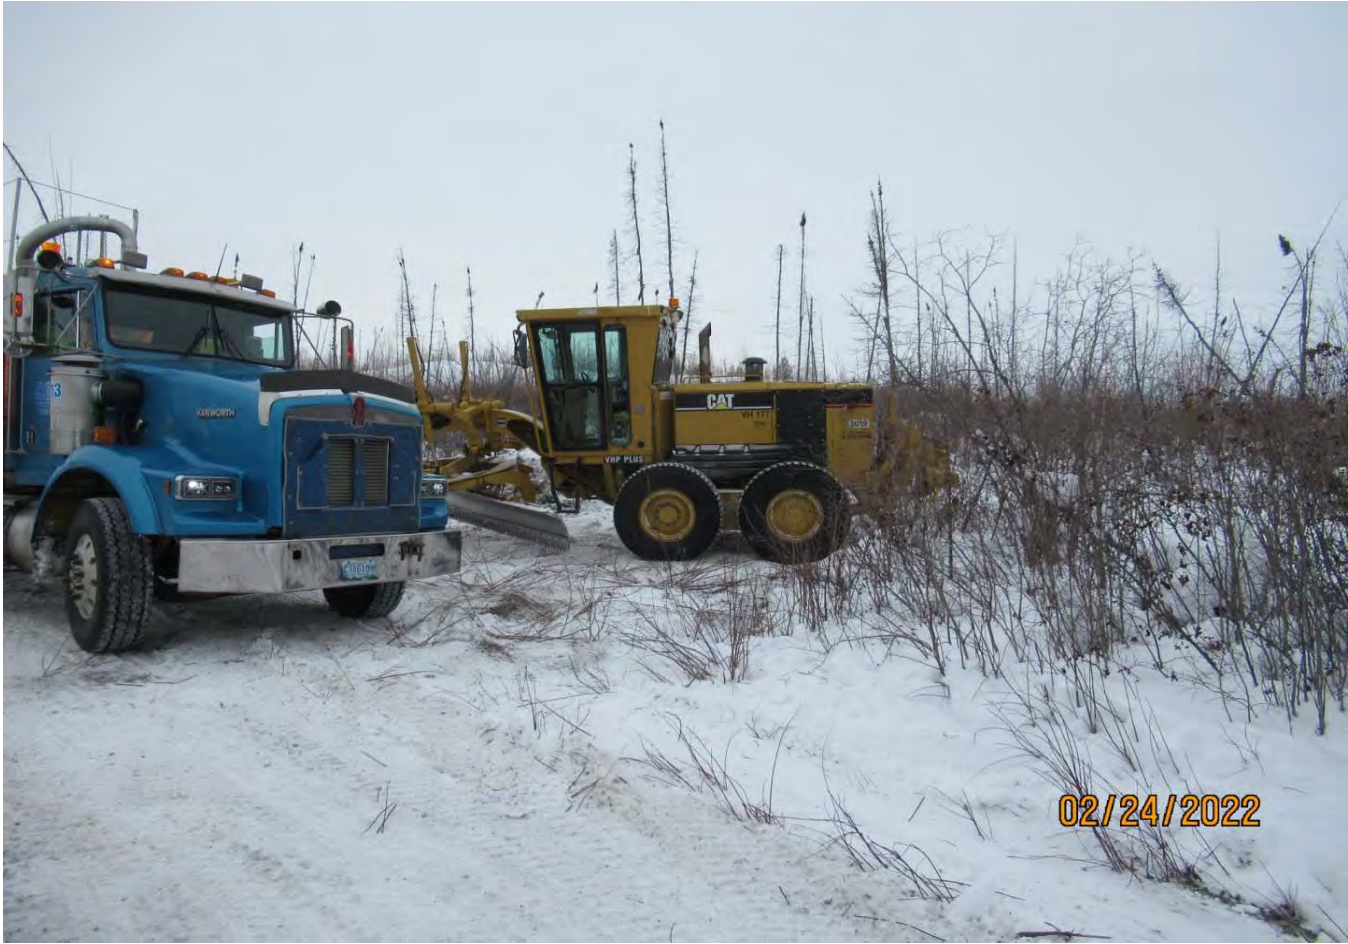
**Figure 9**

A grader is being used for clearing snow and pulling it back in behind the water truck.

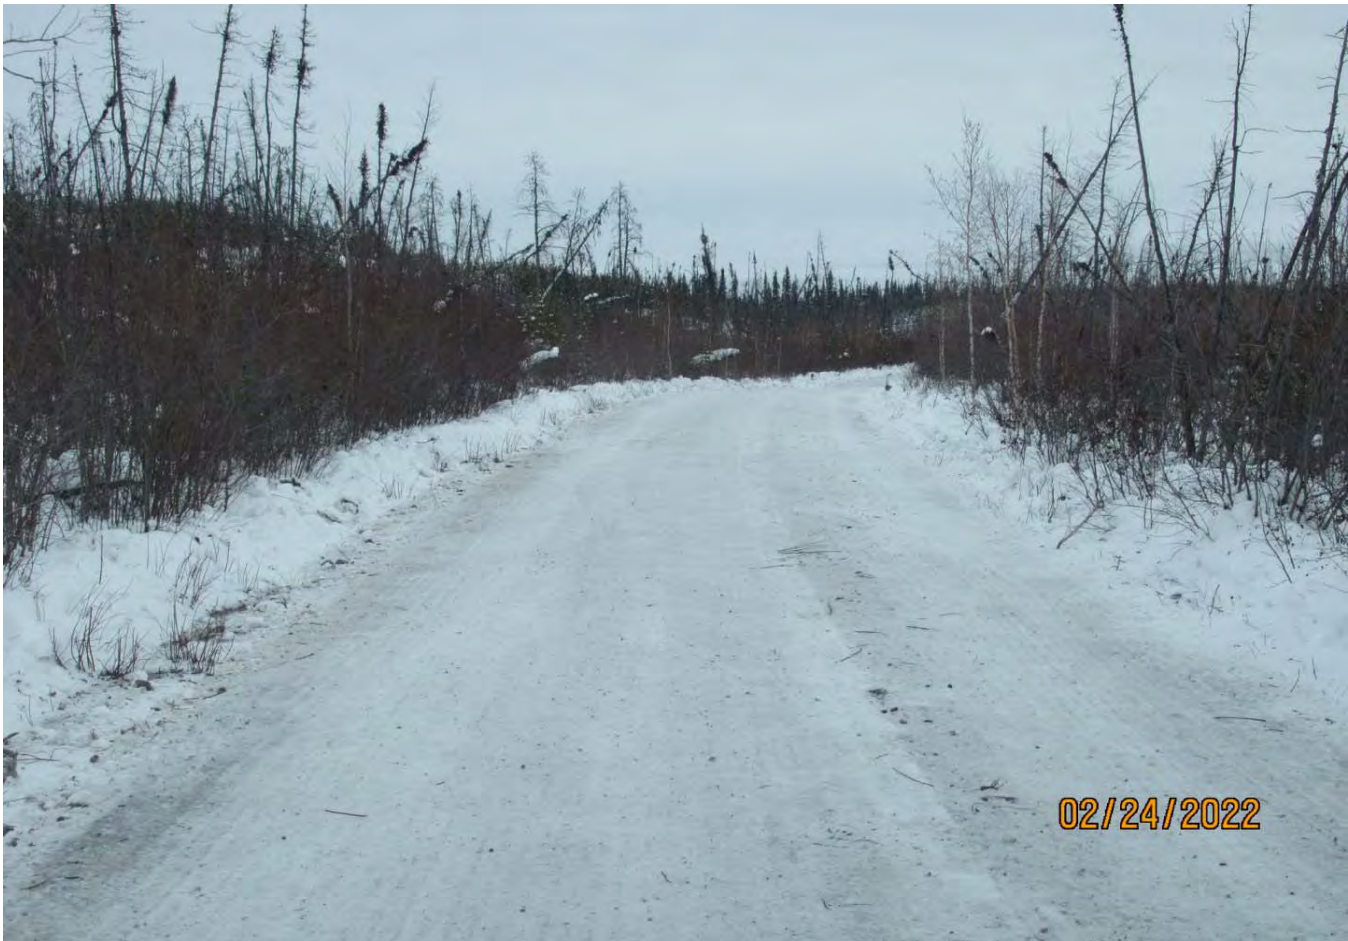
**Figure 10**

Approximately 4.5 kilometres of the winter road has initial icing complete and an example of a portage that has been iced & dragged can be viewed in Figure 10. Prior to the opening of the winter road to vehicular traffic larger than pickups, the road must be iced in from shoulder to shoulder with a minimum of 10 cm of ice to comply with Condition #11 of the permit. The Inspectors are confident that the Contractor will ensure this is completed and this cooperation is appreciated.

Example of a portage with the initial icing complete.

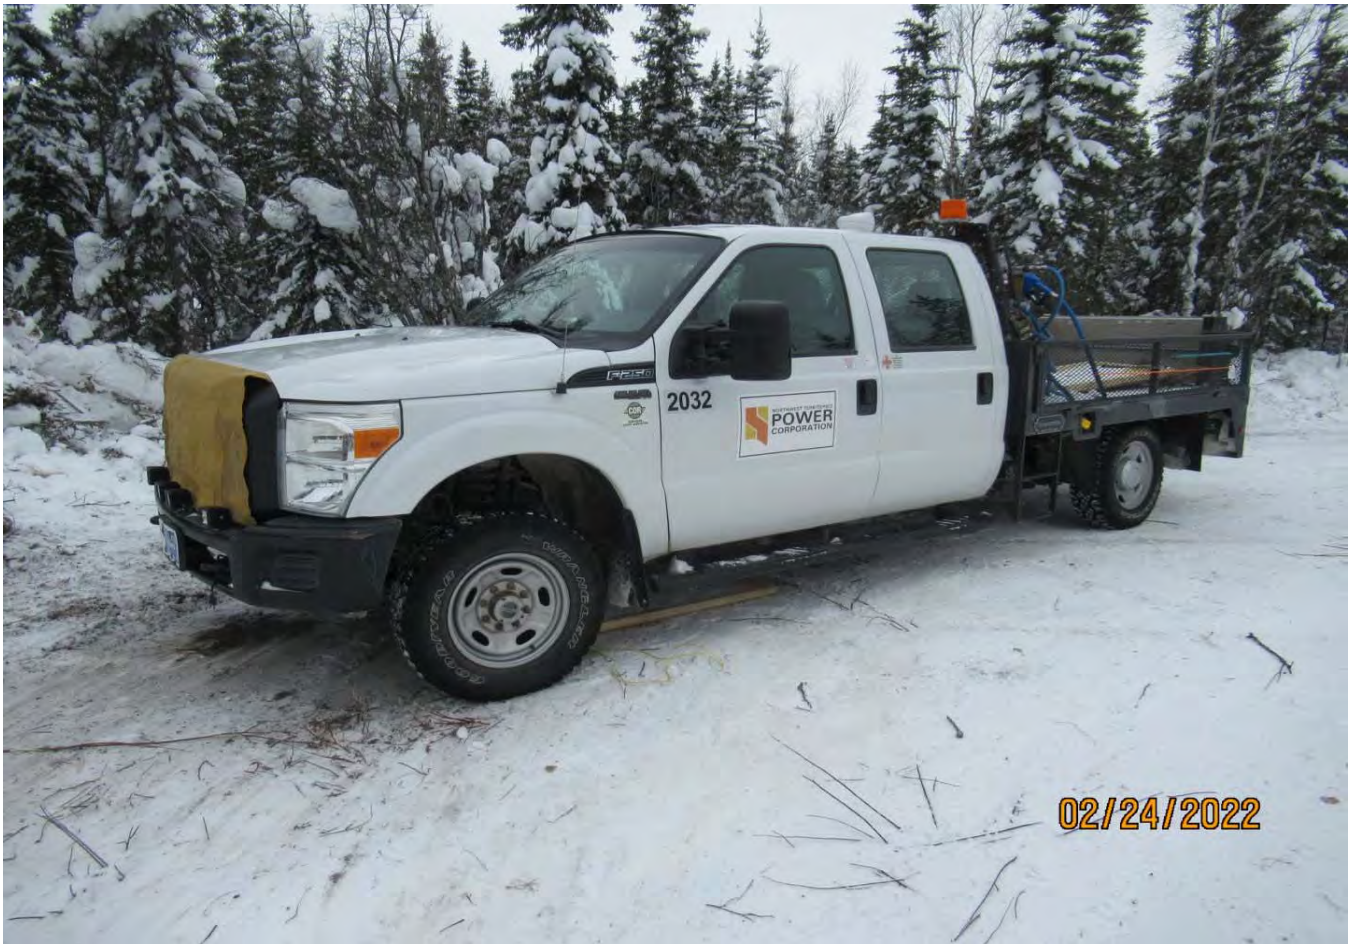
**Figure 11**

The Inspectors were pleased to see a drip board beneath the pickup viewed in Figure 11 but unfortunately no spill response materials were readily available as per Condition #47 of the permit. This concern was discussed with Mr. Bloomstrand and the Inspectors were informed that small spill kits were present in the water truck, grader and loader. This is appreciated but unfortunately with fuel transfers occurring from the tidy tank in the back of the aforementioned pickup, spill response materials are of the utmost importance at this location.

**This parked pickup had a drip board in place.**

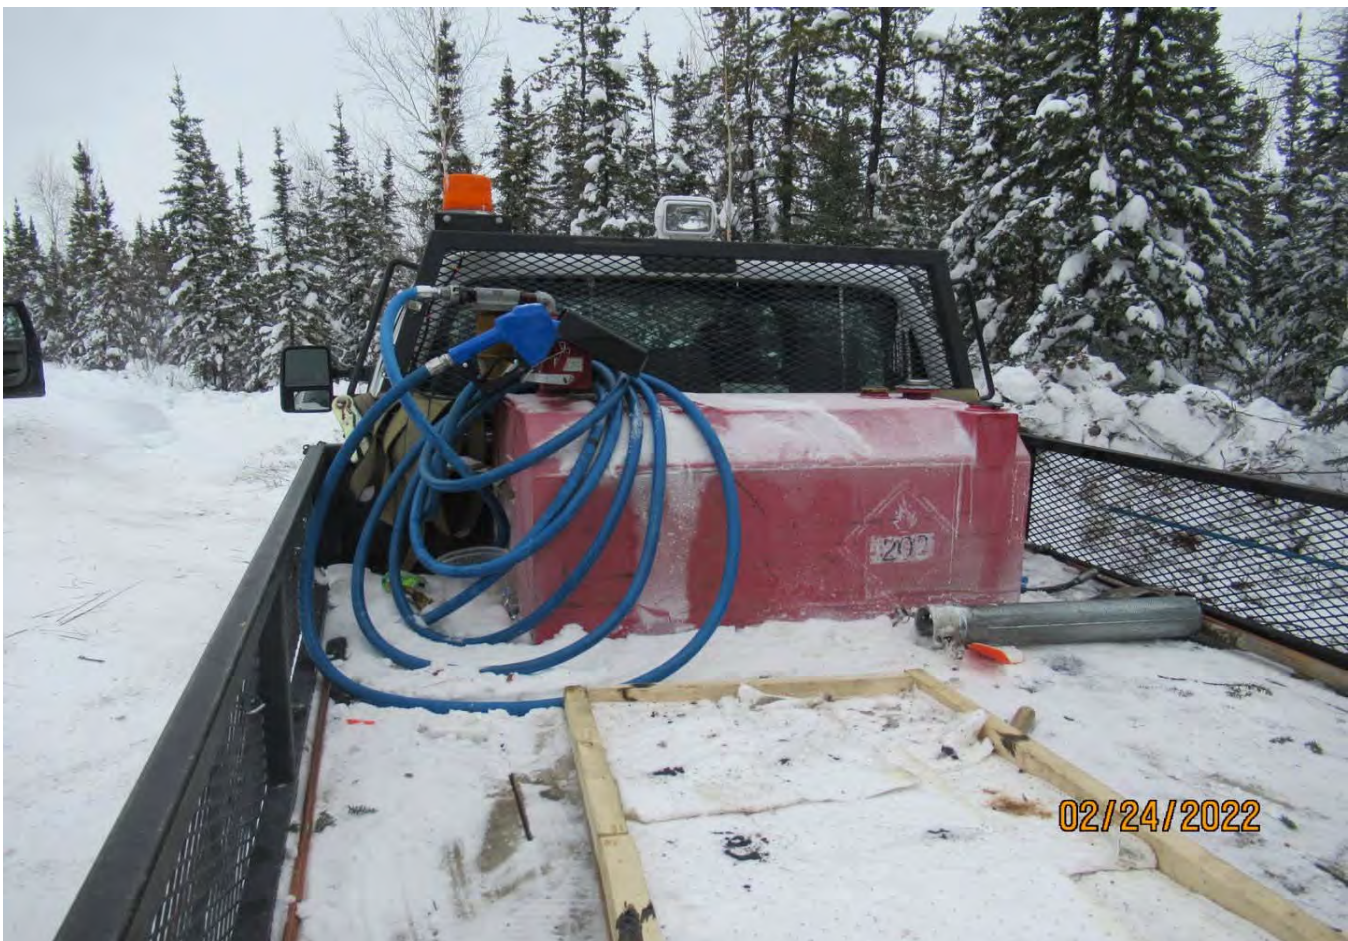
**Figure 12**

**Although a drip board was present for re-fueling, no spill response materials were present in this pickup.**
