File Number G20H006
Type of Operation CAMPS
Location KM 14.2

ENVIRONMENTAL INSPECTION REPORT

Permittee:	GNWT Department of Infrastructure	Permit Expiry Date:	August 10, 2022
Land Use Permit No.	G20H006	Previous Inspection:	February 17, 2022
Quarrying Permit No.		Inspection Date:	March 17, 2022
Contractor:	L.J.'s	Subcontractor:	
Location(s) Inspected:	KM 14.2		
Current Stage of Operation:	On-going		
Program Modifications Approved:

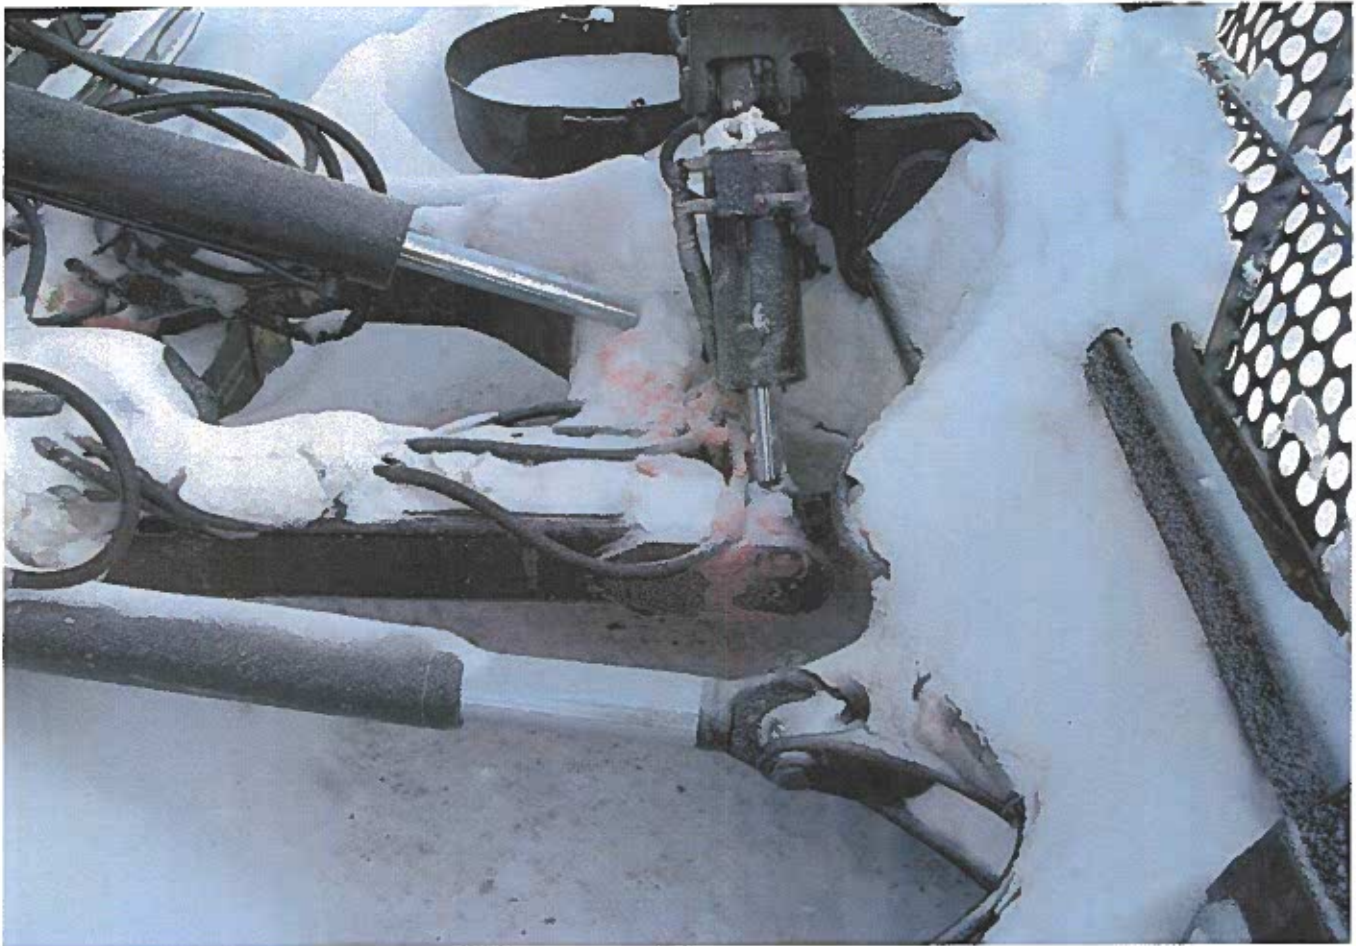
Figure 1

The snow cat at the site is leaking hydraulic fluid and should be repaired or removed from the site. There is drip trays under 2 of the leaks but not under the one side where a bit of oil is on the ground. The workers at the site indicated they will clean up the spill and put a tray under the leaks.
