## WELLSITE SUMMARY INSPECTION REPORT

Well/Facility Name:	Netla C-07	Operator:	Canadian Natural Resource Ltd.
Location of Inspection:	60 ° 46' 13"N 122° 46' 18" W	Access method:	Helicopter
Site Contractor:	N/A	Status:	Non-compliant suspended
Approval Info	ACW-2019-008-CNRL-C-07-WID0191 Variation # 2	WID:	0191
Date of Inspection	23-FEB-2022	H2S Site:	Yes

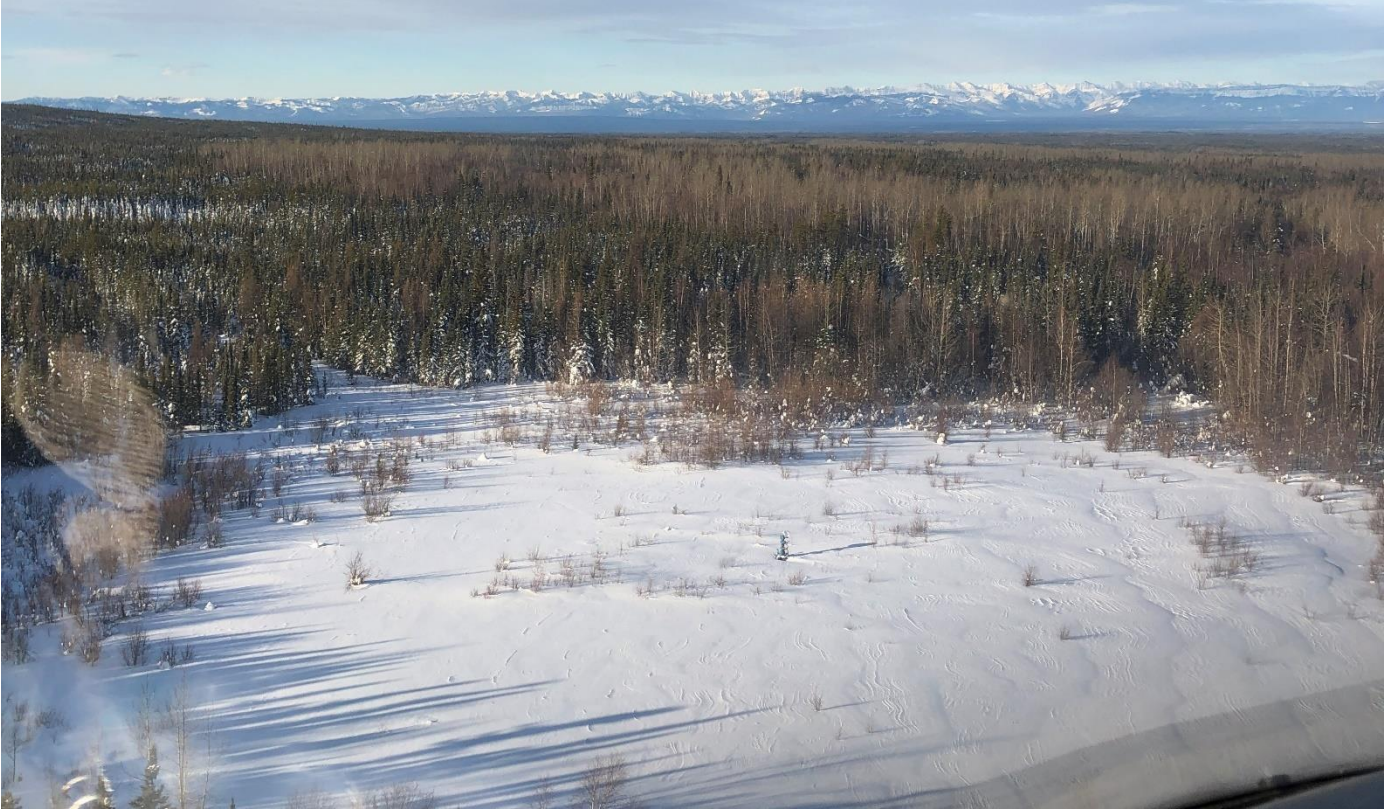
Photo #1: Aerial view of Netla C-07

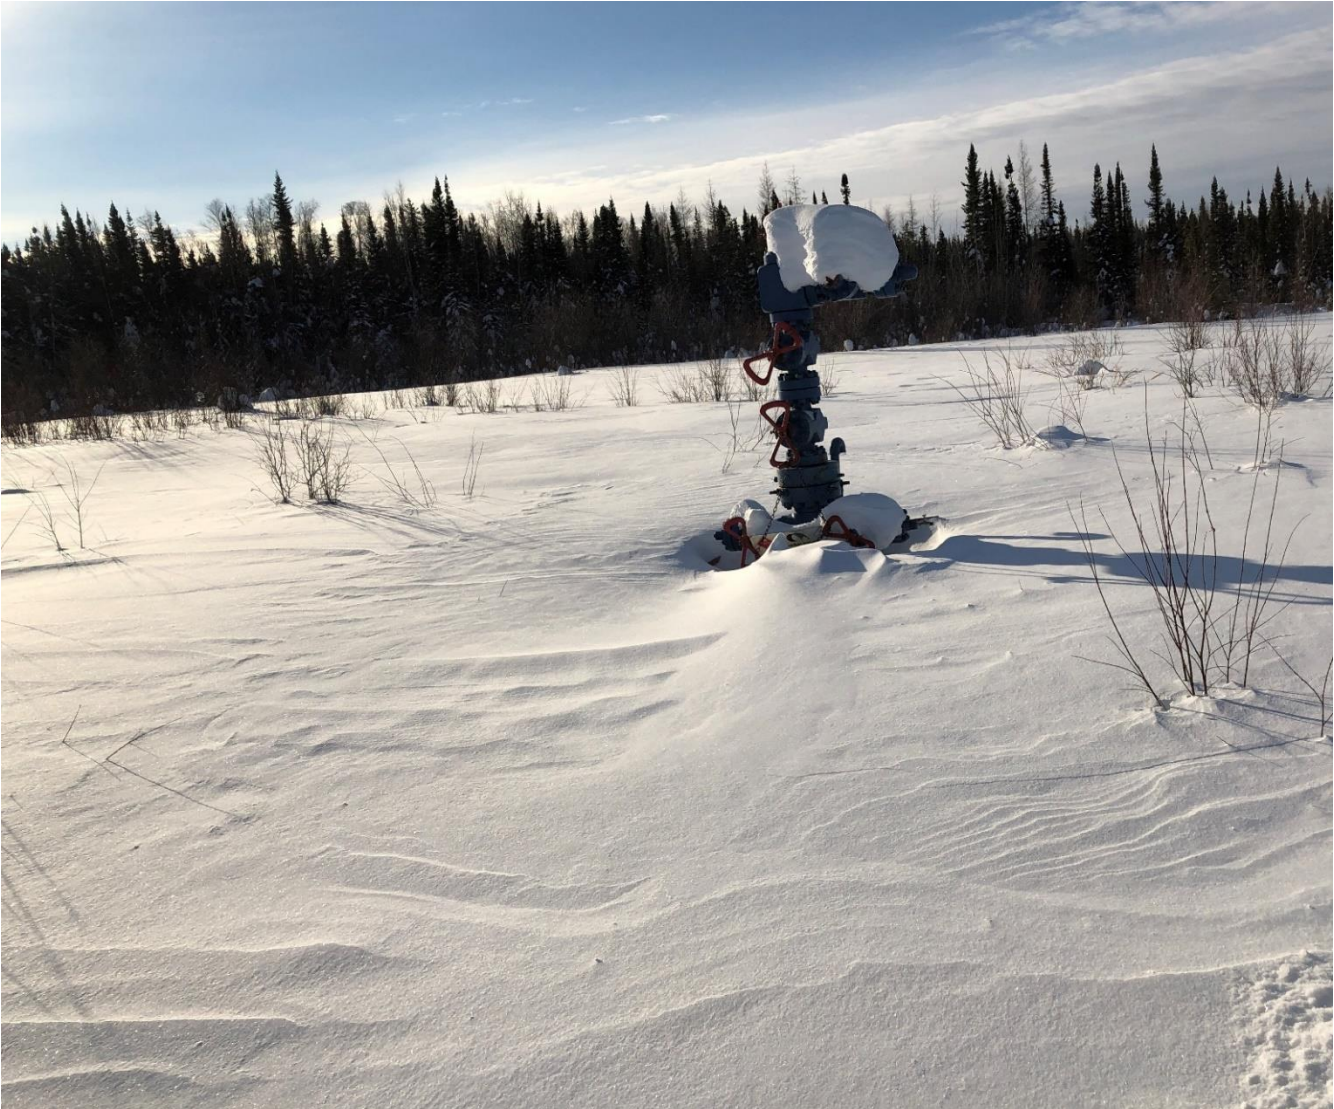
<b>Activity on site</b>	N/A		
<b>Conditions</b>	<b>Satisfactory (Y/N)</b>	<b>Comments</b>	
Site Access	N	No wind indicator installed on site. (See Photo #2)	
Well Head Access	Y		
Signage	N	Well identification sign not secured to well head (See Photo #3)	
General Housekeeping	Y	No debris noted on site above snow cover.	
SCV Open and dead	Y	SCV glove test indicated no negative or positive pressure. (See Photo #3)

At the time of the inspection there was brush encroachment onsite restricting site access and sight lines from some directions limiting safe access to the site. There was no wind indicator installed on the site.

Photo #2: Well head Netla C-07 – No wind indicator – Brush encroachment on wellhead

Section 5A of the *Well Suspension and Abandonment Guidelines and Interpretation Notes* states "All wellheads must be safely accessible for inspection and monitoring".

The well site must allow for year-round access to inspect and monitor including winter months when there may be significant snow depth on the ground. This includes the requirements to install a wind indicator.

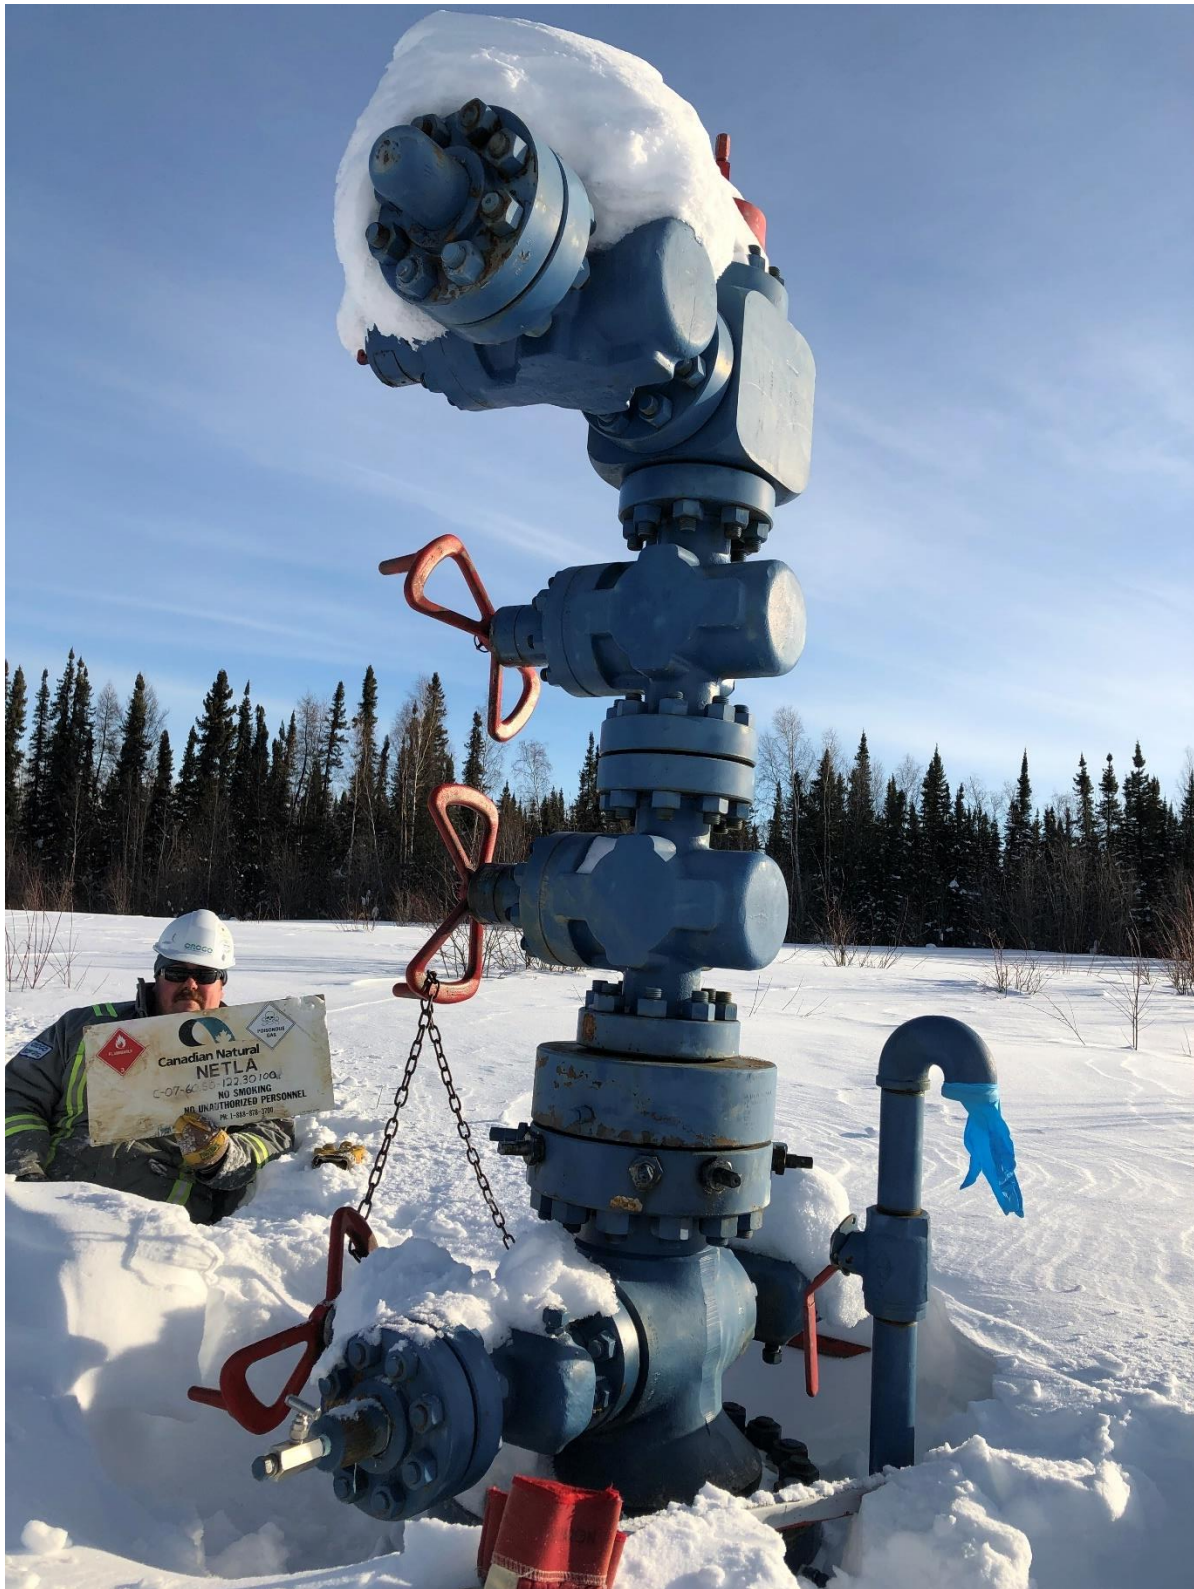
The placement of a nitrile glove over the Surface Casing Vent (SCV) indicated no positive or negative pressure.

Aside from the issues mentioned above, the installed well head valve handles were chained and locked with some handles removed to prevent tampering. The well head identification sign was not secured in place and therefore, not compliant with the *Well Suspension and Abandonment Guidelines and Interpretation Notes*.

Photo #3: Netla C-07 - Well head identification sign not secured - Surface casing vent glove test
