WELLSITE SUMMARY INSPECTION REPORT

Well/Facility Name:	Netla C-07	Operator:	Canadian Natural Resource Ltd.
Location of Inspection:	60 ° 46' 13"N 122° 46' 18" W	Access method:	Helicopter
Site Contractor:	N/A	Status:	Non-compliant suspended
Approval Info	ACW-2019-008-CNRL-C-07-WID0191 Variation # 2	WID:	0191
Date of Inspection	23-FEB-2022	H2S Site:	Yes

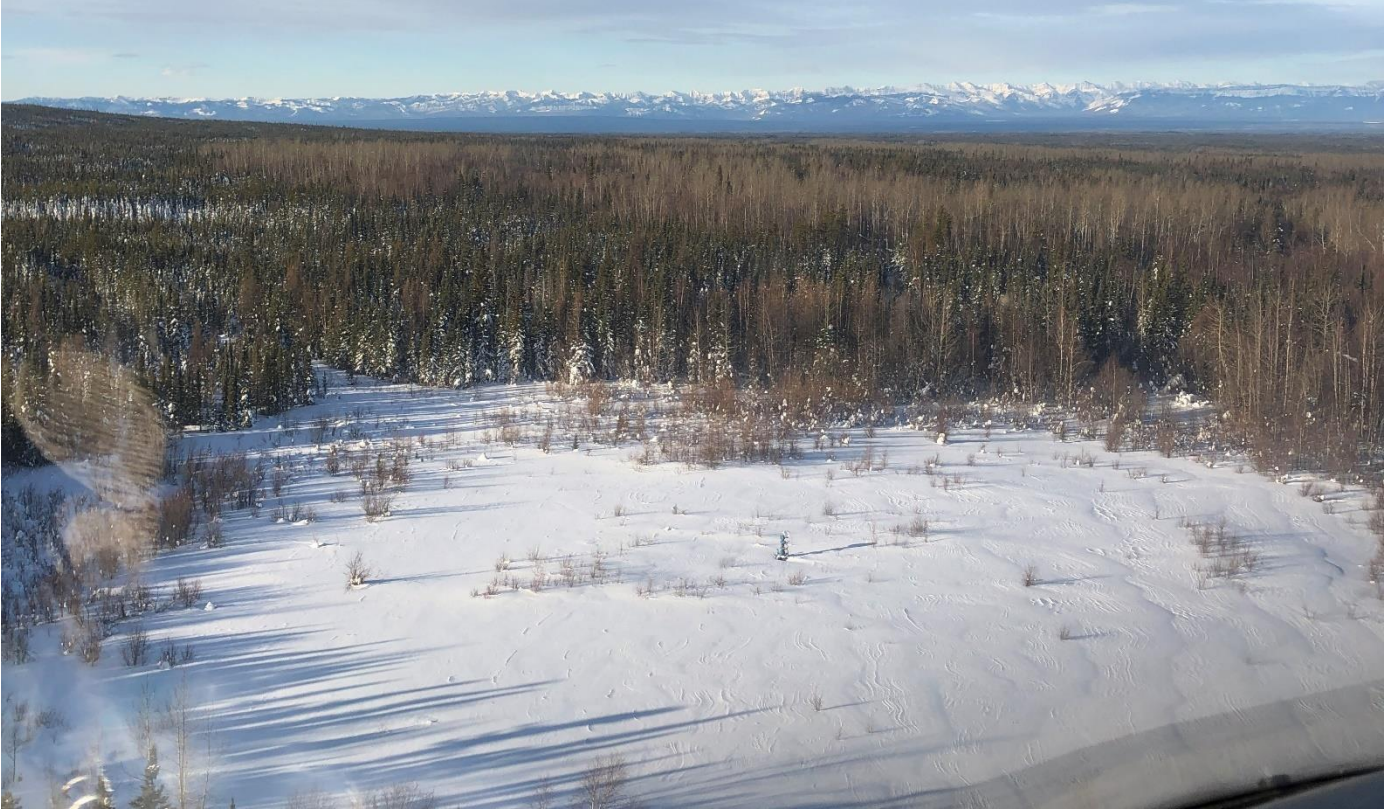
Photo #1: Aerial view of Netla C-07

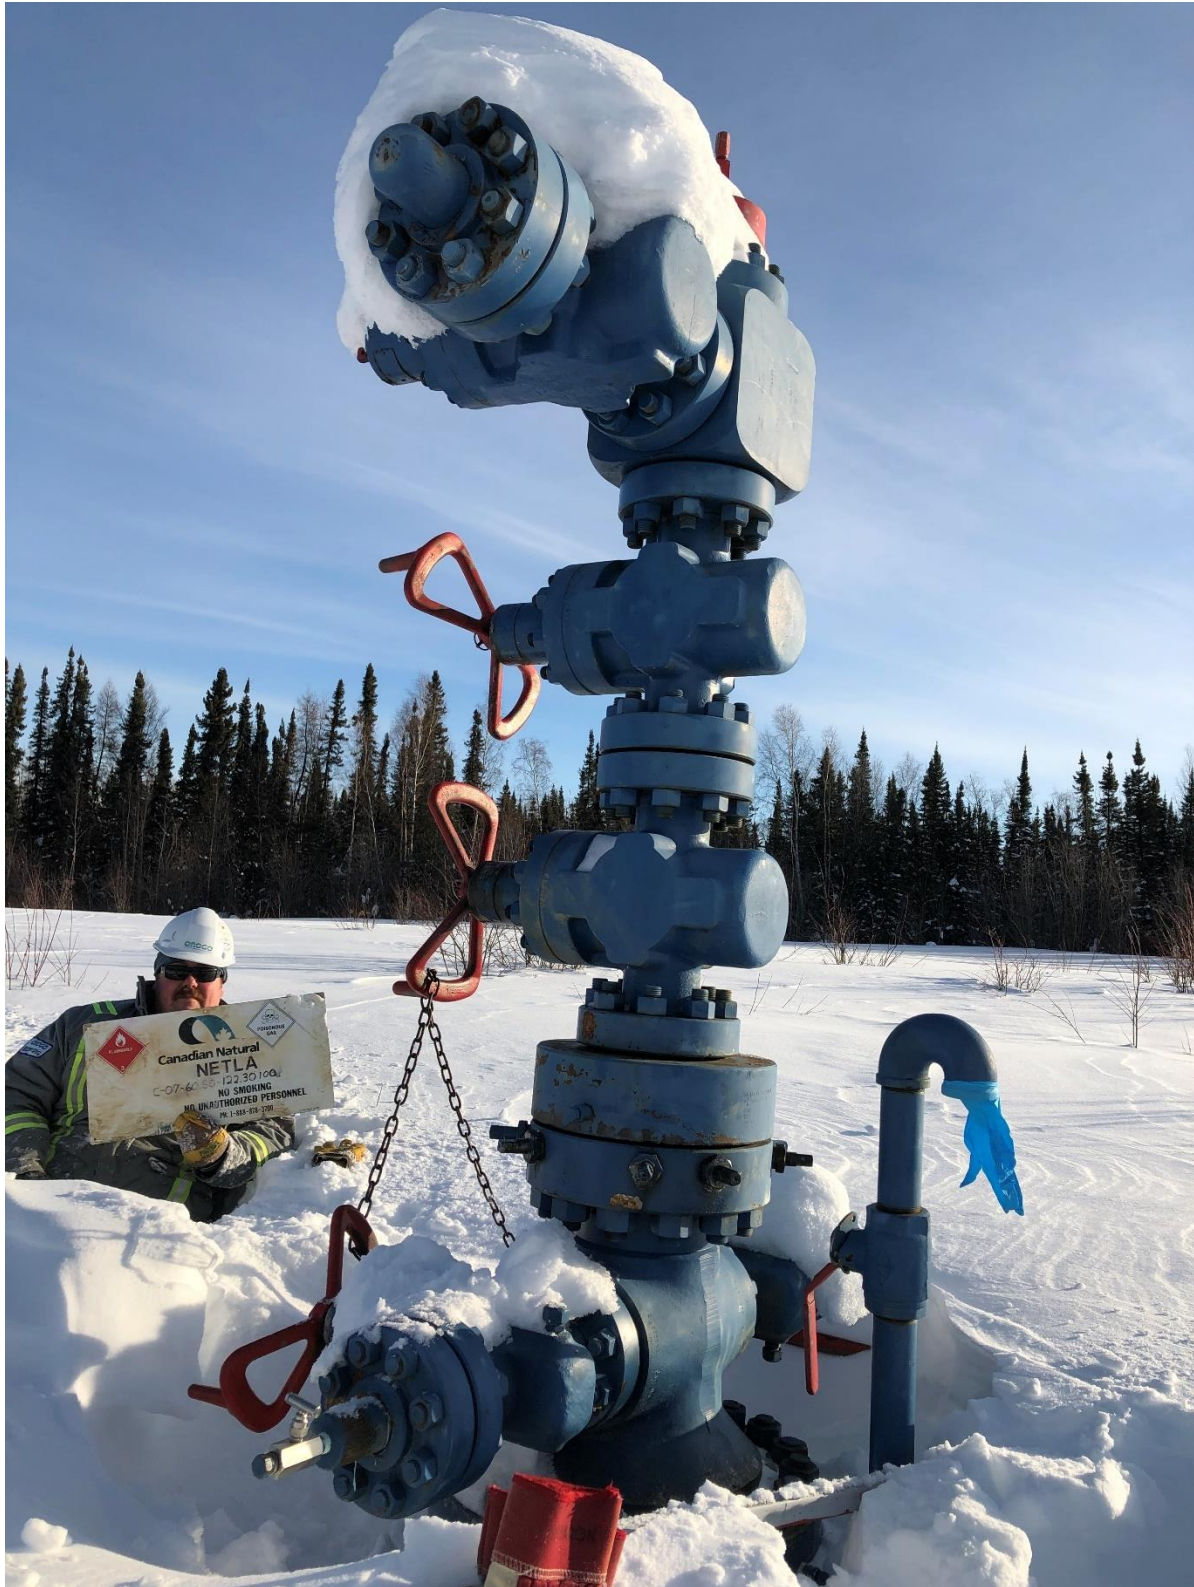
The placement of a nitrile glove over the Surface Casing Vent (SCV) indicated no positive or negative pressure.

Aside from the issues mentioned above, the installed well head valve handles were chained and locked with some handles removed to prevent tampering. The well head identification sign was not secured in place and therefore, not compliant with the *Well Suspension and Abandonment Guidelines and Interpretation Notes*.

Photo #3: Netla C-07 - Well head identification sign not secured - Surface casing vent glove test
