## WELLSITE SUMMARY INSPECTION REPORT

Well/Facility Name:	Emile Lake A-77	Operator:	Canadian Natural Resource Ltd.
Location of Inspection:	60° 49' 9" N 122° 43' 36" W	Access method:	Helicopter
Site Contractor:	N/A	Status:	Non-compliant suspended
Approval Info	ACW-2019-010-CNRL-A-77-WID1964 Variation # 2	WID:	1964
Date of Inspection	23-FEB-2022	H2S Site:	Yes

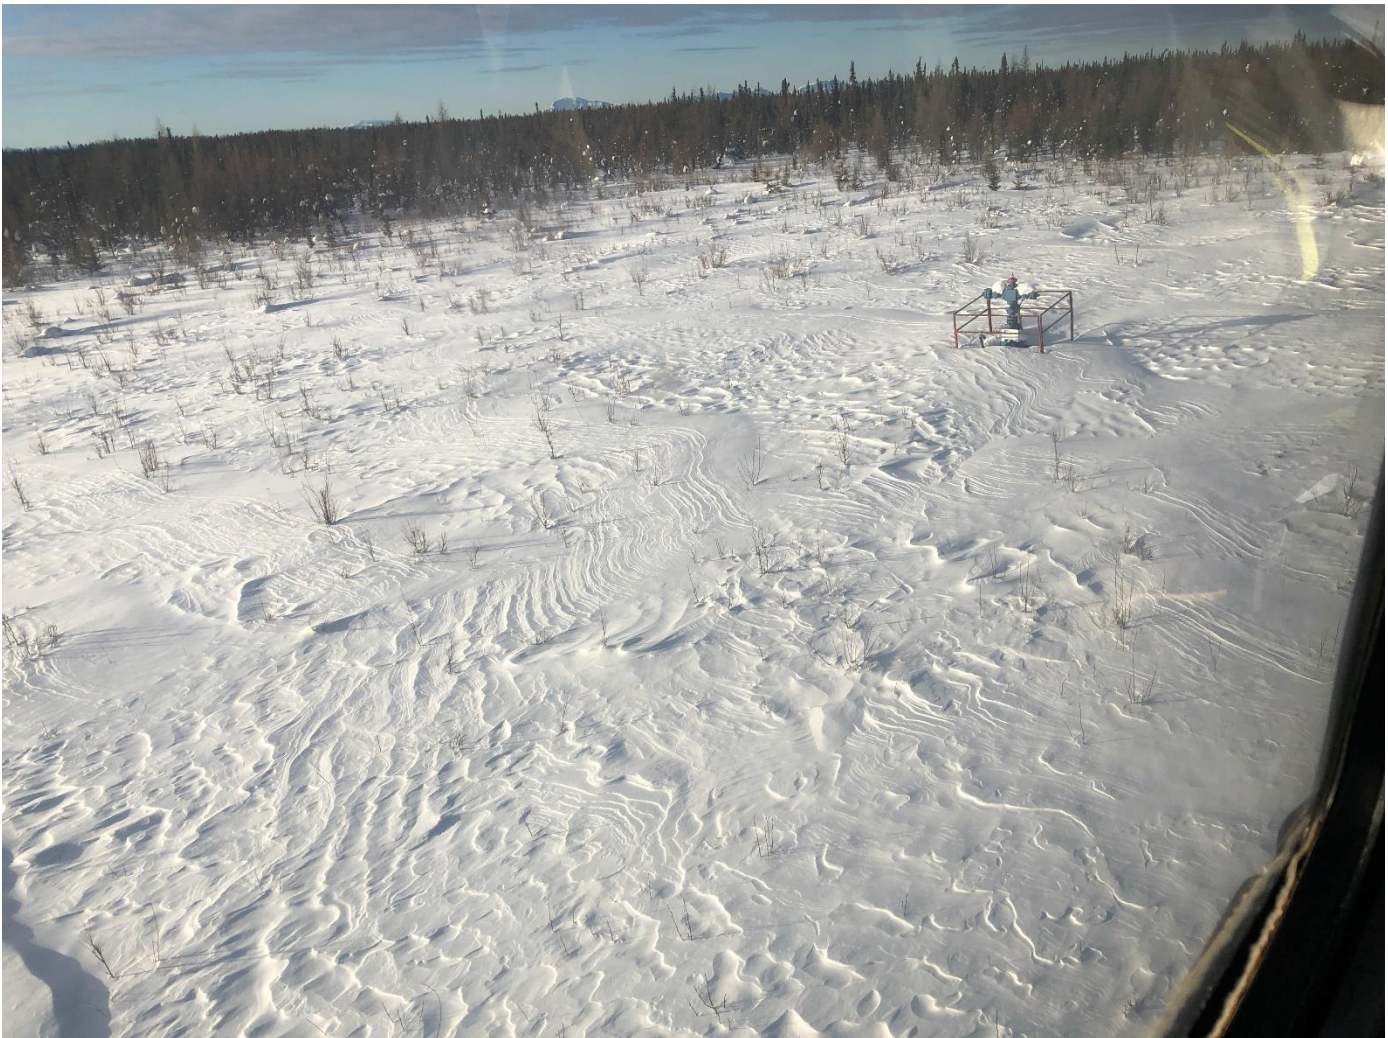
Photo #1: Aerial view of Emile Lake A-77.

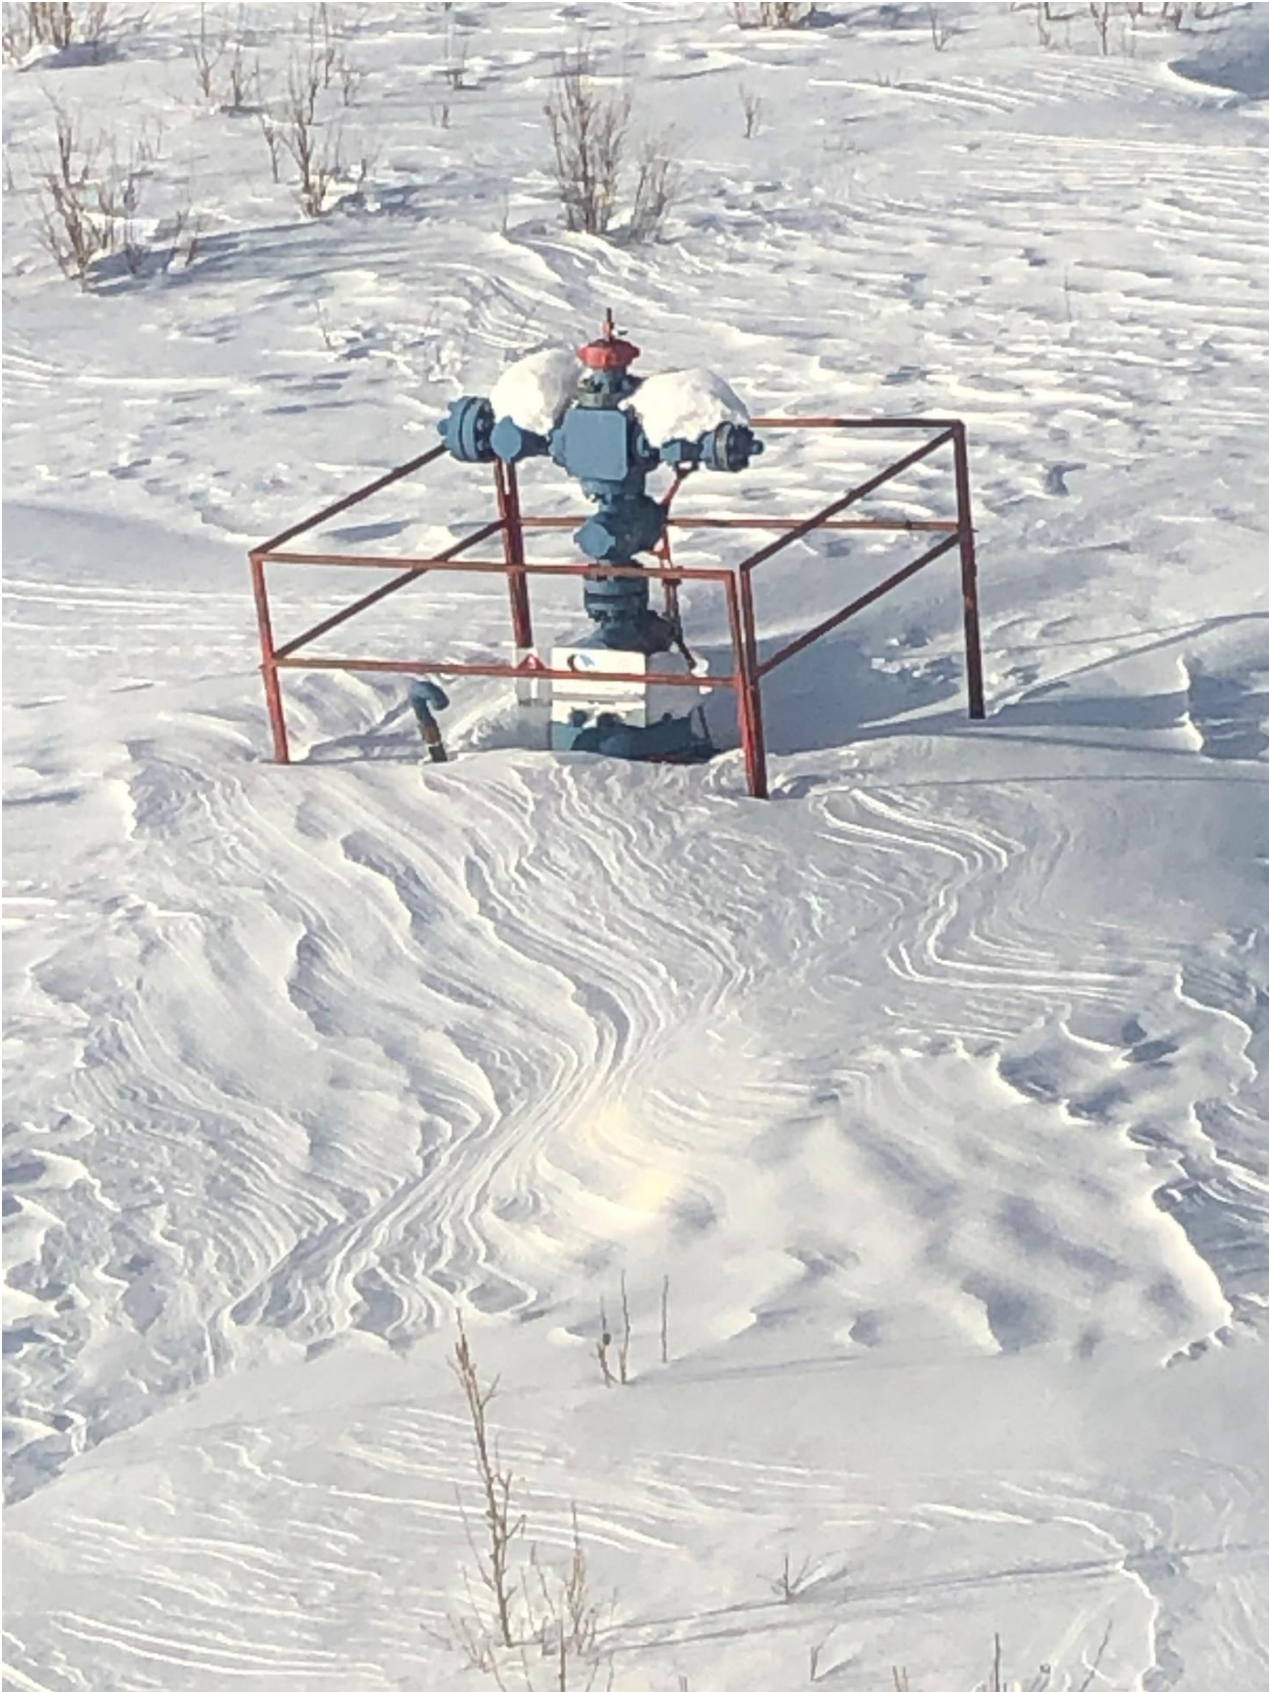
At the time of the inspection there was no wind indicator installed on the site.

Photo #2: Well head Emile Lake A-77 – No Wind Indicator

Section 5A of the *Well Suspension and Abandonment Guidelines and Interpretation Notes* states "All wellheads must be safely accessible for inspection and monitoring".

The well site must allow for year-round access to inspect and monitor including winter months when there may be significant snow depth on the ground. This includes the requirements to:

- Ensure safe ingress, egress and access to the well head and valves for inspection and monitoring; and
- Install a wind indicator.

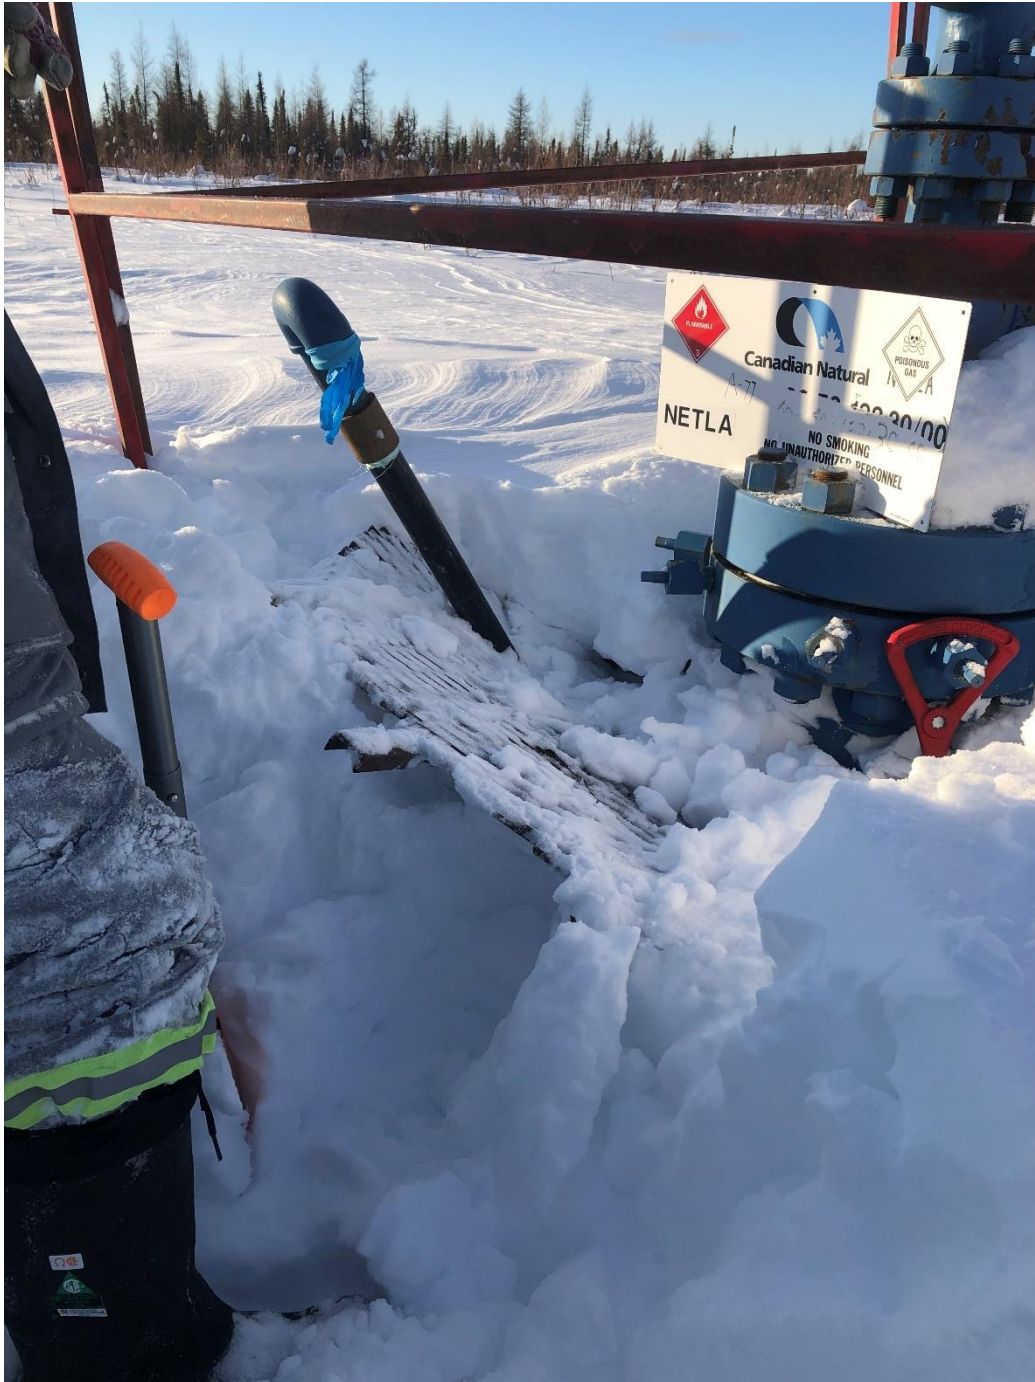
CNRL previously reported the presence of a non-serious surface casing vent flow. The placement of a nitrile glove over the Surface Casing Vent (SCV) indicated a slight vacuum at the time of inspection. The SCV valve was not accessible due to snow and/or cellar grating. The SCV valve must be accessible at all times of year to enable testing and verification that the valve is open.

Aside from the issues mentioned above, the installed well head valve handles were chained and locked with some handles removed to prevent tampering. The well head identification sign was secured in place and compliant with the *Well Suspension and Abandonment Guidelines and Interpretation Notes*.

Photo #3: Emile Lake A-77 - Well head identification sign – Surface Casing Valve not accessible
