## WELLSITE SUMMARY INSPECTION REPORT

| Well/Facility Name: | Emile Lake A-77 | Operator: | Canadian Natural Resource Ltd. |
| Date of Inspection | 23-FEB-2022 | H2S Site: | Yes |

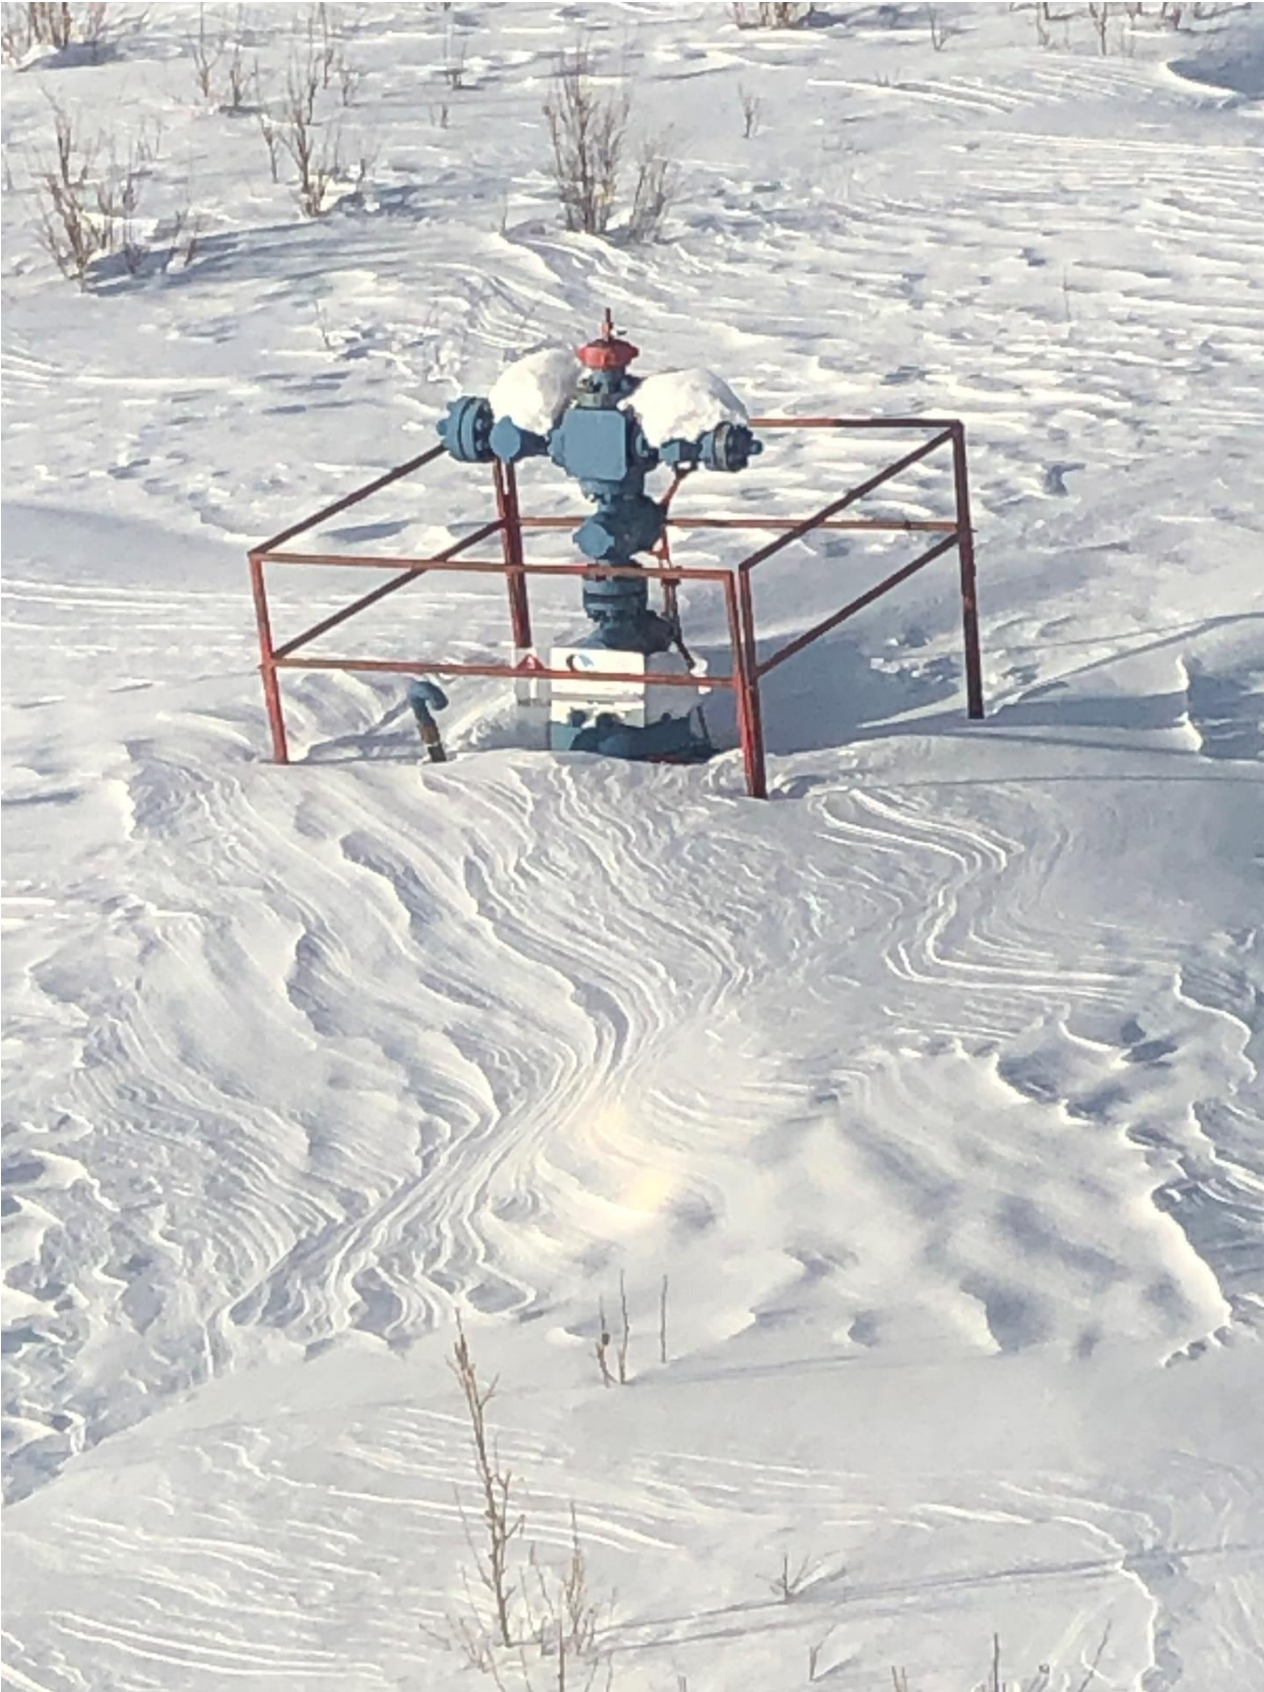
| Site Access | N | No wind indicator installed on site (See Photo #2). | |

At the time of the inspection there was no wind indicator installed on the site.

Photo #2: Well head Emile Lake A-77 – No Wind Indicator

The well site must allow for year-round access to inspect and monitor including winter months when there may be significant snow depth on the ground. This includes the requirements to:

- Ensure safe ingress, egress and access to the well head and valves for inspection and monitoring; and
- Install a wind indicator.
