WELLSITE SUMMARY INSPECTION REPORT

Well/Facility Name:	Liard P-16	Operator:	Canadian Natural Resource Ltd.
Location of Inspection:	60° 52' 44" N 123° 31' 37" W	Access method:	Helicopter
Site Contractor:	N/A	Status:	Non-compliant suspended
Approval Info	ACW-2019-011-CNRL-P-16-WID1976 Variation # 2	WID:	1976
Date of Inspection	23-FEB-2022	H2S Site:	Yes

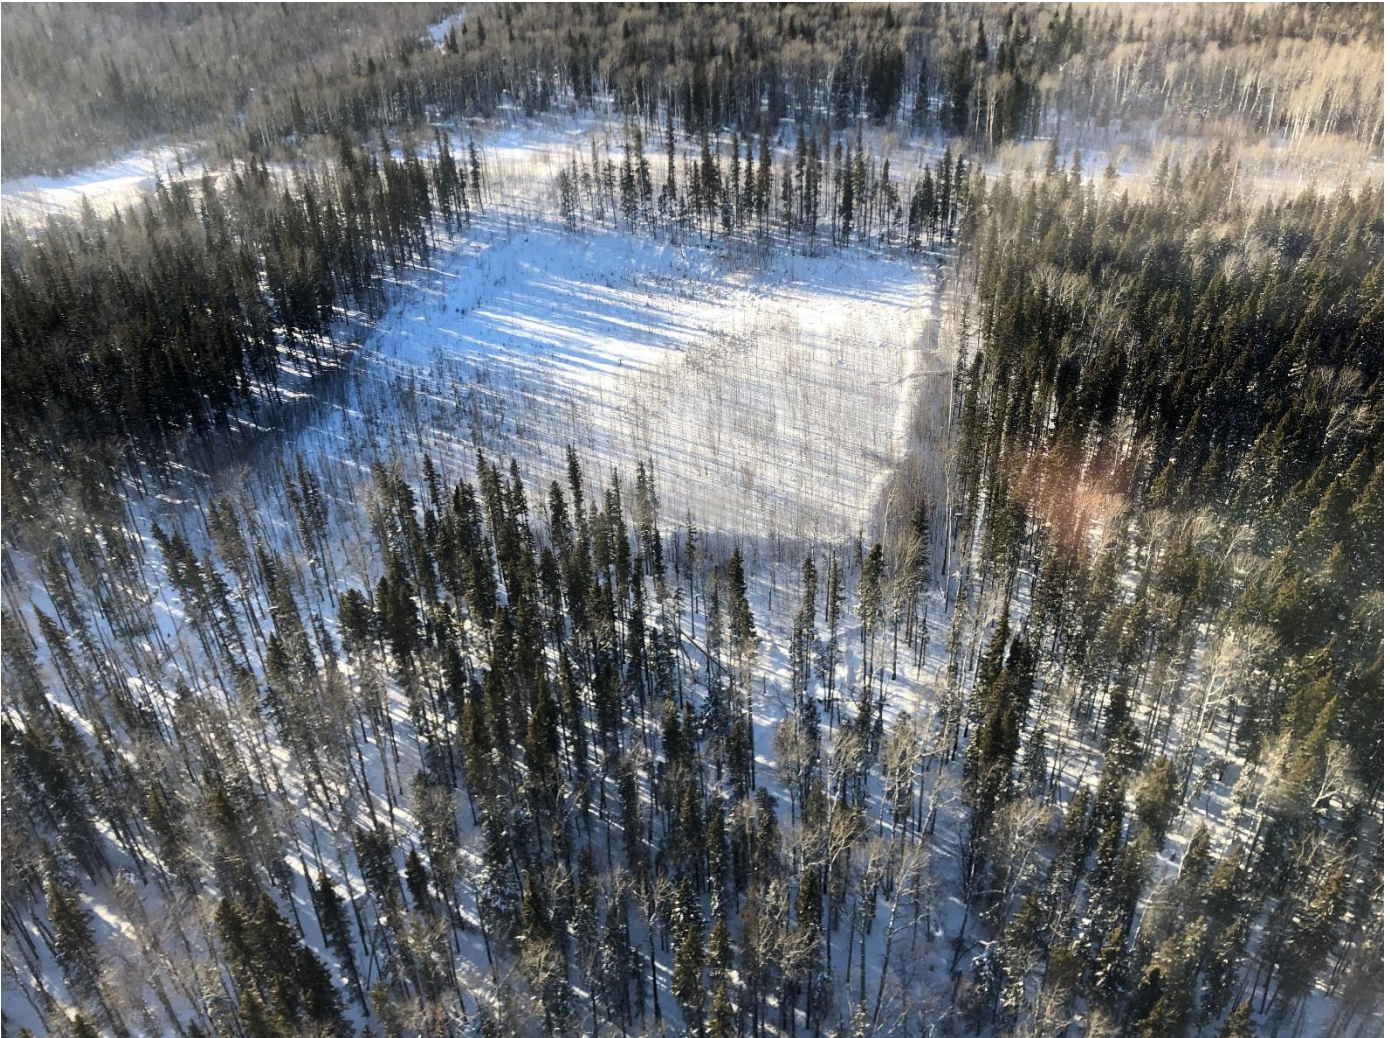
Activity on site	N/A		
Conditions	Satisfactory (Y/N)	Comments	
Site Access	N	Site access is restricted by encroachment of brush (See Photo #1). No wind indicator installed on site (See Photo #2).	
Well Head Access	Y	Vegetation is beginning to encroach on the well head and will likely need clearing within the next 18 months (See Photo #2).	
Signage	N/A	Unable to confirm compliant signage in place	
General Housekeeping	Y	No debris noted on site above snow cover.	
SCV Open and dead	N/A

At the time of the inspection there was brush encroachment onsite restricting site access and sight lines from some directions limiting safe access to the site. There was no wind indicator installed on the site.

Photo #1: Aerial view of Liard P-16.

The well site must allow for year-round access to inspect and monitor including winter months when there may be significant snow depth on the ground. This includes the requirements to:

- Maintain the wellsite to allow rotary wing aircraft to land at a safe distance upwind of the well head;
- Ensure safe ingress, egress and access to the well head and valves for inspection and monitoring; and
- Install a wind indicator.

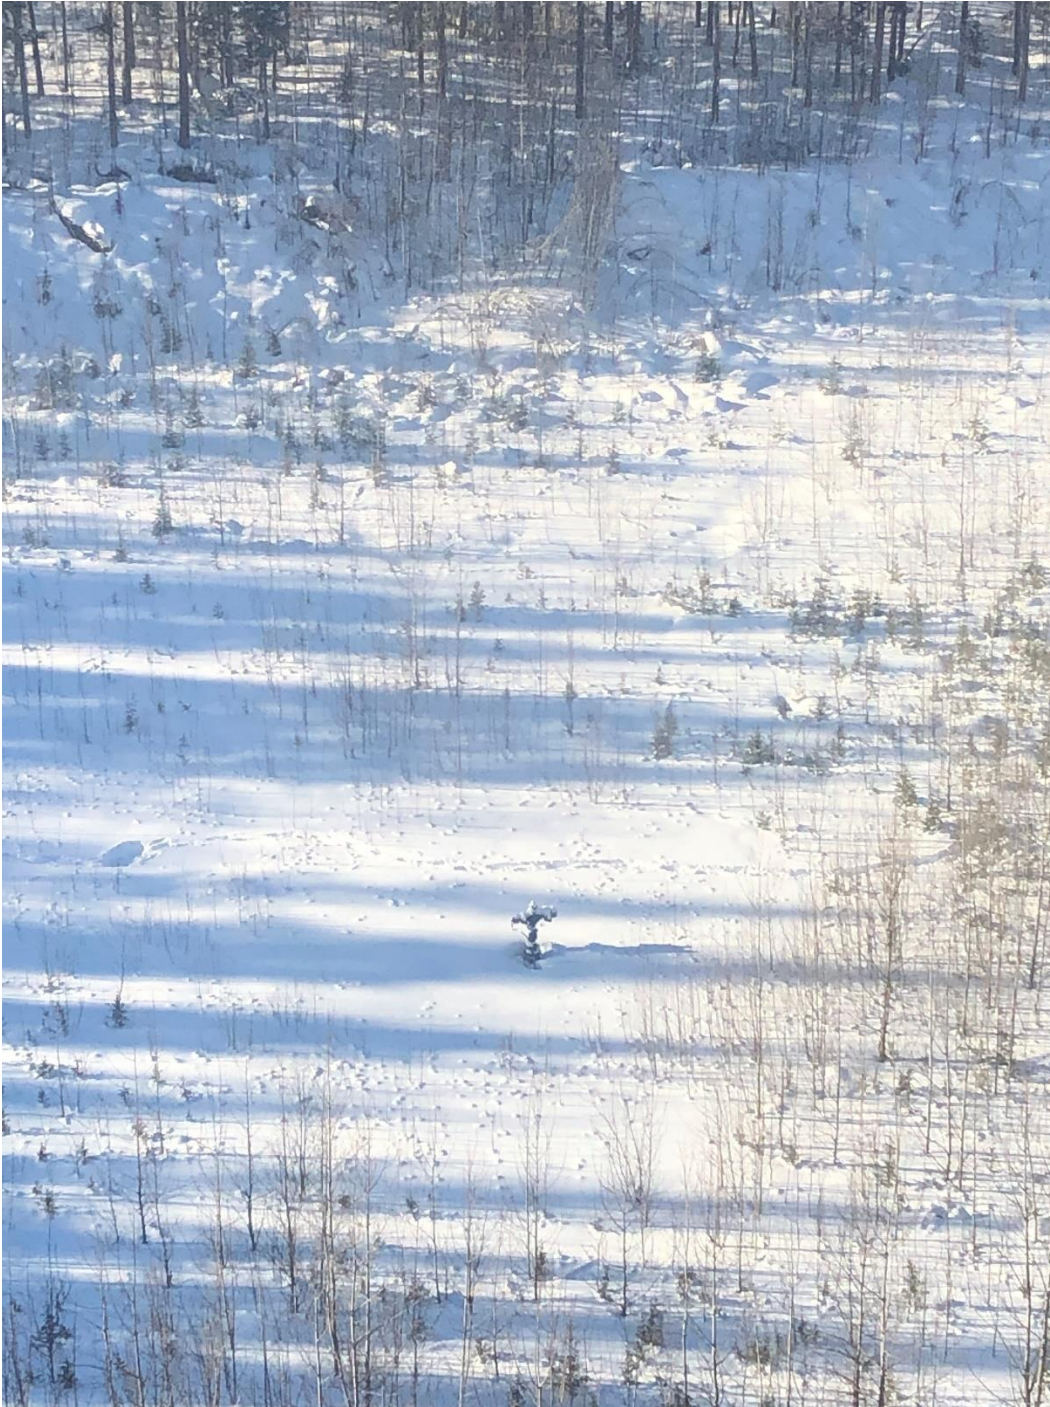
Photo #2: Aerial view of Liard P-16 Well Head – Vegetation Encroachment
