WELLSITE SUMMARY INSPECTION REPORT

Well/Facility Name:	Arrowhead River I-75	Operator:	Canadian Natural Resource Ltd.
Location of Inspection:	60° 34' 38" N 122° 58' 8" W	Access method:	Helicopter
Site Contractor:	N/A	Status:	Non-compliant suspended
Approval Info	ACW-2019-012-CNRL-I-75-WID1981 Variation # 1	WID:	1981
Date of Inspection	23-FEB-2022	H2S Site:	Yes (*well classified as sour)

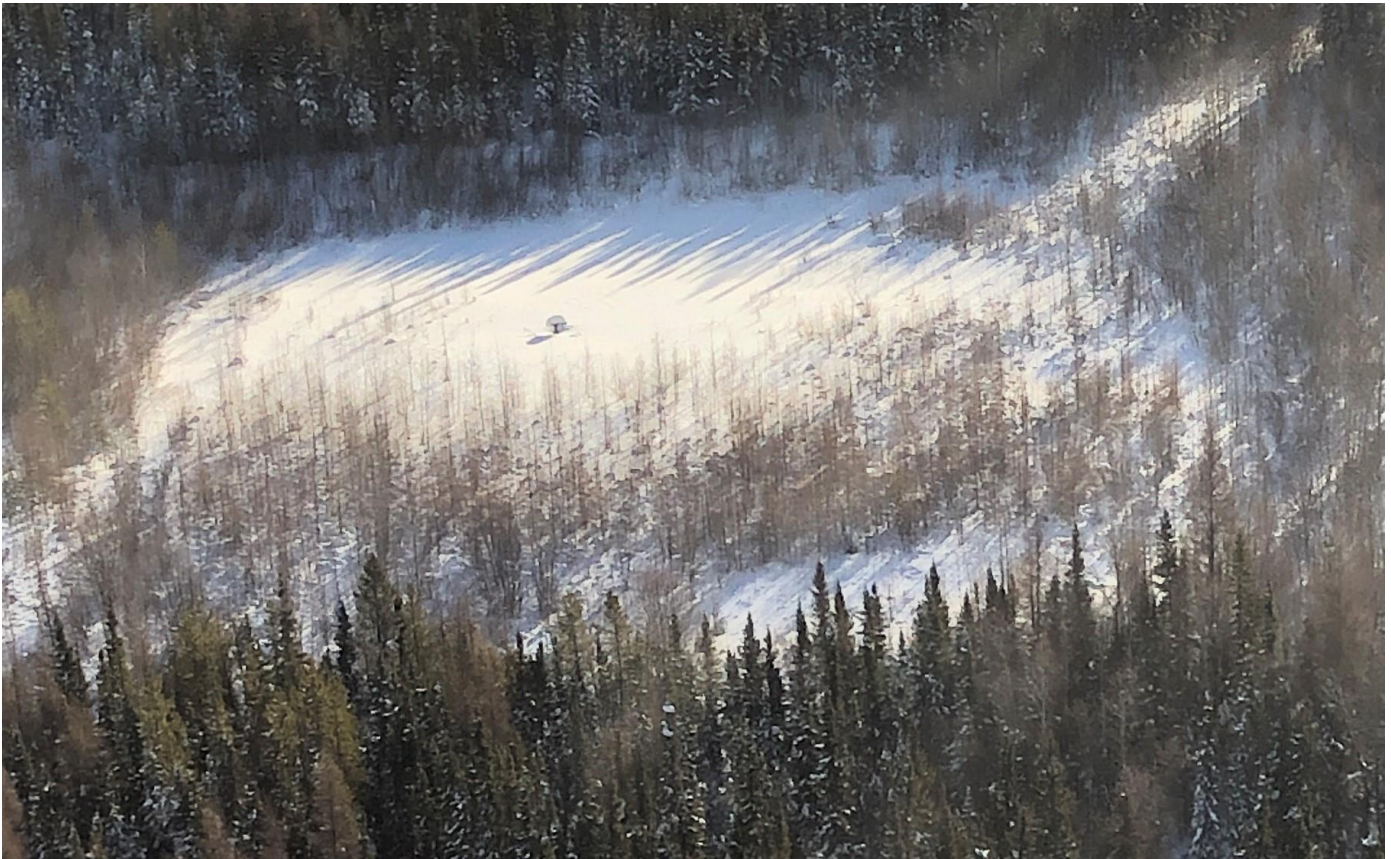
At the time of the inspection there was brush encroachment onsite restricting site access and sight lines from some directions limiting safe access to the site. There was no wind indicator installed on the site.

Photo #1: Aerial view of Arrowhead River I-75

- Maintain the wellsite to allow rotary wing aircraft to land at a safe distance upwind of the well head;
- Ensure safe ingress, egress and access to the well head and valves for inspection and monitoring; and
- Install a wind indicator.

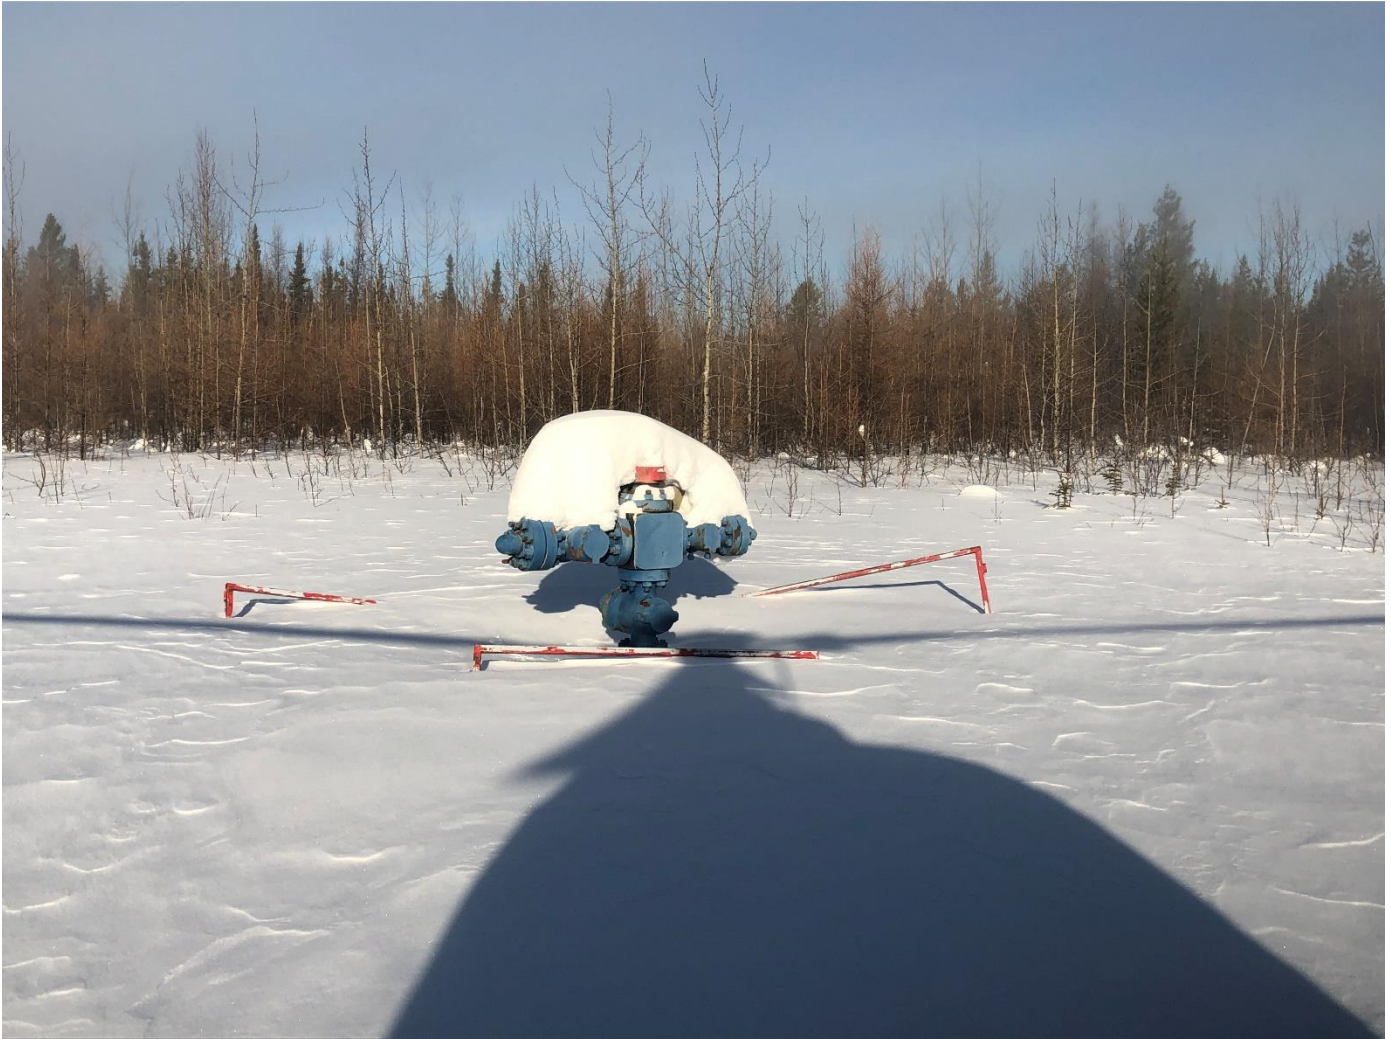
Photo #2: Arrowhead River I-75 - Well head – No wind indicator

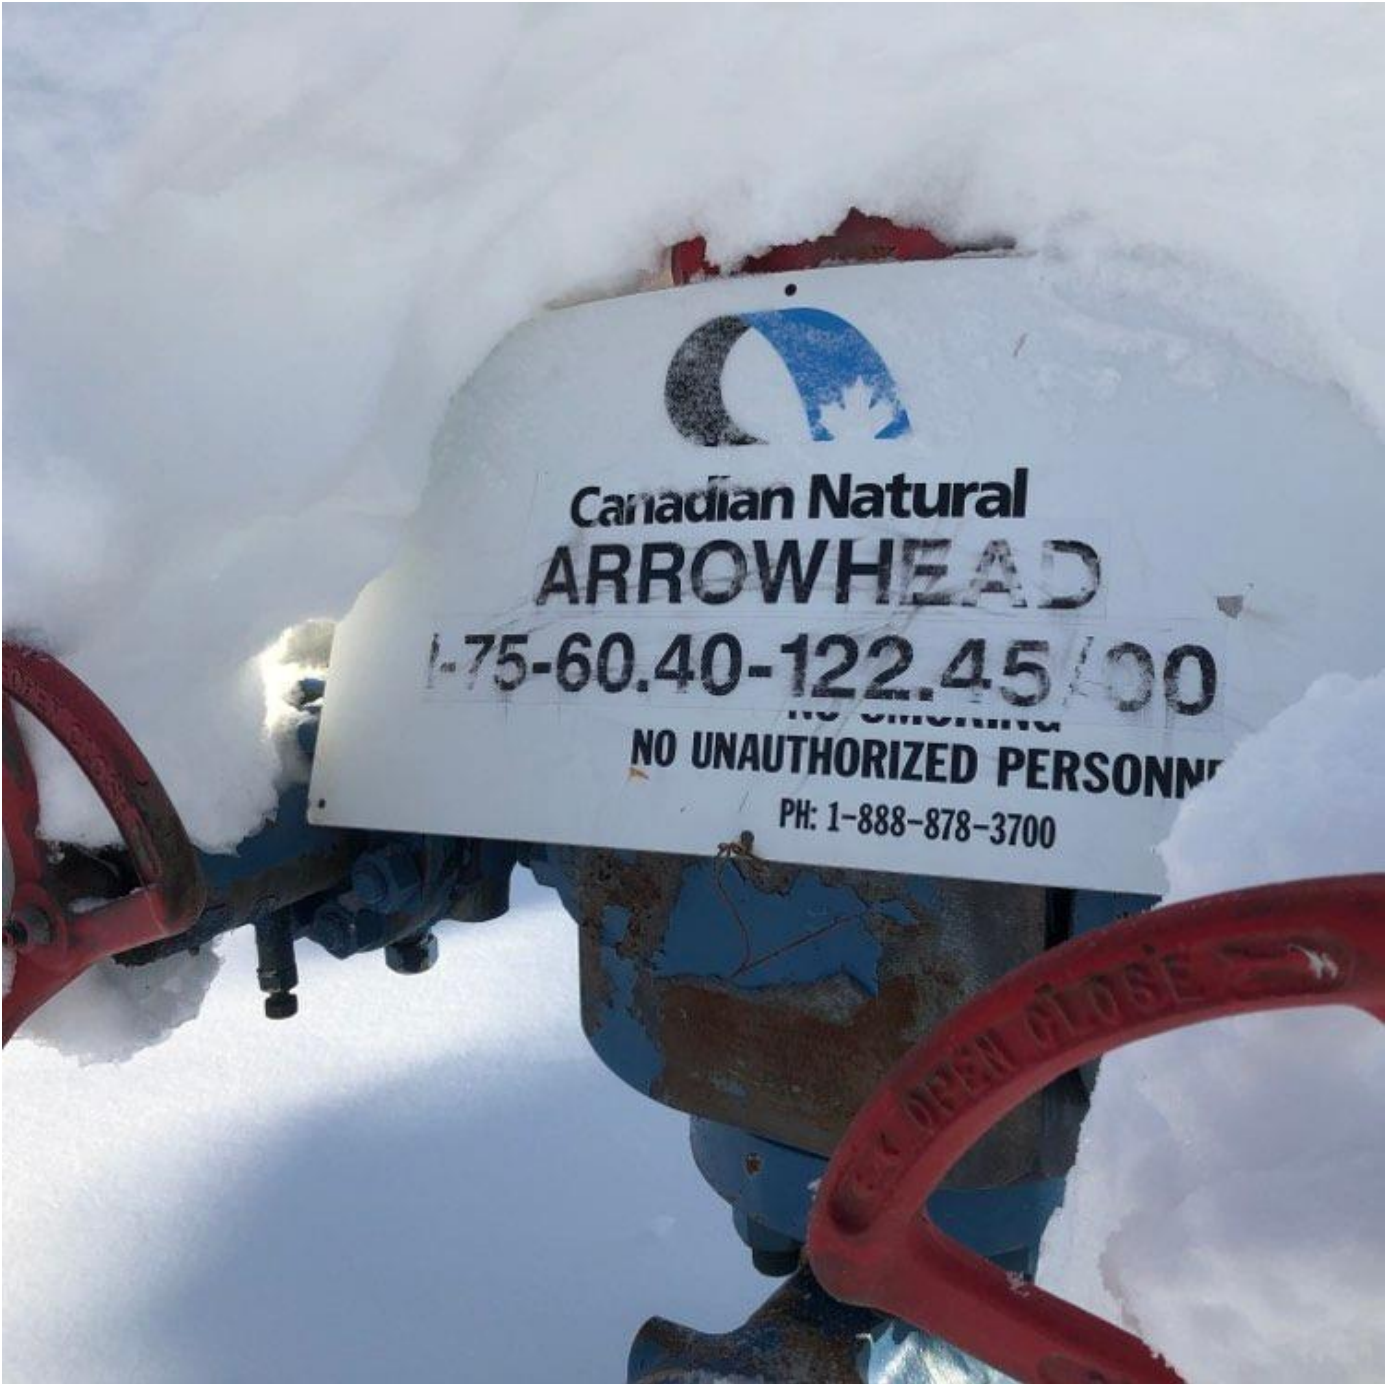
The Surface Casing Vent (SCV) and valve were not able to be located due to the amount of snow on site. SCV and valve should be easily located at all times of year to enable testing and verification that the valve is open.

Photo #3: Arrowhead River I-75 - Well head identification sign
