WELLSITE SUMMARY INSPECTION REPORT

Well/Facility Name:	Arrowhead River J-74	Operator:	Canadian Natural Resource Ltd.
Location of Inspection:	60° 33' 36" N 122° 58' 54" W	Access method:	Helicopter
Site Contractor:	N/A	Status:	Non-compliant suspended
Approval Info	ACW-2019-014-CNRL-J-74-WID1987 Variation # 2	WID:	1987
Date of Inspection	23-FEB-2022	H2S Site:	No

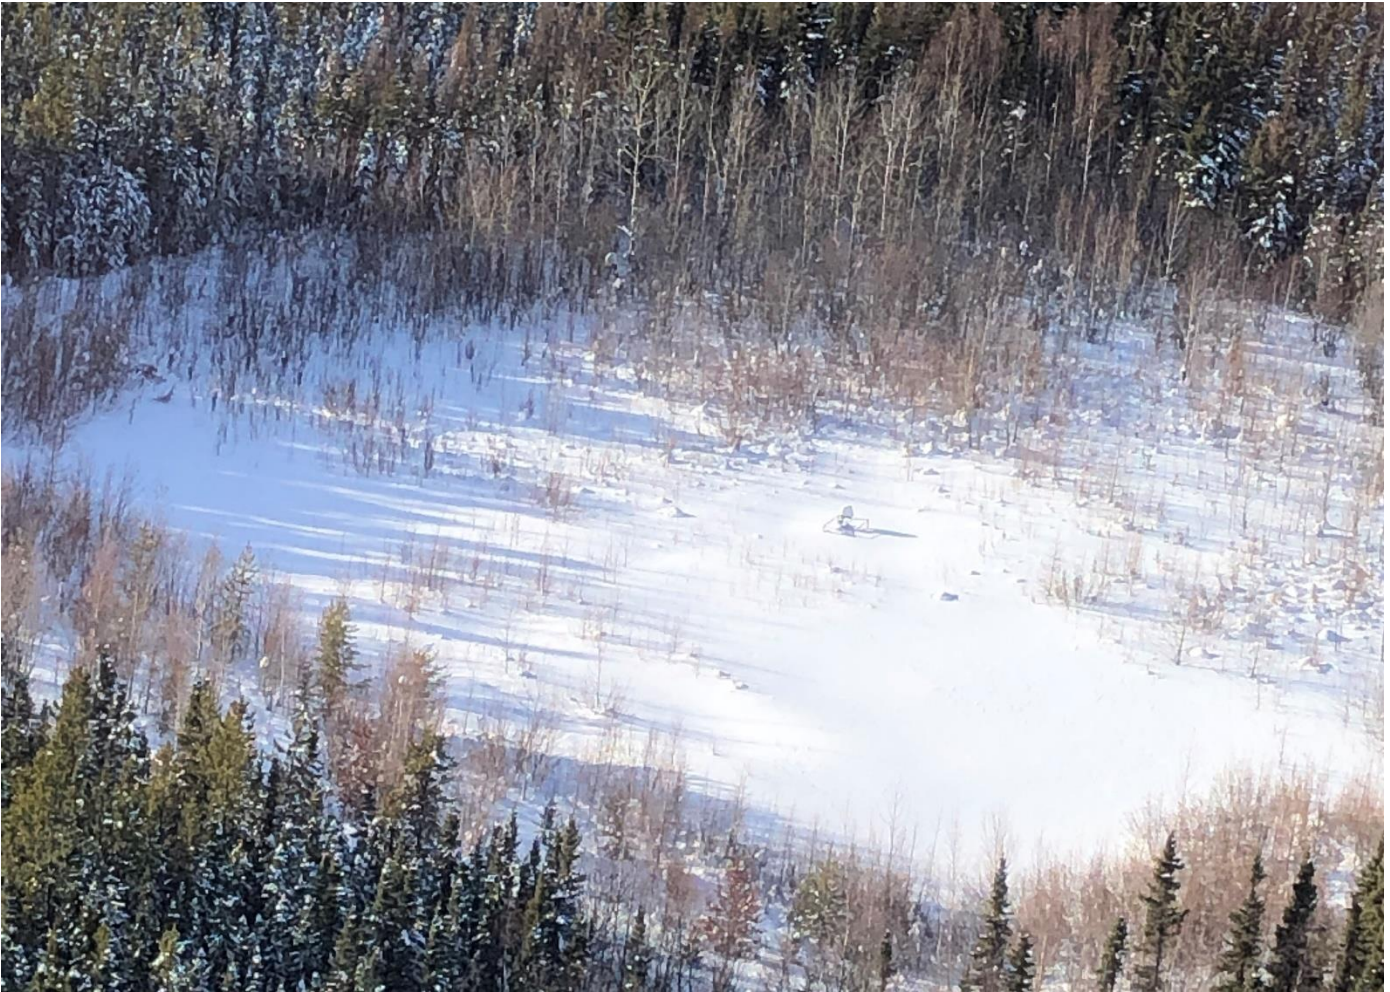
Activity on site	N/A		
Conditions	Satisfactory (Y/N)	Comments	
Site Access	N	Site access is restricted by encroachment of brush (See Photo #1). No wind indicator installed at the site (See Photo #1).	
Well Head Access	N/A		
Signage	N/A	Well identification sign installed. Unable to confirm compliant signage in place (See Photo #2).	
General Housekeeping	Y	No debris noted on site above snow cover.	
SCV Open and dead	N/A

At the time of the inspection there was brush encroachment onsite restricting site access and sight lines from some directions limiting safe access to the site. There was no wind indicator installed on the site.

Photo #1: Aerial view of Arrowhead River J-74 – Brush encroachment - No wind indicator.

The well site must allow for year-round access to inspect and monitor including winter months when there may be significant snow depth on the ground. This includes the requirements to:

- Maintain the wellsite to allow rotary wing aircraft to land at a safe distance upwind of the well head;
- Ensure safe ingress, egress and access to the well head and valves for inspection and monitoring; and
- Install a wind indicator.
