Inspection: Arrowhead River C-55 (WID 1979) Well – ACW-2020-003-CNRL-C-55-WID1979

OROGO Operations Inspection Summary Report

Well name: Arrowhead River C-55

Nature of activity: Abandonment

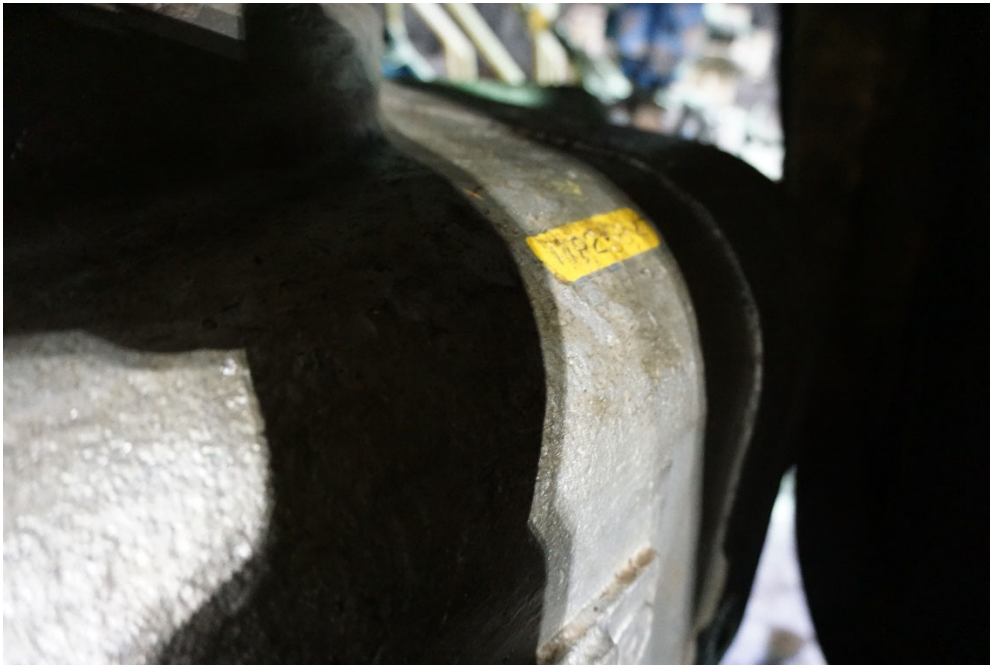
Equipment certifications	<input checked="" type="checkbox"/> Compliant <input type="checkbox"/> Non-Compliant <input type="checkbox"/> Corrected Non- Compliance	Comments: Serial Numbers of the BOP matched the certifications submitted to OROGO on December 15, 2022: - Annular: MP2590 - Double Gate: MP2584 (Photo #1)
Authorization / Approval available	<input checked="" type="checkbox"/> Compliant <input type="checkbox"/> Non-Compliant <input type="checkbox"/> Corrected Non- Compliance	Comments: Authorizations issued by OROGO located in the Consultants trailer and the Dog House.
Boiler inspection	<input checked="" type="checkbox"/> Compliant <input type="checkbox"/> Non-Compliant <input type="checkbox"/> Corrected Non-Compliance	Comments: Boiler certifications were readily available and matched the on-site equipment. (Photos #2 & #3)
Guards and covers on moving equipment	<input checked="" type="checkbox"/> Compliant <input type="checkbox"/> Non-Compliant <input type="checkbox"/> Corrected Non- Compliance	Comments: All guards and covers on moving equipment were in a condition satisfactory to the Inspectors

PHOTO #1: Double gate serial number.

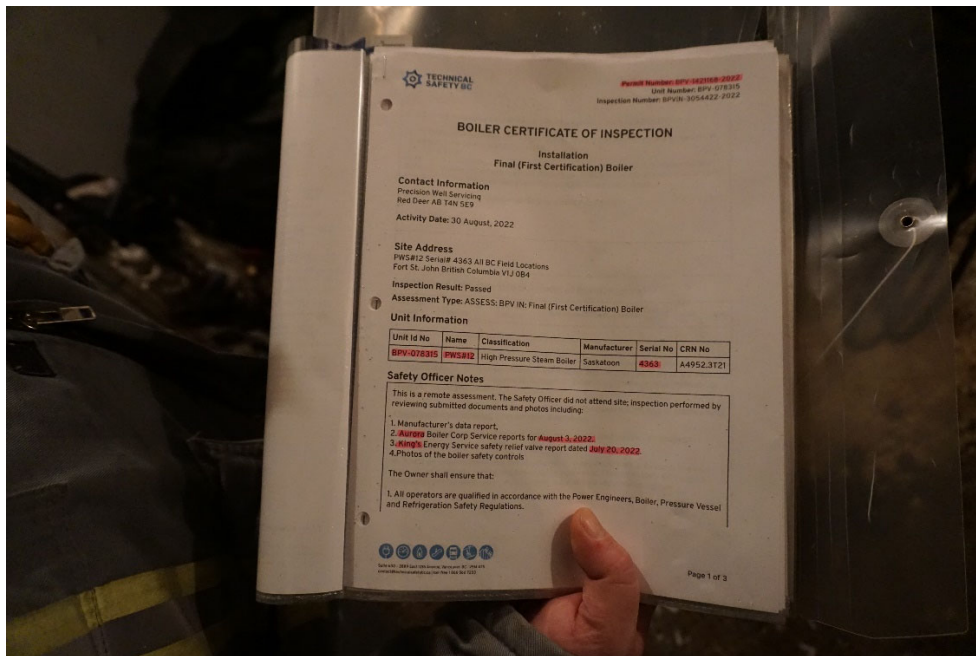
PHOTO #2: Boiler certifications matched the equipment that was on site.

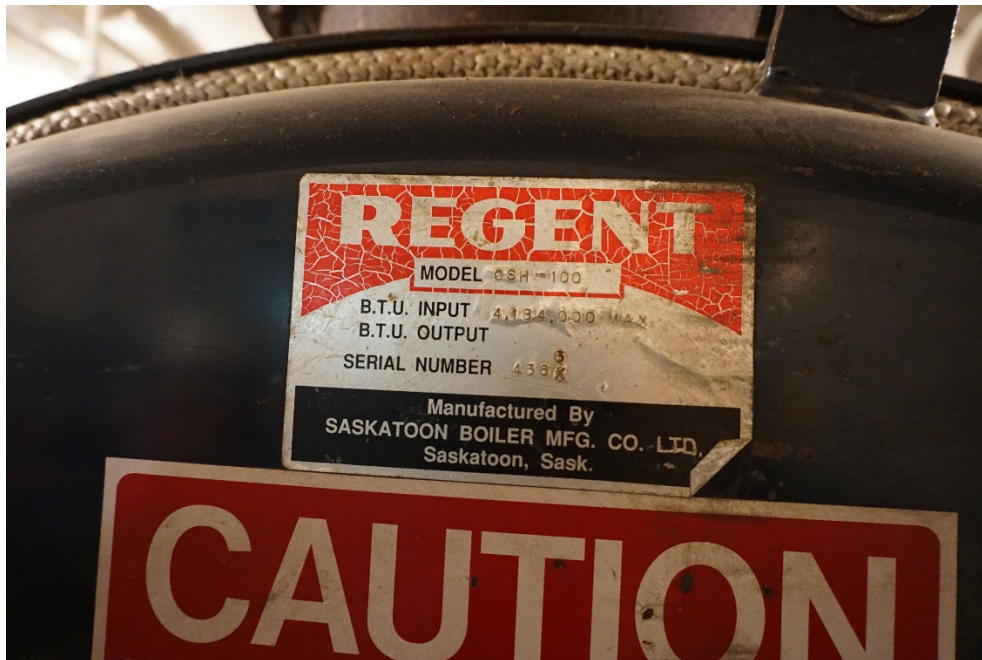
PHOTO #3: View of the Boiler with Serial number 4363.

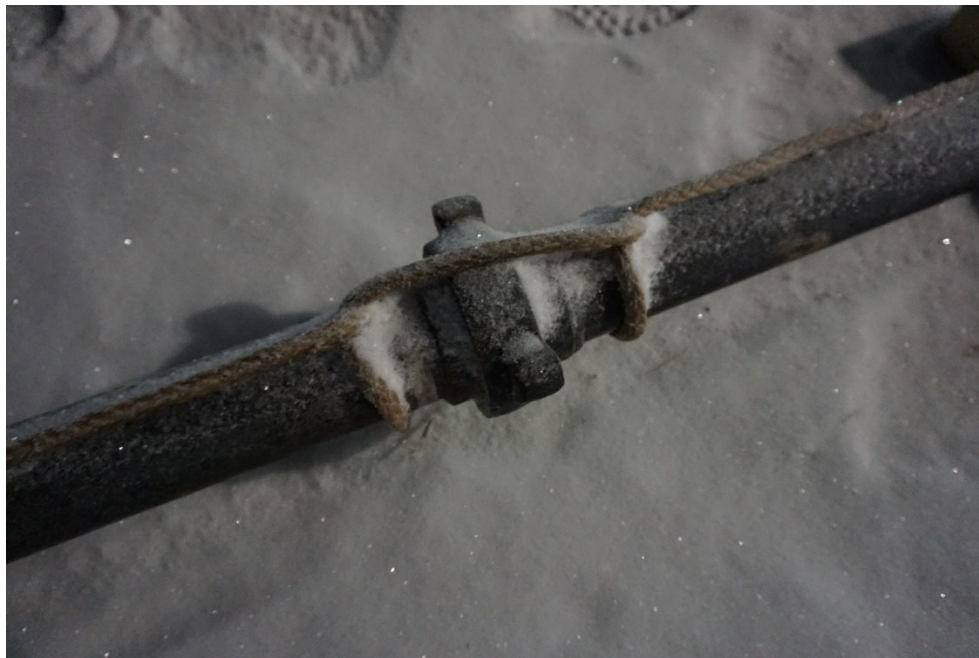
Pump lines and hoses secured, intact and appropriate?	<input checked="" type="checkbox"/> Compliant <input type="checkbox"/> Non-Compliant <input type="checkbox"/> Corrected Non- Compliance	Comments: All pump lines and hoses were secured and in a condition satisfactory to the Inspectors (Photo #4)
Adequate lighting	<input checked="" type="checkbox"/> Compliant <input type="checkbox"/> Non-Compliant <input type="checkbox"/> Corrected Non- Compliance	Comments: Click or tap here to enter text.
Wind indicators visible and functional	<input checked="" type="checkbox"/> Compliant <input type="checkbox"/> Non-Compliant <input type="checkbox"/> Corrected Non- Compliance	Comments: Wind indicators were present on site and in a location that was highly visible. (Photo #5)
Fire extinguishers	<input checked="" type="checkbox"/> Compliant <input type="checkbox"/> Non-Compliant <input type="checkbox"/> Corrected Non- Compliance	Comments: All fire extinguishers inspected have been recertified within the last 12 months.

PHOTO #4: Pressurized line from the P-tank to the Flare stack was secured with continuous anchor line on either side of the segment coupling.

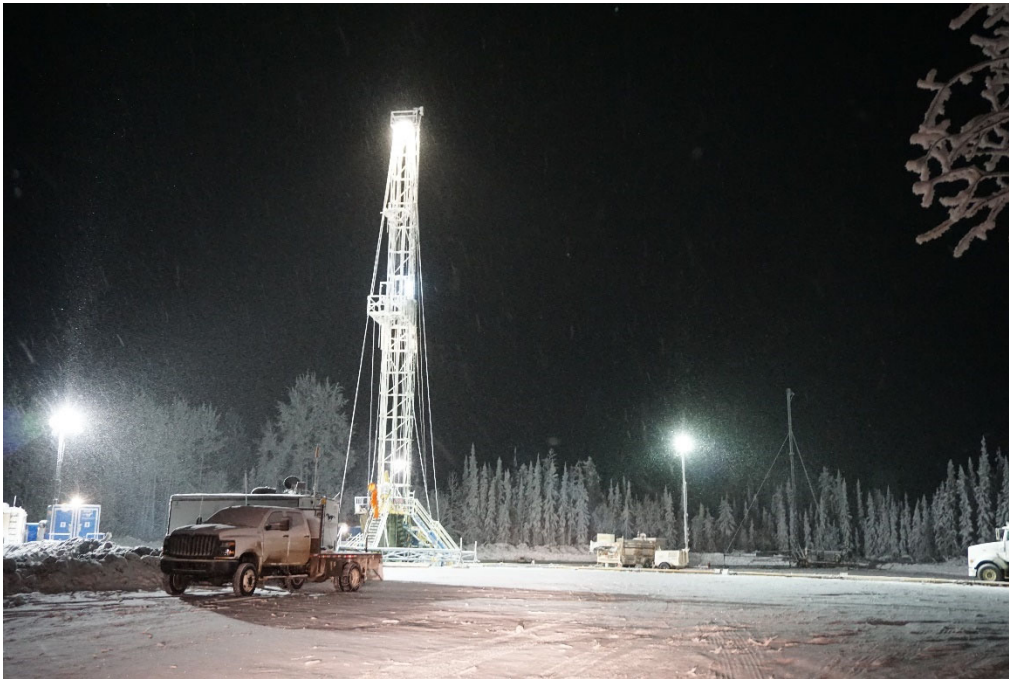
PHOTO #5: Wind indicators were visible on site and can be seen in the foreground before the service rig.

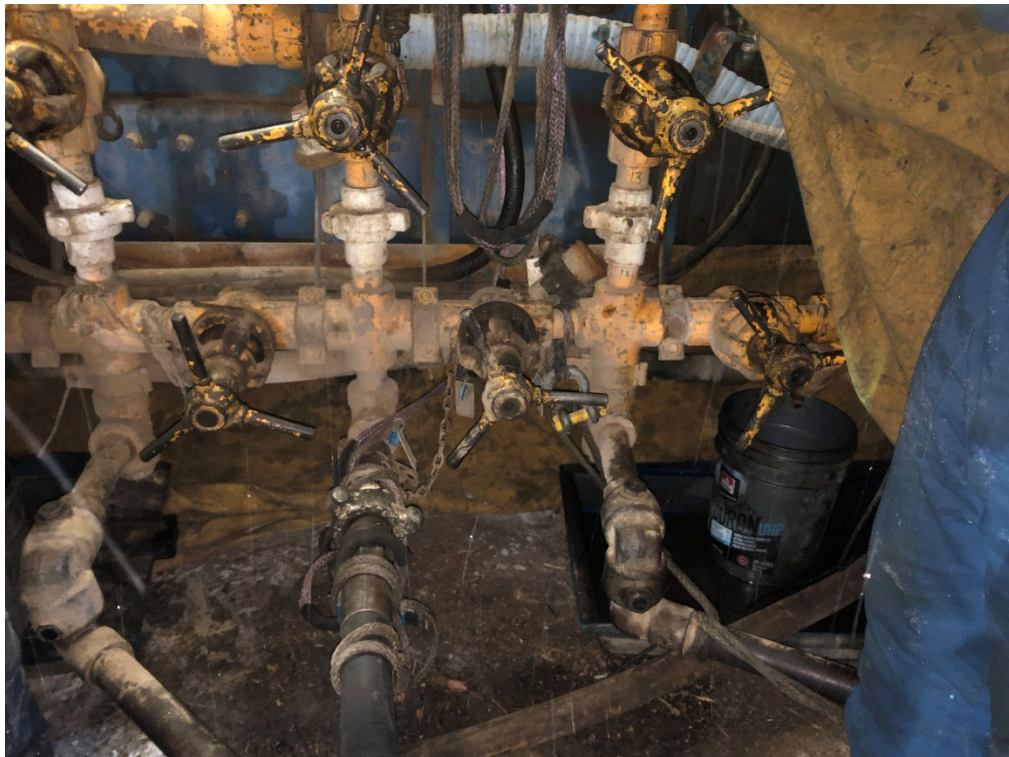
Flow turns	<input checked="" type="checkbox"/> Compliant <input type="checkbox"/> Non-Compliant <input type="checkbox"/> Corrected Non- Compliance	Comments: All flow turns inspected were compliant and installed correctly (Photo #6).

PHOTO #6: Flow turns on the rig pump were satisfactory to the Inspectors.

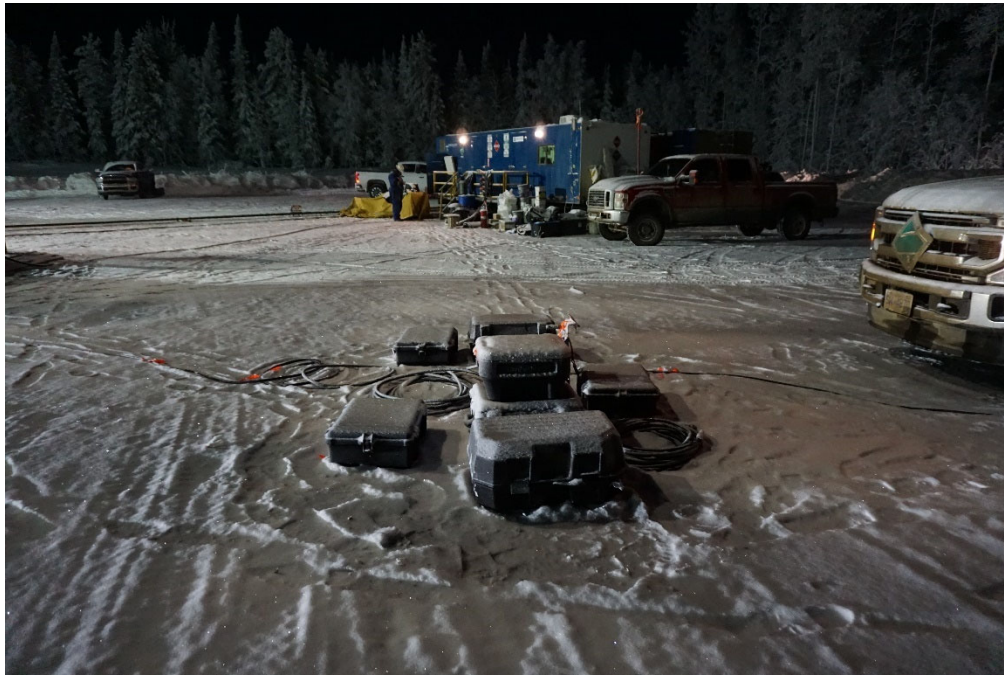
SCBAs and/or supplied air available and visible	<input checked="" type="checkbox"/> Compliant <input type="checkbox"/> Non-Compliant <input type="checkbox"/> Corrected Non- Compliance	Comments: 6 SCBA's (2-Lease Entrance, 2-Dog house and 2 with the Air Hand) were on site. Additionally, there was a 6-bottle supplied air trailer with 6 SABA masks. (Photos #7 & #8)
---	---	--

PHOTO #7: SCBA and SABA located on front of the air hands truck.

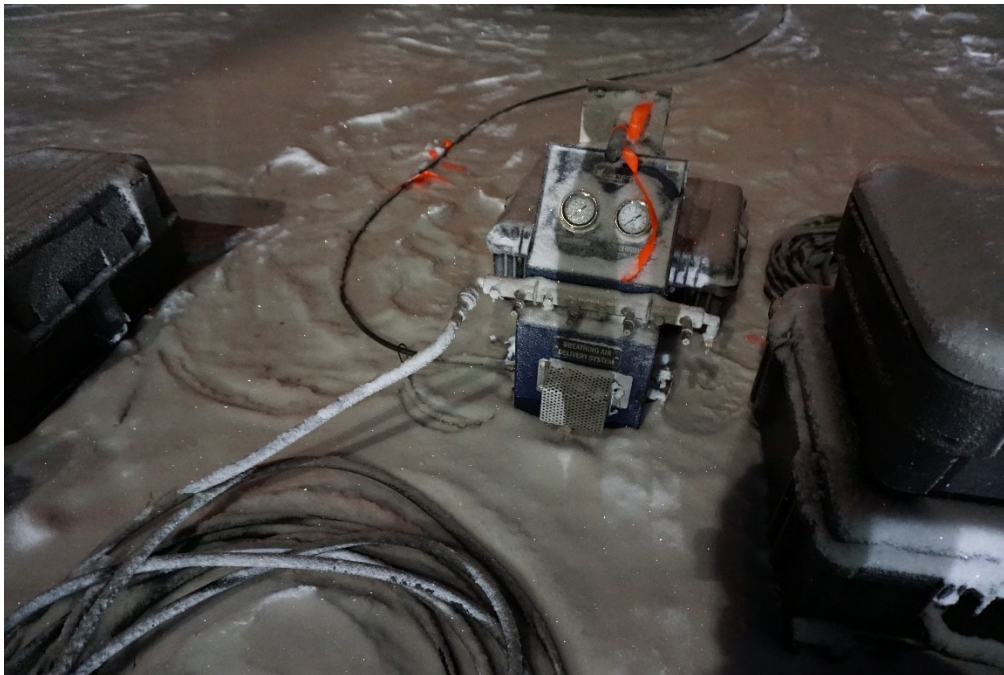
PHOTO #8: Another view of the supplied air manifold which can assist up to 4 personnel.

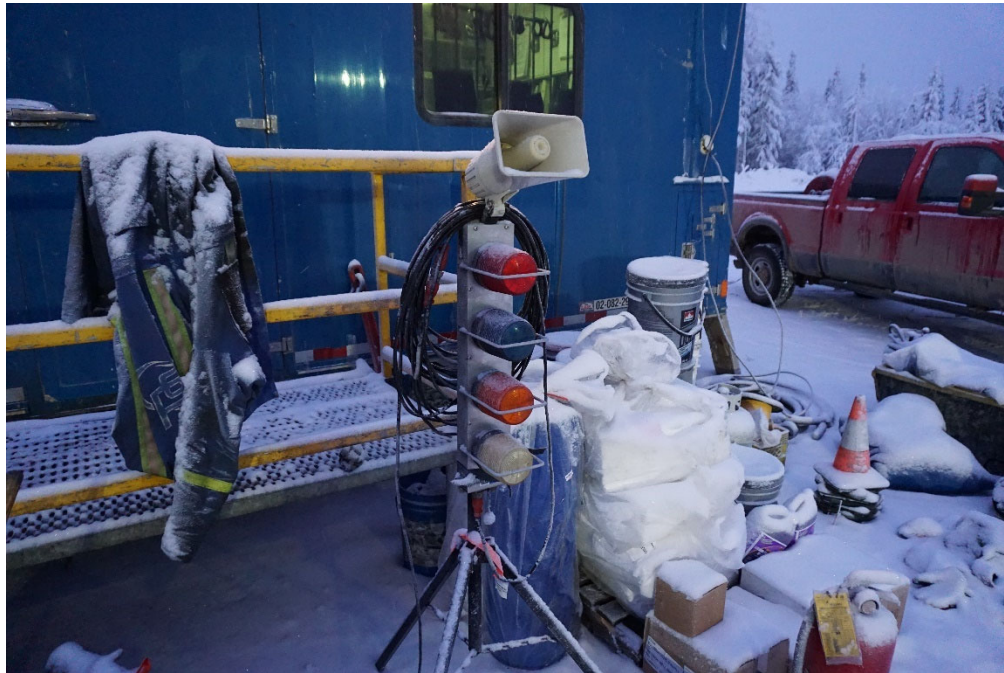
Hazard identification and signage	<input checked="" type="checkbox"/> Compliant <input type="checkbox"/> Non-Compliant <input type="checkbox"/> Corrected Non- Compliance	Comments: Signage with indicator lights to identify where a H ₂ S hazard may be present was located in front of the Dog house and when the alarm is sounded, lights would illuminate and indicate where the hazard was located on the site. (Photos #9 & #10)
-----------------------------------	---	--

PHOTO #9: H₂S sensors sound an alarm and lights illuminate indicating where the hazard is present.

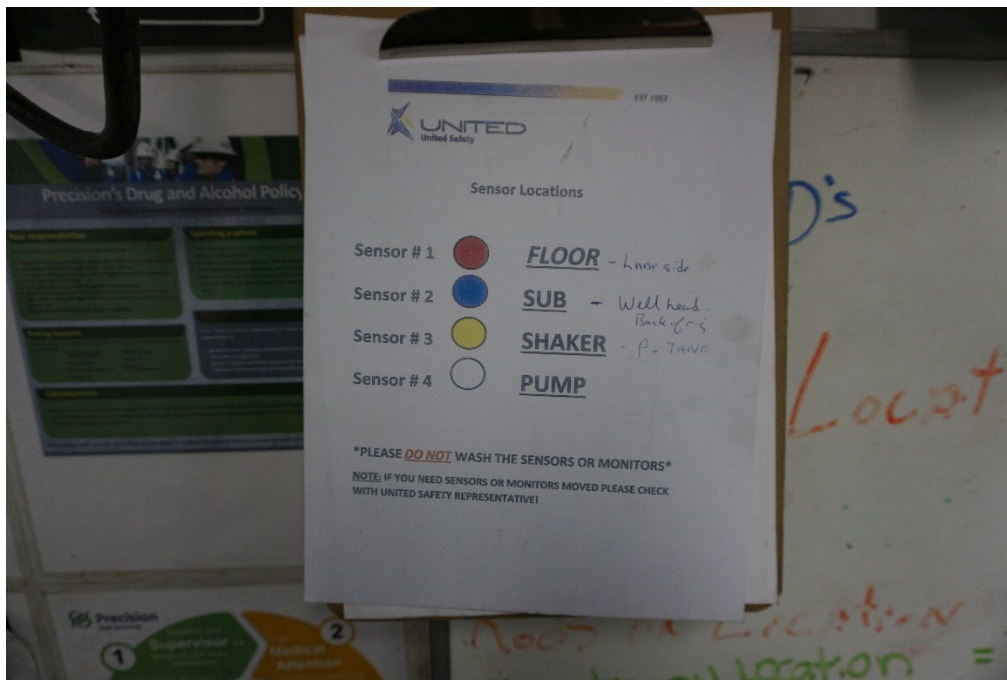
PHOTO #10: H₂S sensors were located at the Rig floor, Well head, Pressure tank, and the Rig pump.
