NWT OFFICE OF THE REGULATOR OF OIL AND GAS OPERATIONS

Inspection:

S. Pointed Mountain L-68 (WID1207) - ACW-2021-PPR-L-68-WID1207 V. 15

OROGO Operations Inspection Summary Report

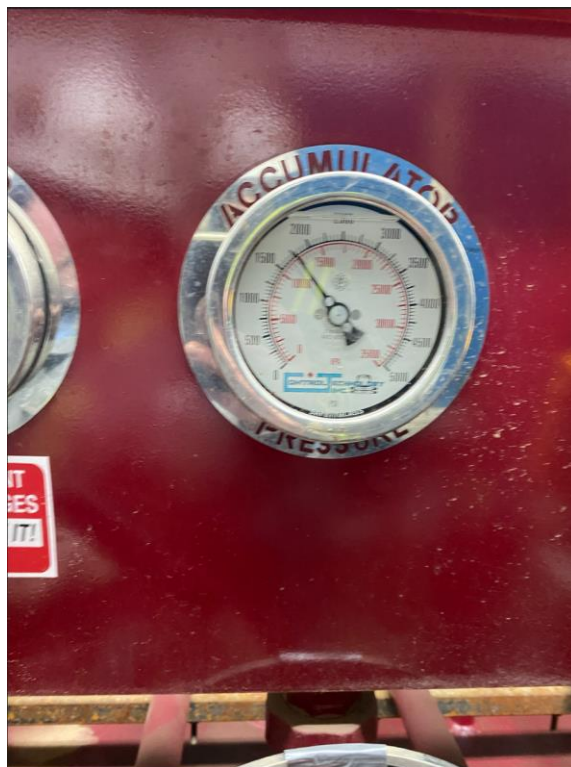
Function tests and documentation	<input checked="" type="checkbox"/> Compliant <input type="checkbox"/> Non-Compliant <input type="checkbox"/> Corrected Non-Compliance	<p>Comments: A function test of the BOP and accumulator was conducted during the inspection. Piping was in the wellbore, and the accumulator was bled down to minimum pressure that triggers the compressor to start and maintain operating pressures.</p> <ul style="list-style-type: none"> Initial Pressure: 19,000 kPa (See Photo 1) Pipe Ram - Closed: 16,000 kPa Pipe Ram - Open: 15,000 kPa Annular: 12,000 kPa (See Photo 2) Recharge: 1 min 19 sec to 20,000 kPa
Sufficient N ₂ back-up?	<input checked="" type="checkbox"/> Compliant <input type="checkbox"/> Non-Compliant <input type="checkbox"/> Corrected Non- Compliance	<p>Comments: Sizing calculations conducted by Precision Well Servicing on February 1, 2026. Minimum closing volumes 51.44L / total useable volume - 148L (See Photos 3 and 4). As the calculated closing volumes are less than the total usable volumes, this back up system is compliant.</p>

Photo 2: Accumulator at 12,000 kPa after 3 function test and before recharge

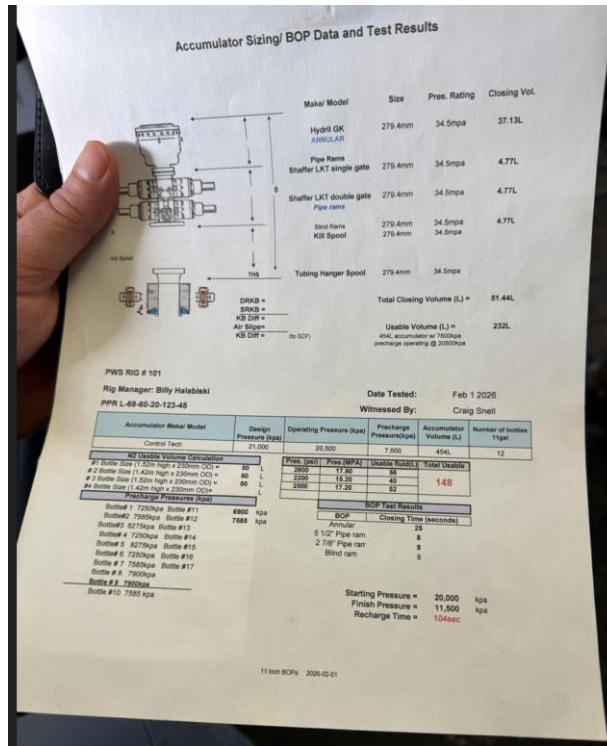
Details: Sizing calculation to ensure proper BOP closing volumes were met or exceeded (See Photo 3).

Photo 3: Accumulator sizing calculations

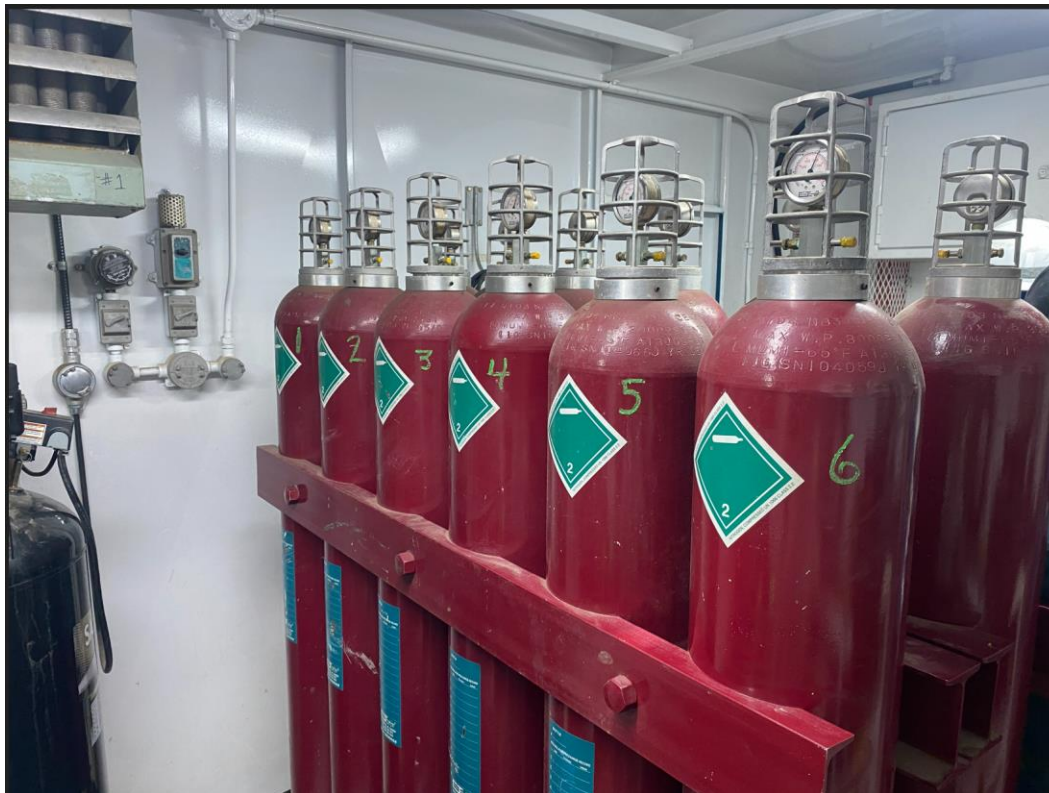
Photo 4: Accumulator bladdered nitrogen bottles

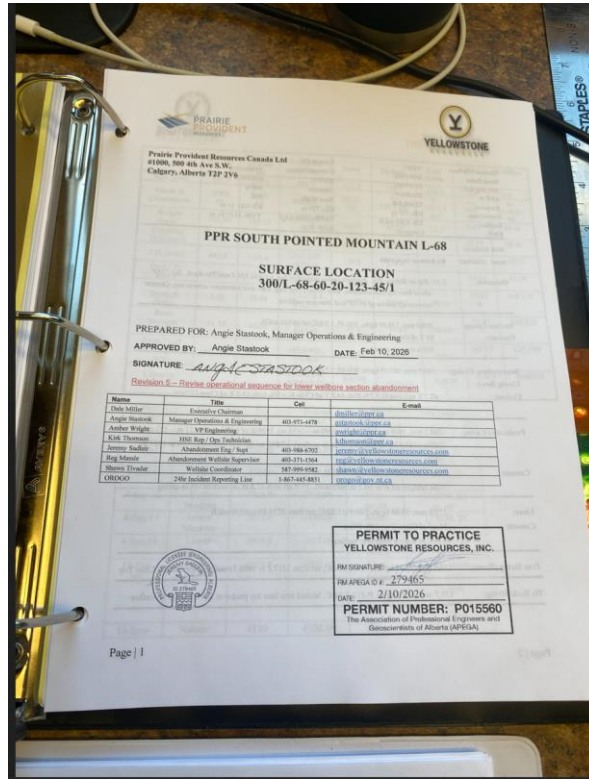
Photo 7: February 10, 2026, approved abandonment program

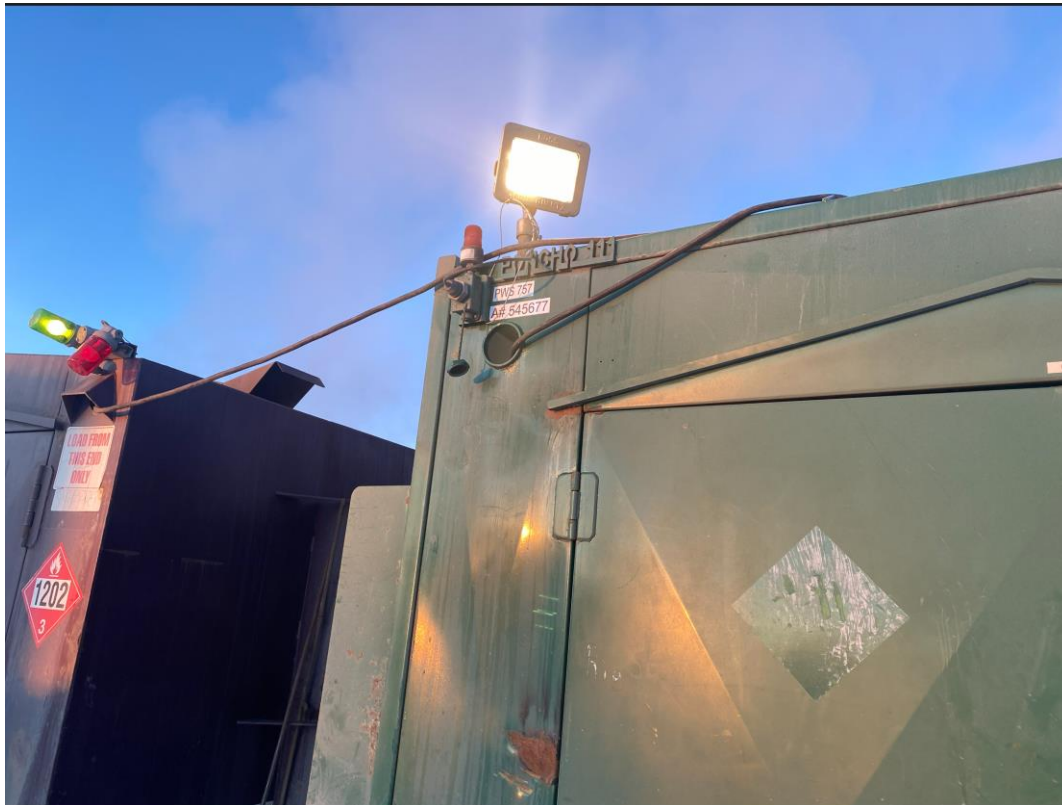
Photo 8: Boiler PWS 757 (out of service)

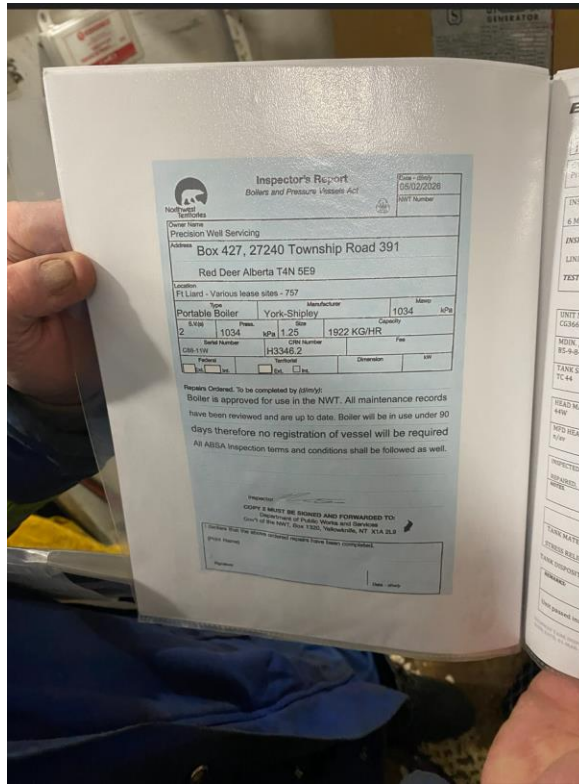
Photo 9: Boiler PWS 757 boiler inspection report

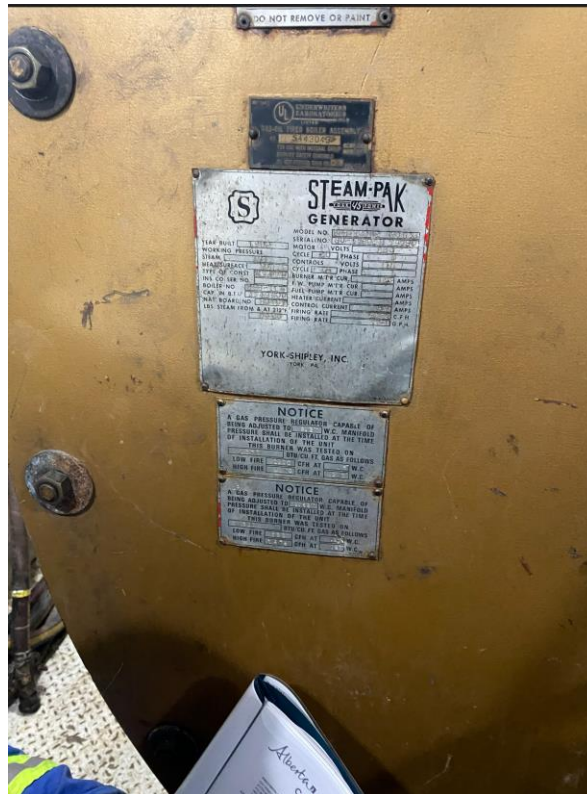
Photo 10: Boiler PWS 757 boiler information placard

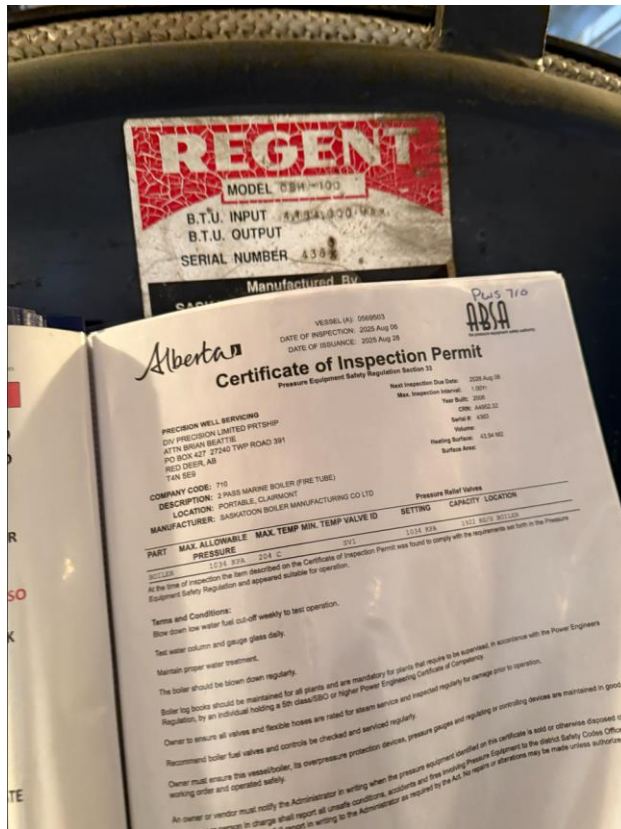
Equipment certifications	<input checked="" type="checkbox"/> Compliant <input type="checkbox"/> Non-Compliant <input type="checkbox"/> Corrected Non- Compliance	Comments: All certifications reviewed for compliance prior to operations. BOP compliant components confirmed to be in service on site.
Authorization / Approval available	<input checked="" type="checkbox"/> Compliant <input type="checkbox"/> Non-Compliant <input type="checkbox"/> Corrected Non- Compliance	Comments: OA-2021-001-PPR and ACW-2021-PPR-L-68-WID 1207 Variation 15, along with the approved program were posted in the doghouse and consultant's trailer (See Photo 7).
Boiler inspection	<input checked="" type="checkbox"/> Compliant <input type="checkbox"/> Non-Compliant <input type="checkbox"/> Corrected Non-Compliance	Comments: Boiler (PWS 757) was not in service due to a valve deficiency that was isolated. Inspection certificates were confirmed and compared to equipment on site. (See Photos 8, 9 and 10). Boiler (PWS 710) was in service at the time of the inspection. Inspection certificates were confirmed and compared to equipment on site. (See Photos 11, 12 and 13).

Photo 12: Boiler PWS 710 boiler inspection report

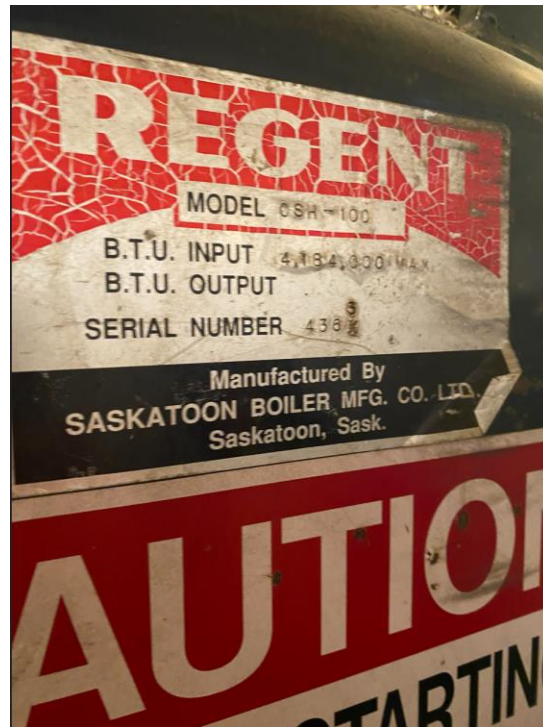
Photo 13: Boiler PWS 710 boiler information placard

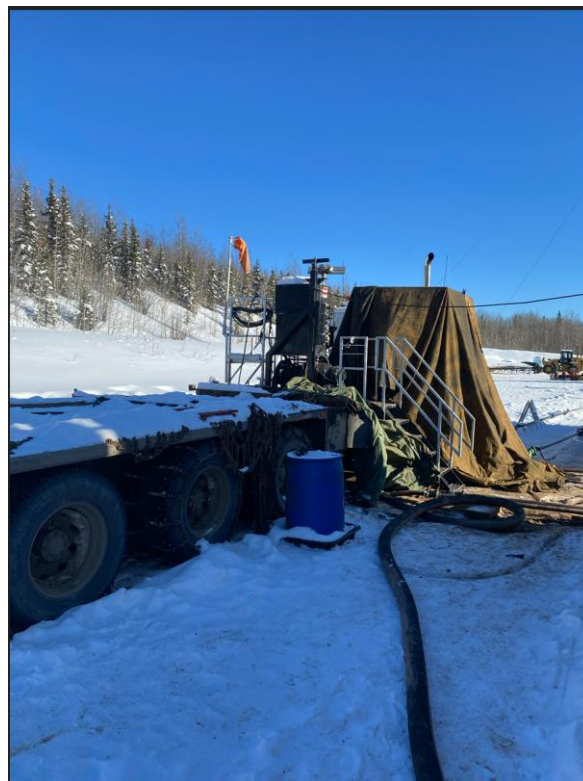
Photo 14: Wind indicator on rig tank truck

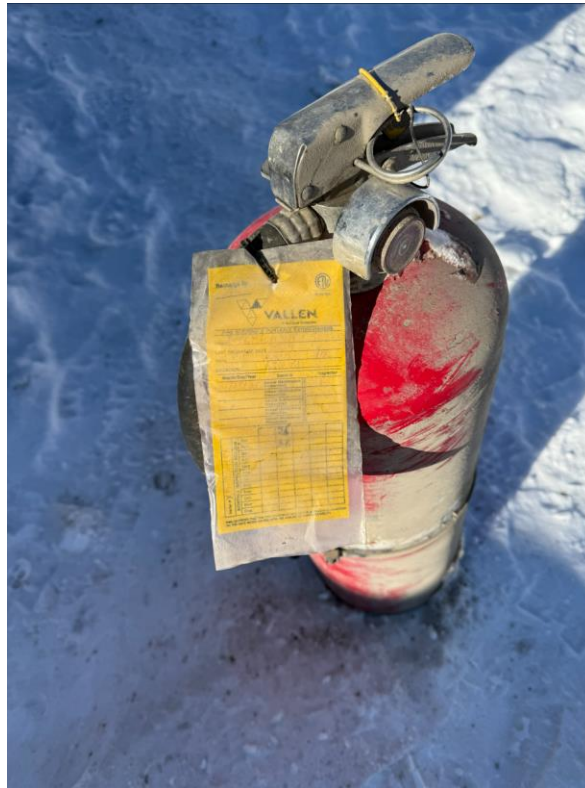
Guards and covers on moving equipment	<input checked="" type="checkbox"/> Compliant <input type="checkbox"/> Non-Compliant <input type="checkbox"/> Corrected Non- Compliance	Comments:
Adequate lighting	<input checked="" type="checkbox"/> Compliant <input type="checkbox"/> Non-Compliant <input type="checkbox"/> Corrected Non- Compliance	Comments:
Wind indicators visible and functional	<input checked="" type="checkbox"/> Compliant <input type="checkbox"/> Non-Compliant <input type="checkbox"/> Corrected Non- Compliance	Comments: Wind indicator on rig tank truck (See Photo 14). Flagging tape and flags can be seen throughout the well site as secondary wind indicators.
Fire extinguishers	<input checked="" type="checkbox"/> Compliant <input type="checkbox"/> Non-Compliant <input type="checkbox"/> Corrected Non- Compliance	Comments: All fire extinguishers inspected on site were last verified to be in service on February 17, 2026 (See Photo 15).

Photo 15: Fire extinguisher inspected February 17, 2026

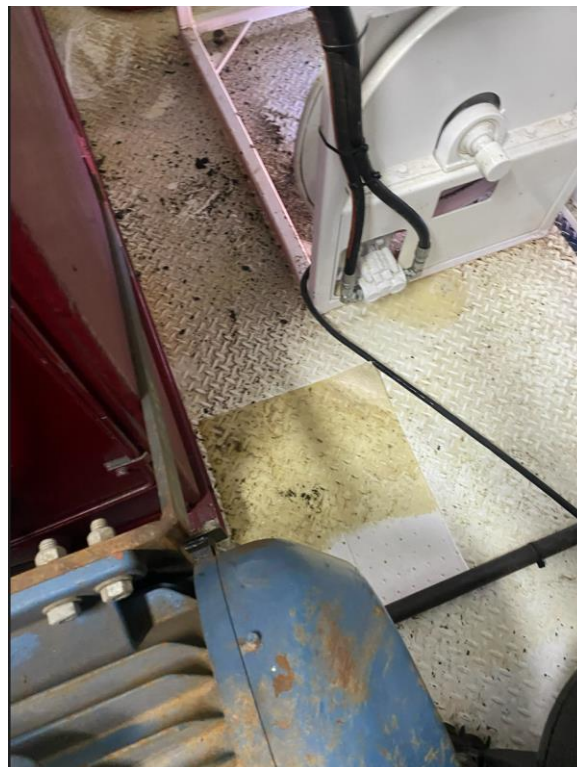
Comments: Swivel joints on the BOP hydraulic line spools in the accumulator container appeared to be leaking only when lines were depressurized. Precision Well Servicing identified the leaks were coming from the grease nipples on the swivel joints. These joints appeared to be new and likely had not been sufficiently greased. Precision Well Servicing greased each joint and confirmed no leaks under pressure or under low pressure on February 18, 2026 (See Photos 16 and 17). – **Corrected Non-Compliance**

Photo 16: Leak below swivel joints in accumulator container

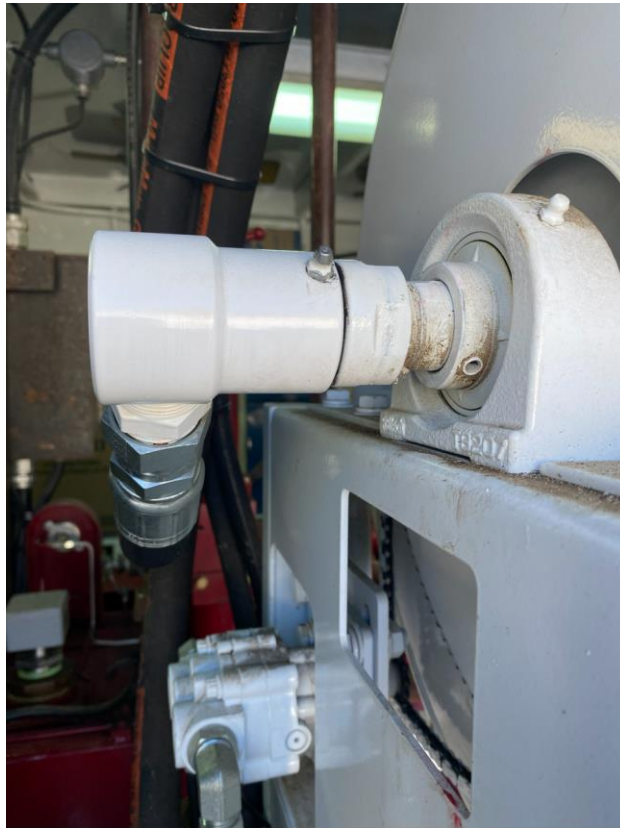
Photo 17: Swivel joint grease nipple after greasing

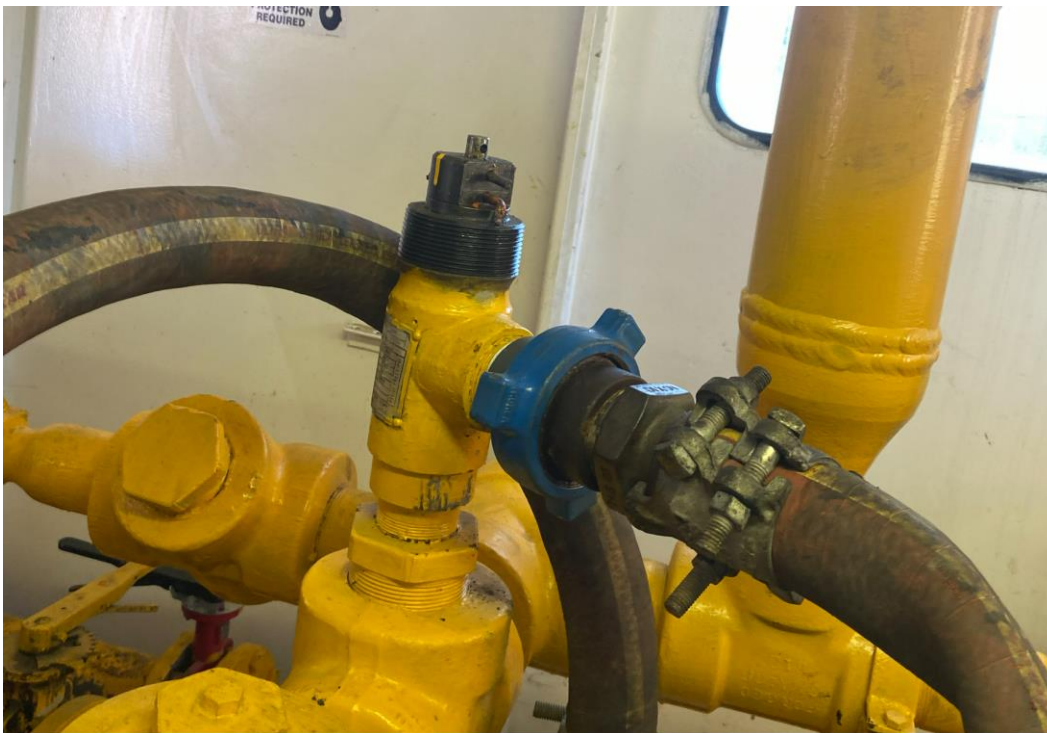
Rig pump pop valve had 2 orange shear pins in place (35 MPa) and compliant for operations (See Photo 18). - **Compliant**

Photo 18: Rig pump pop valve with 2 orange shear pins (35Mpa)

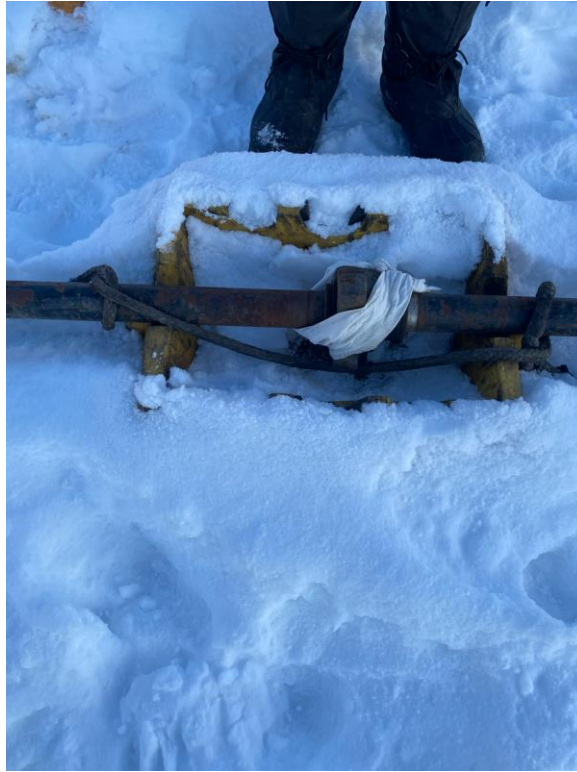
Flow lines from the well centre to the manifold had anchored joints to minimize safety hazards should they become disconnected under pressure (See Photo 19). – **Compliant**

Photo 19: Flow lines from the well centre to the manifold with anchored joints

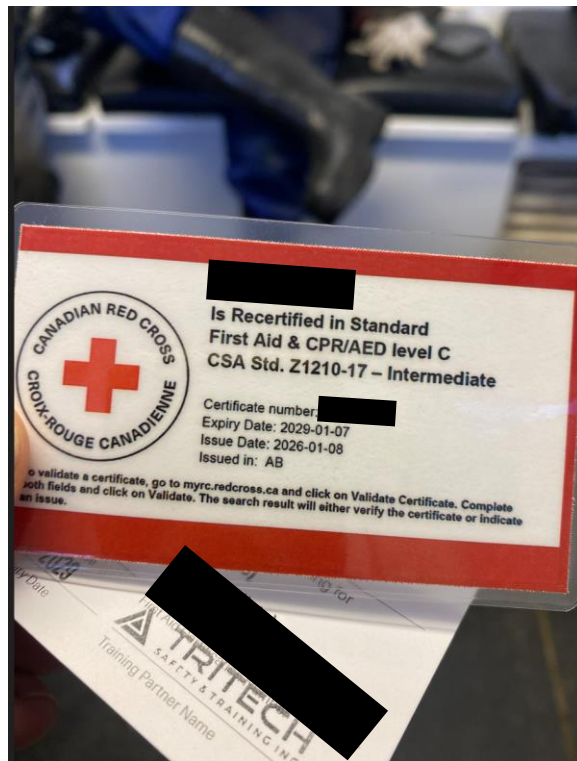
Comments: All onsite personnel had valid safety tickets (see Photos 20 and 21).

Photo 20: Valid First Aid certificate from one of the rig crew

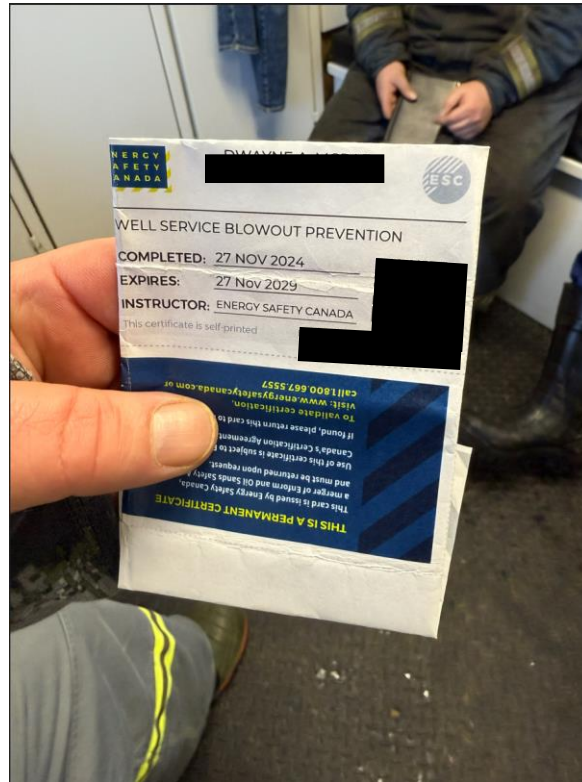
Photo 21: Drillers BOP certification

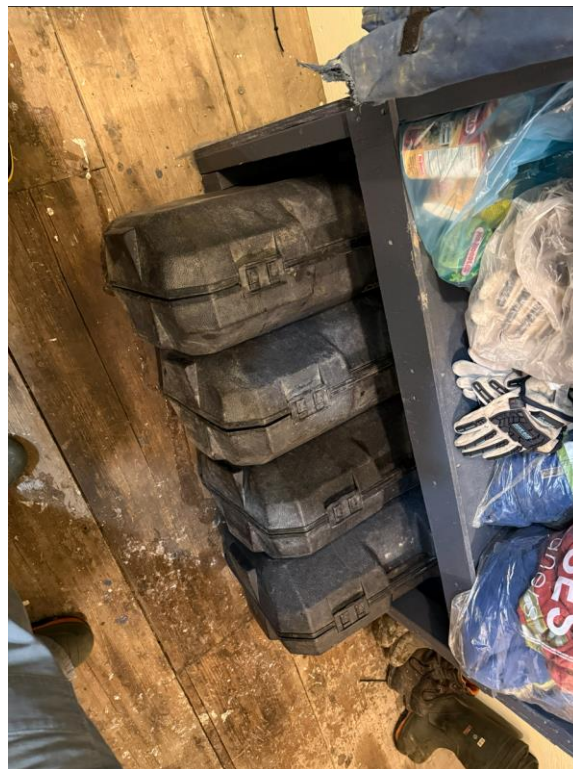
Comments: Four SCBAs were on site in warm storage beside the doghouse. The SCBAs were inspected and compliant (See Photos 22 and 23).

Photo 22: Four SCBA's in heated storage next to doghouse

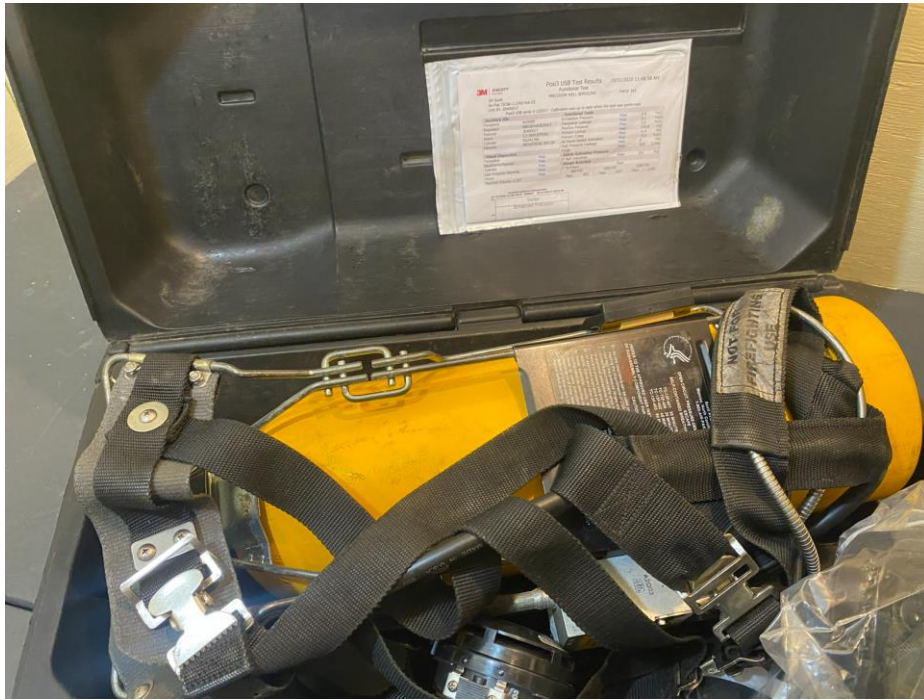
Photo 23: SCBA components inspected and verified with function test documents

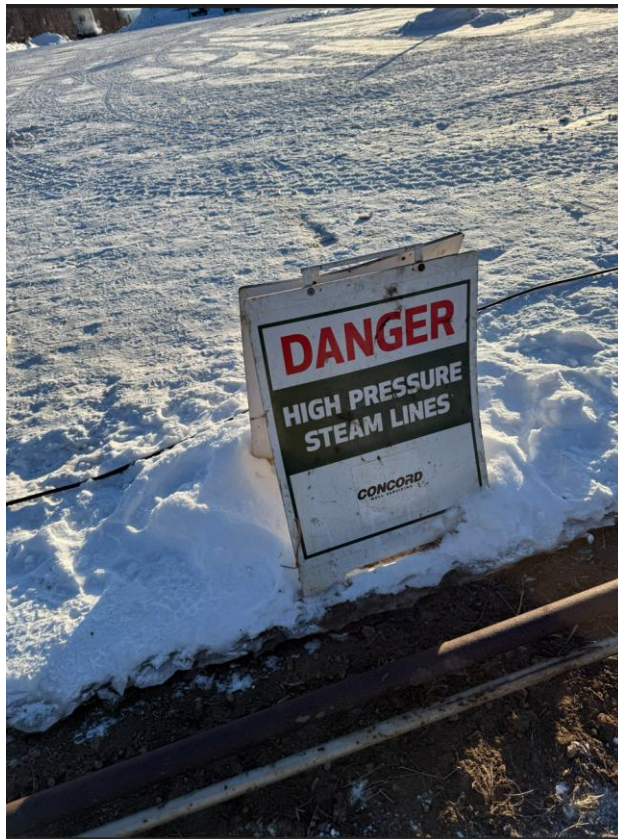
Photo 24: High pressure steam line signage

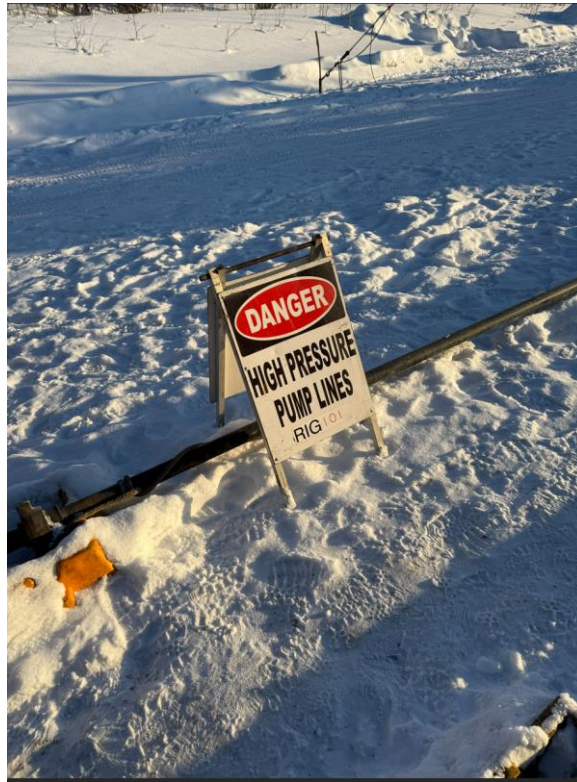
Photo 25: High pressure pump line signage

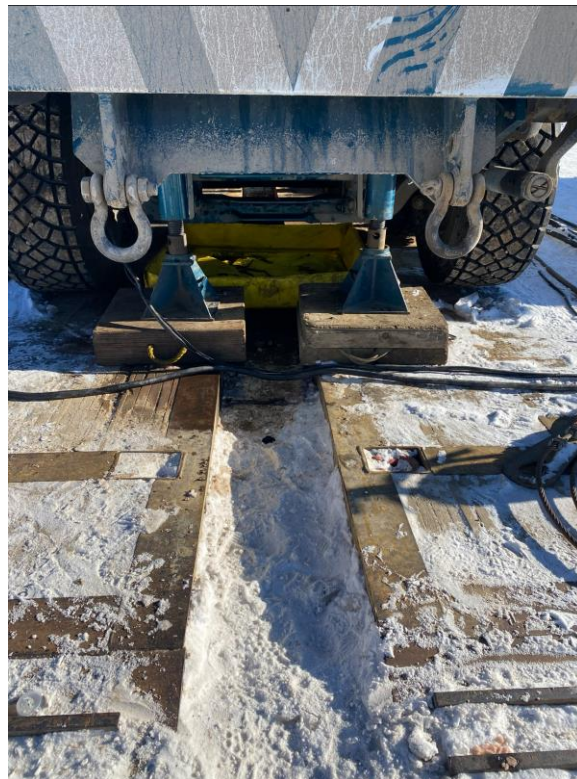
Rig matting	<input checked="" type="checkbox"/> Compliant <input type="checkbox"/> Non-Compliant <input type="checkbox"/> Corrected Non- Compliance	Comments: Rig matting in place under the rig at the time of the inspection (See Photo 26).
-------------	---	---

Photo 26: Rig matting under rig

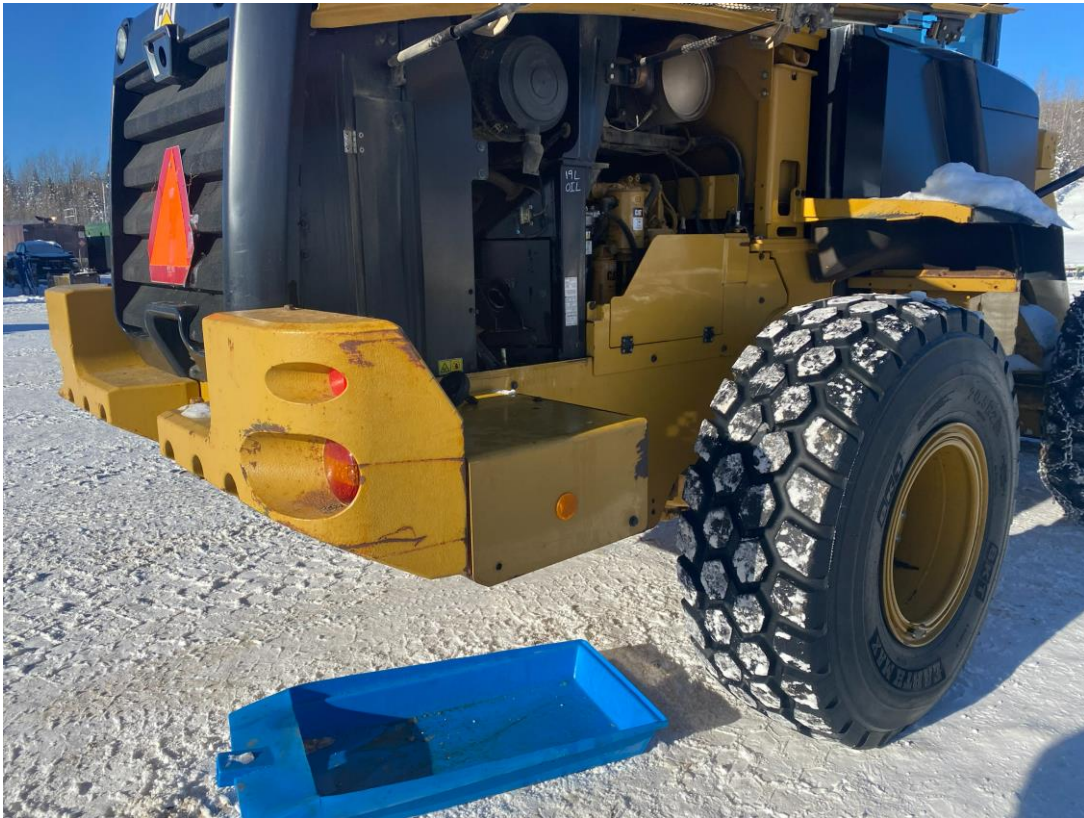
Drip trays	<input checked="" type="checkbox"/> Compliant <input type="checkbox"/> Non-Compliant <input type="checkbox"/> Corrected Non- Compliance	Comments: Drip trays located under all stationary equipment and at the fuel transfer station (See Photos 27 and 28).
Fuel handling and materials storage	<input checked="" type="checkbox"/> Compliant <input type="checkbox"/> Non-Compliant <input type="checkbox"/> Corrected Non- Compliance	Comments:
Spill response equipment on site and accessible	<input checked="" type="checkbox"/> Compliant <input type="checkbox"/> Non-Compliant <input type="checkbox"/> Corrected Non- Compliance	Comments: See Photo 29.
Tubing laydown area protection	<input checked="" type="checkbox"/> Compliant <input type="checkbox"/> Non-Compliant <input type="checkbox"/> Corrected Non- Compliance	Comments:
Permafrost protection	<input checked="" type="checkbox"/> Compliant <input type="checkbox"/> Non-Compliant <input type="checkbox"/> Corrected Non- Compliance	Comments: Permafrost not identified on this site.

Photo 27: Drip tray under equipment during refueling at tank access port

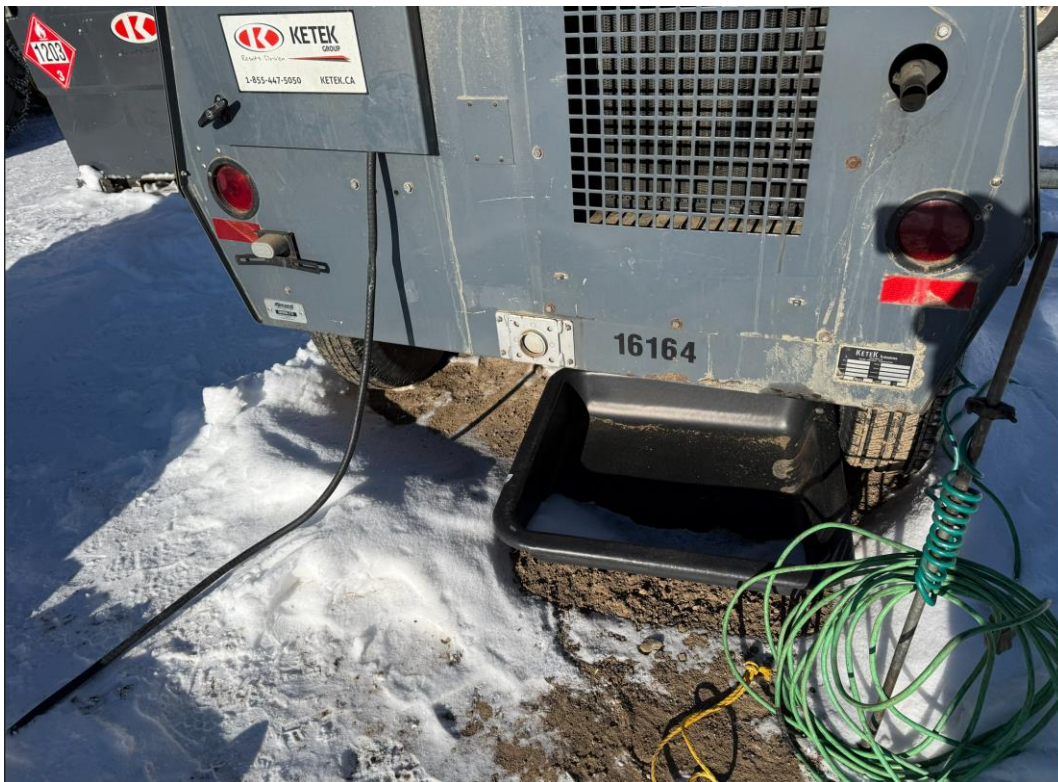
Photo 28: Drip tray under generator

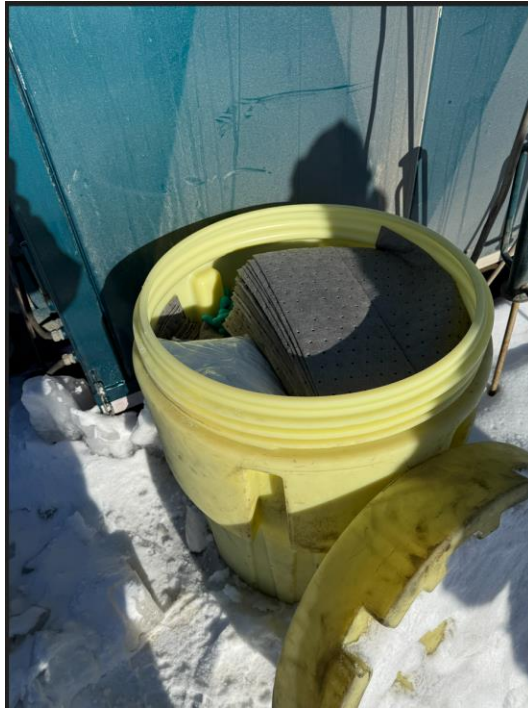
Photo 29: Spill kit behind accumulator container
