## Well Inspection Report

Well name: J-37-60-10-117-30

Date of inspection: 2022-09-25

J-37 Wellsite Inspection Pictures 2022

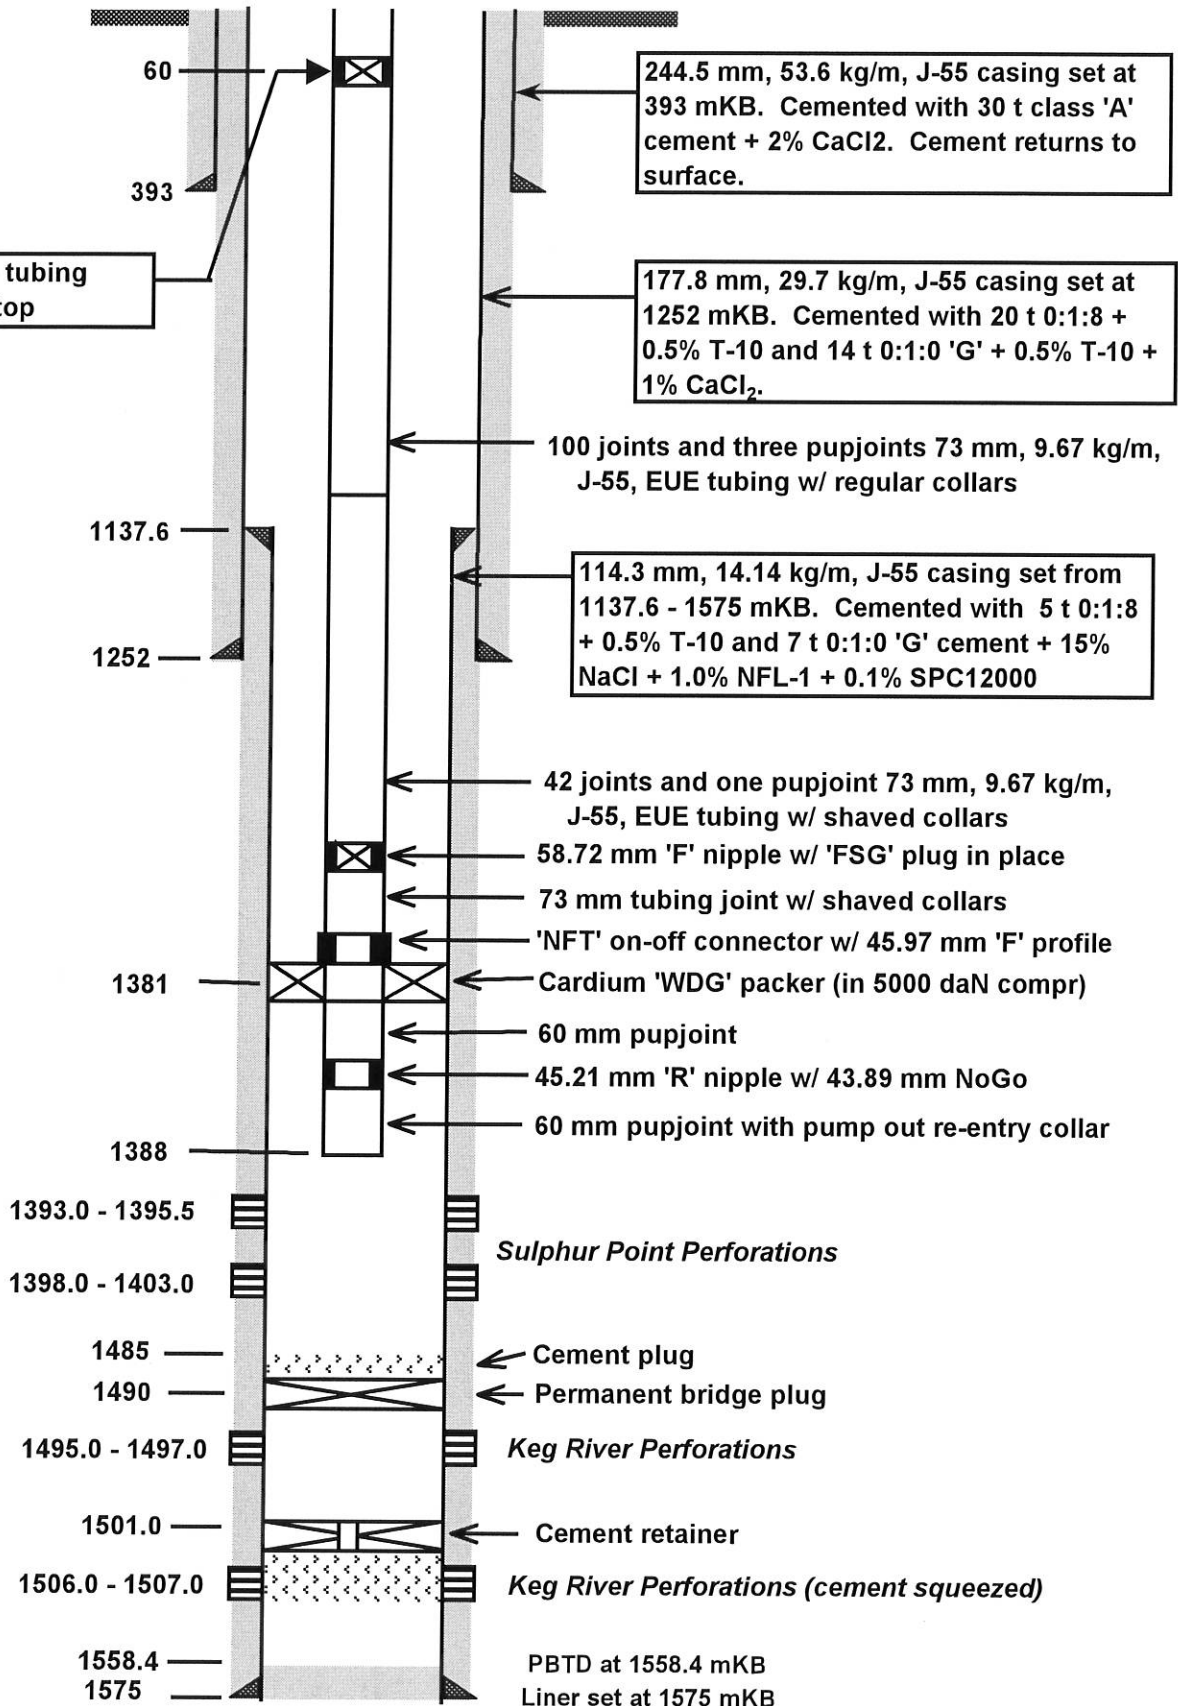
Bottom Hole Diagram (as of March 25, 2003)

collar stop, A-3 tubing  
plug and slip stop
