Inspection: Cameron J-37 (WID 1751) Well – ACW-2021-SOG-J-37-WID1751

OROGO Operations Inspection Summary Report

Well name: Cameron J-37

Nature of activity: Abandonment

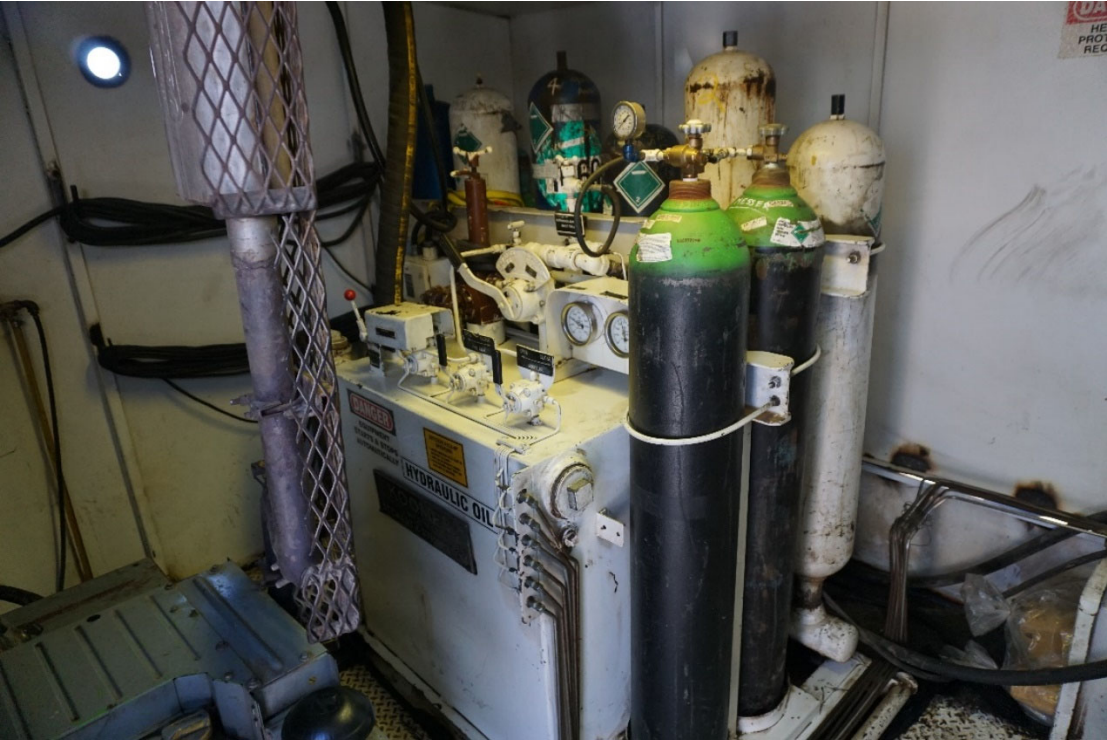
Comments: Function Test Compliant – did not drop below 8.4 MPa after three functions and recharged in <5 min. (Photo #1)

PHOTO #1: Accumulator shack and nitrogen bottles located adjacent to the Doghouse.

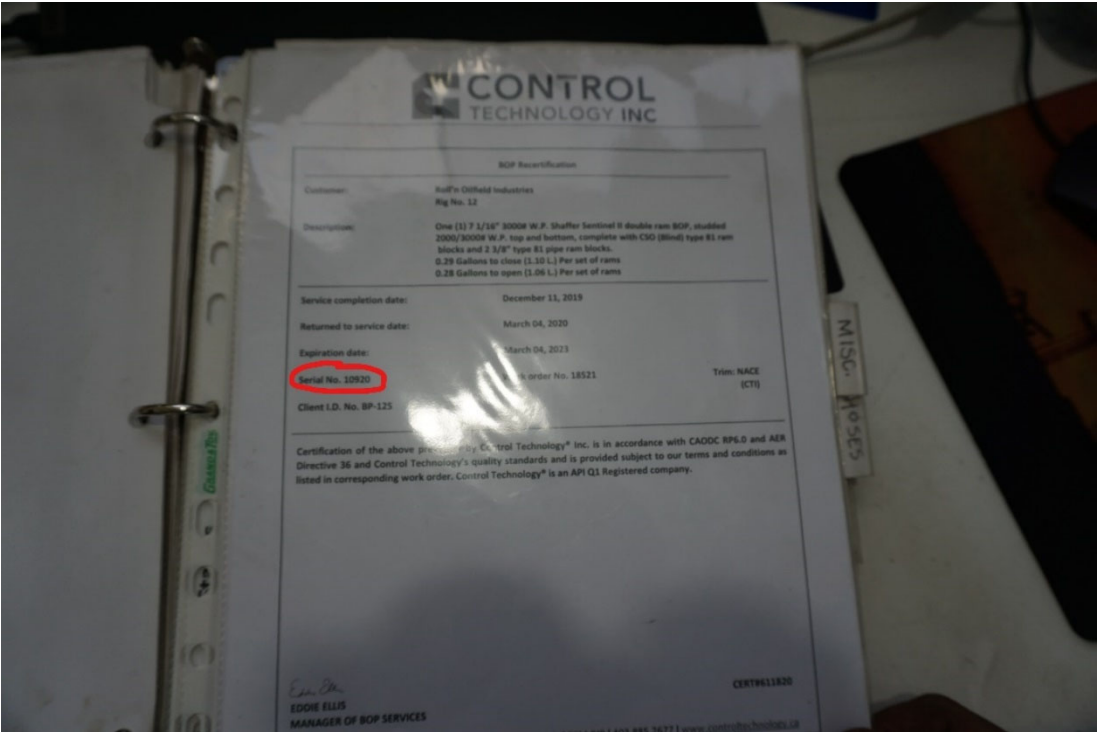
BOP certifications	<input checked="" type="checkbox"/> Compliant <input type="checkbox"/> Non-Compliant <input type="checkbox"/> Corrected Non- Compliance	Comments: Serial Numbers of the BOP matched the certifications submitted to OROGO on December 20, 2022. - Annular: SPH1311 - Double Gate: 10920 (Photos #2 & #3).
BOP pressure rating	<input checked="" type="checkbox"/> Compliant <input type="checkbox"/> Non-Compliant <input type="checkbox"/> Corrected Non- Compliance	Comments: The BOP used for this operation was 7 1/16"/34.5 MPa which is an appropriate pressure rating for this well.
Kill sheet in dog house	<input checked="" type="checkbox"/> Compliant <input type="checkbox"/> Non-Compliant <input type="checkbox"/> Corrected Non- Compliance	Comments:
Stabbing valves and cross-overs	<input checked="" type="checkbox"/> Compliant <input type="checkbox"/> Non-Compliant <input type="checkbox"/> Corrected Non- Compliance	Comments:

PHOTO #2: Double gate certifications were present on site and available upon request.

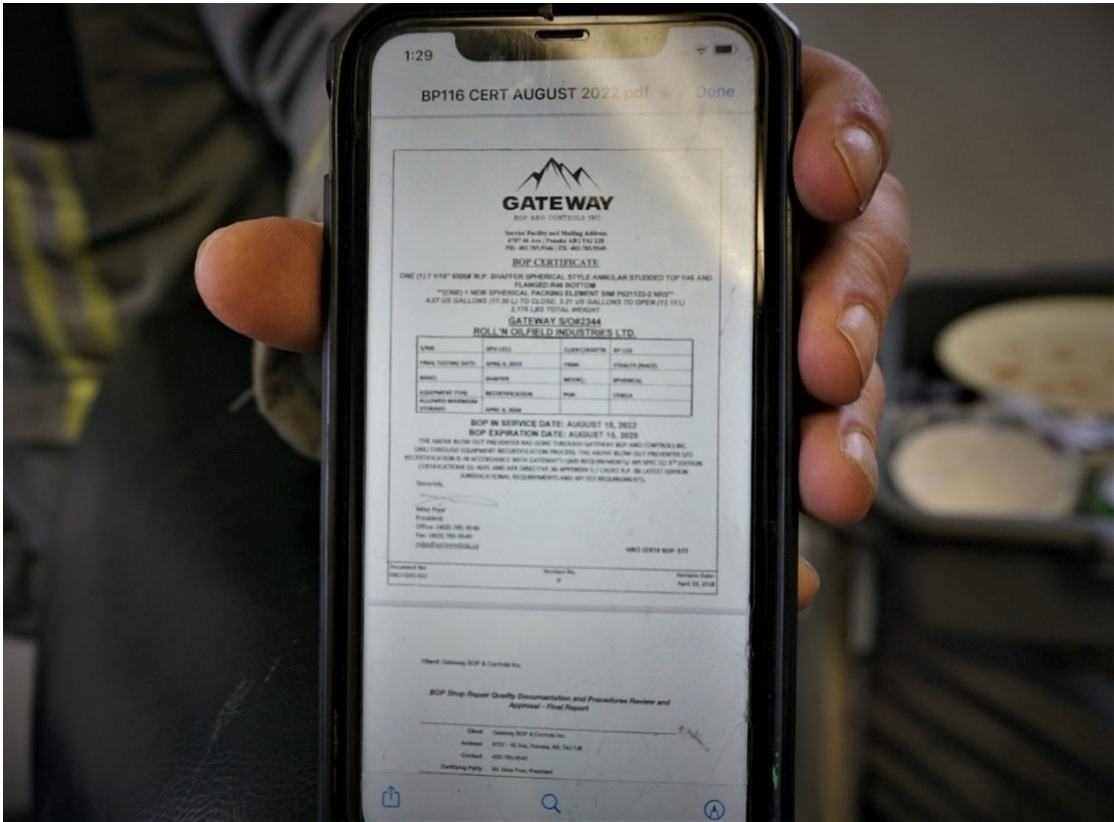
PHOTO #3: Annular certifications were present on site and available upon request.

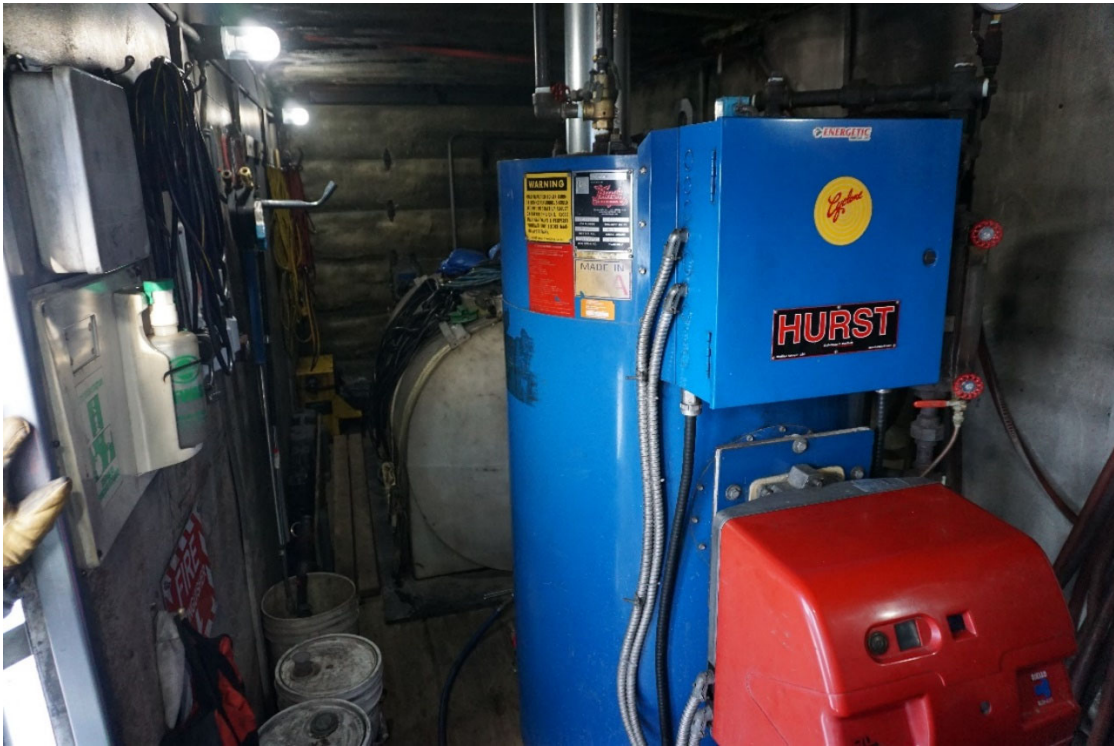
PHOTO #4: Inside view of the boiler and water tank.

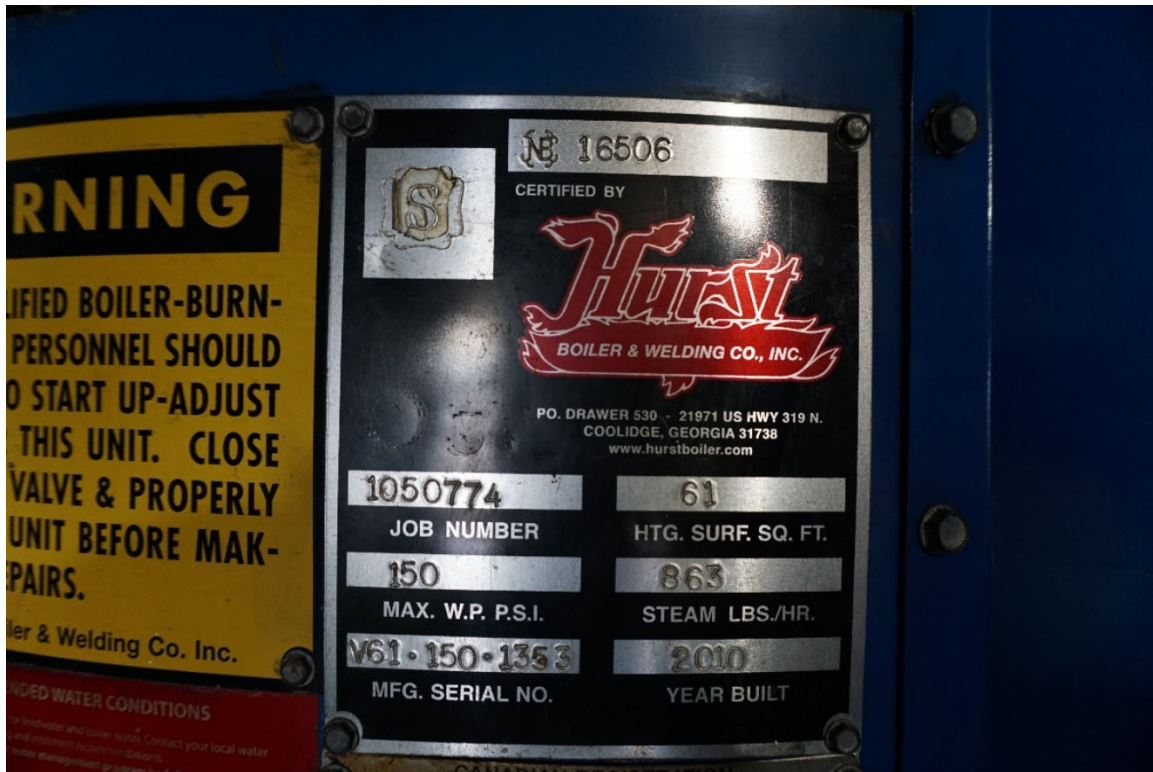
PHOTO #5: Close up view of the boiler serial number.

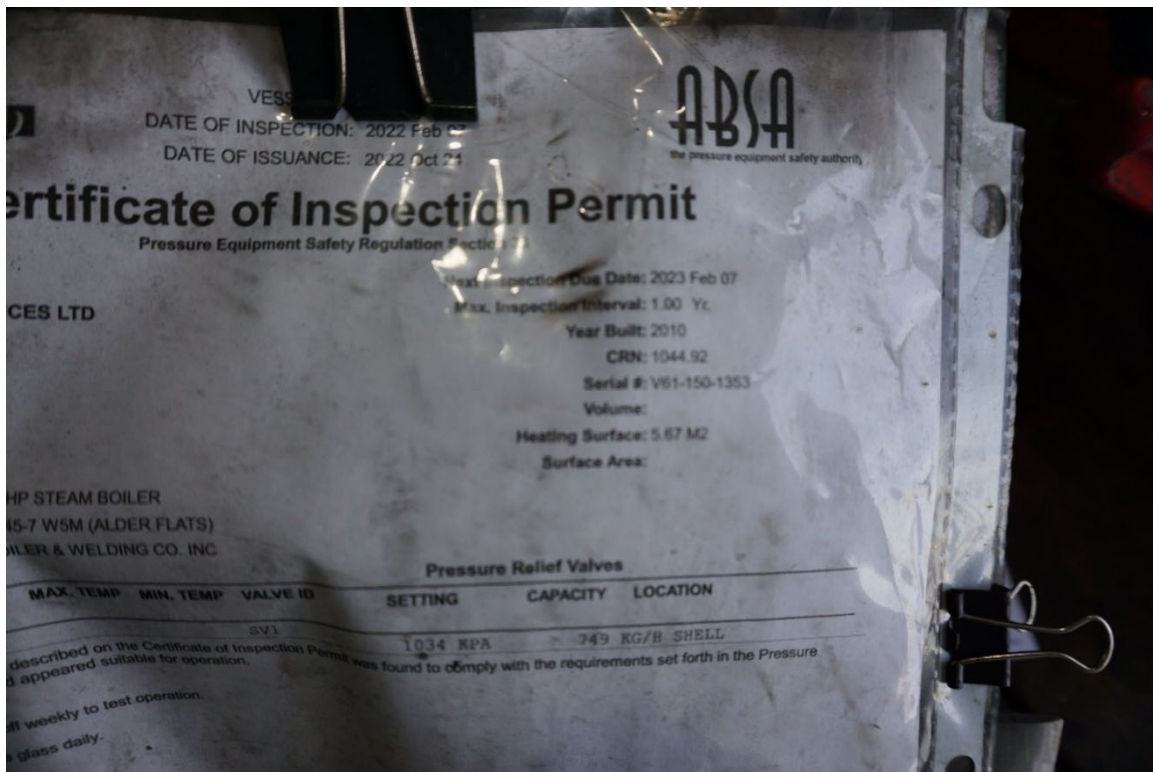
PHOTO #6: Serial number V61-150-1353 matched the boiler serial number above in Photo #5.

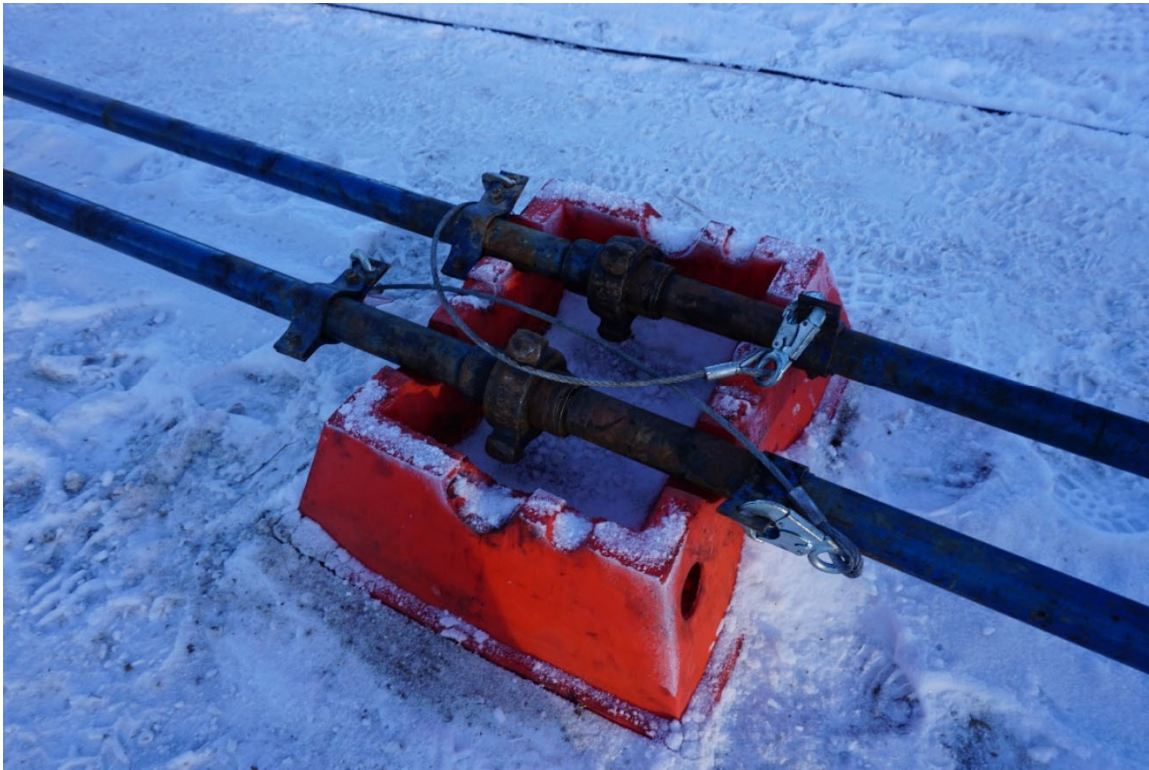
Pump lines and hoses secured, intact and appropriate?	<input checked="" type="checkbox"/> Compliant <input type="checkbox"/> Non-Compliant <input type="checkbox"/> Corrected Non- Compliance	Comments: All pump lines/hoses were secured in a condition satisfactory to the Inspectors (Photo #7)
Adequate lighting	<input checked="" type="checkbox"/> Compliant <input type="checkbox"/> Non-Compliant <input type="checkbox"/> Corrected Non- Compliance	Comments: The inspection was conducted during daylight hours.
Wind indicators visible and functional	<input checked="" type="checkbox"/> Compliant <input type="checkbox"/> Non-Compliant <input type="checkbox"/> Corrected Non- Compliance	Comments: Wind indicators were present on the crown of the derrick. No concerns were noted since the wind indicator was in a highly visible area. (Photo #8)
Fire extinguishers	<input type="checkbox"/> Compliant <input type="checkbox"/> Non-Compliant <input checked="" type="checkbox"/> Corrected Non- Compliance	Comments: Most fire extinguishers inspected have been re-certified within the last 12 months but unfortunately the two (2) fire extinguishers located adjacent to the P-tank and Flare stack could not be verified by Inspectors. Prior to the end of the inspection, ELM staff delivered two extra fire extinguishers to site for replacement at the P-tank and Flare stack line. (Photo #9)

Flow lines and choke lines secured	<input checked="" type="checkbox"/> Compliant <input type="checkbox"/> Non-Compliant <input type="checkbox"/> Corrected Non- Compliance	Comments: As seen in Photo #7, flow lines and choke lines were secured.

PHOTO #7: Pump lines were secured with heavy gauge cable and no concerns were noted.

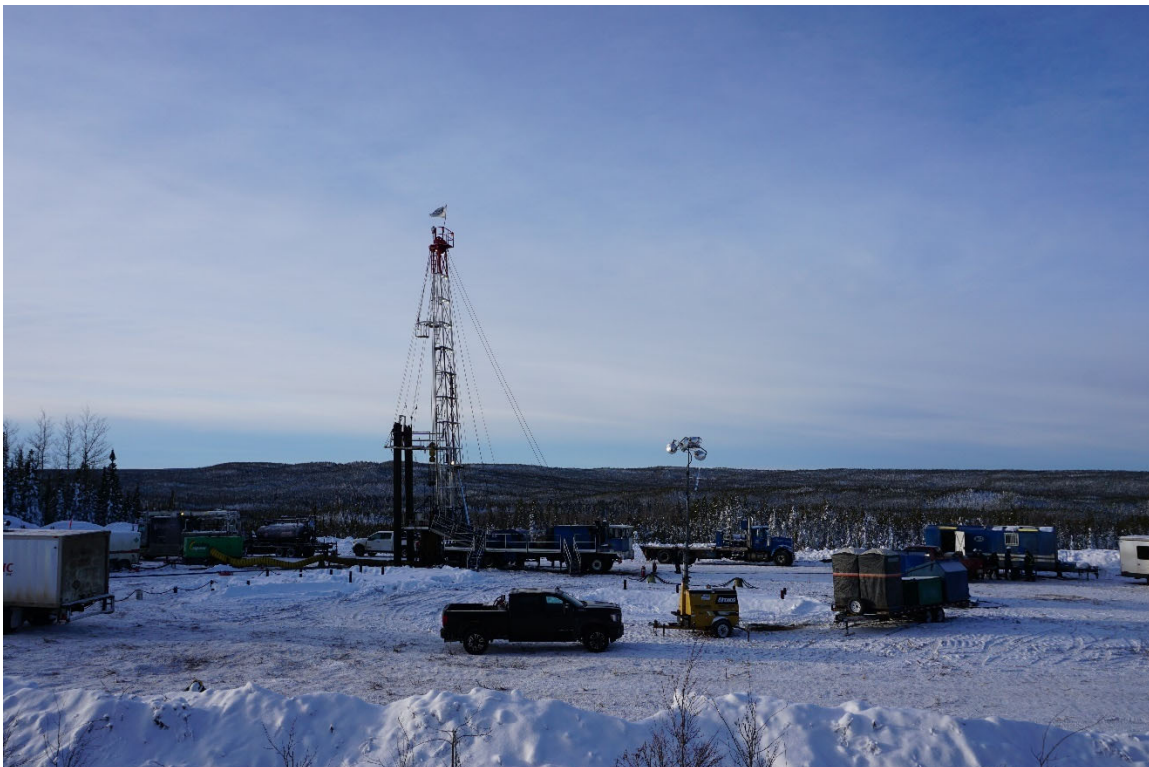
PHOTO #8: A flag located on the crown of the Derrick.

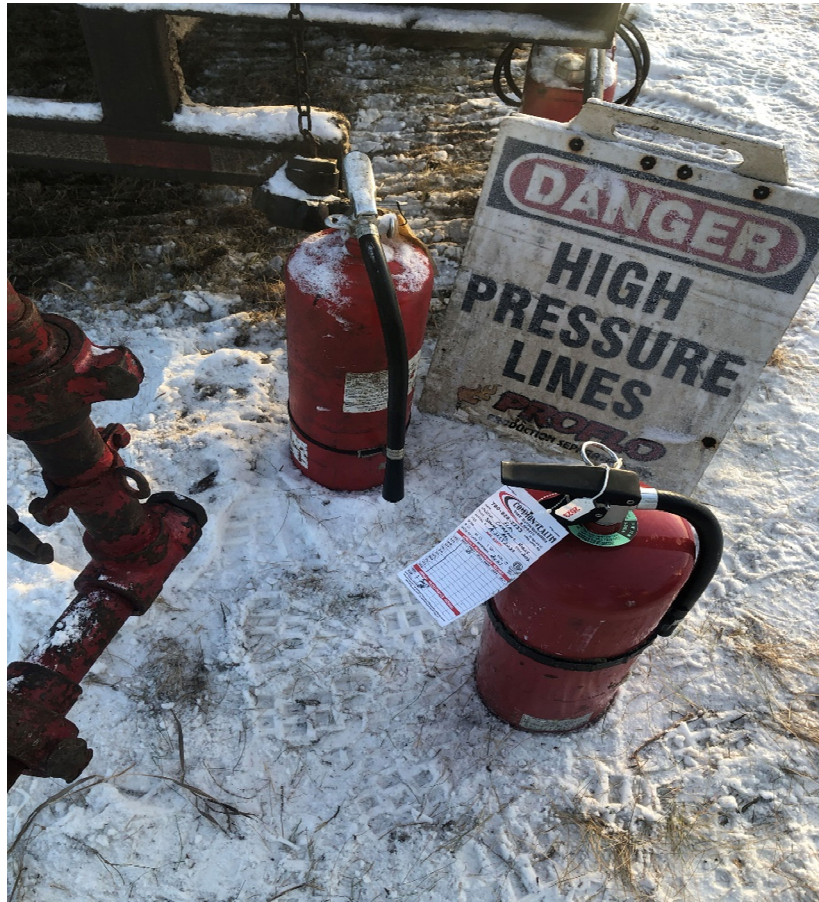
PHOTO #9: Verified fire extinguishers were brought to site for replacement at the Pressure tank.

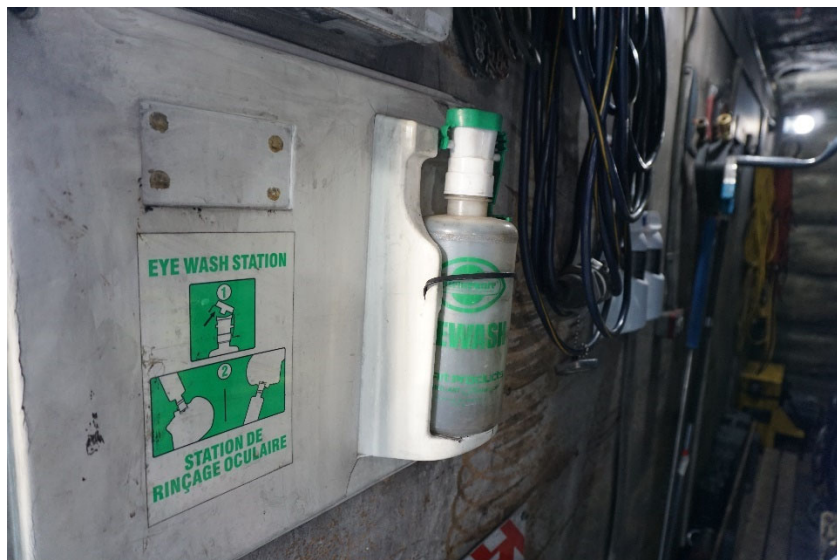
PHOTO #10: The white aerosol style eye wash equipment in the background was expired and must be replaced prior to the next scheduled inspection.

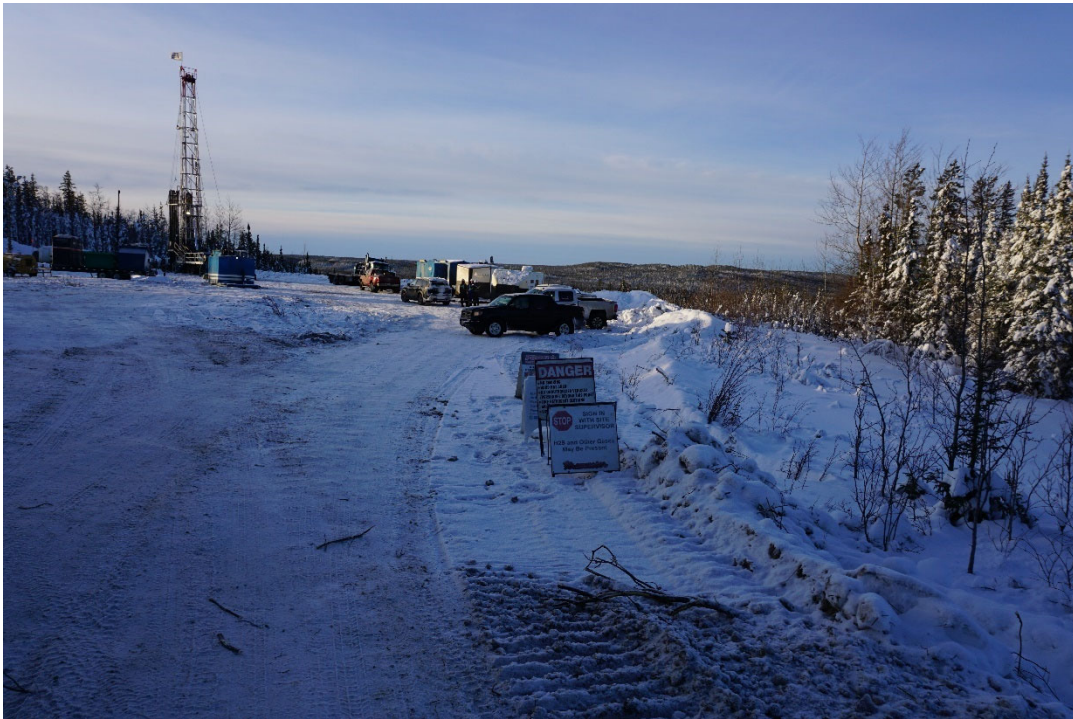
PHOTO #11: Hazard signage was present at the lease entrance.

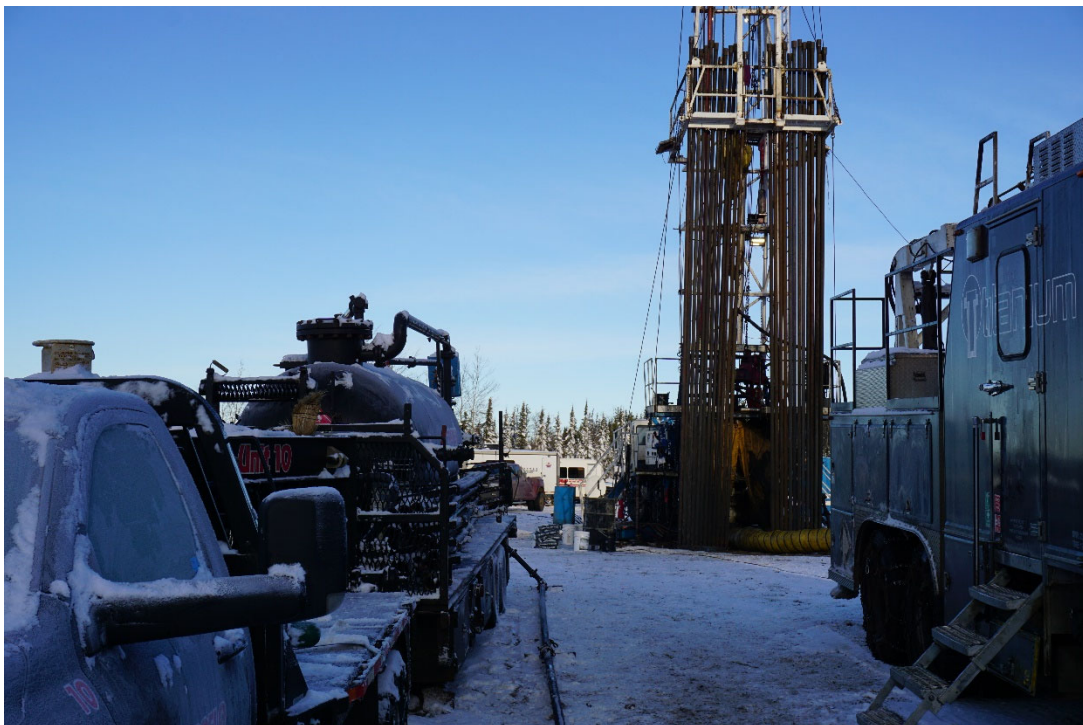
Tubing laydown area protection	<input checked="" type="checkbox"/> Compliant <input type="checkbox"/> Non-Compliant <input type="checkbox"/> Corrected Non- Compliance	Comments: Tubing racks were not utilized on the site and they were being stood upright on the monkey bars at the time of the inspection. No concerns were noted since no obvious impacts were observed on the ground surface near the Service rig.

PHOTO #12: 73.0 mm tubing string being staged on the monkey bars.
