OROGO Well Inspection Summary Report

Well name: Cameron L-29

4 digit WID: 2041

Date of inspection: 2022-09-23

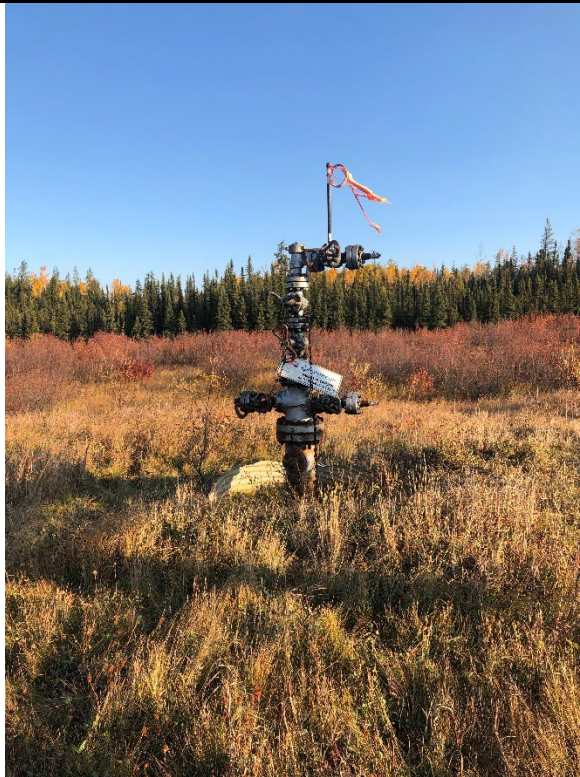
Photo #2: Cameron L-29 wellhead

1)WIND INDICATOR: The current wind indicator on site is still functional but will require replacement in the near future to stay in compliance with Section 5A of the Well Suspension and Abandonment Guidelines and Interpretation Notes (Guidelines) (See photo #2).

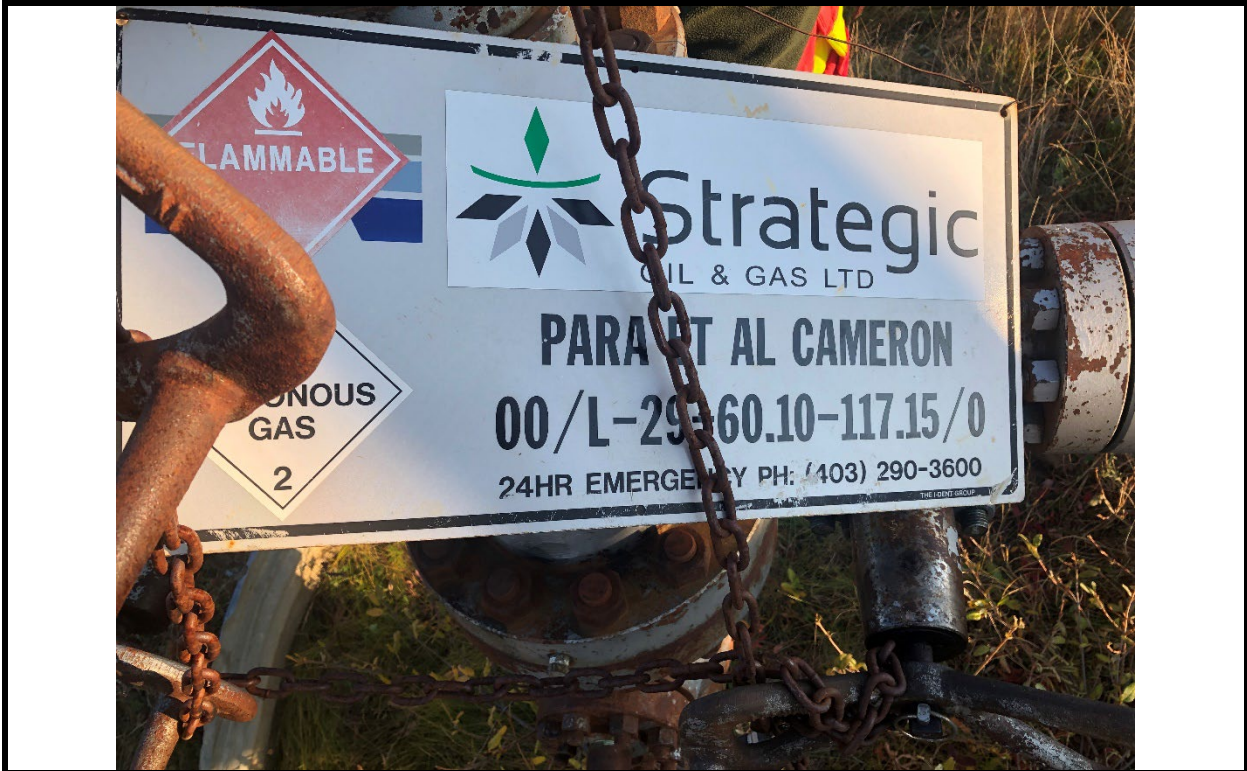
Photo #3: Cameron L-29 wellhead sign

2)WELLHEAD SIGN: The current wellhead sign indicating the well name and ID does not meet the requirements of Section 5A of the revised Guidelines issued in 2022. In addition the current sign does not provide the correct emergency contact information for Strategic (See photo #3). During the next planned visit of Strategic Oil and Gas Ltd. (Strategic) to this well, the sign will have to be updated to reflect the requirements of Section 5A of the Guidelines revised in 2022.
