**Inspection: Liard 2K-29 (WID 1980) Well – ACW-2022-PAR-2K-29-WID1980**

Inspector Brandon Bradbury, Safety Officer/Conservation Officer conducted an inspection of the abandonment of the Liard 2K-29 (WID 1980) well on August 1, 2023, which was accompanied by an AER Inspector Matthew Quail, Field Inspector.

# OROGO Operations Inspection Summary Report

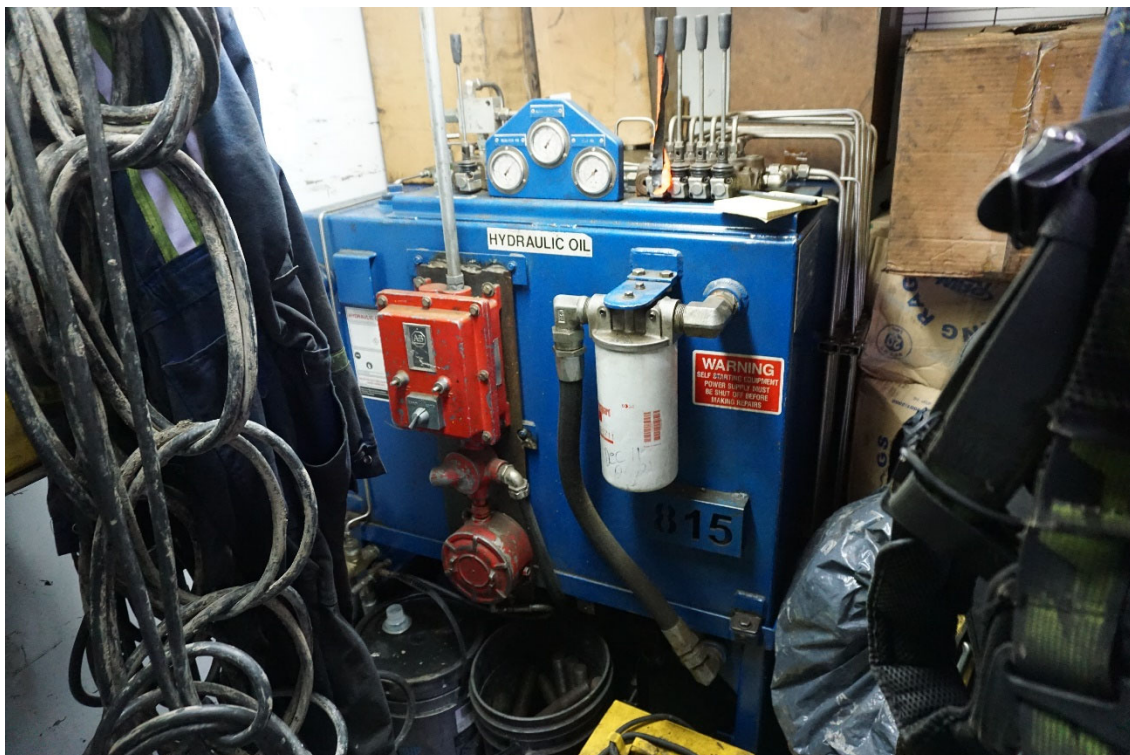
Accumulator function test	<input checked="" type="checkbox"/> Compliant <input type="checkbox"/> Non-Compliant <input type="checkbox"/> Corrected Non-Compliance	Comments: Function test was conducted during the inspection and no concerns were noted since pressure never dropped below 8.4MPa and once recharged, did not bleed off. (Photo #1) <ul style="list-style-type: none"> <li>• Starting Pressure: 13.5 MPa</li> <li>• Blind Ram (Closed): 6 sec / 13.25 MPa</li> <li>• Pipe Ram (Closed): 3 sec / 13.0 MPa</li> <li>• Annular (Closed) : 23 sec / 10.5 MPa</li> <li>• Recharge: 37sec / 13.5 MPa</li> </ul>
Sufficient N <sub>2</sub> back-up?	<input checked="" type="checkbox"/> Compliant <input type="checkbox"/> Non-Compliant <input type="checkbox"/> Corrected Non- Compliance	Comments: N <sub>2</sub> located in the accumulator building were sufficient to provide a redundant pressure to the accumulator during actuation.

Photo #1: Accumulator repressurized after function test.

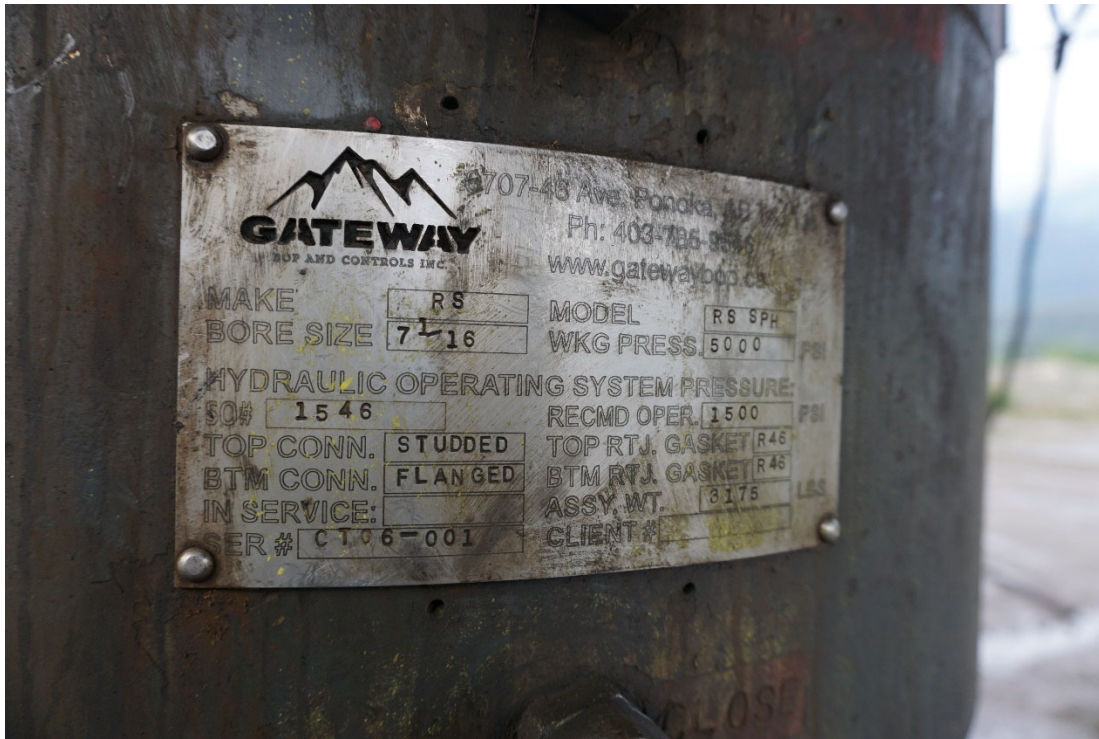
Photo #2: Annular BOP (Serial Number: CT06-001)

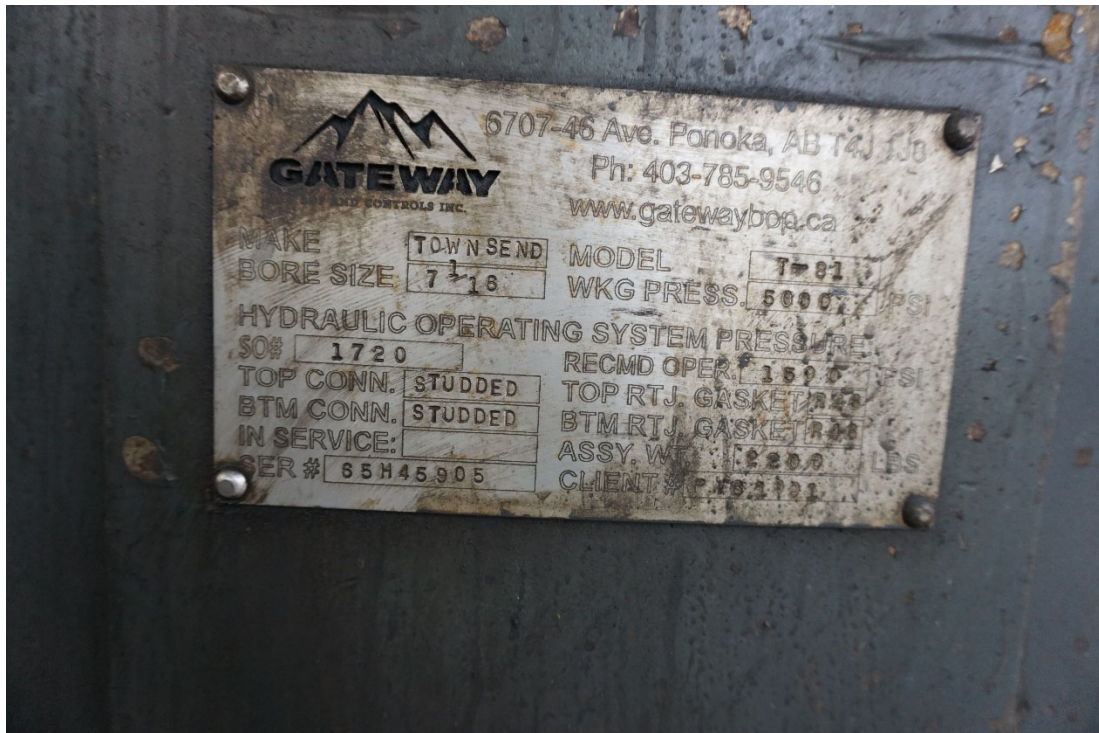
Photo #3: Double gate BOP (Serial Number: 65H45905)

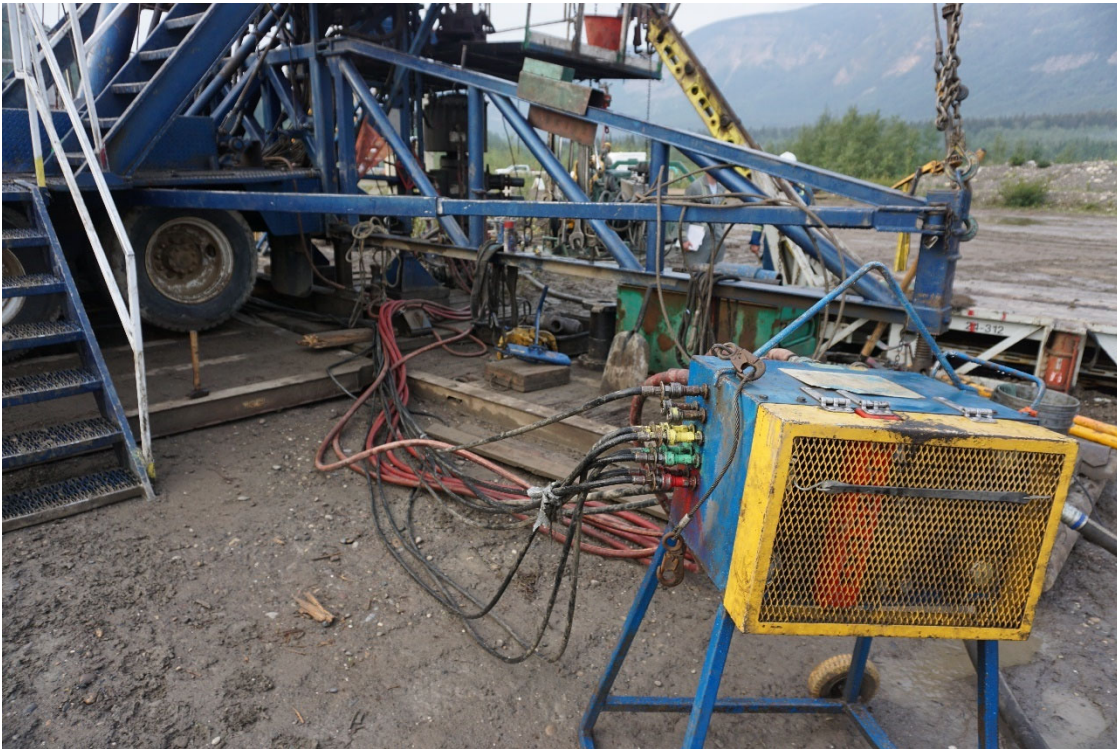
Equipment spacing	<input checked="" type="checkbox"/> Compliant <input type="checkbox"/> Non-Compliant <input type="checkbox"/> Corrected Non- Compliance	Comments: All equipment spacing at the time of the inspection were compliant: <ul style="list-style-type: none"> <li>Well Centre to Flare: 84m</li> <li>Well Centre to Doghouse: 32m</li> <li>Well Centre to Rig Tank: 50m</li> <li>Pump to Rig Tank: 8.6m</li> <li>Flare to Pressure Tank: 29m</li> <li>Pressure Tank to well: 45m</li> </ul>
Engine kills	<input checked="" type="checkbox"/> Compliant <input type="checkbox"/> Non-Compliant <input type="checkbox"/> Corrected Non- Compliance	Comments: The rig pump engine kill and 2 engine kills on the rig functioned as designed and no concerns were noted.
Pump lines and hoses secured, intact and appropriate?	<input checked="" type="checkbox"/> Compliant <input type="checkbox"/> Non-Compliant <input type="checkbox"/> Corrected Non- Compliance	Comments: All pump lines and hoses were secured and intact at the time of inspection (Photo #4)

Photo #4: Fire rated Kelly hoses were greater than 7 meters from the BOP stack.

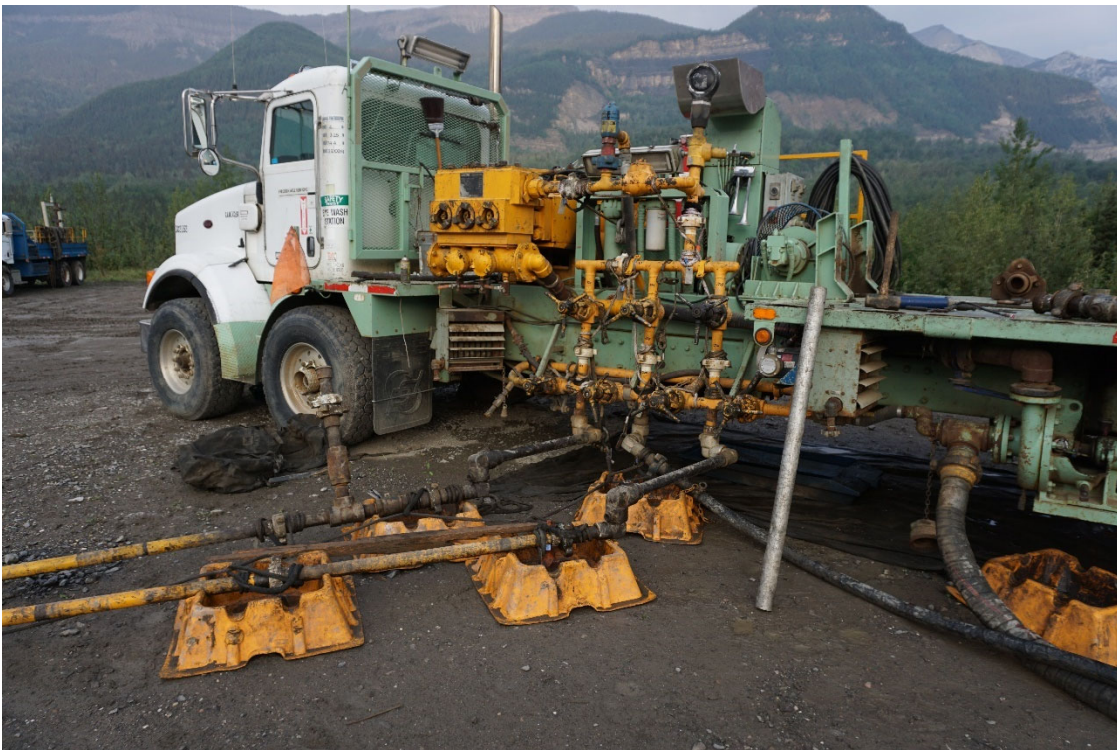
Flow lines and choke lines secured	<input checked="" type="checkbox"/> Compliant <input type="checkbox"/> Non-Compliant <input type="checkbox"/> Corrected Non- Compliance	Comments: Flow lines were secured and no concerns were noted. (Photo #5)
Flow turns	<input checked="" type="checkbox"/> Compliant <input type="checkbox"/> Non-Compliant <input type="checkbox"/> Corrected Non- Compliance	Comments: All required flow turns were in place and connected in the proper orientation during the inspection (Photo #5)
General housekeeping	<input checked="" type="checkbox"/> Compliant <input type="checkbox"/> Non-Compliant <input type="checkbox"/> Corrected Non- Compliance	Comments:

Photo #5: Pump lines secured, flow turns are in the correct position.

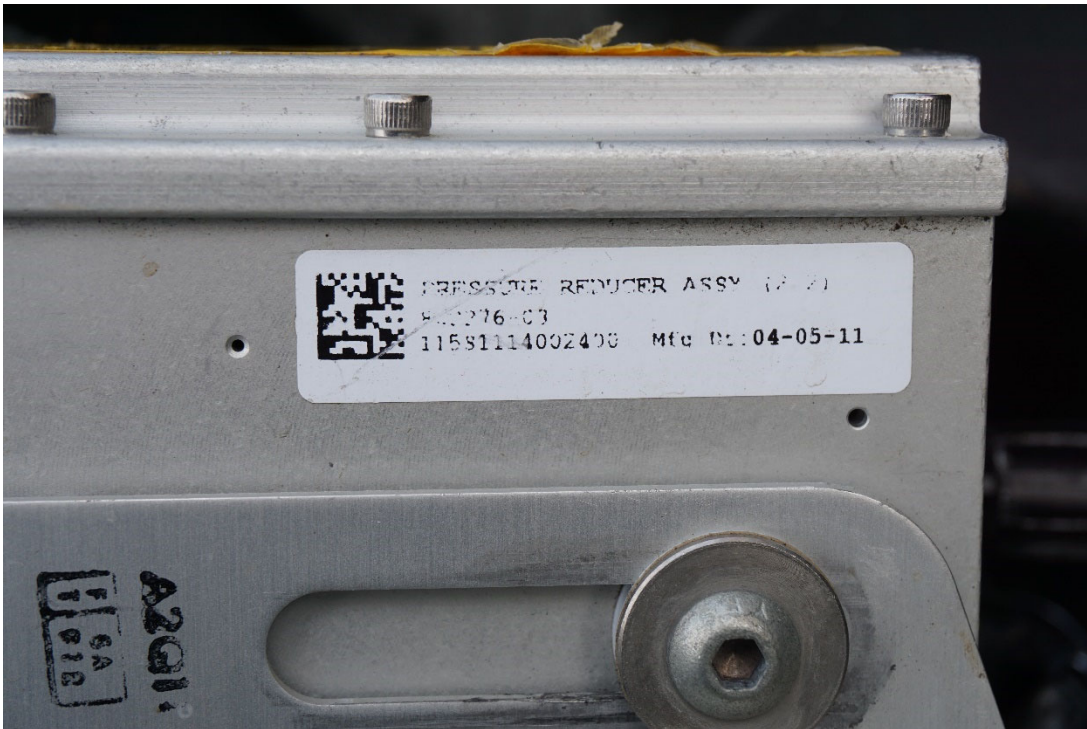
Photo #7: The above noted inspection sheet was assigned to this reducer, but serial numbers did not match.

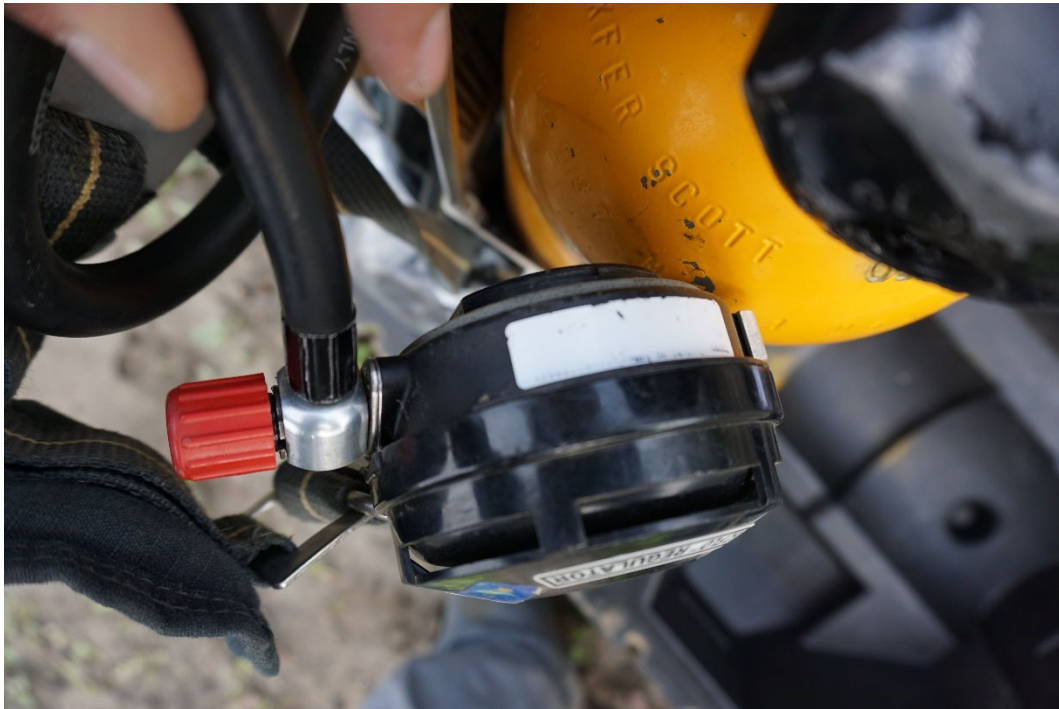
Photo #8: Verification of the SCBA's on site was done through a barcode system however, Serial numbers on United's equipment (reducer/regulator) were not legible or did not match to verify with the Inspection sheet serial numbers. Inspectors recommended replacing the white serial number stickers on the testers equipment so they can be easily confirmed on site during future inspections.

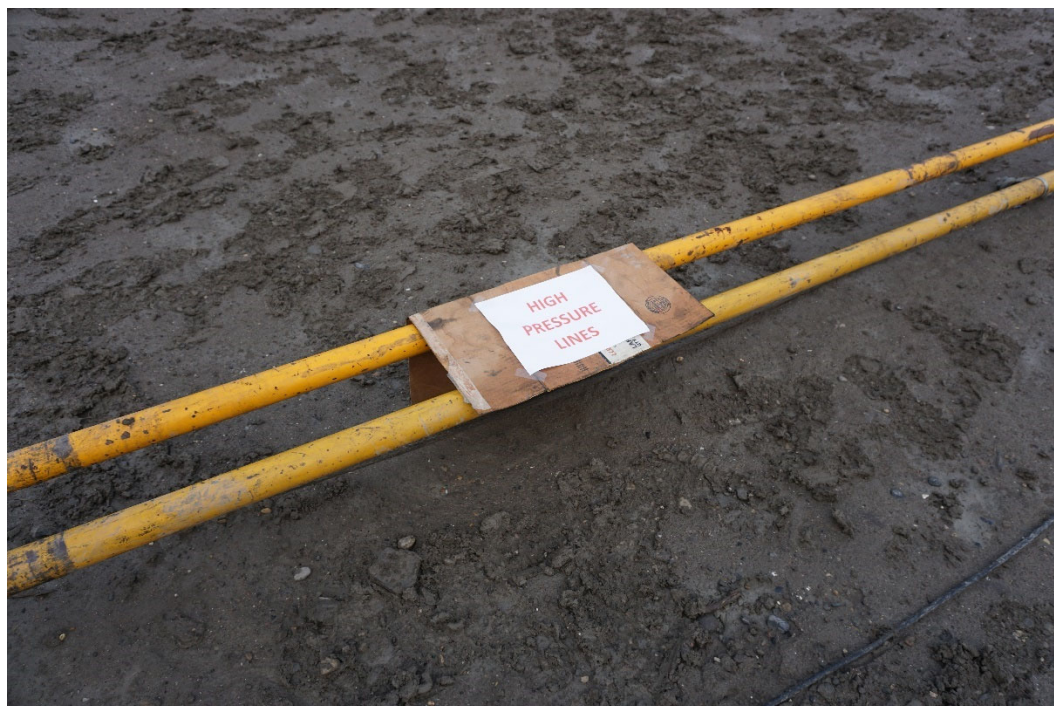
First Aid equipment and EMS on site and accessible	<input checked="" type="checkbox"/> Compliant <input type="checkbox"/> Non-Compliant <input type="checkbox"/> Corrected Non- Compliance	Comments: EMS was on site for the safety meeting at the beginning of the shift and was on standby near the wellsite.
Gas detection equipment on site and accessible	<input checked="" type="checkbox"/> Compliant <input type="checkbox"/> Non-Compliant <input type="checkbox"/> Corrected Non- Compliance	Comments: All personnel had an H <sub>2</sub> S monitor.
Communication plans available	<input checked="" type="checkbox"/> Compliant <input type="checkbox"/> Non-Compliant <input type="checkbox"/> Corrected Non- Compliance	Comments:
Hazard identification and signage	<input checked="" type="checkbox"/> Compliant <input type="checkbox"/> Non-Compliant <input type="checkbox"/> Corrected Non- Compliance	Comments: Hazard signage was present at the lease entrance, and near high pressure hose lines/and hazardous areas. Since wildlife has damaged and moved some signs during previous operations, drilling personnel ensured a visible sign was present on pump lines (Photo #9).

Photo #9: Temporary hazard signage was placed on pump lines after wildlife in the area misplaced them. No concerns were noted since signage was still made visible to all workers on site.

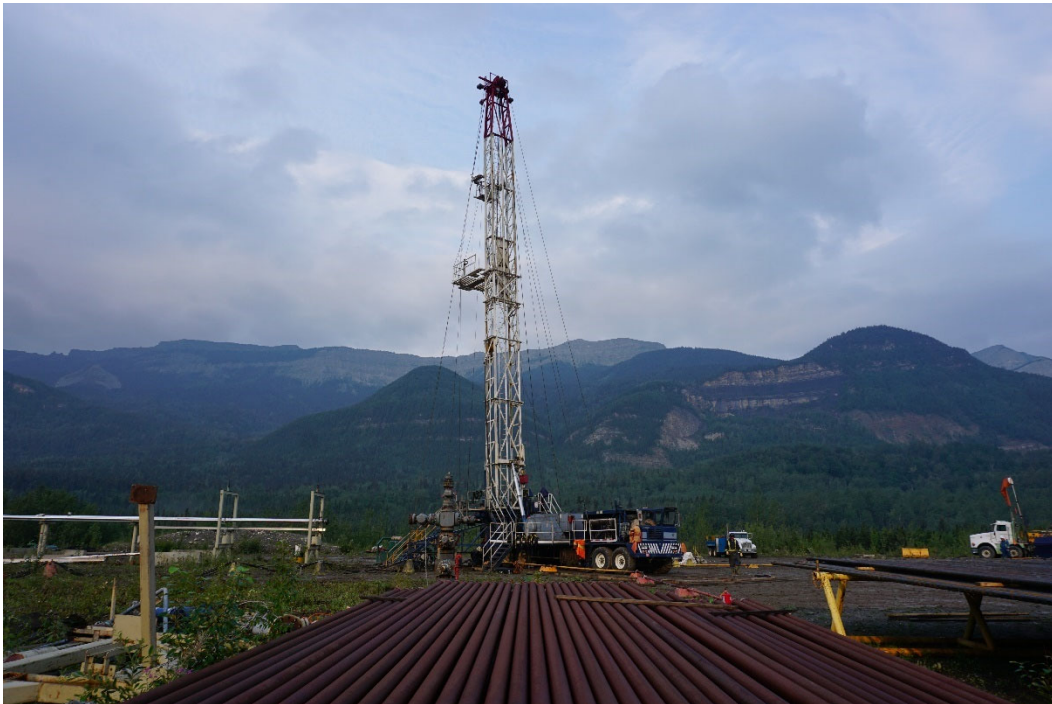
Rig matting  Compliant  Non-Compliant  Corrected Non- Compliance  
Comments: Rig matting was present under the service rig (Photo #10).

Photo #10: Rig matting placed below the rig during active operations.

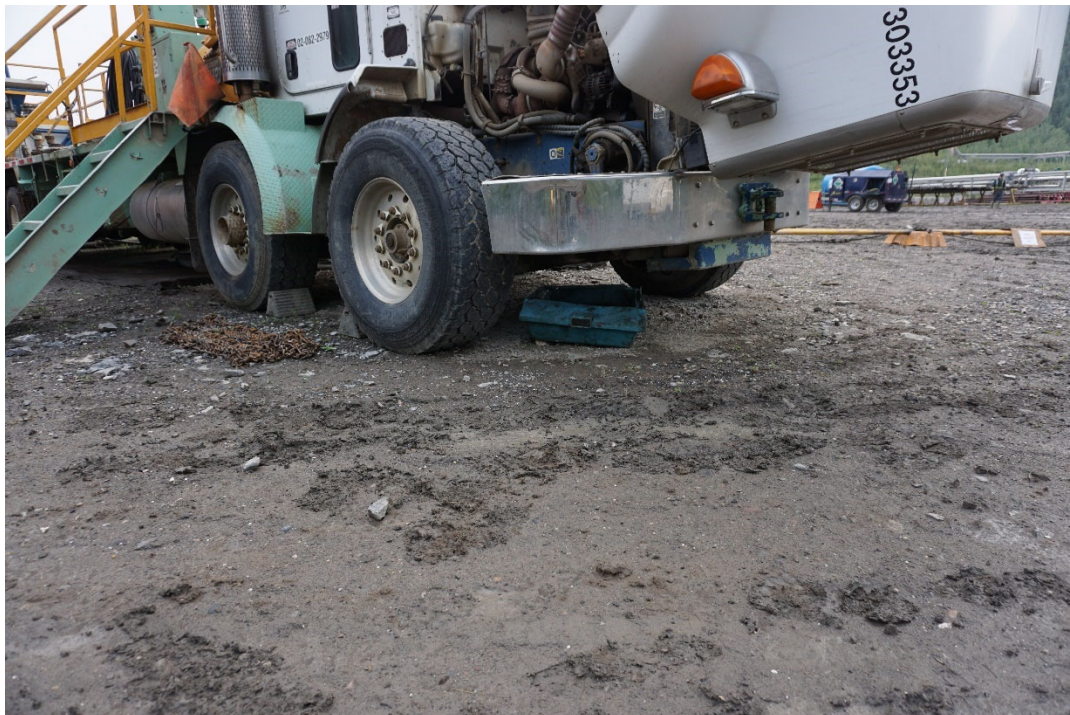
Drip trays  Compliant  Non-Compliant  Corrected Non- Compliance  
Comments: Drip trays were placed under parked equipment and no concerns were noted (Photo #11).

Photo #11: Drip tray placed below parked equipment.

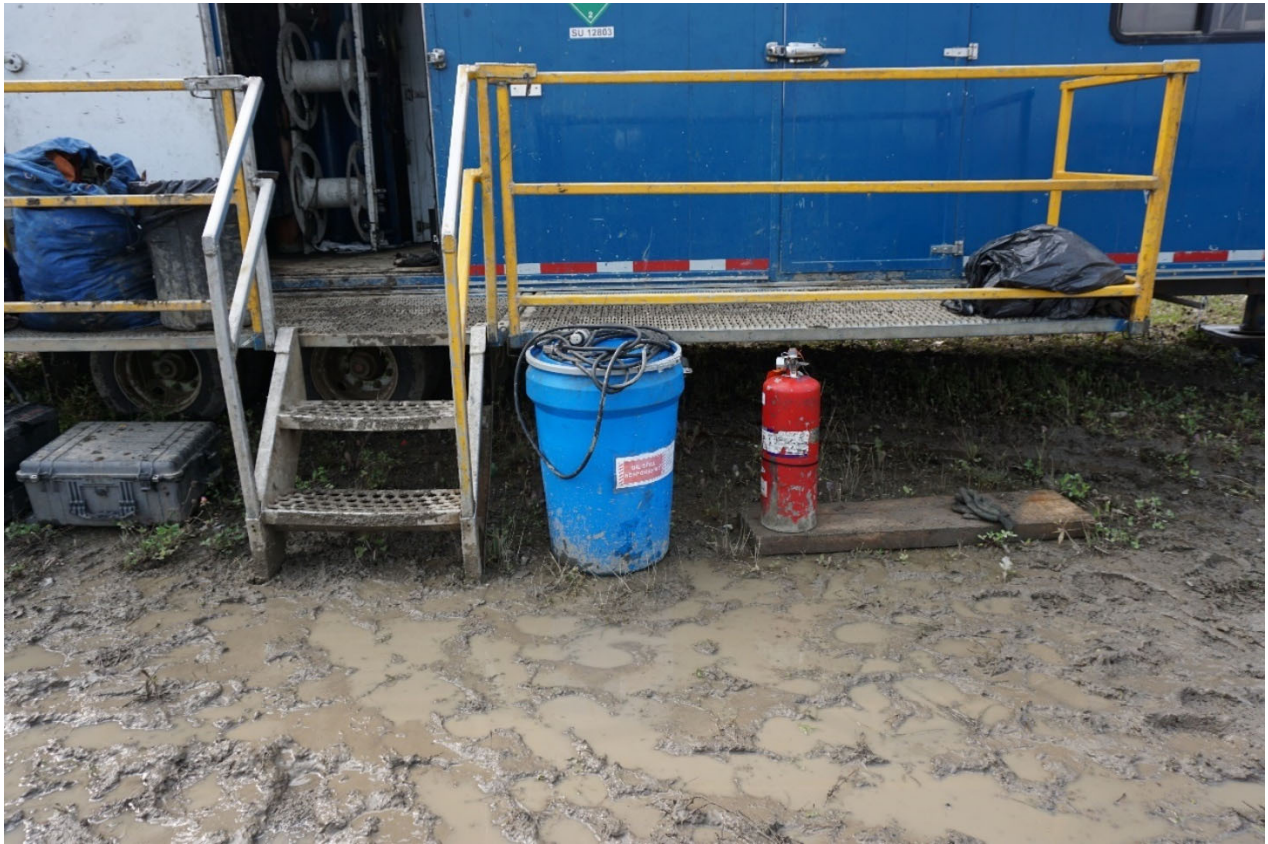
Spill response equipment on site and accessible  Compliant  Non-Compliant  Corrected Non- Compliance  
Comments: A 205l spill kit was placed in a visible area near the doghouse. (Photo #12).

Photo #12: A 205l Spill Kit was present on site and no concerns were noted.
