Inspection: Liard M-25 (WID 1867) Well – ACW-2022-PAR-M-25-WID1867

OROGO Operations Inspection Summary Report

Well name: Liard M-25

Nature of activity: Abandonment

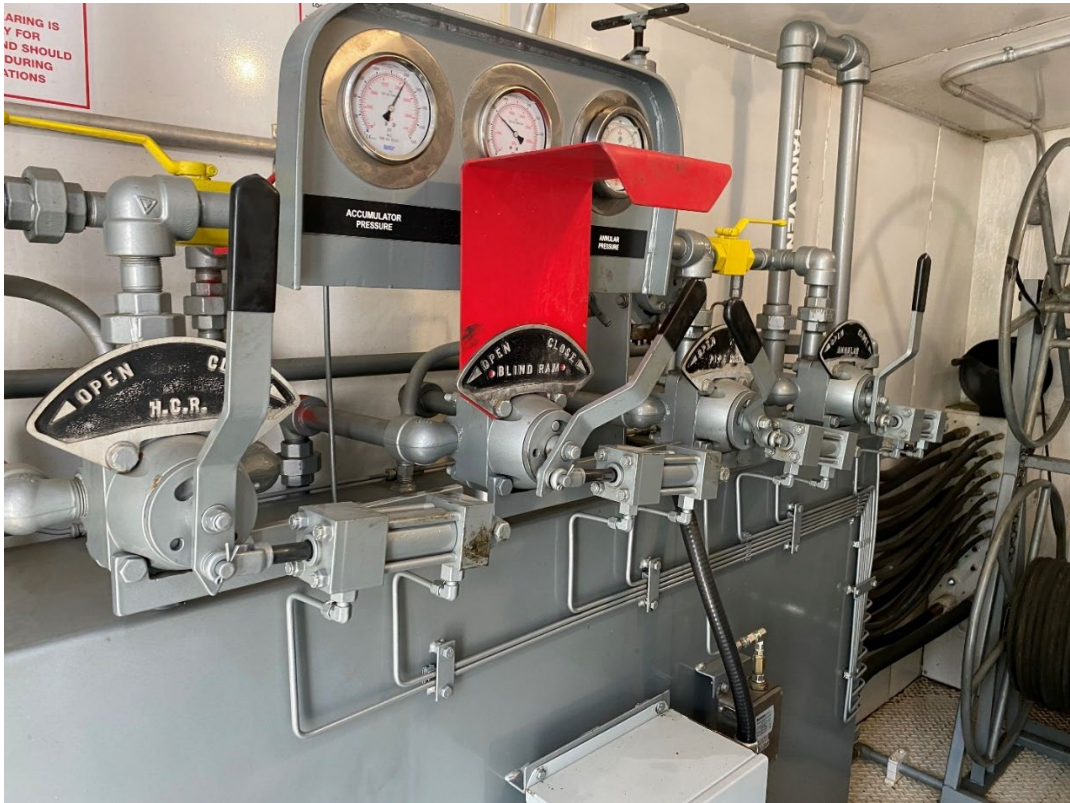
Accumulator function test	<input checked="" type="checkbox"/> Compliant <input type="checkbox"/> Non-Compliant <input type="checkbox"/> Corrected Non-Compliance	Comments: Function test was conducted during the inspection and no concerns were noted (Photo #1 and 2): <ul style="list-style-type: none"> Starting Pressure: 21 MPa Pipe Ram (Closed): 4 sec / 18.5 MPa Blind Ram (Closed): 5 sec / 16.5 MPa Annular (Closed) : 23 sec / 11.5 MPa Recharge: 2min 44sec / 21MPa
Sufficient N ₂ back-up?	<input checked="" type="checkbox"/> Compliant <input type="checkbox"/> Non-Compliant <input type="checkbox"/> Corrected Non- Compliance	Comments: N ₂ located in the accumulator building were sufficient to provide a redundant pressure to the accumulator during actuation.
BOP drills and documentation	<input checked="" type="checkbox"/> Compliant <input type="checkbox"/> Non-Compliant <input type="checkbox"/> Corrected Non- Compliance	Comments:

Photo #1: Accumulator

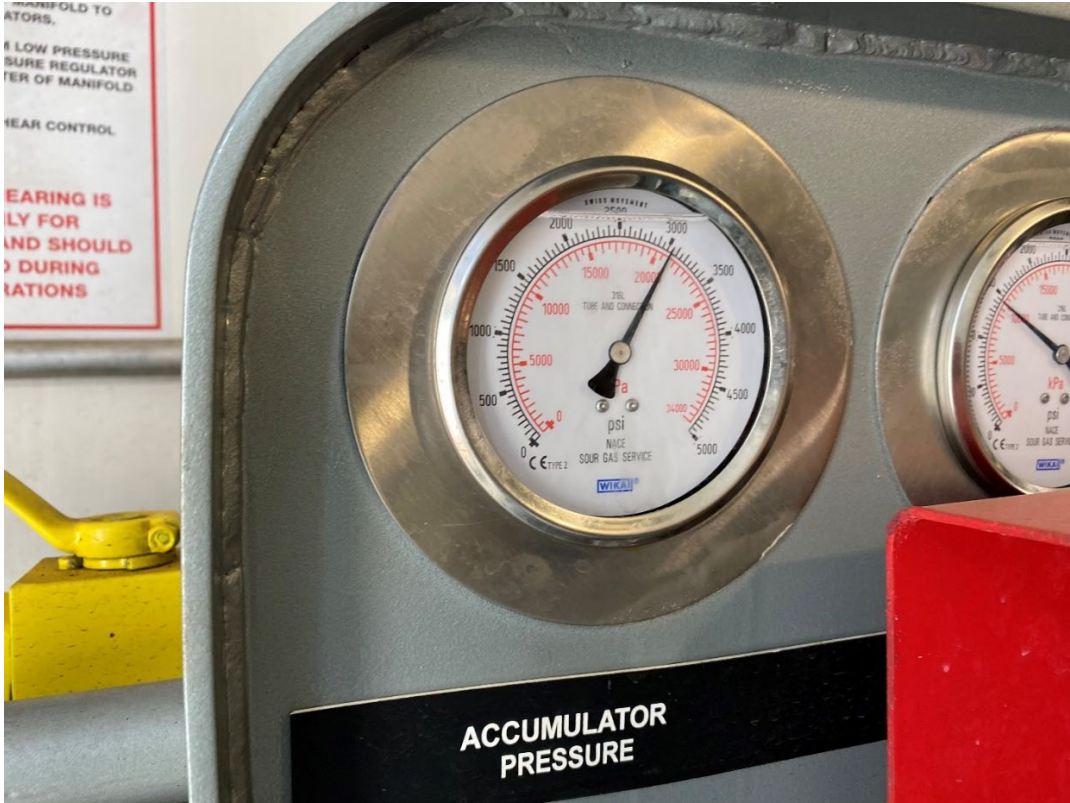
Photo # 2: Accumulator initial pressure at 21 MPa

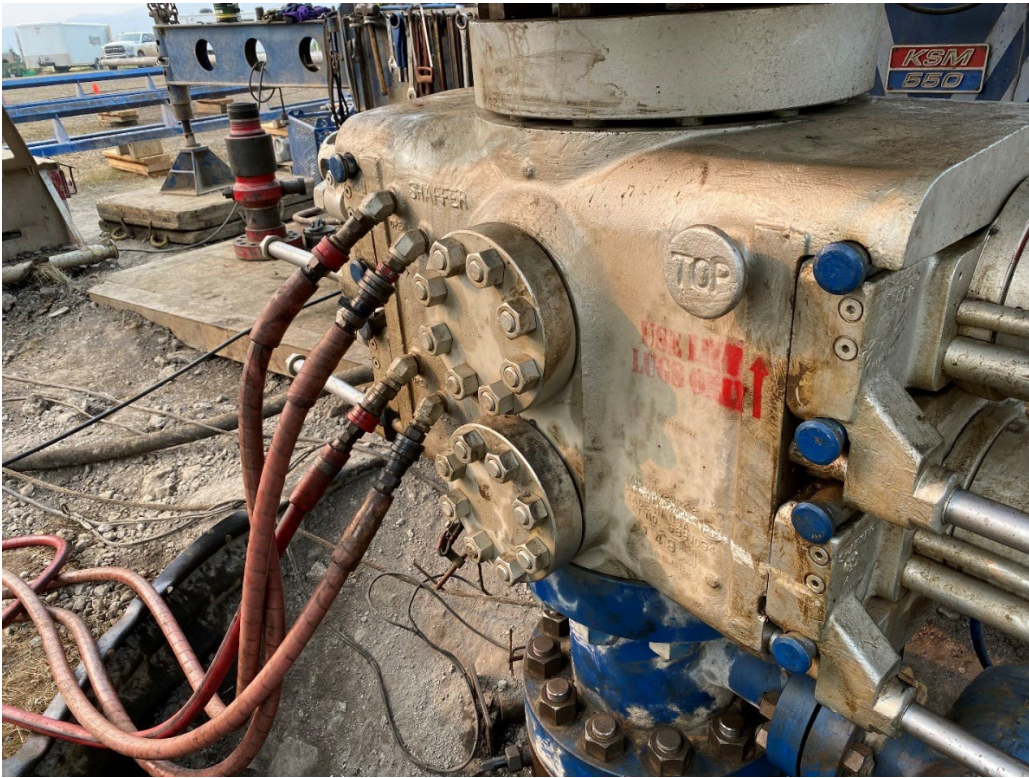
Function tests and documentation	<input checked="" type="checkbox"/> Compliant <input type="checkbox"/> Non-Compliant <input type="checkbox"/> Corrected Non- Compliance	Comments:
Equipment certifications	<input checked="" type="checkbox"/> Compliant <input type="checkbox"/> Non-Compliant <input type="checkbox"/> Corrected Non- Compliance	Comments: All certifications were checked on site and matched the equipment in use. NOTE: the certifications for the pressure vessel, while confirmed valid on site, were not provided as part of equipment certifications submitted by Paramount as stipulated in term 12 of the well approval.
BOP certifications	<input checked="" type="checkbox"/> Compliant <input type="checkbox"/> Non-Compliant <input type="checkbox"/> Corrected Non- Compliance	Comments: The Annular (S/N: MP3374) and Double Gate (S/N: MP3373) had valid certificates and was the equipment in use on site (Photo #3 and 4).

Photo #3: Double Gate in use on site

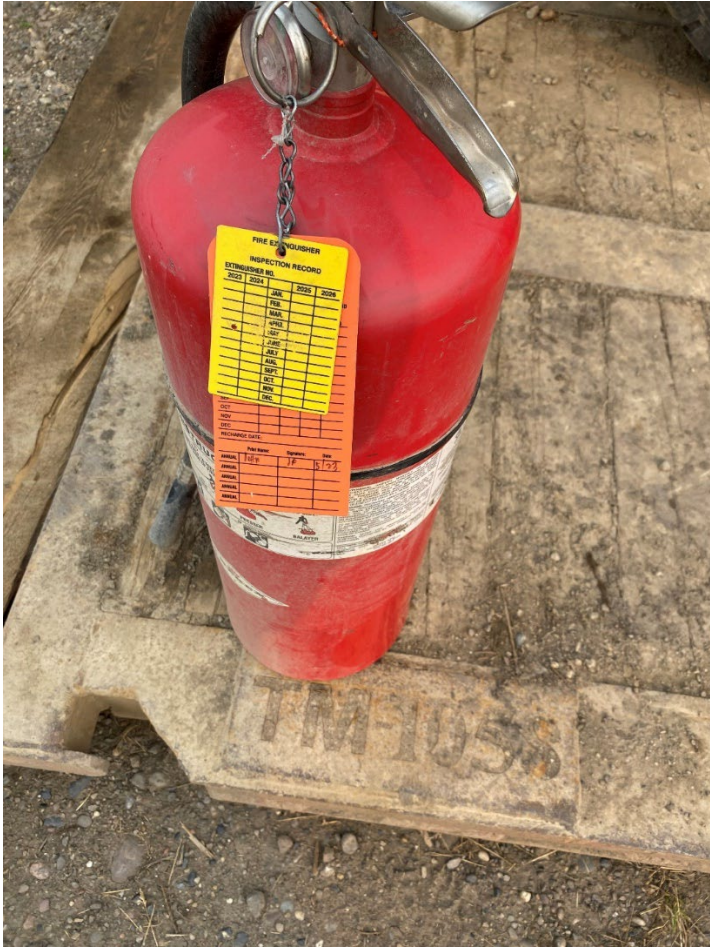
Fire extinguishers	<input checked="" type="checkbox"/> Compliant <input type="checkbox"/> Non-Compliant <input type="checkbox"/> Corrected Non- Compliance	Comments: All fire extinguishers inspected were confirmed operable within the last 12 months (Photo # 5)

Photo #5: Fire extinguisher last inspected May 2023

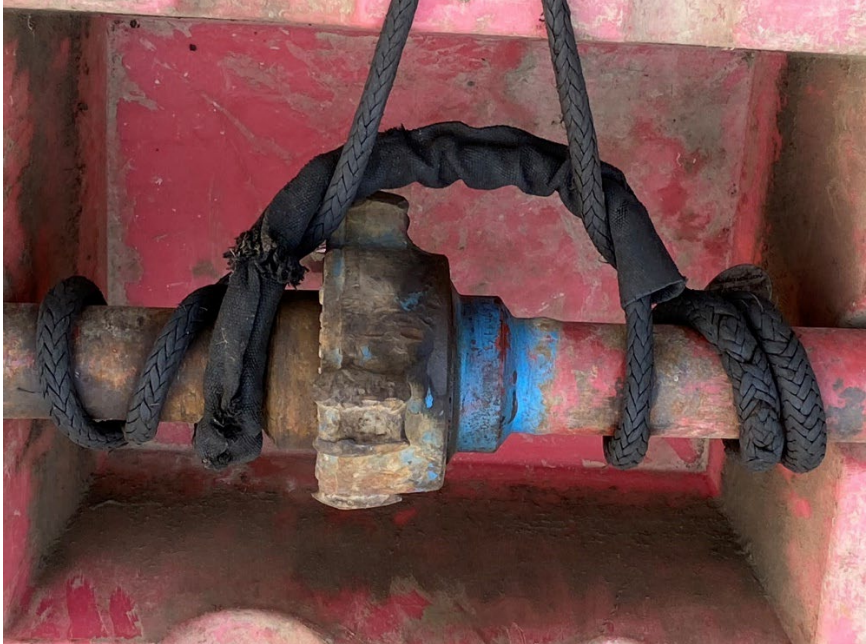
Equipment spacing	<input checked="" type="checkbox"/> Compliant <input type="checkbox"/> Non-Compliant <input type="checkbox"/> Corrected Non- Compliance	Comments: All equipment spacing at the time of the inspection were compliant: <ul style="list-style-type: none"> Well Centre to Flare: 52m Well Centre to Doghouse: 29m Well Centre to Rig Tank: 72m Well Centre to E-Line: 30m Pump to Rig Tank: 7m Flare to Pressure Tank: 37m
Engine kills	<input type="checkbox"/> Compliant <input type="checkbox"/> Non-Compliant <input checked="" type="checkbox"/> Corrected Non- Compliance	Comments: the rig pump Engine kill did not function on the first attempt. This non-compliance was diagnosed to be a blown fuse and was replaced which rectified the problem. All other engine kills worked as designed.
Pump lines and hoses secured, intact and appropriate?	<input checked="" type="checkbox"/> Compliant <input type="checkbox"/> Non-Compliant <input type="checkbox"/> Corrected Non- Compliance	Comments: All pump lines and hoses were secured and intact at the time of inspection (Photo #6)

Photo #6: Flow lines secured

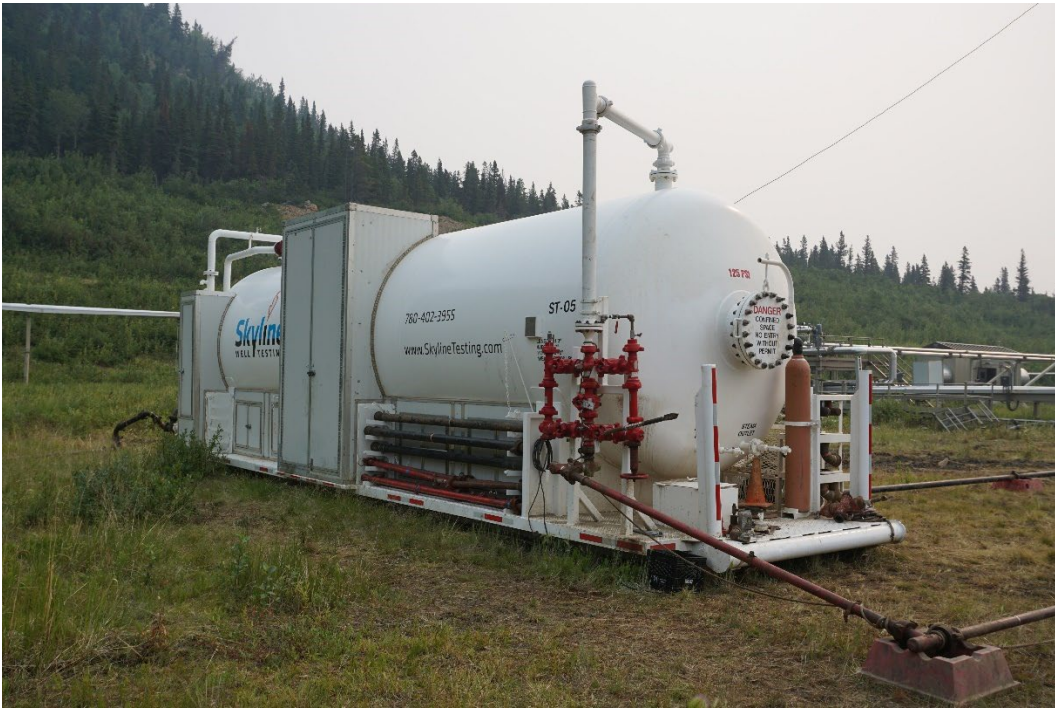
Photo #7: Flow turns were present and installed correctly.

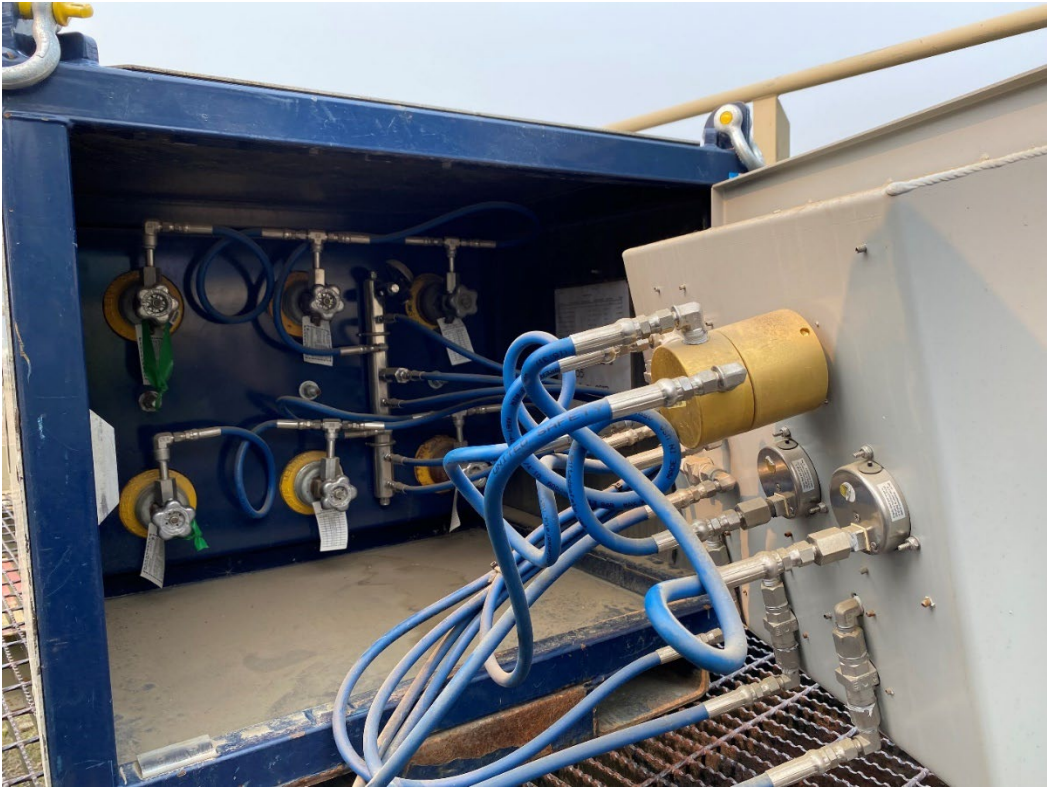
- 6 tank supplied air system (Photo #8)
- Primary manifold located with the supplied air unit.
- A remote manifold was located at the rig
- 300' of 3/8" hose
- 650' of 1/4" hose.

Photo #8: Supplied Air 6 tank system

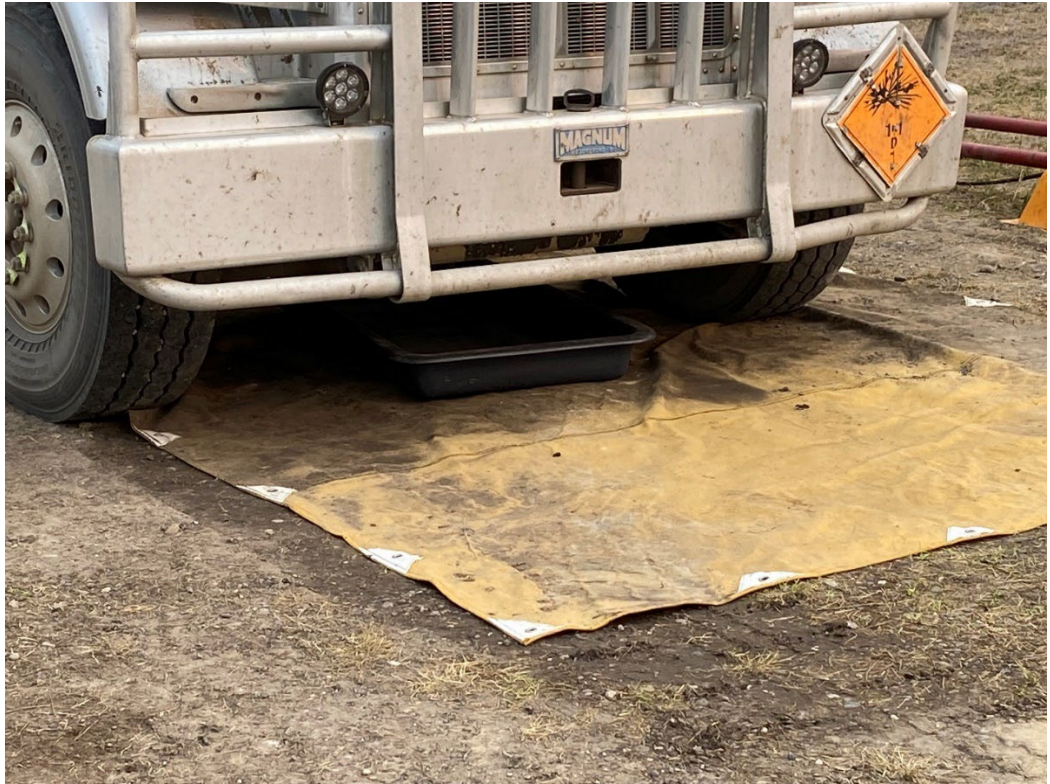
Drip trays	<input checked="" type="checkbox"/> Compliant <input type="checkbox"/> Non-Compliant <input type="checkbox"/> Corrected Non- Compliance	Comments: Drip trays were present on site. Photo #10
------------	---	--

Photo #10: Drip trays in place under equipment

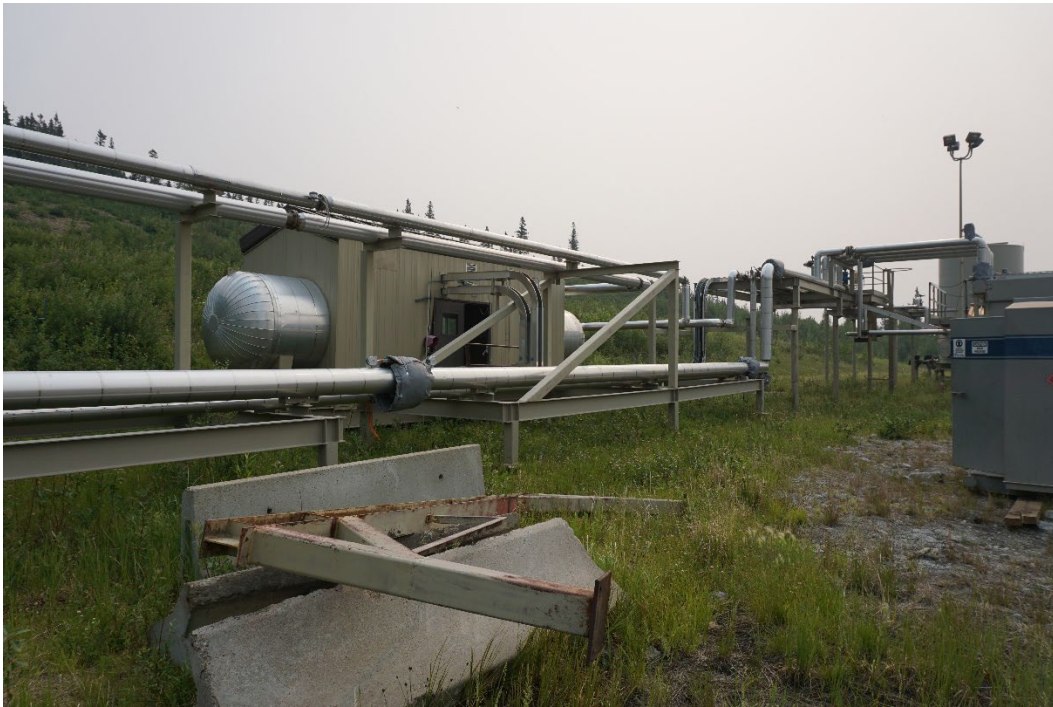
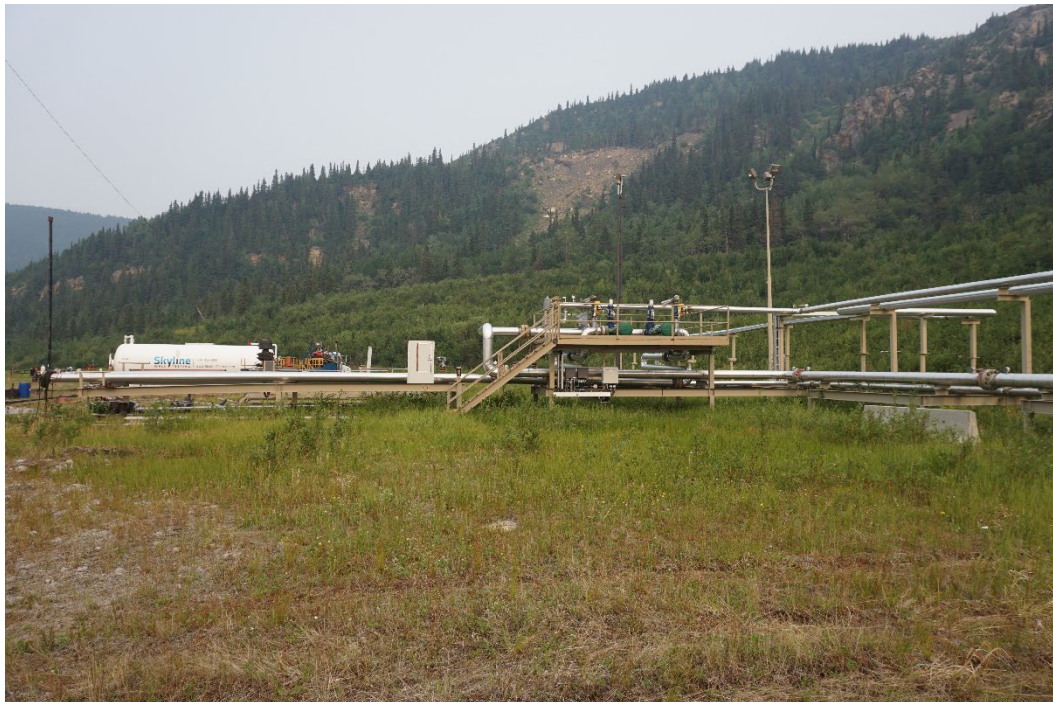
It was noted during the inspection there were surface oil and gas installations on the site (Photos #11 & #12). As per section 6E of the *Well suspension and Abandonment Guidelines and Interpretation Notes*, all installations must be removed within 12 months of the cutting and capping operations.

Photo #11: Installations on site

Photo #12: Another view of Installations on site that must be removed within 12 months of an abandonment of a well.
