## OROGO Well Inspection Summary Report

Well name: Cameron E-07

4 digit WID: 2042

Date of inspection: 2022-09-23

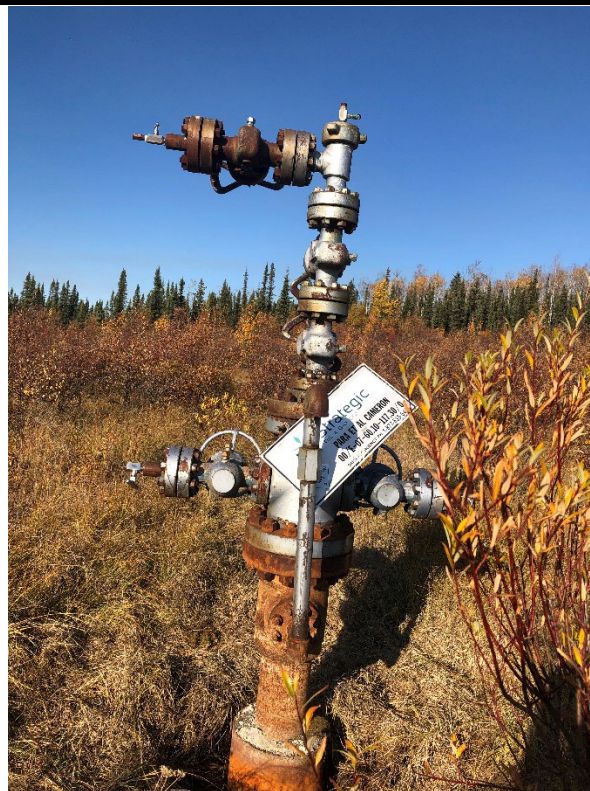
**Photo #2:** E-07 wellhead

- 1) WELLHEAD SIGN: The current wellhead sign indicating the well name and ID does not meet the requirements of Section 5A of the revised Well Suspension and Abandonment Guidelines and Interpretation Notes (Guidelines) issued in 2022 (Photo #2). This sign does however meet the requirements of the Guidelines issued in 2017. During the next planned visit of Strategic Oil and Gas Ltd.(Strategic) to this well, the sign will have updated to reflect the requirements of Section 5A of the Guidelines revised in 2022 .

- 2) WIND INDICATOR: There was no wind indicator on site at the time of inspection. During the next planned visit of Strategic to this well, a wind indicator will need to be installed to meet requirements of Section 5A of the Guidelines (See photo #2).

- 3) BRUSHING AROUND WELLHEAD: During the inspection, vegetation had encroached the area surrounding the wellhead (See Photo #2). Section 5A of the Guidelines requires clearing of all brush and debris within 25m of the wellhead. During the next planned visit of Strategic to this well, brushing will need to meet the requirements of Section 5A of the Guidelines.
