OROGO Well Inspection Summary Report

Well name: Cameron F-73

Operator: Strategic Oil and Gas

Date of inspection: 2022-09-23

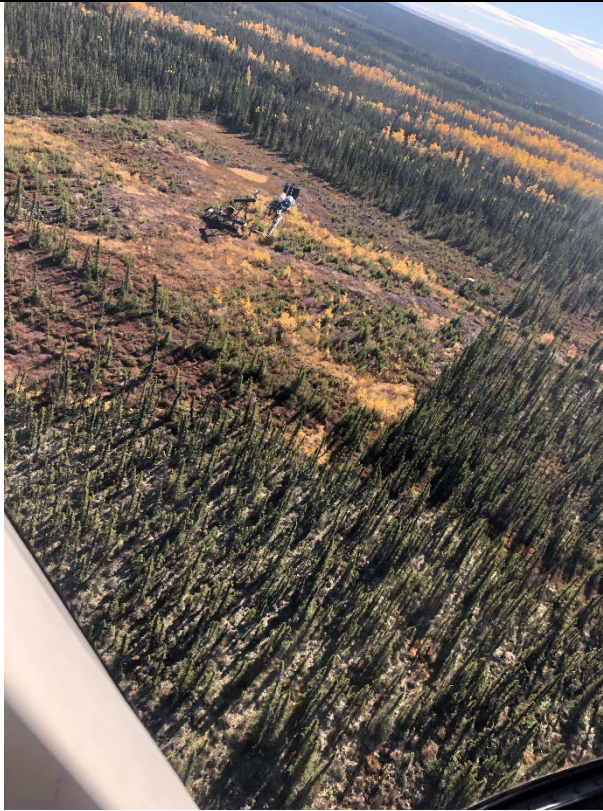
Photo #1: Aerial view of F-73/2F-73 well site

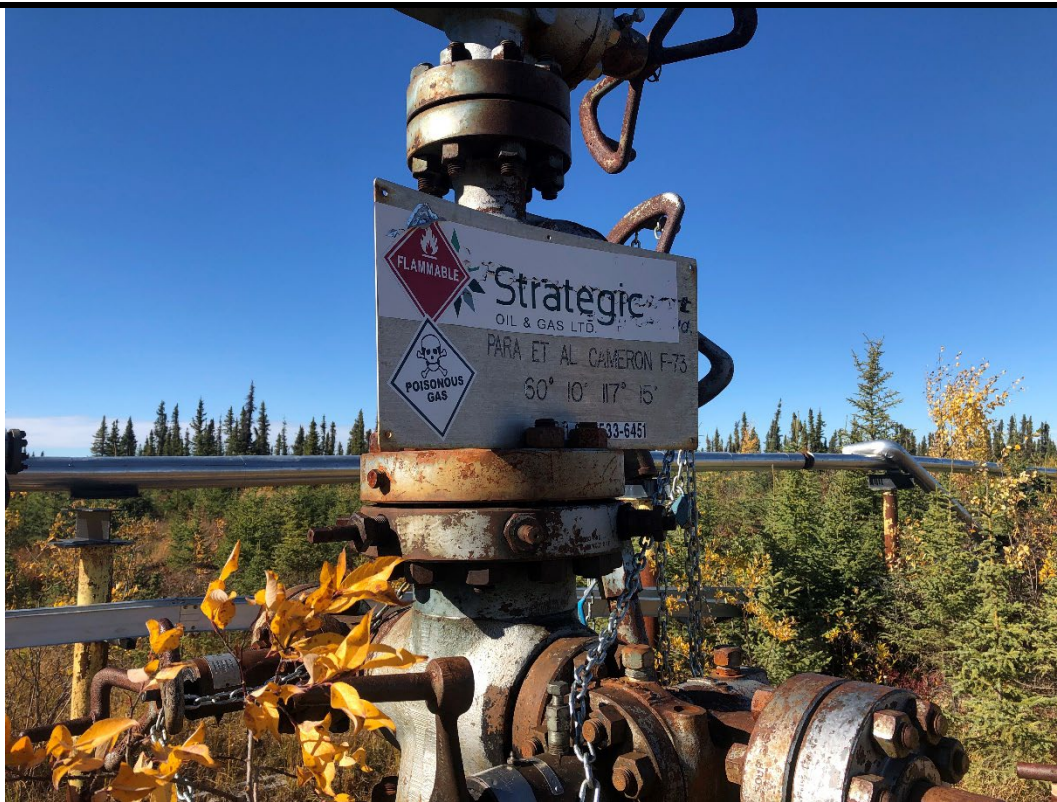
1) WELLHEAD SIGN: The current wellhead sign indicating the well name and ID does not meet the requirements of Section 5A of the revised Well Suspension and Abandonment Guidelines and Interpretation Notes (Guidelines) issued in 2022 (Photo #2). This sign does however meet the requirements of the Guidelines issued in 2017. During the next planned visit of Strategic Oil and Gas Ltd.(Strategic) to this well, the sign will have to be updated to reflect the requirements of Section 5A of the Guidelines revised in 2022 .

2) BRUSHING AROUND WELLHEAD: During the inspection, vegetation had encroached the area surrounding the wellhead (See Photo #2). Section 5A of the Guidelines requires clearing of all brush and debris within 25m of the wellhead. During the next planned visit of Strategic to this well, brushing will need to meet the requirements of Section 5A of the Guidelines.

Photo #2: F-73 wellhead

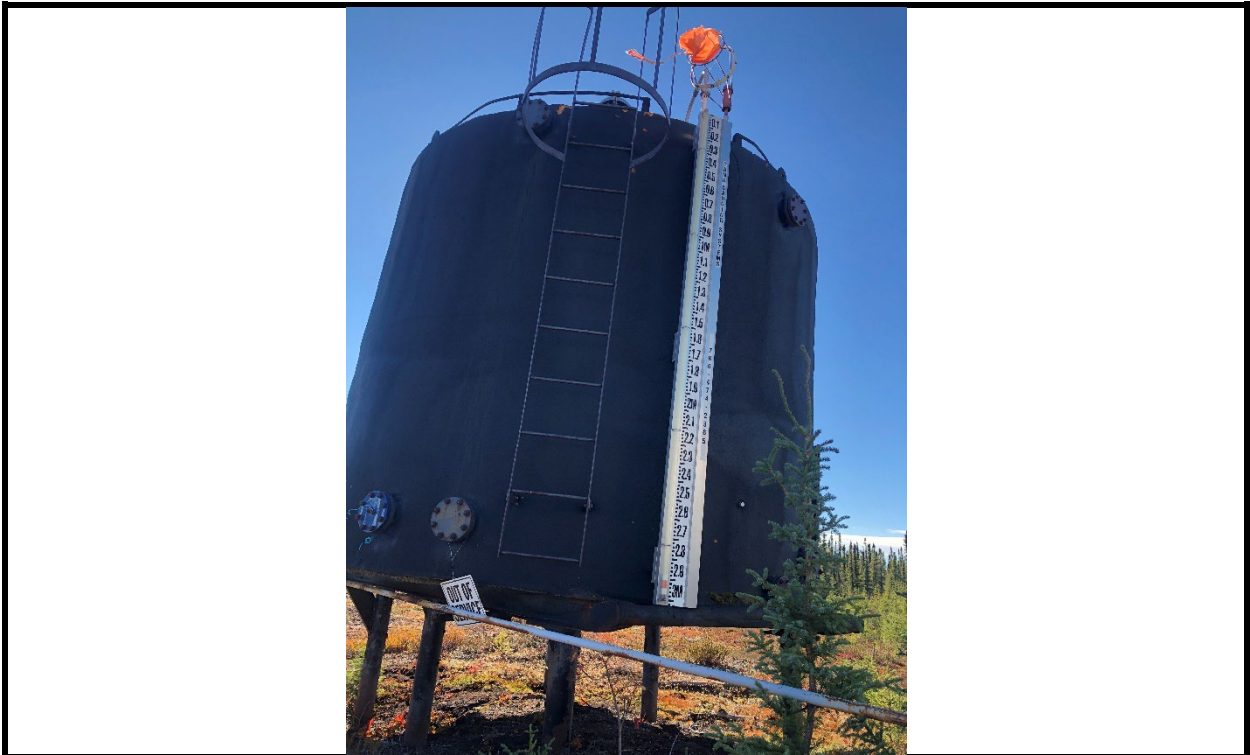
EXISTING INFRASTRUCTURE: This site shares facilities on the same block as Cameron 2F-73 (WID2025). One fuel tank and three chemical storage tanks were on site at the time of inspection. All tanks are empty and marked 'Out of Service'. In addition, there is a flare line and gathering system pipeline that have all been blinded and discontinued as well as a pump jack on site. This infrastructure will require removal within 12 months of abandoning the well.

Photo #3: Fuel tank (Empty) and wind indicator

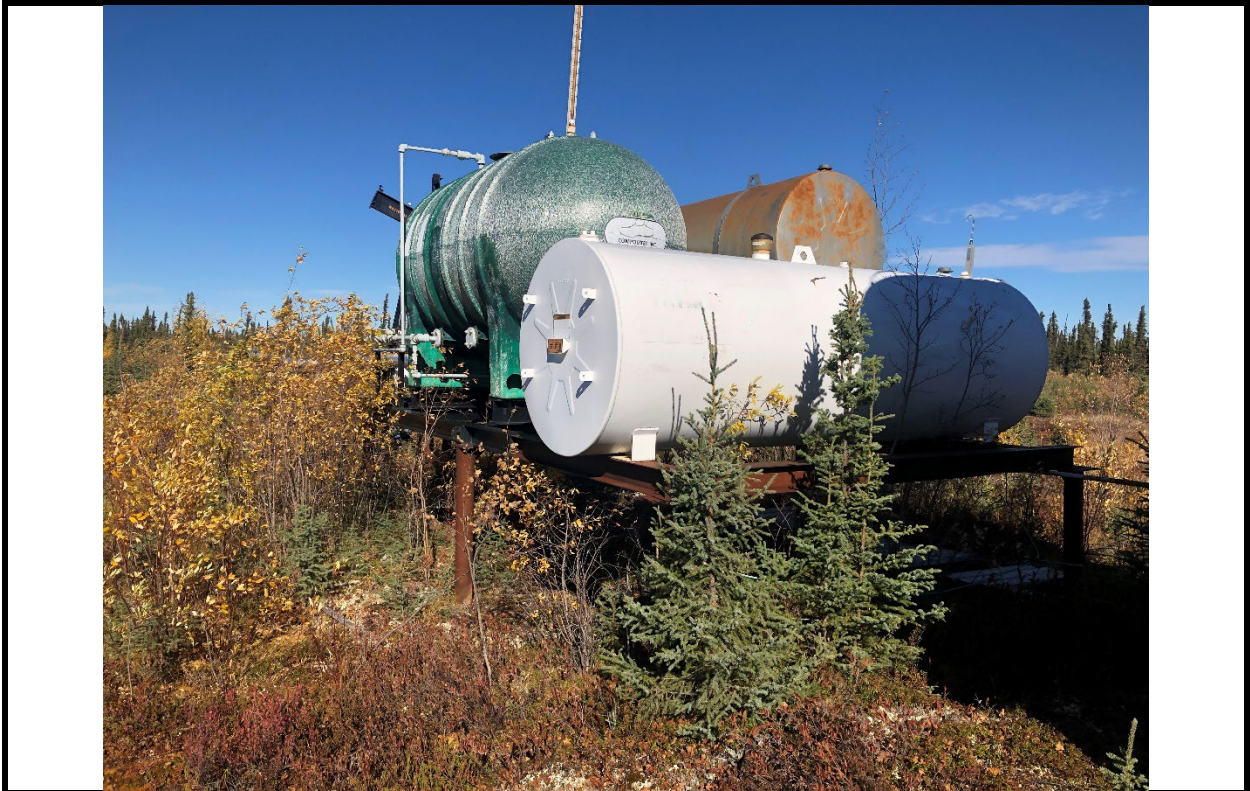
Photo #4: Chemical storage tanks (empty)

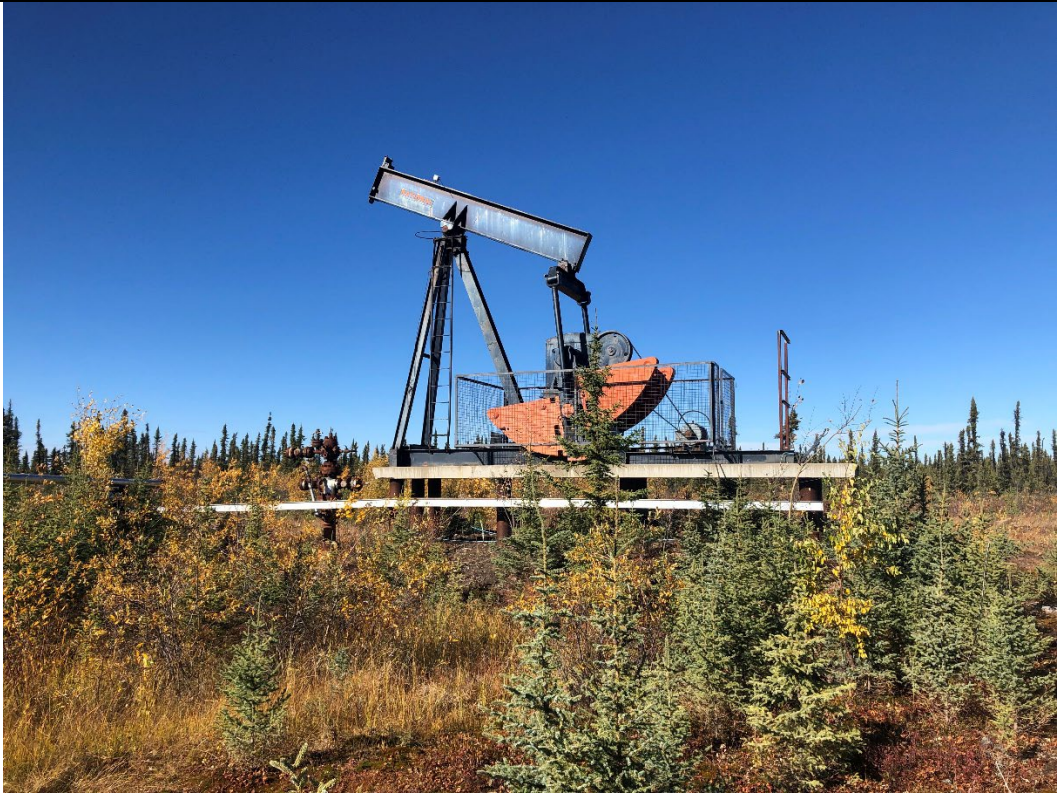
Photo #5: Pump jack at F-73/2F73

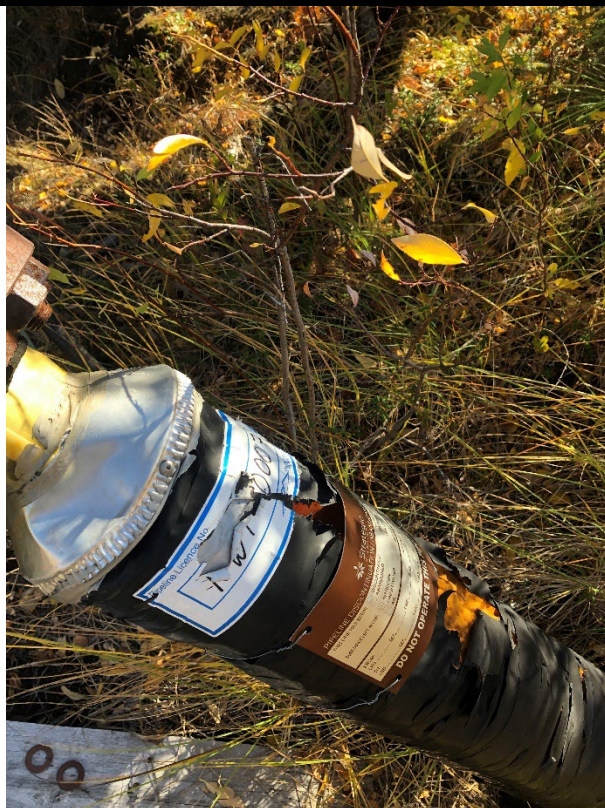
Photo #6: F-73/2F-73 inlet to gathering system. Tagged 'Do Not Operate'
