## OROGO Well Inspection Summary Report

Well name: Cameron F-75

4 digit WID: 1971

Date of inspection: 2022-09-23

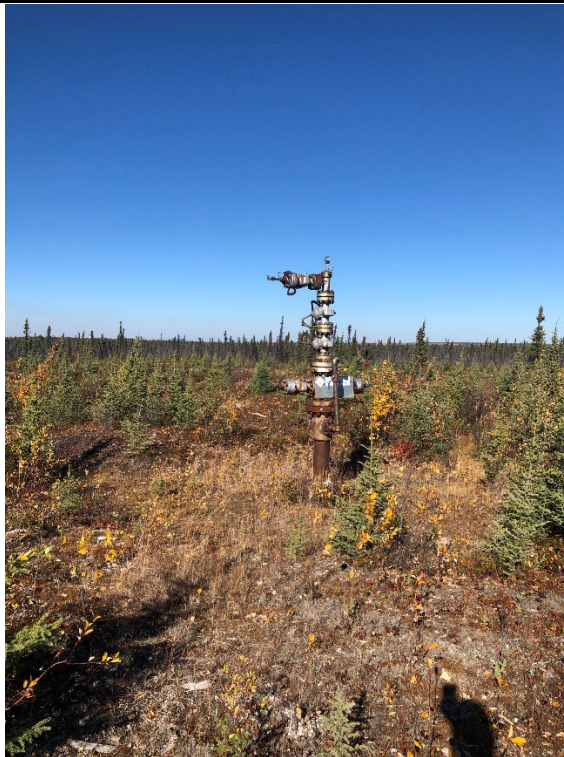
**Photo #2:** F-75 wellhead

- 2) BRUSHING AROUND WELLHEAD: During the inspection, vegetation had encroached the area surrounding the wellhead (See Photo #2). Section 5A of the Guidelines requires clearing of all brush and debris within 25m of the wellhead. During the next planned visit of Strategic to this well, brushing will need to meet the requirements of Section 5A of the Guidelines.

- 3) WIND INDICATOR: There was no wind indicator on site at the time of inspection. During the next planned visit of Strategic to this well, a wind indicator will need to be installed to meet requirements of Section 5A of the Guidelines (See photo #2).

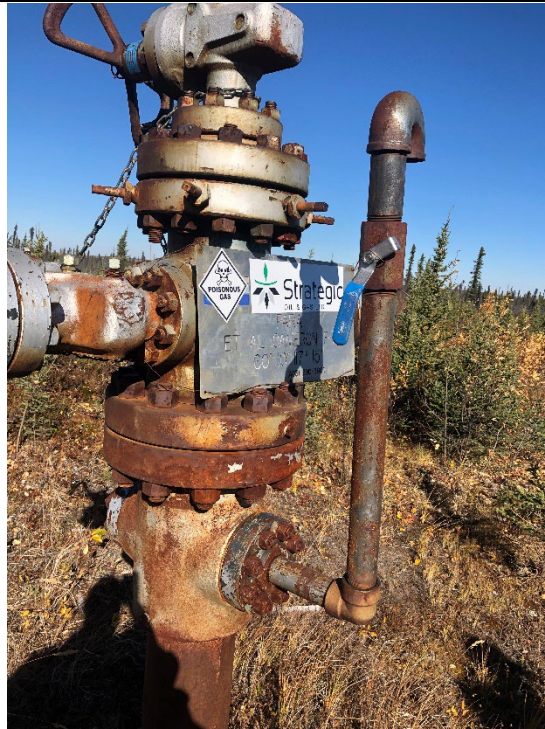
**Photo #3:** F-75 wellhead sign

- 1) WELLHEAD SIGN: The current wellhead sign indicating the well name and ID does not meet the requirements of Section 5A of the revised Well Suspension and Abandonment Guidelines and Interpretation Notes (Guidelines) issued in 2022. In addition the current sign does not provide the correct emergency contact information (See photo #3). During the next planned visit of Strategic Oil and Gas Ltd. (Strategic) to this well, the sign will have updated to reflect the requirements of Section 5A of the Guidelines revised in 2022.
