**Inspection: Cameron M-31 (WID 1122) Well – ACW-2022-SOG-M-31-WID1122**

# OROGO Operations Inspection Summary Report

Well name: Cameron M-31

Nature of activity: Abandonment

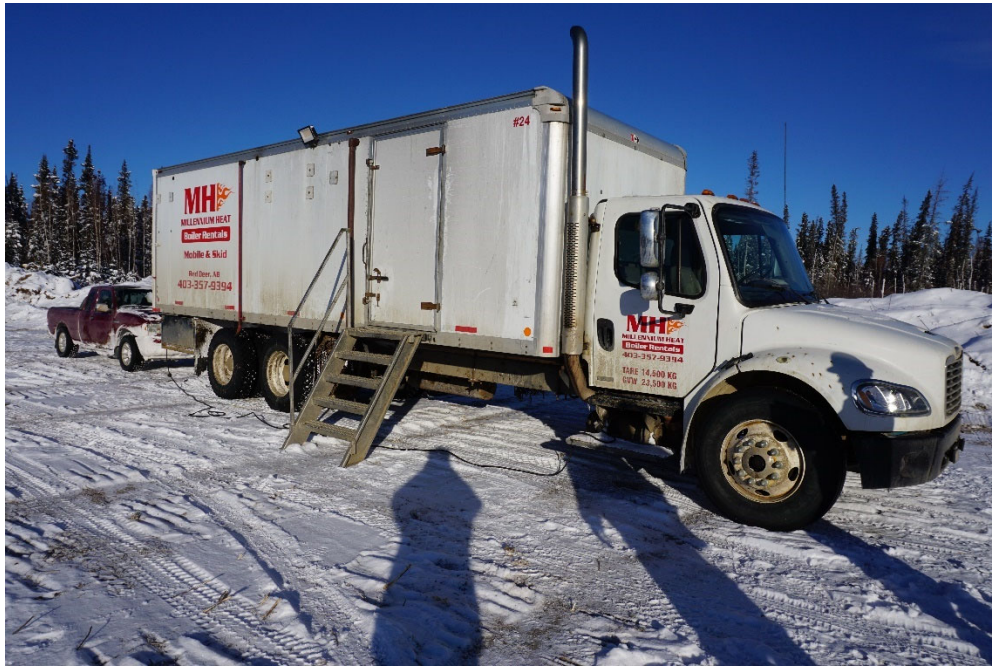
PHOTO #1: View of the Boiler.

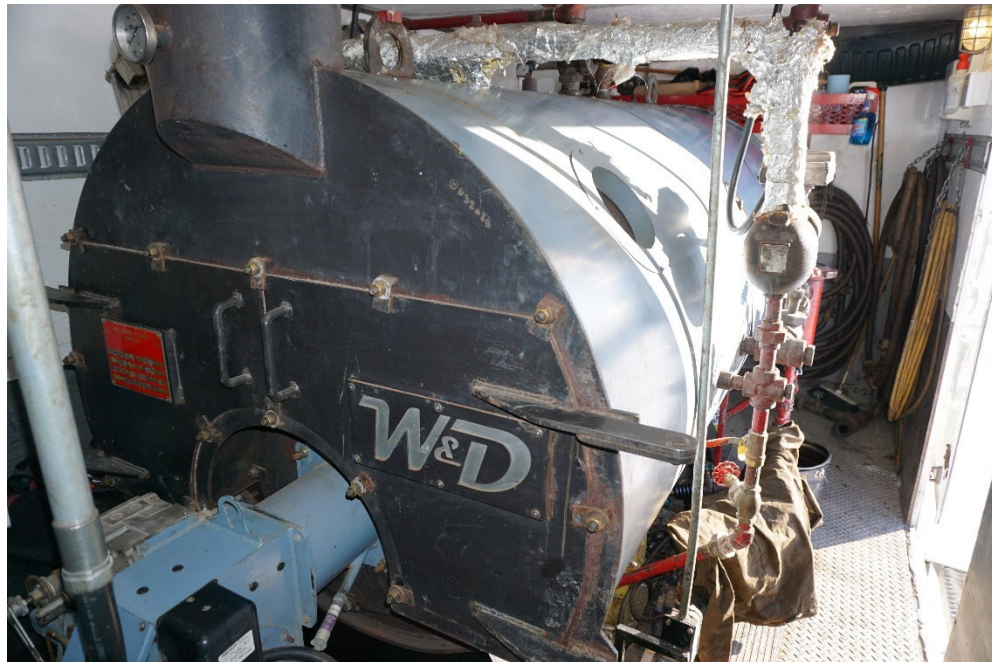
PHOTO #2: Another view of the boiler inside.

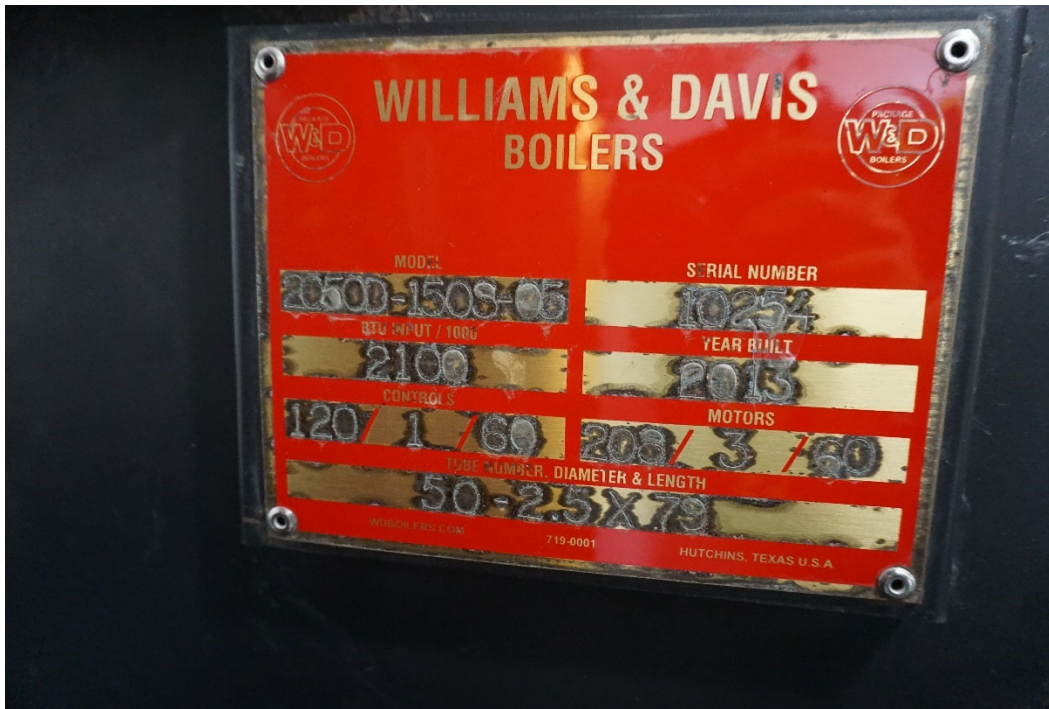
PHOTO #3: Serial number 10254 matched the Certifications on site.

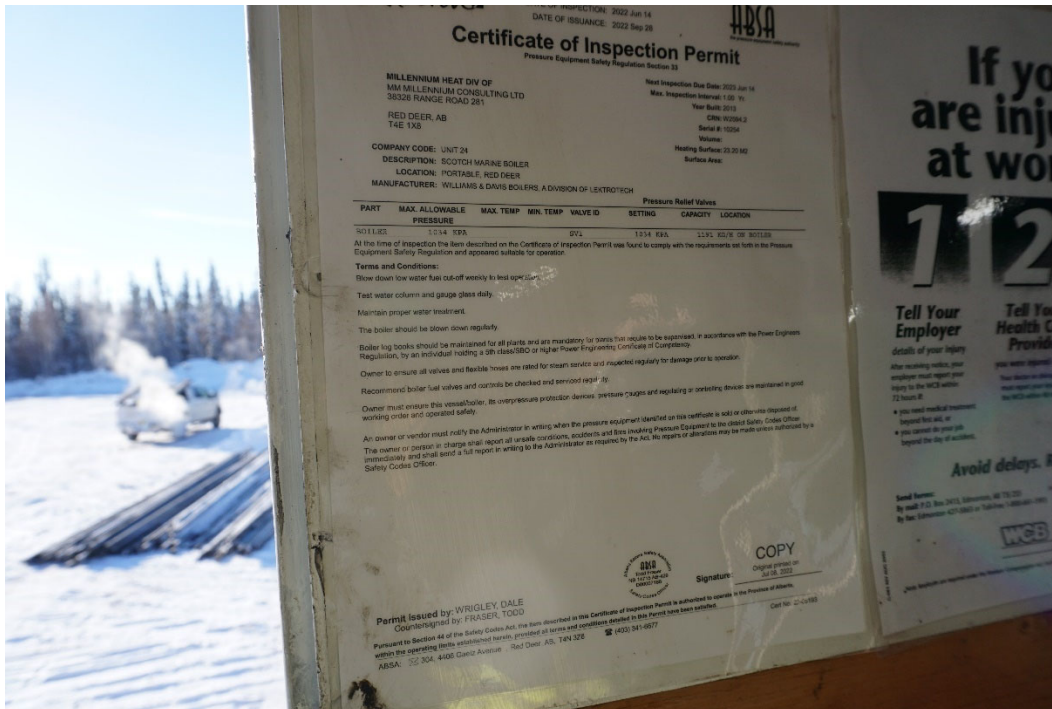
PHOTO #4: View of the Boiler Certifications hung up on the wall inside.

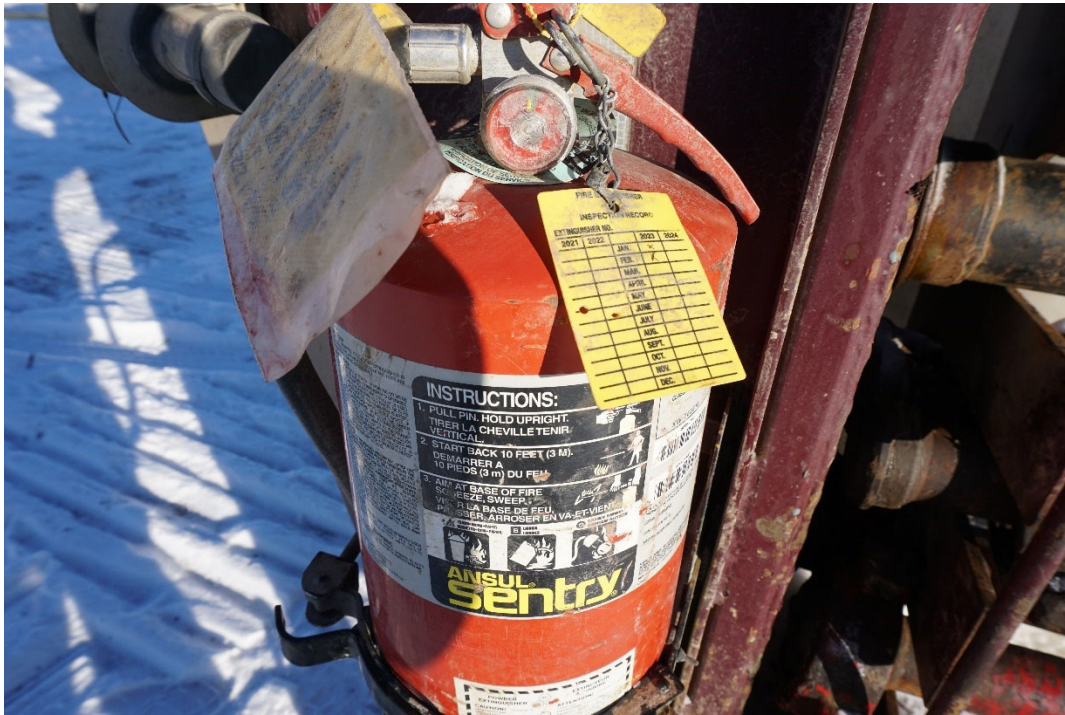
Adequate lighting	<input checked="" type="checkbox"/> Compliant <input type="checkbox"/> Non-Compliant <input type="checkbox"/> Corrected Non- Compliance	Comments: The inspection was conducted during daylight hours.
Wind indicators visible and functional	<input checked="" type="checkbox"/> Compliant <input type="checkbox"/> Non-Compliant <input type="checkbox"/> Corrected Non- Compliance	Comments: Rig and associated infrastructure were yet to arrive on site.
Fire extinguishers	<input checked="" type="checkbox"/> Compliant <input type="checkbox"/> Non-Compliant <input type="checkbox"/> Corrected Non- Compliance	Comments: All fire extinguishers were inspected and were re-certified within the last 12 months (Photo #5).

PHOTO #5: Fire extinguishers have been recertified within the last 12 months.

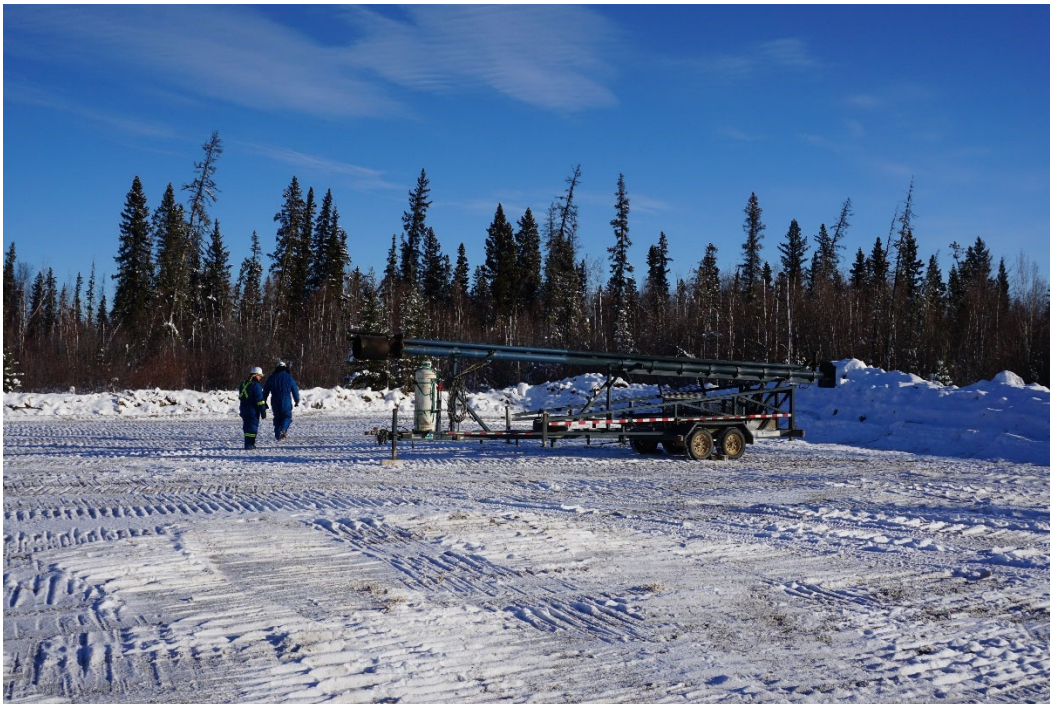
Comments: Only the Pressure tank and the Flare stack were present on site but were not hooked up yet. Inspectors verified distances and realized that the flare stack was under the minimum 50 meters from the well center. Since the crew was just beginning to rig-up, testers were able to move the flare stack to the correct location on the lease (Photo #6).

- Flare stack - Well centre = 50m
- Rig pump - Rig tank = N/A
- Rig Tank - Well centre = N/A
- Pressure tank - Well center = 23.4m
- Doghouse - Well center =N/A
- Flare stack - Pressure tank = 27.2m

PHOTO #6: Flare stack was being re-positioned to an area that was at least 50 meters from the well center.

Spacing requirements of all well abandonment equipment was discussed on site with the site supervisor and Inspectors are confident that all equipment will have the proper minimum spacing during active abandonment operations.

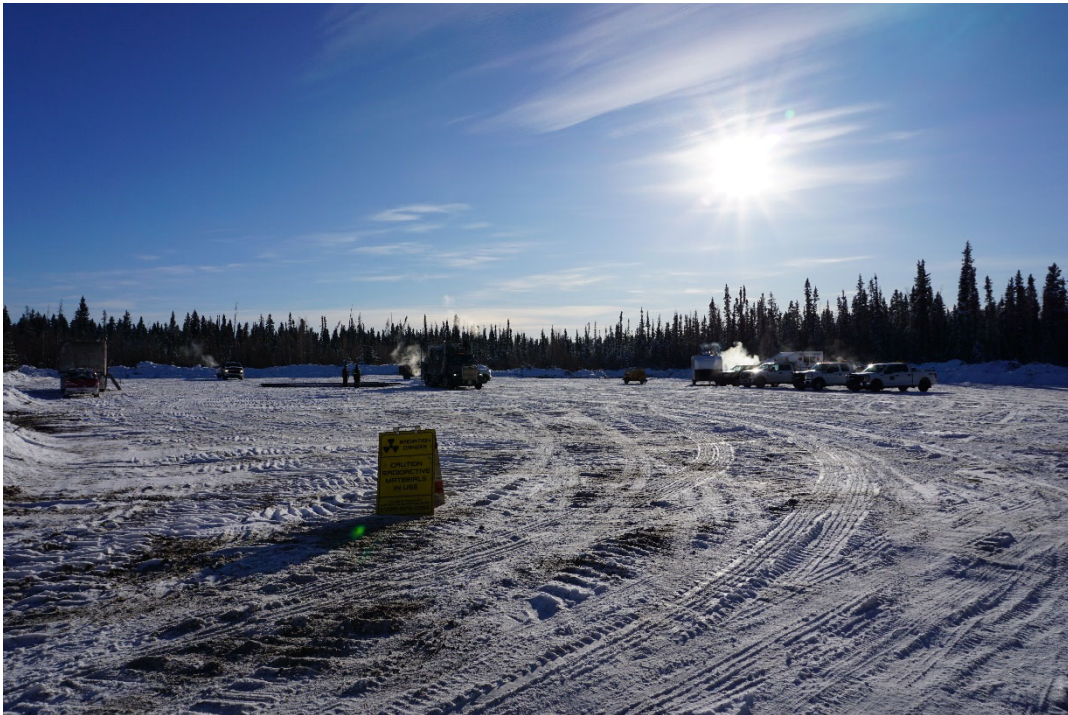
PHOTO #7: Hazard signs were located at the lease entrance.

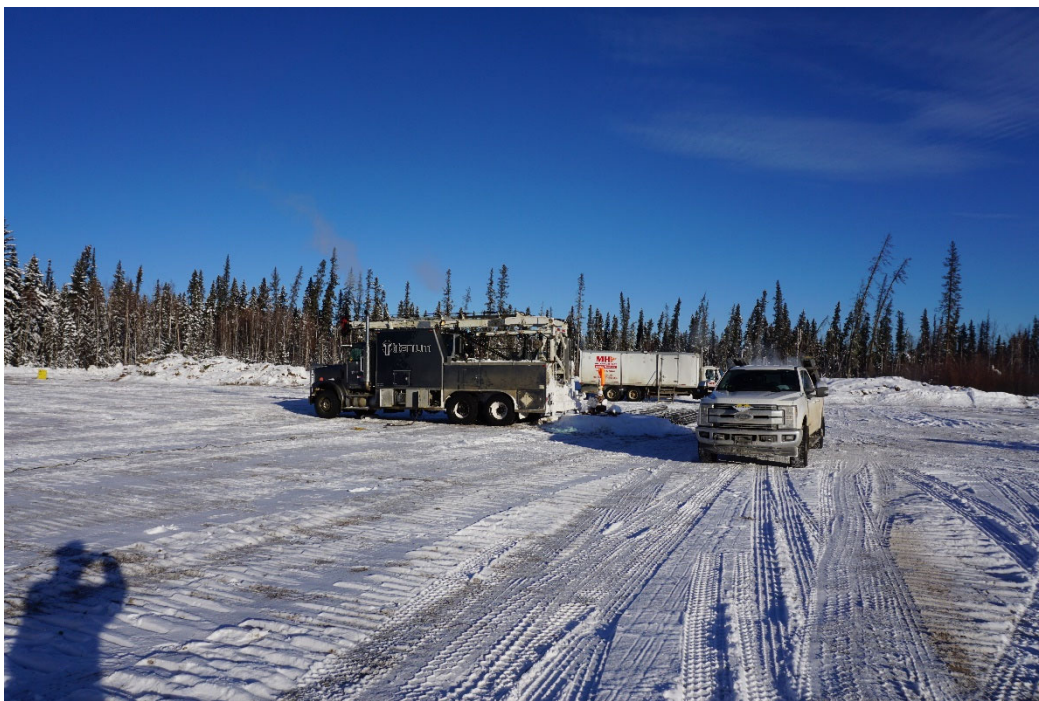
Spill response equipment on site and accessible	<input checked="" type="checkbox"/> Compliant <input type="checkbox"/> Non-Compliant <input type="checkbox"/> Corrected Non- Compliance	Comments: Spill response materials were located on site and no major concerns were noted.
Tubing laydown area protection	<input checked="" type="checkbox"/> Compliant <input type="checkbox"/> Non-Compliant <input type="checkbox"/> Corrected Non- Compliance	Comments: Rig and associated infrastructure were yet to arrive on site, but tubing was staged on the ground surface near the wireline truck (Photo #8).

PHOTO #8: Drill tubing staged on the ground surface behind the wireline truck.
