NWT OFFICE OF THE REGULATOR OF OIL AND GAS OPERATIONS

Inspection: Cameron K-74 (WID 1972) Well – ACW-2023-SOG-K-74-WID1972

OROGO Operations Inspection Summary Report

Well name: Cameron K-74

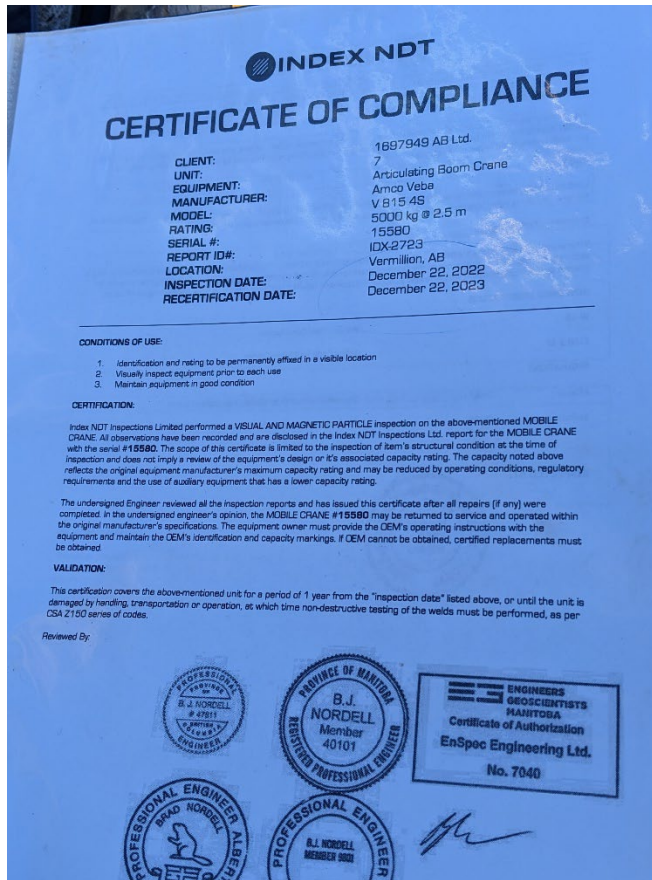
PHOTO #1: Certificate of compliance for the articulating boom crane.

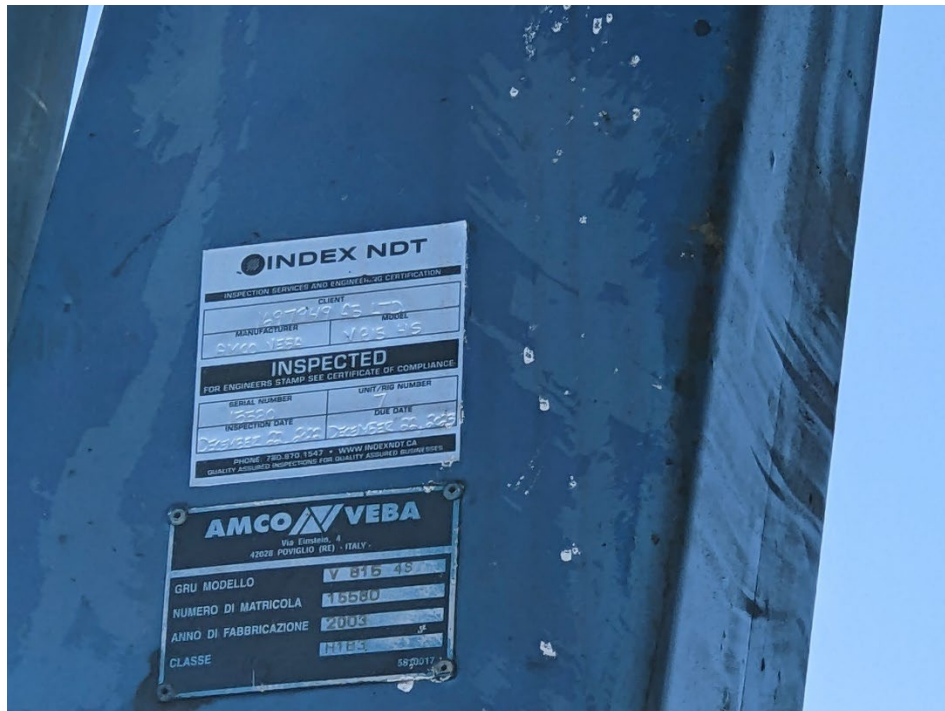
PHOTO #2: Articulating boom crane identification seal.

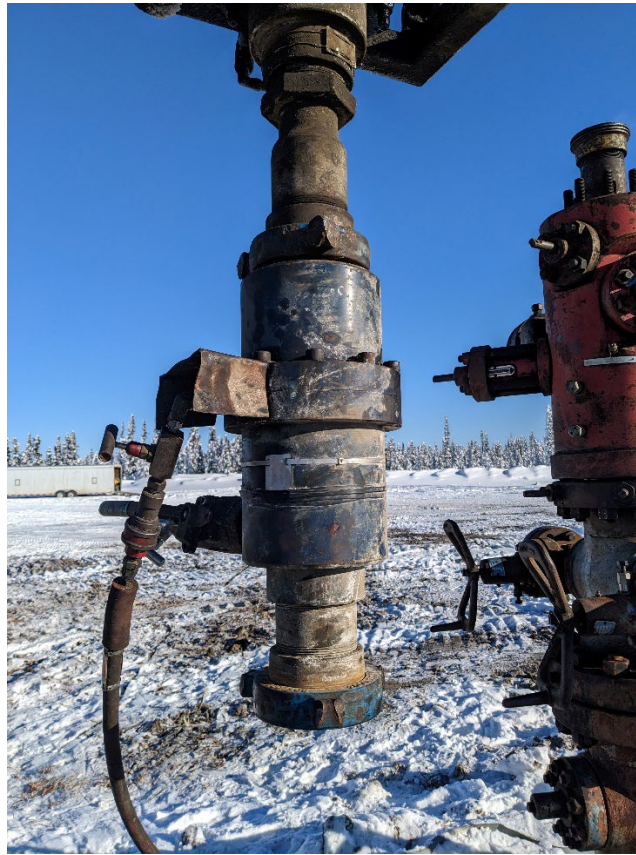
PHOTO #3: Coiled tubing annular disconnected after down hole abandonment operations were complete.

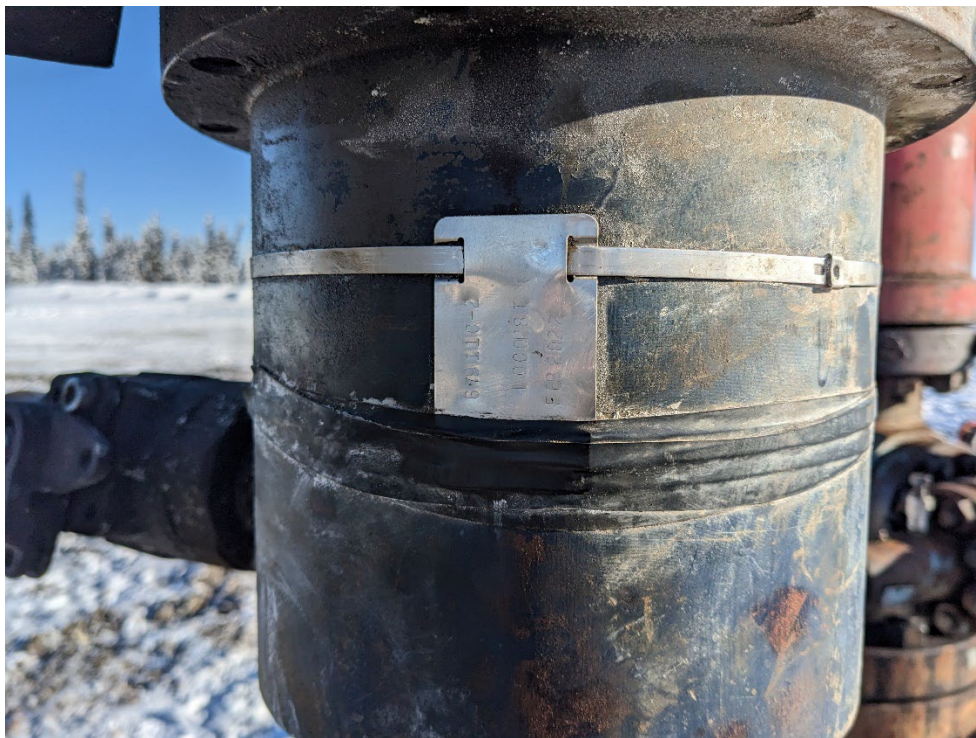
PHOTO #4: Annular tag matching the certification.

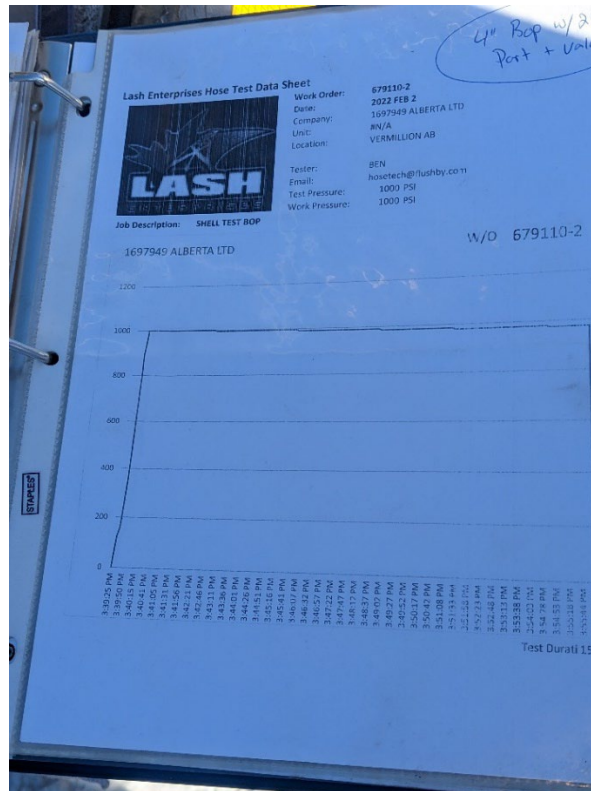
PHOTO #5: Annular certification pressure tested February 2, 2022

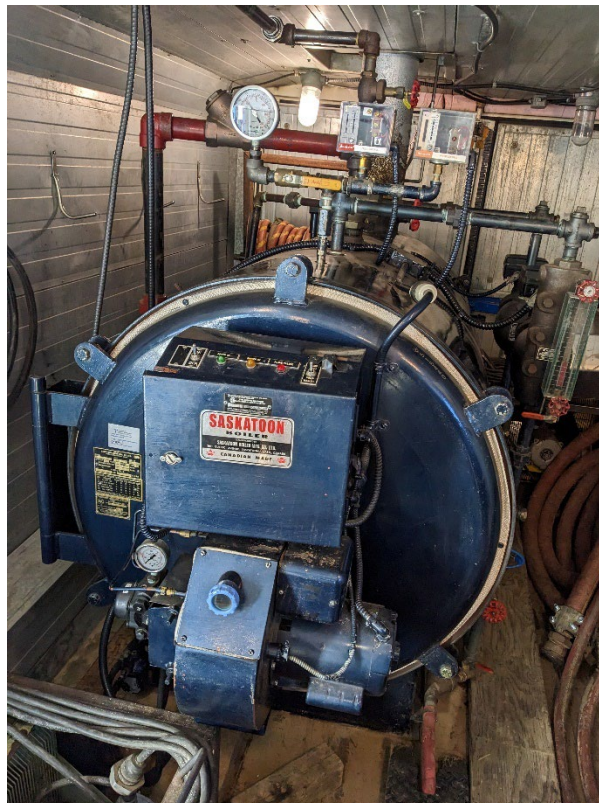
PHOTO #6: On-site Boiler.

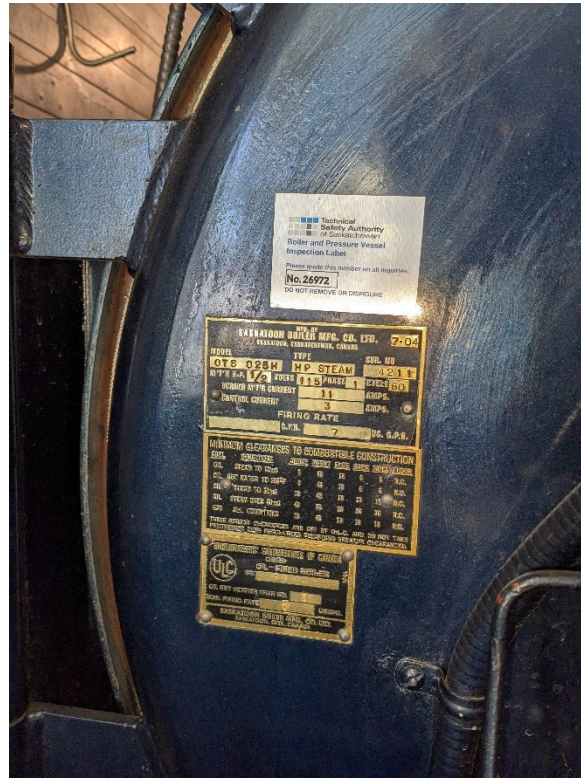
PHOTO #7: Boiler identification seal.

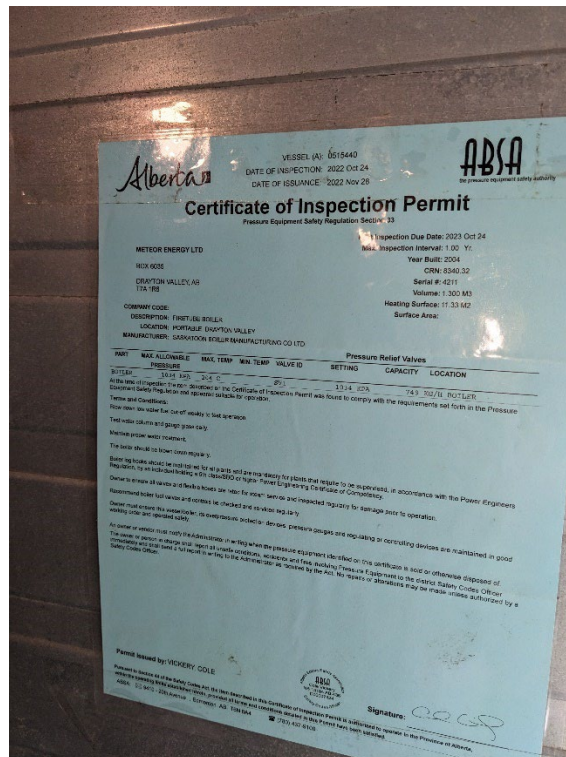
PHOTO #8: Boiler certification.

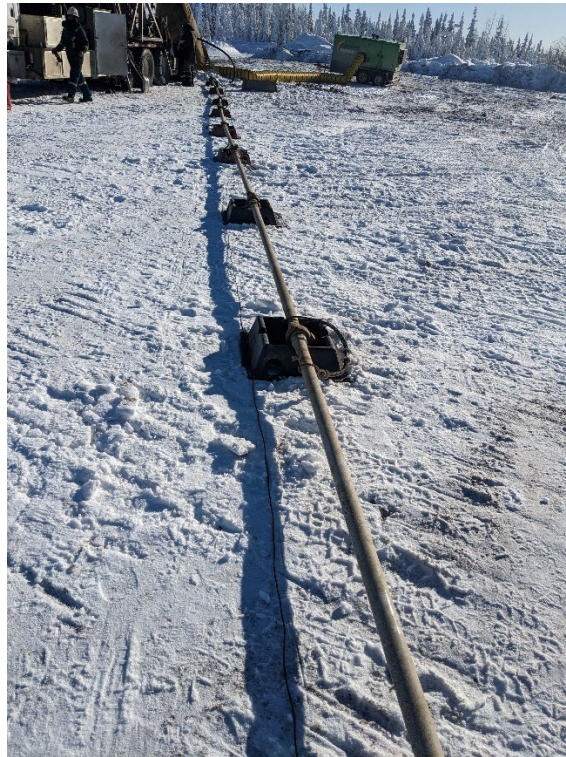
Pump lines and hoses secured, intact and appropriate?	<input checked="" type="checkbox"/> Compliant <input type="checkbox"/> Non-Compliant <input type="checkbox"/> Corrected Non- Compliance	Comments: All pump lines/hoses were secured and in a condition satisfactory to the Inspectors (Photos #9 & 10).
Adequate lighting	<input checked="" type="checkbox"/> Compliant <input type="checkbox"/> Non-Compliant <input type="checkbox"/> Corrected Non- Compliance	Comments:
Wind indicators visible and functional	<input checked="" type="checkbox"/> Compliant <input type="checkbox"/> Non-Compliant <input type="checkbox"/> Corrected Non- Compliance	Comments:
Fire extinguishers	<input checked="" type="checkbox"/> Compliant <input type="checkbox"/> Non-Compliant <input type="checkbox"/> Corrected Non- Compliance	Comments: All fire extinguishers inspected have been recertified within the last 12 months.
Equipment spacing	<input checked="" type="checkbox"/> Compliant <input type="checkbox"/> Non-Compliant <input type="checkbox"/> Corrected Non- Compliance	Comments: The lease site at K-74 provided adequate spacing for equipment in accordance with IRP 20. - Rig Tank to Well Centre:47m (>15m)

PHOTO #9: Pump line between well and rig tank.

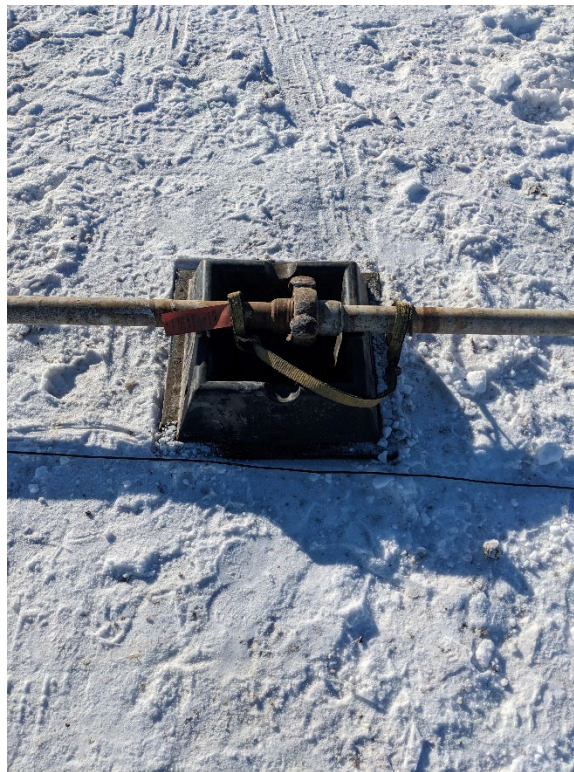
PHOTO #10: Pump line between well and rig tank secured between joints.

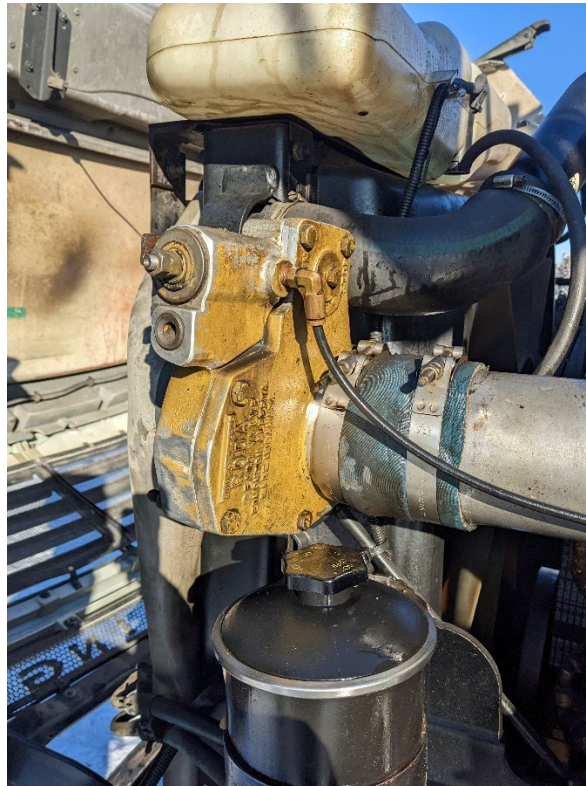
Engine kills	<input checked="" type="checkbox"/> Compliant <input type="checkbox"/> Non-Compliant <input type="checkbox"/> Corrected Non- Compliance	Comments: Engine kills operated as designed and required manual reset of the air kill mechanism (Photo #11).
Sufficient N ₂ back-up?	<input checked="" type="checkbox"/> Compliant <input type="checkbox"/> Non-Compliant <input type="checkbox"/> Corrected Non- Compliance	Comments: N/A as this is a Coiled Tubing Unit. This unit had manual pumps to pressurize the BOP (Photo #12).
Flow turns	<input checked="" type="checkbox"/> Compliant <input type="checkbox"/> Non-Compliant <input type="checkbox"/> Corrected Non- Compliance	Comments: All flow turns inspected were compliant and installed correctly. (Photo #9)
General housekeeping	<input checked="" type="checkbox"/> Compliant <input type="checkbox"/> Non-Compliant <input type="checkbox"/> Corrected Non- Compliance	Comments: The site was generally clean, and the Inspectors had no concerns with housekeeping throughout the site.

PHOTO #11: Air cut off device that is part of the engine kill assembly.

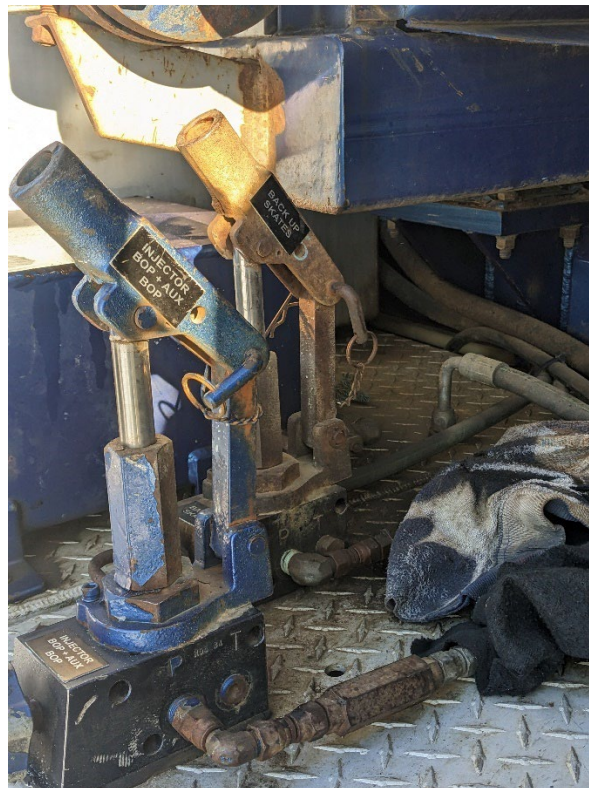
PHOTO #12: Manual pumps to pressurize Coiled Tubing Unit BOP.

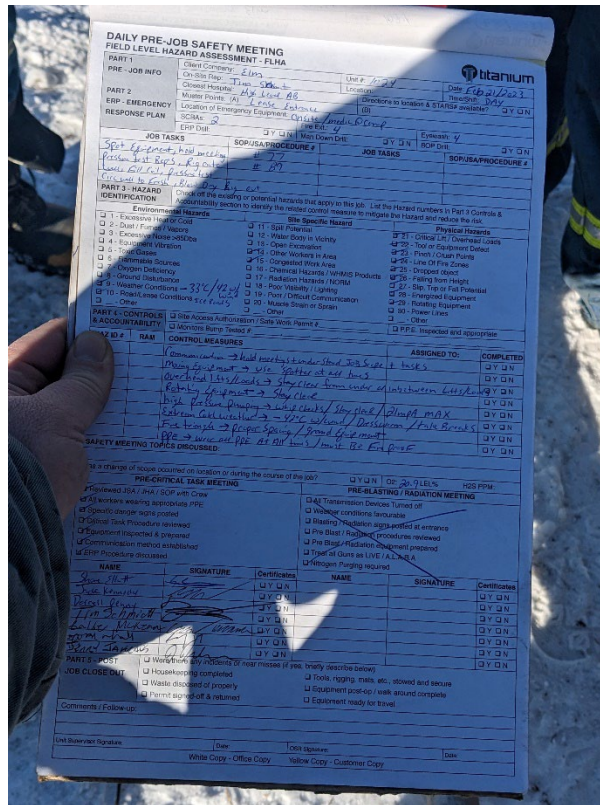
PHOTO #13: Record of February 21, 2023 pre safety job meeting.

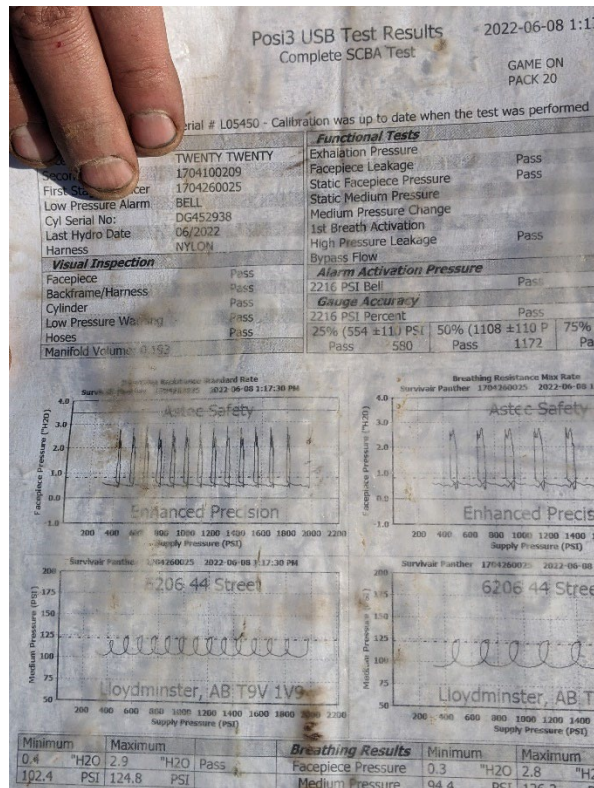
PHOTO #14: Record of inspection of one of the SCBA's on site.

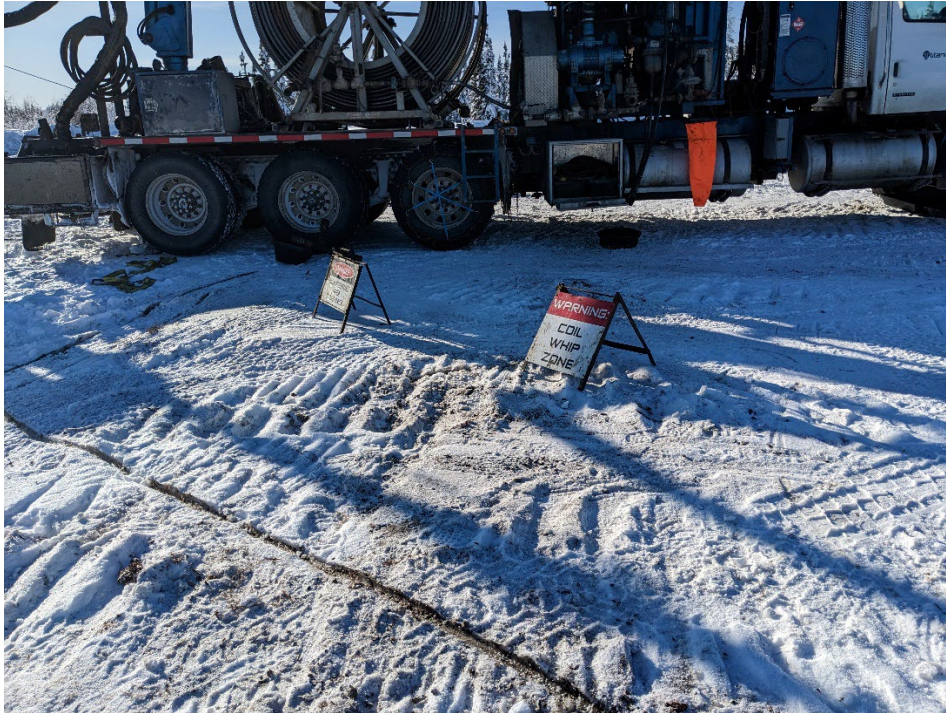
PHOTO #15: Hazard identification signs in place.
