OROGO Well Abandonment Verification Inspection Summary Report

Well name/ Facility: Cameron K-74

Operator: Strategic Oil and Gas Ltd.

Date of inspection: 2024-09-18

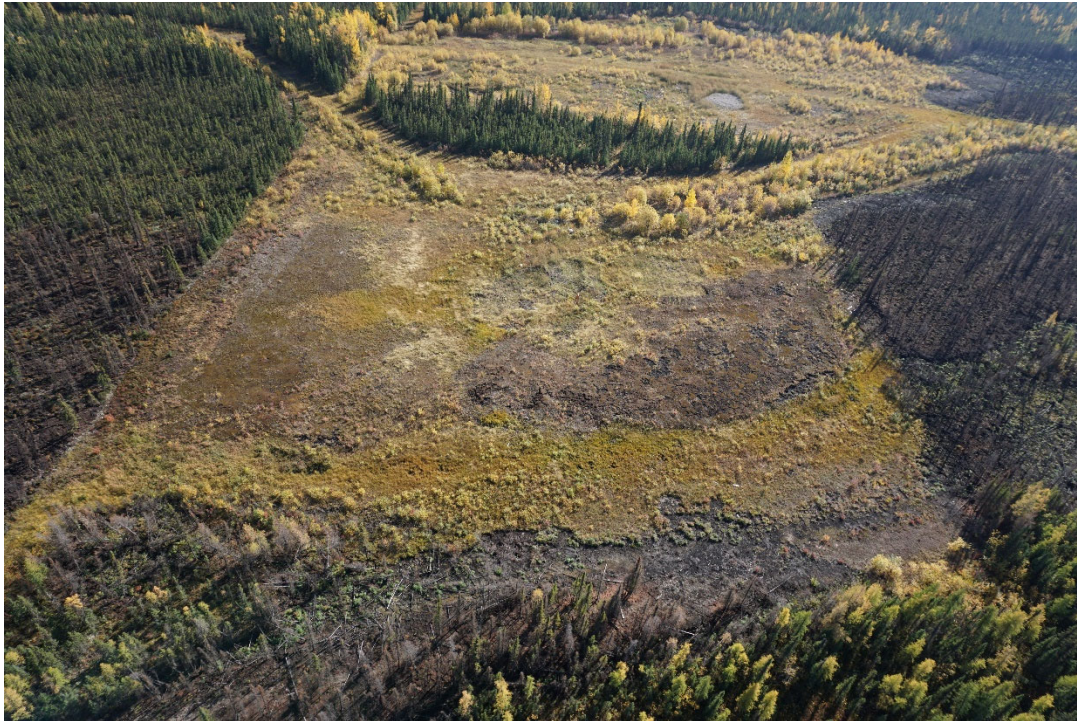
Photo #1. Aerial view of the K-74 well site facing south.

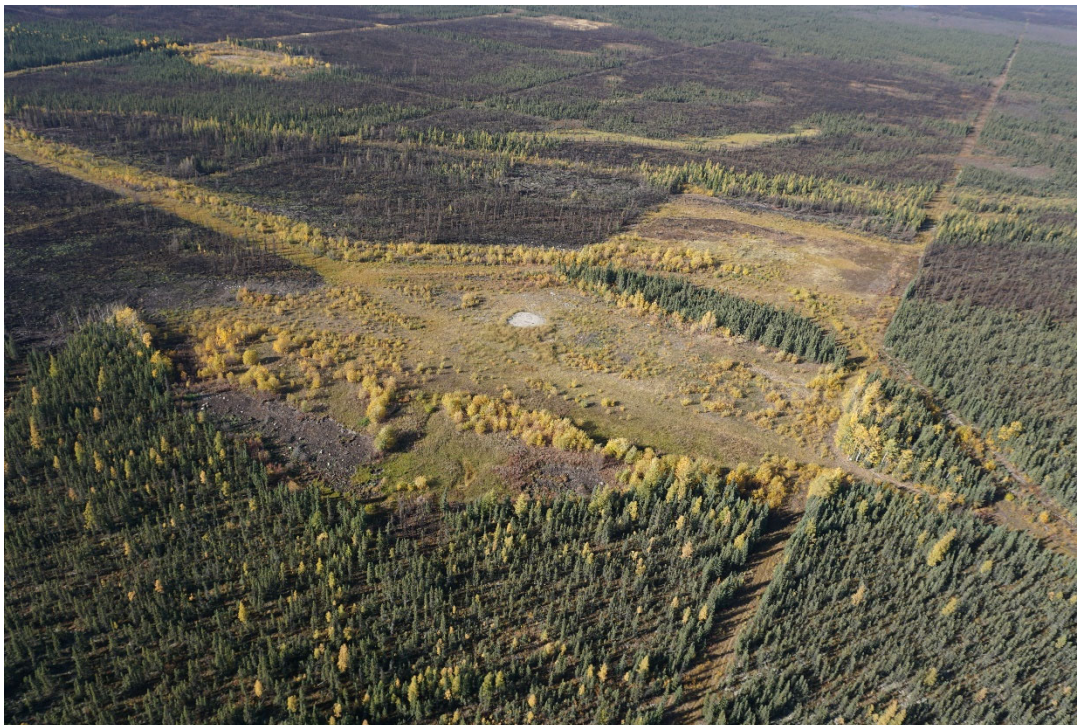
Photo #2. Another view of the K Camp laydown and K-74 wellsite towards the north. Helicopter landed on the gravel in the center of the camp laydown for reference.

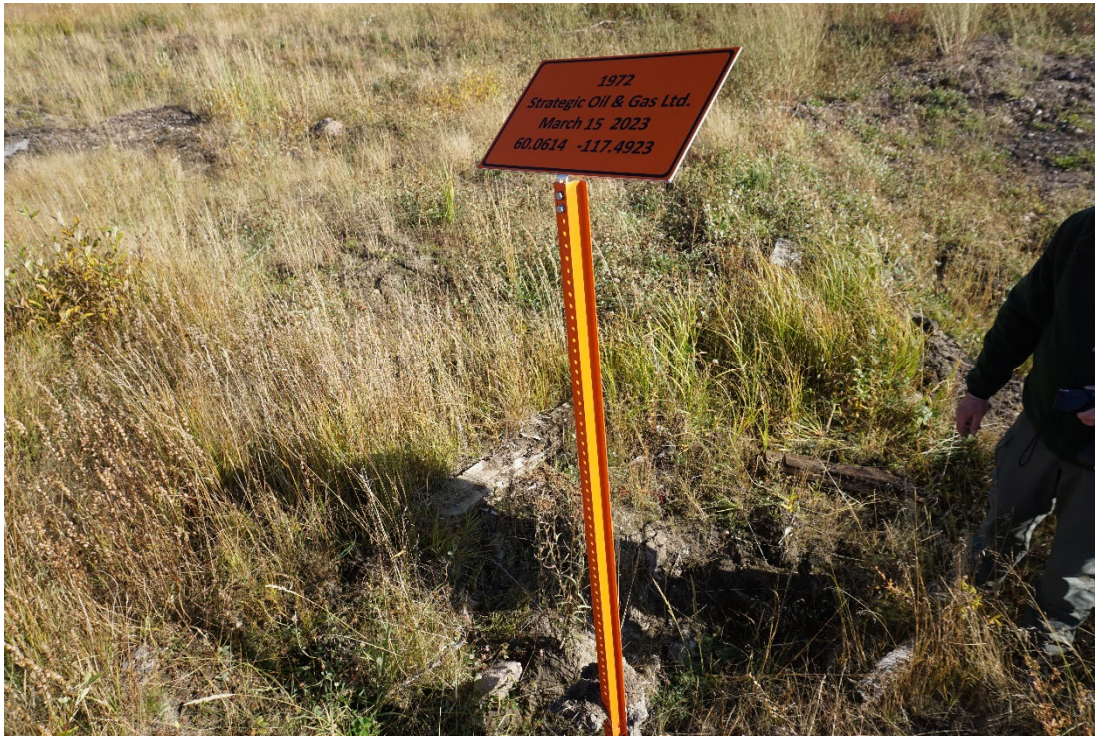
Well center appears not to have been backfilled as part of the well abandonment operations (Photo #3)

Photo #3. It appears this sign may fall down in the future since it was very unstable upon inspection.

As per OROGO's notice on September 25, 2024, temporary mitigation is required to be complete prior to October 31, 2024. Additionally, a plan to address the permanent mitigation of this excavation is required to be submitted to OROGO no later than December 15, 2024

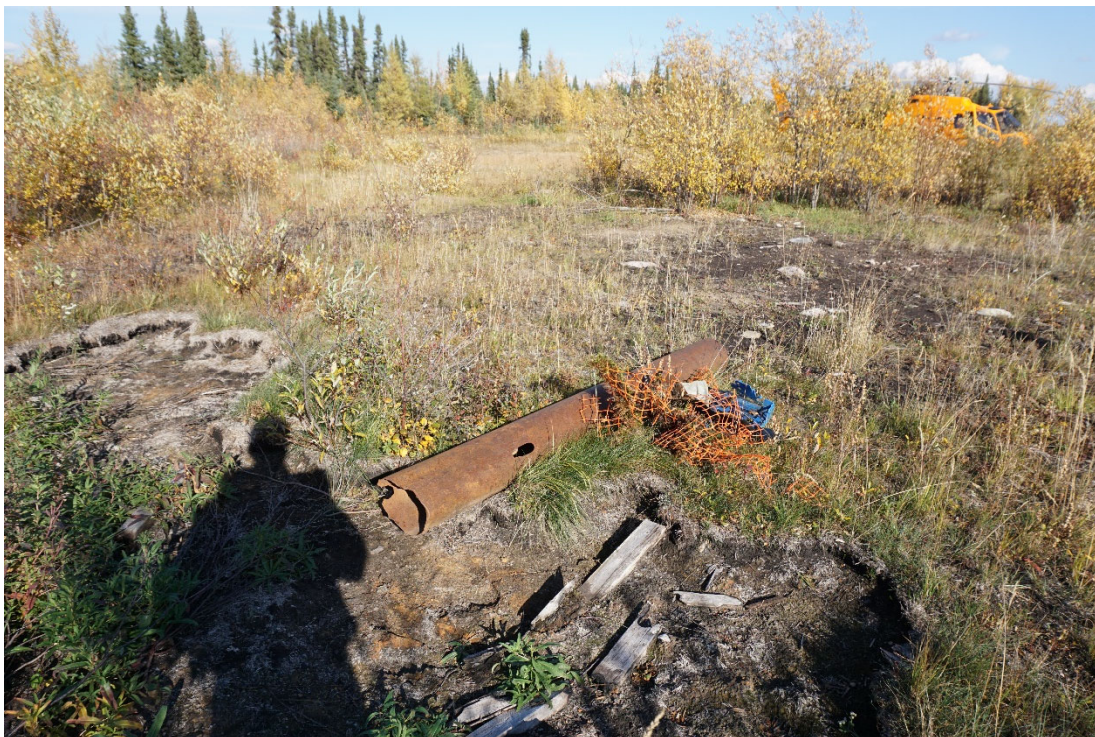
If yes, provide details: Surface debris was collected on site by Inspectors and consolidated by a section of casing which can be viewed in Photo #4.

If yes, provide details: There was only 1 large section of casing that was found approximately 30m west of the gravel pad where the helicopter landed, and various debris and waste was collected throughout the site by Inspectors and consolidated at this location. The waste viewed in Photo #4 must be removed for proper offsite disposal.

Photo #4. Various waste items were collected by Inspectors and consolidated by this large piece of casing approximately 30 meters west of the gravel pad.

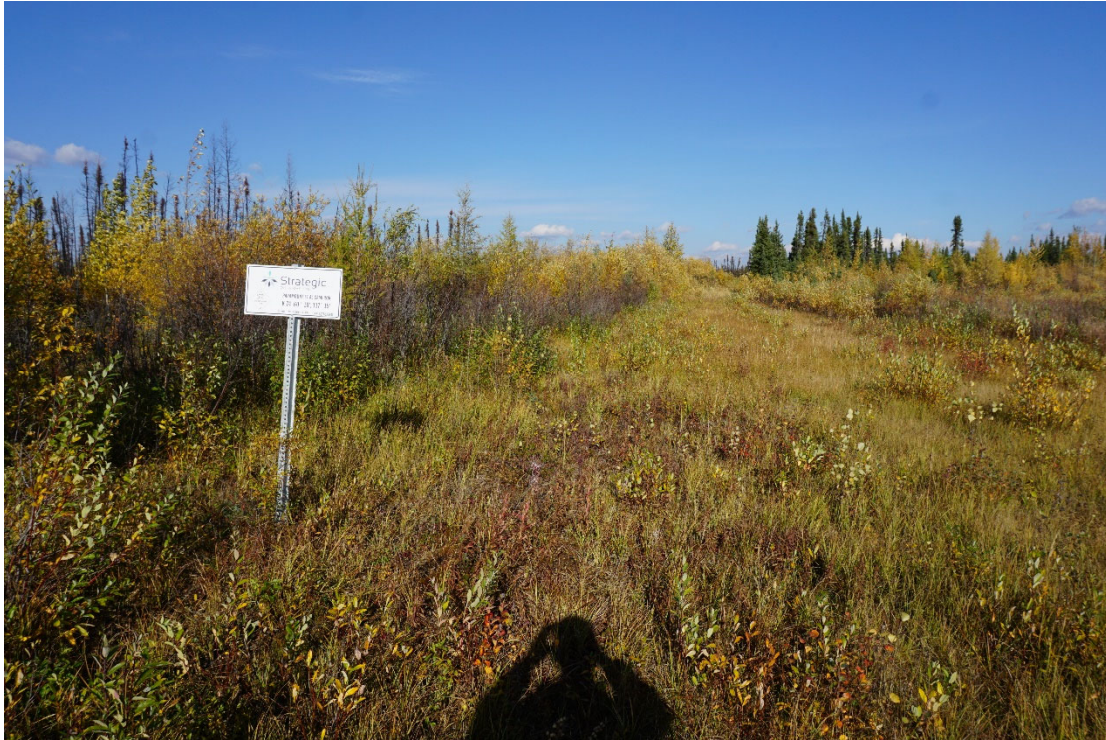
Lease entrance sign was also still resent and must be removed for proper offsite disposal along with any other hazard or identifying signage that may be still present in the land use area. (Photo #5)

Photo #5. Lease entrance sign remains on site and must be removed for proper offsite disposal.
