**Inspection: Cameron L-47 (WID 1736) Well – ACW-2023-SOG-L-47-WID1736**

# OROGO Operations Inspection Summary Report

Well name: Cameron L-47

Nature of activity: Abandonment

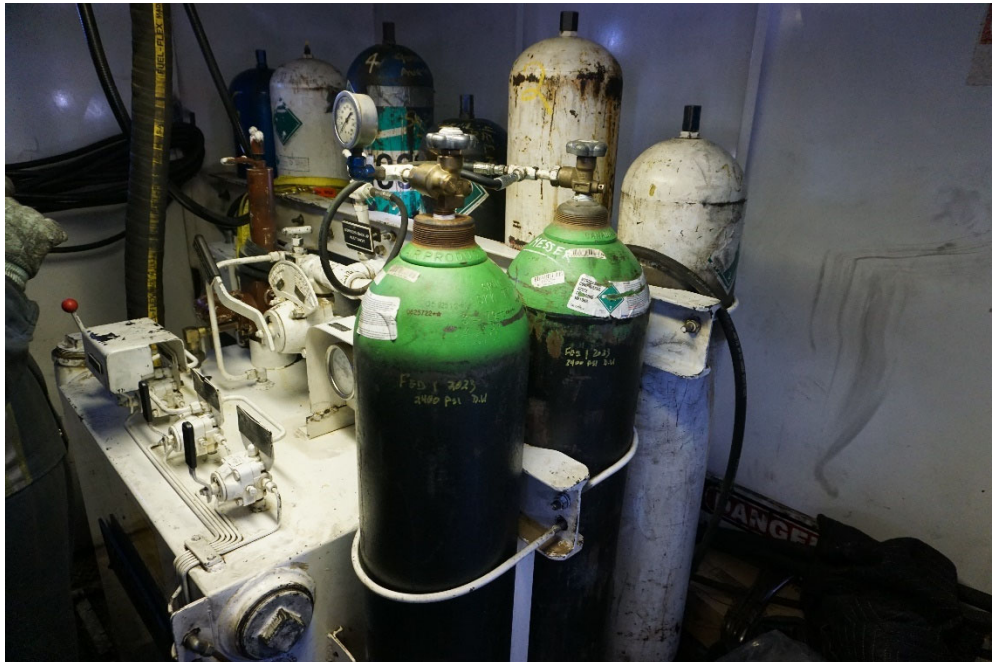
Comments: Function Test Compliant – did not drop below 8.4 MPa after three functions and recharged in &lt;5 min. (Photo #1)

PHOTO #1: View of the Accumulator shack. 6x 11gal Nitrogen tanks with 2x back up tanks.

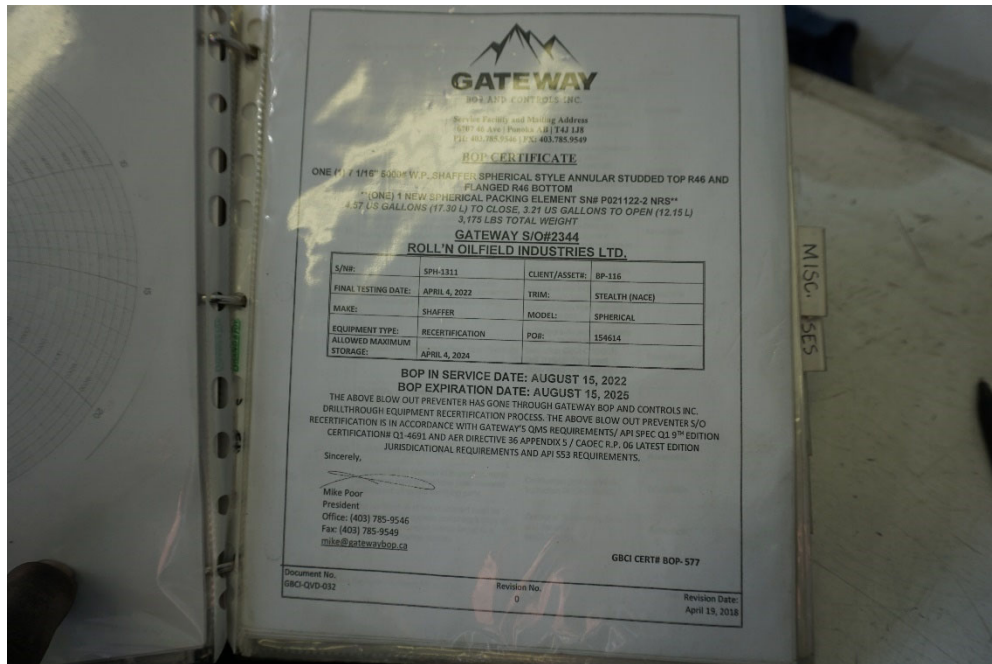
Comments: Serial Numbers of the BOP matched the certifications submitted to OROGO on December 20, 2022. - Annular: SPH1311 - Double Gate: 10920 (Photos #2 & #3).

PHOTO #2: BOP Certificate for the Annular matched the equipment being used on site.

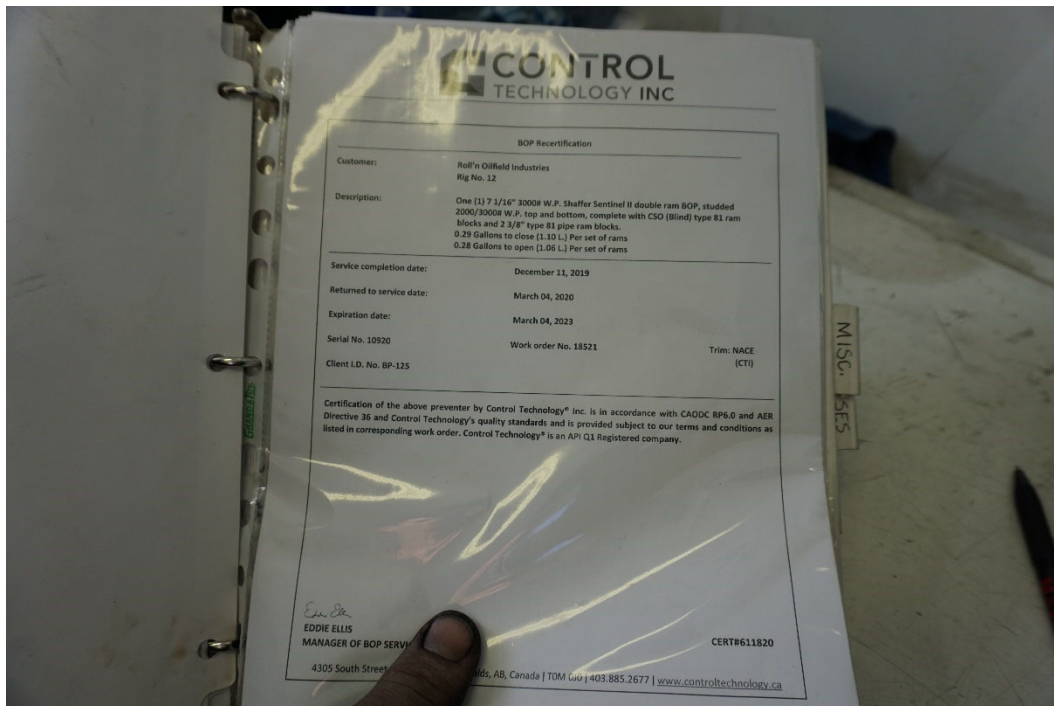
The above noted certification (Photo #3) for the Double gate BOP will be pulled out of service on March 4<sup>th</sup>, 2023 and another Double gate BOP was on site during the inspection to replace the double gate BOP that is currently in use.

While verifying the serial numbers of the new Double gate BOP and the certifications provided on site, Inspectors were only able to match the S/O number 2742, however the S/N# on the Double gate (6-5H34304) did not match up with the certifications in the Doghouse (6-5M34304).

It was determined that the S/N# on the Gateway BOP and Controls Inc Certification was an administrative error and the on-site personnel rectified this concern immediately and provided the Inspectors with updated copies of the Certifications at 21:29h on February 23<sup>rd</sup>, 2023.

PHOTO #3: Double gate BOP Certification shows that March 4<sup>th</sup>, 2023 is the out of service date and must be replaced with a certified Double gate BOP before March 4<sup>th</sup>.

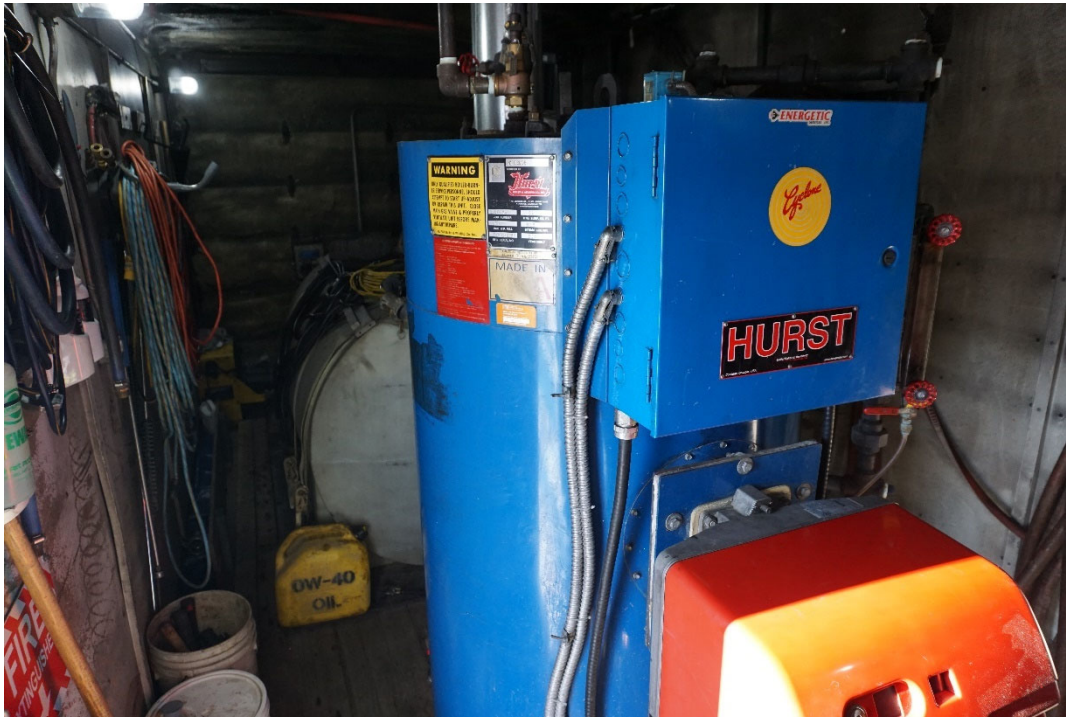
PHOTO #4: View of the Boiler and fresh water holding tank on site.

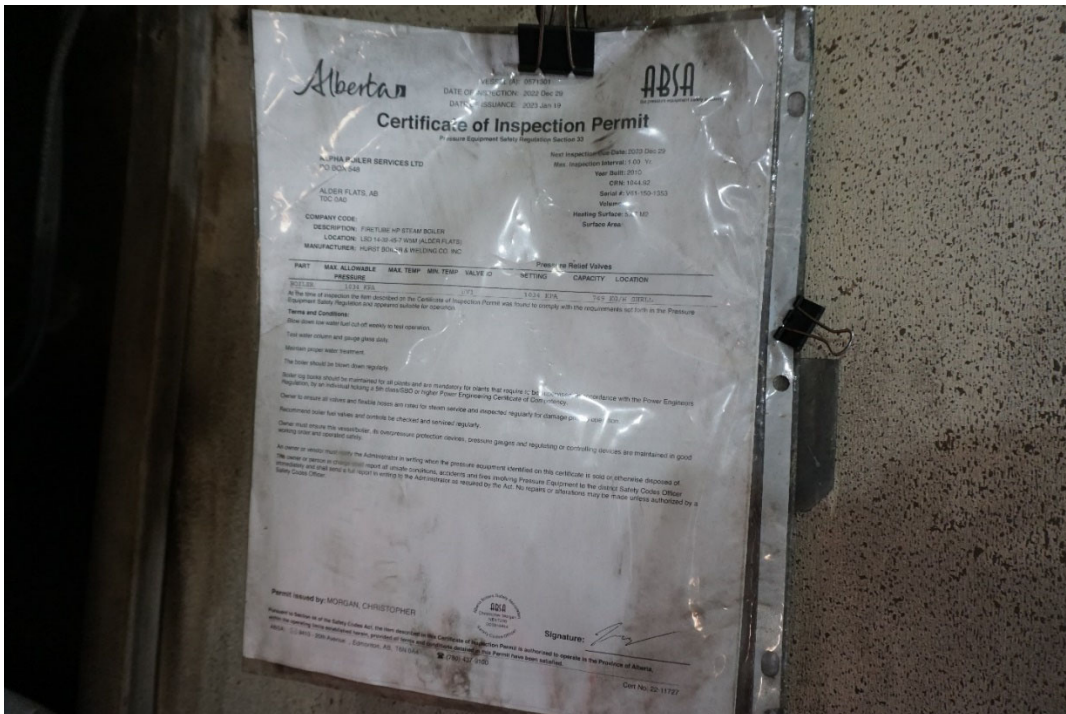
PHOTO #5: Boiler Certifications for S/N V61-150-1353 matched the Boiler on site.

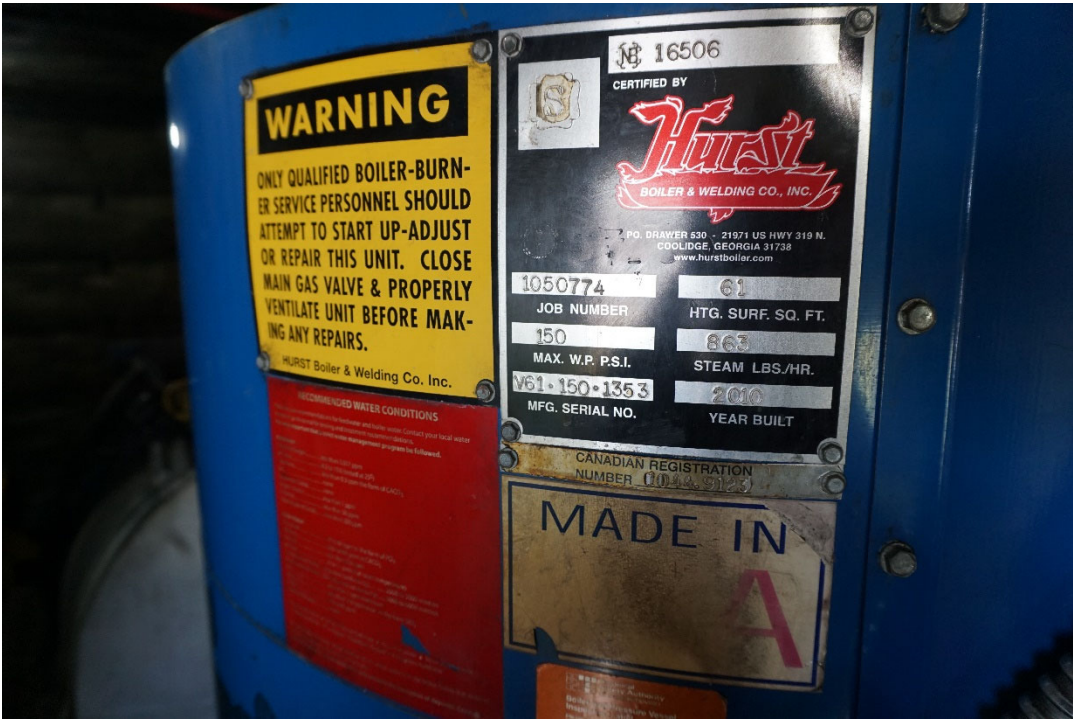
PHOTO #6: Boiler S/N# V61-15-1353.

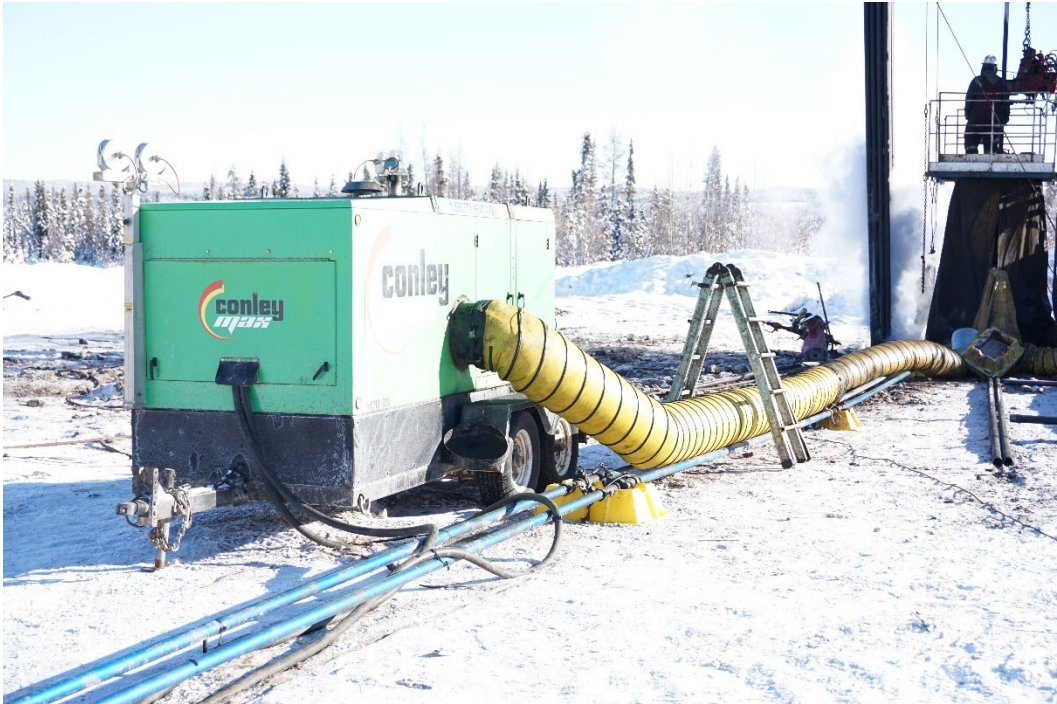
Pump lines and hoses secured, intact and appropriate?	<input checked="" type="checkbox"/> Compliant <input type="checkbox"/> Non-Compliant <input type="checkbox"/> Corrected Non- Compliance	Comments: All pump lines/hoses were secured in a condition satisfactory to the Inspectors (Photos #7 & #8).
Adequate lighting	<input checked="" type="checkbox"/> Compliant <input type="checkbox"/> Non-Compliant <input type="checkbox"/> Corrected Non- Compliance	Comments: The inspection was conducted during daylight hours.
Wind indicators visible and functional	<input checked="" type="checkbox"/> Compliant <input type="checkbox"/> Non-Compliant <input type="checkbox"/> Corrected Non- Compliance	Comments: Wind indicators were present on the crown of the derrick. No concerns were noted since the wind indicators were in a visible area.
Fire extinguishers	<input checked="" type="checkbox"/> Compliant <input type="checkbox"/> Non-Compliant <input type="checkbox"/> Corrected Non- Compliance	Comments: All fire extinguishers were inspected and were re-certified within the last 12 months.

PHOTO #7: Lines were elevated to prevent thawing of the underlying ground and no concerns were noted.

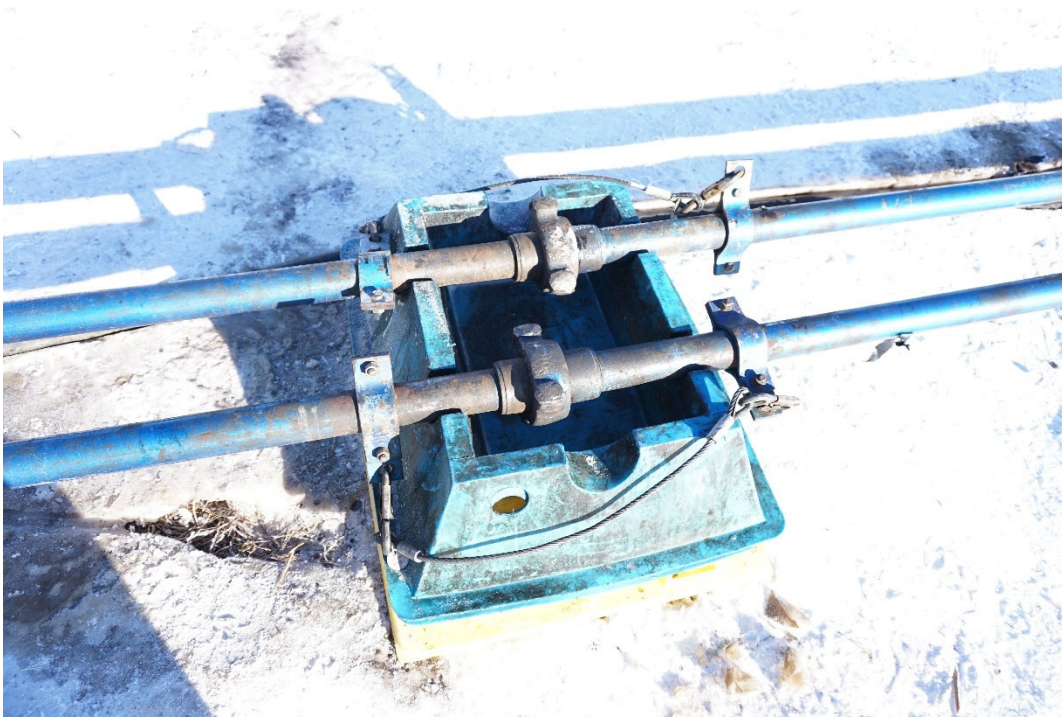
BOP pressure rating	<input checked="" type="checkbox"/> Compliant <input type="checkbox"/> Non-Compliant <input type="checkbox"/> Corrected Non- Compliance	Comments: The BOP used for this operation was 7 1/16"/34.5 MPa which is an appropriate pressure rating for this well.
Kill sheet in dog house	<input checked="" type="checkbox"/> Compliant <input type="checkbox"/> Non-Compliant <input type="checkbox"/> Corrected Non- Compliance	Comments:
Stabbing valves and cross-overs	<input checked="" type="checkbox"/> Compliant <input type="checkbox"/> Non-Compliant <input type="checkbox"/> Corrected Non- Compliance	Comments:
Flow lines and choke lines secured	<input checked="" type="checkbox"/> Compliant <input type="checkbox"/> Non-Compliant <input type="checkbox"/> Corrected Non- Compliance	Comments: As seen in Photo #8, flow lines and choke lines were secured.
Other Blowout Prevention Equipment notes: N/A

PHOTO #8: Lines from the Rig tank were secured.

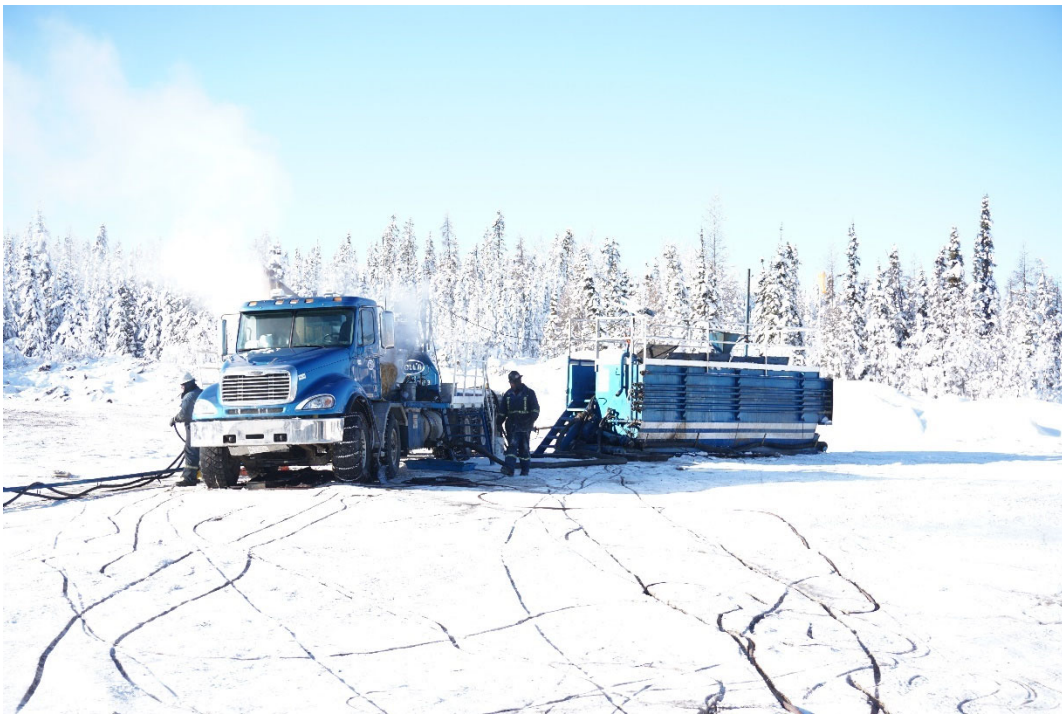
Comments: Most equipment on site had adequate spacing except for the Rig tank which was below the minimum spacing requirements from the well centre although there was adequate room behind to meet the minimum distance 50 meters required from the well center (Photo #9).

- Flare stack - Well centre = 61m
- Rig pump - Rig tank = 8.3m
- **Rig Tank - Well centre = 49.4m (>50m)**
- Pressure tank - Well center =27.4m
- Doghouse - Well center =32.0m
- Flare stack - Pressure tank = 32.9m

PHOTO #9: Although adequate room was available behind the rig tank to meet the minimum spacing requirements (50m), the rig tank was located 49.4m from the well center.

Although equipment spacing has improved since the previous inspection, Strategic Oil & Gas Ltd. is still required to ensure **all** spacing requirements adopted by OROGO, listed in the Alberta Energy Regulator's Directive 36, are met during future operations.

**Should the lease site not allow appropriate spacing while maintaining safe ingress/egress of the site, an exemption must be applied for through OROGO prior to the commencement of operations.**

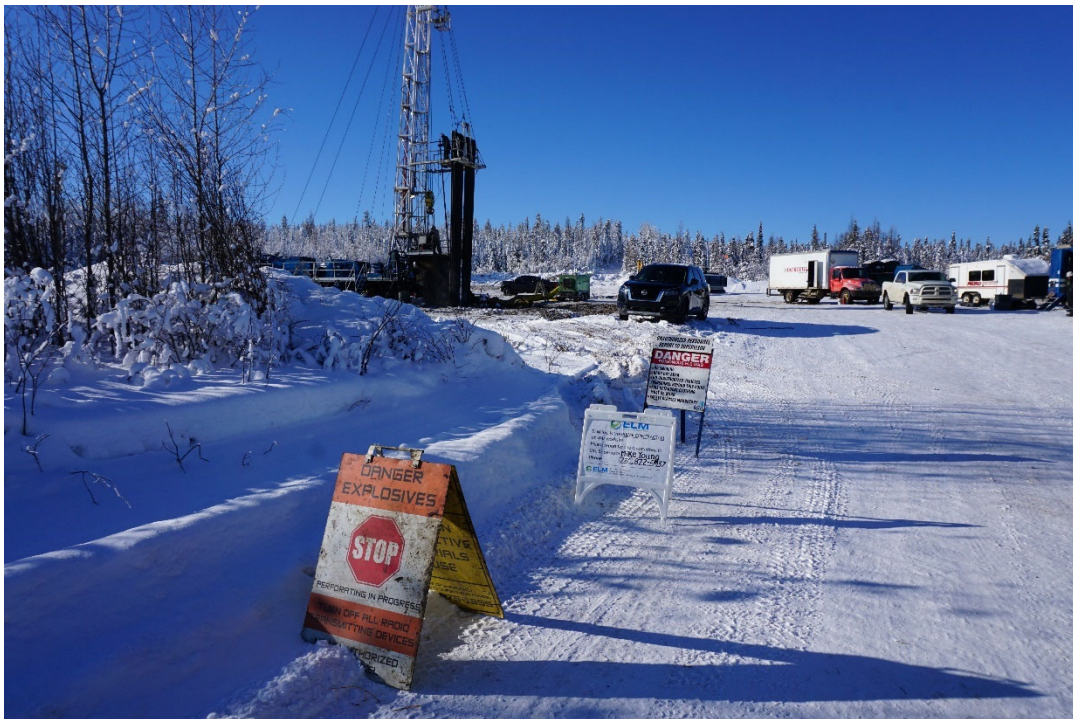
PHOTO #11: Lease entrance signage was in place and no concerns were noted.

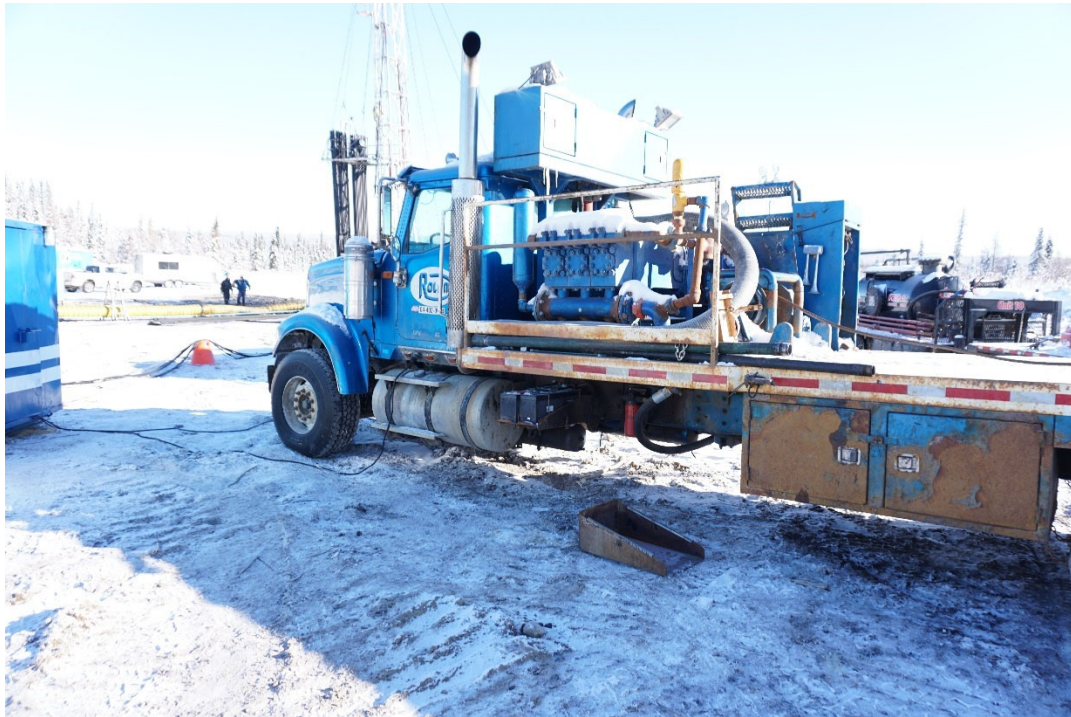
Rig matting	<input checked="" type="checkbox"/> Compliant <input type="checkbox"/> Non-Compliant <input type="checkbox"/> Corrected Non- Compliance	Comments: Rig matting was placed below the service rig.
Drip trays	<input type="checkbox"/> Compliant <input checked="" type="checkbox"/> Non-Compliant <input type="checkbox"/> Corrected Non- Compliance	Comments: Drip trays were located under equipment and the only equipment that required a drip tray was the truck used to move the accumulator shack. Drip trays must be present under pared equipment during future operations to prevent the likelihood of hydrocarbon impacts to the underlying soils (Photo #12).
Materials handling and storage	<input checked="" type="checkbox"/> Compliant <input type="checkbox"/> Non-Compliant <input type="checkbox"/> Corrected Non- Compliance	Comments:
Spill response equipment on site and accessible	<input checked="" type="checkbox"/> Compliant <input type="checkbox"/> Non-Compliant <input type="checkbox"/> Corrected Non- Compliance	Comments: Spill response materials were located on site and no major concerns were noted.

PHOTO #12: This piece of equipment required a drip tray placed underneath which was used for transporting the Accumulator shack.

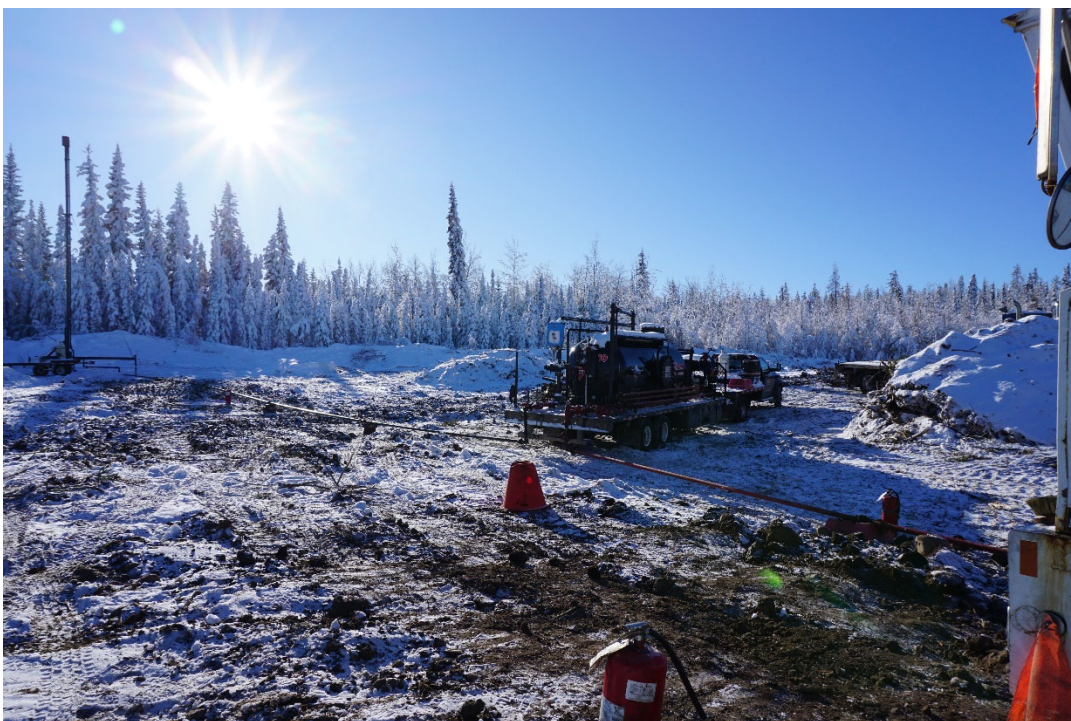
The Pressure tank and the Flare stack both had adequate spacing from the well center but lines connecting from the P-tank to the well were not connected. The site supervisor advised Inspectors on site that the reason for not having the P-tank and flare stack hooked up was because there were no open perforations down hole during this operation.

PHOTO #13: P tank and flare stack both hooked up prior to the end of the inspection.

Although there were no open perforations down hole, Inspectors advised the site supervisor that the P-tank must be connected to the well so that in the unlikely event of a “kick” or unexpected rise in downhole pressure occurs (due to a failed barrier, or micro annulus), they could still shut in the well and manage pressure. As seen in Photo #13, this concern was adequately addressed prior to the end of the Inspection and this cooperation is appreciated.
