## WELLSITE SUMMARY INSPECTION REPORT

Well/Facility Name:	Cameron A-73	Operator:	Strategic Oil and Gas Ltd. (SOG)
Location of Inspection:	Cameron Hills	Access method:	Helicopter
Site Contractor:	None	Status:	Compliant Suspended – Exploratory Well
Approval Info	OA-2018-003	WID:	1747
Date of Inspection	10/SEP/2020	H2S Site:	Yes

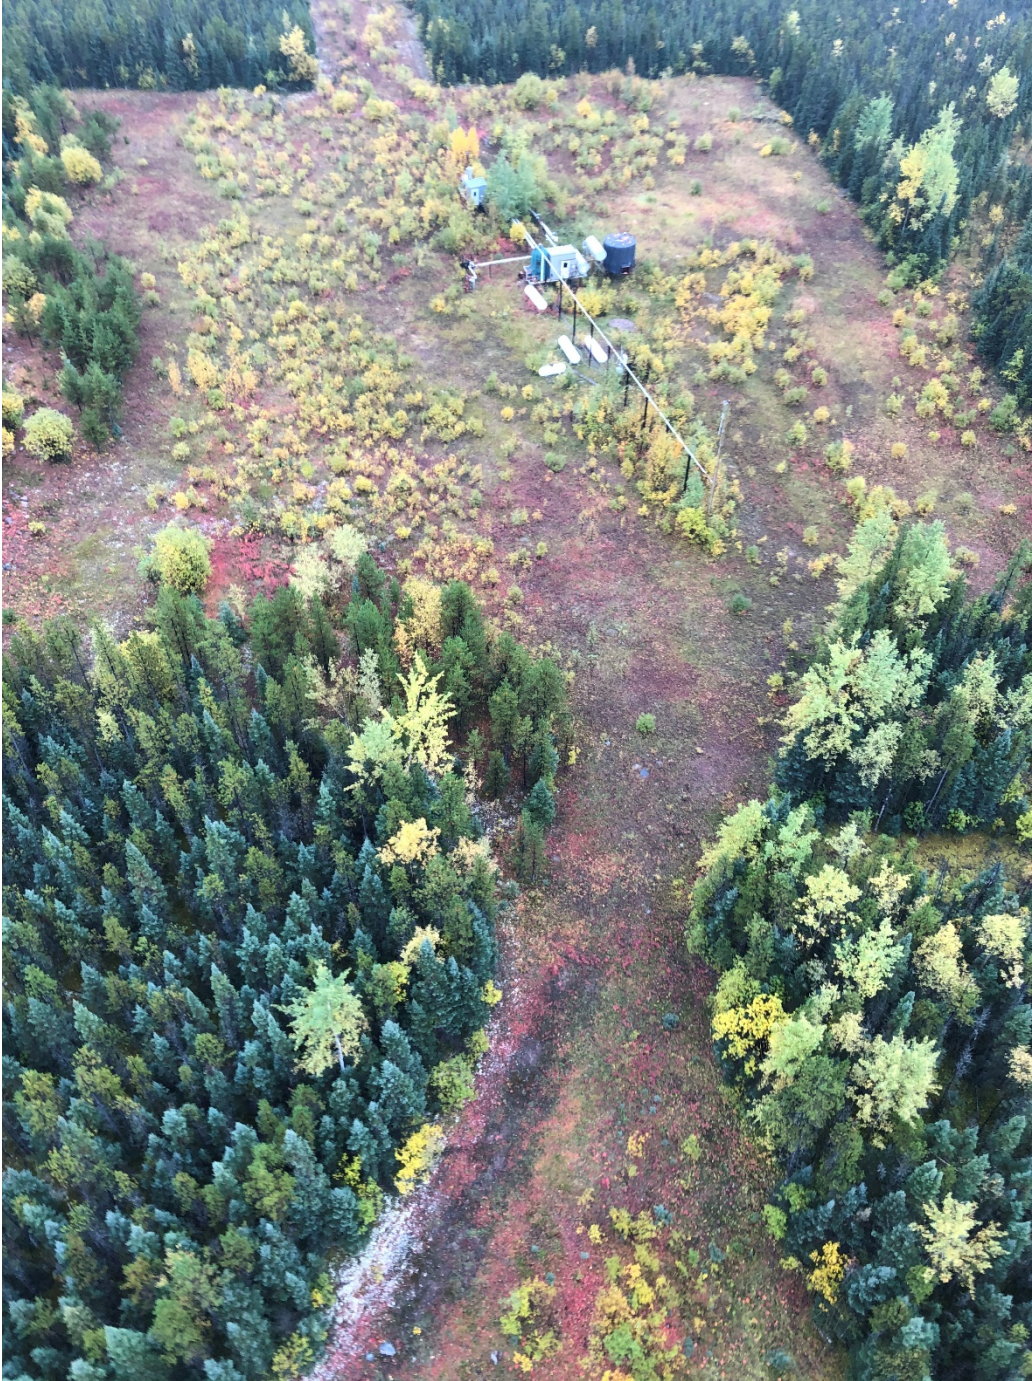
Activity on site	Satisfactory (Y/N)	Comments
Site Access	N <sup>1</sup>	Limited areas cleared for landing. Multiple areas should be cleared to ensure up wind position of the aircraft for safe access. (See Photo#1)  1. Section 5A of the Well Suspension and Abandonment Guidelines and Interpretation Notes requires that wells must be safely accessible for inspection and monitoring.
Wellhead Access	Y	
Signage	Y	
General Housekeeping	Y <sup>2 and 3</sup>	Four (4) propane vessels on site. One reading 40% full and another reading 80% full (See Photos # 2 and 3) the remaining two tanks appeared to be empty. There was a strong smell of ethanethiol/mercaptan down wind of the propane vessels.  2. Propane vessels should be secured to ensure there are no leakage from the tank, fittings or valves. Additionally, these tanks are no longer required as this well site is shut in and planned to be abandoned. They should be scheduled for removal during the next winter operational season.  The steel tank adjacent the separator building appears to contain fluid (See Photo #4).  3. The fluid in this tank needs to be identified and removed as it is no longer required as this well site is shut in and planned to be abandoned. The fluid should be scheduled for removal during the next winter operational season. Additionally, once the fluid is removed, the tank should be marked “Out of Service”.

New growth at well site is reaching the height of the tail rotor on a A-Star B2 helicopter. To ensure safe landing and access to the site, brushing is required to allow for multiple landing zones that can accommodate different wind directions

Photo #1: Aerial photograph of A-73

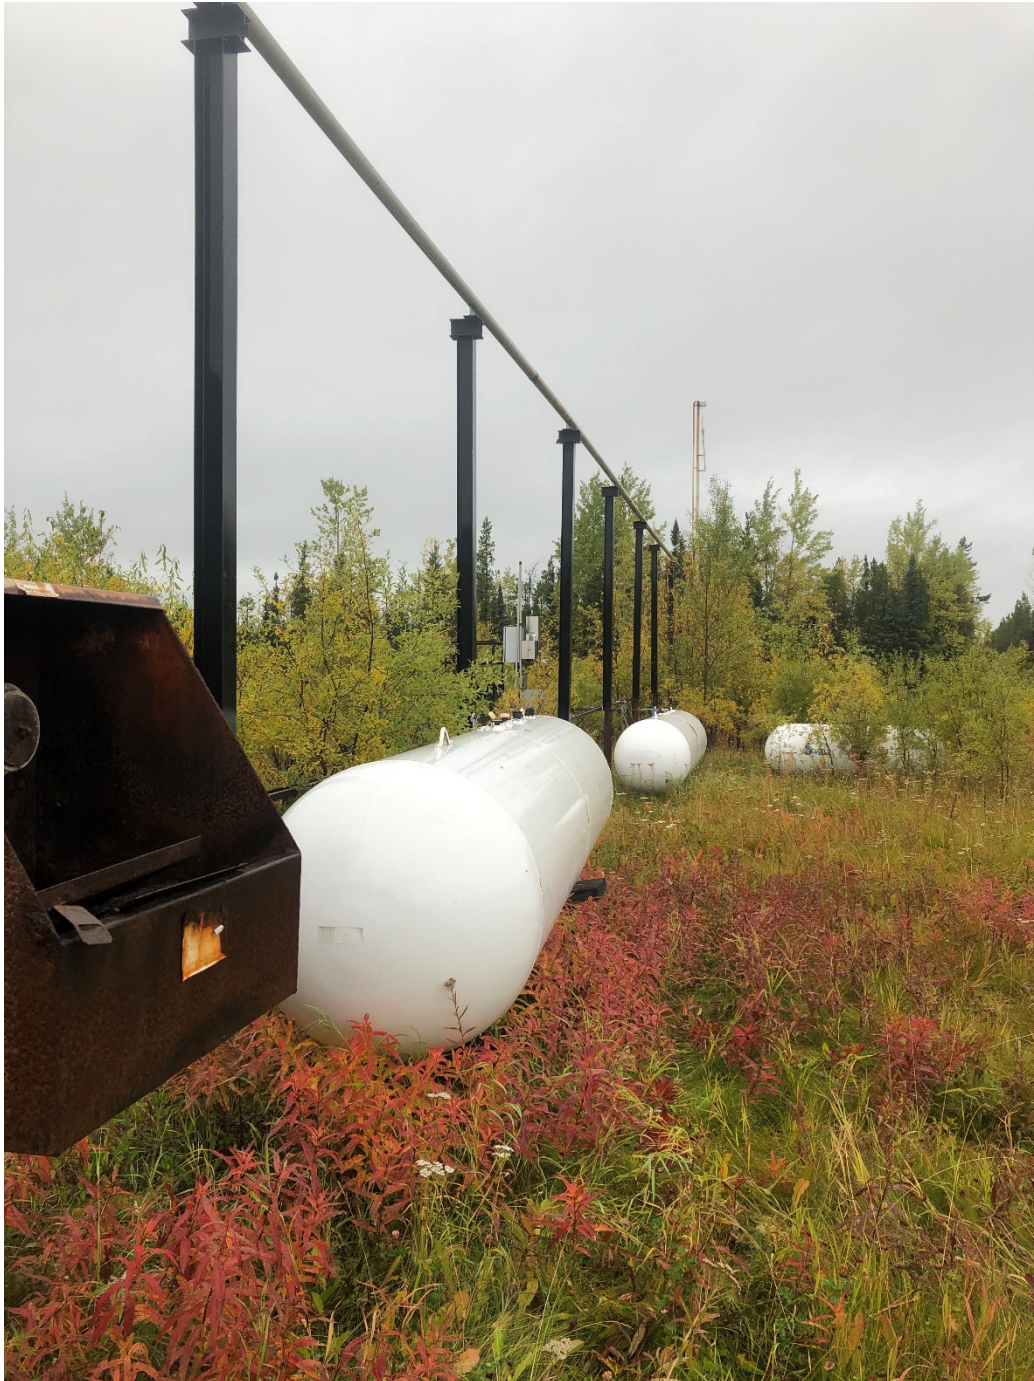
Photo #2: Four (4) propane vessels on site

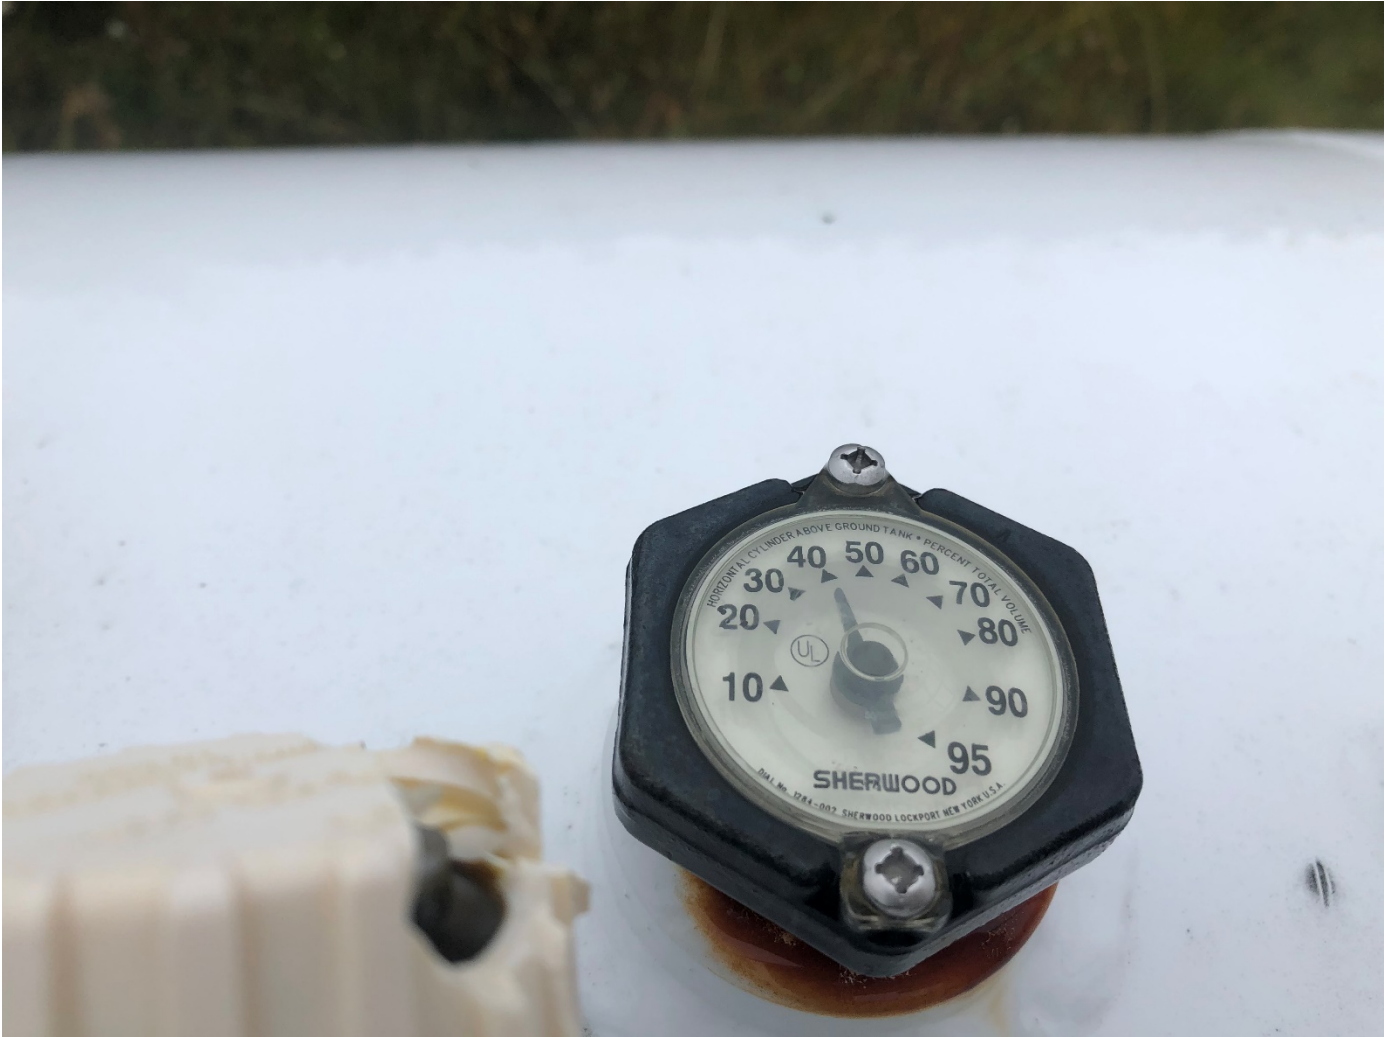
Photo #3: Propane vessel gauge reading approximately 40%

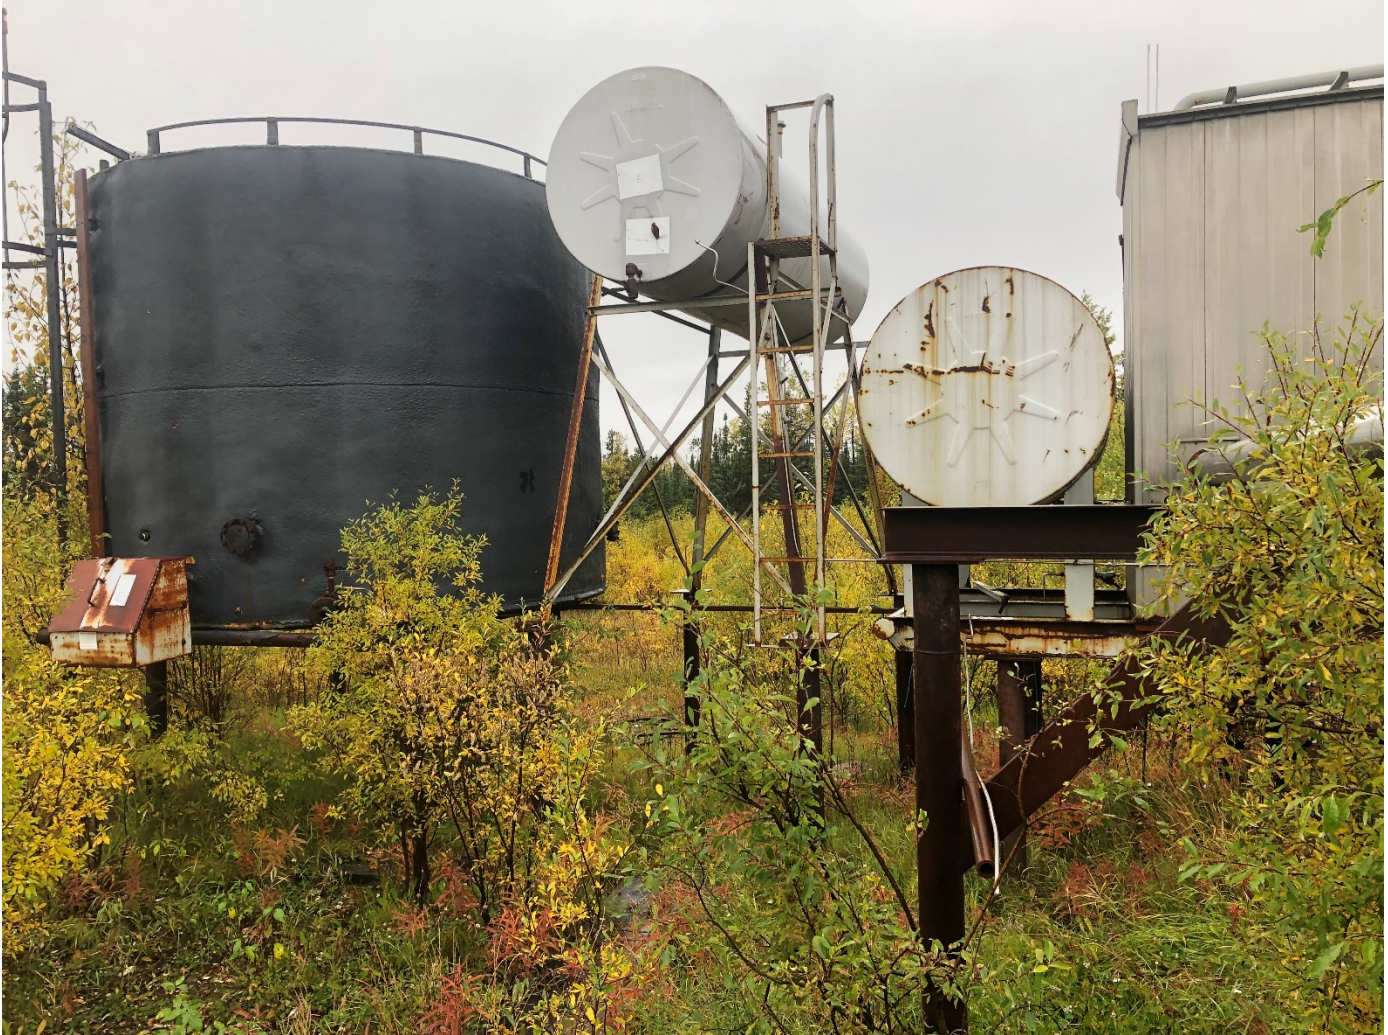
Photo #4: Steel tank directly adjacent the separator building that appears to contain fluid.

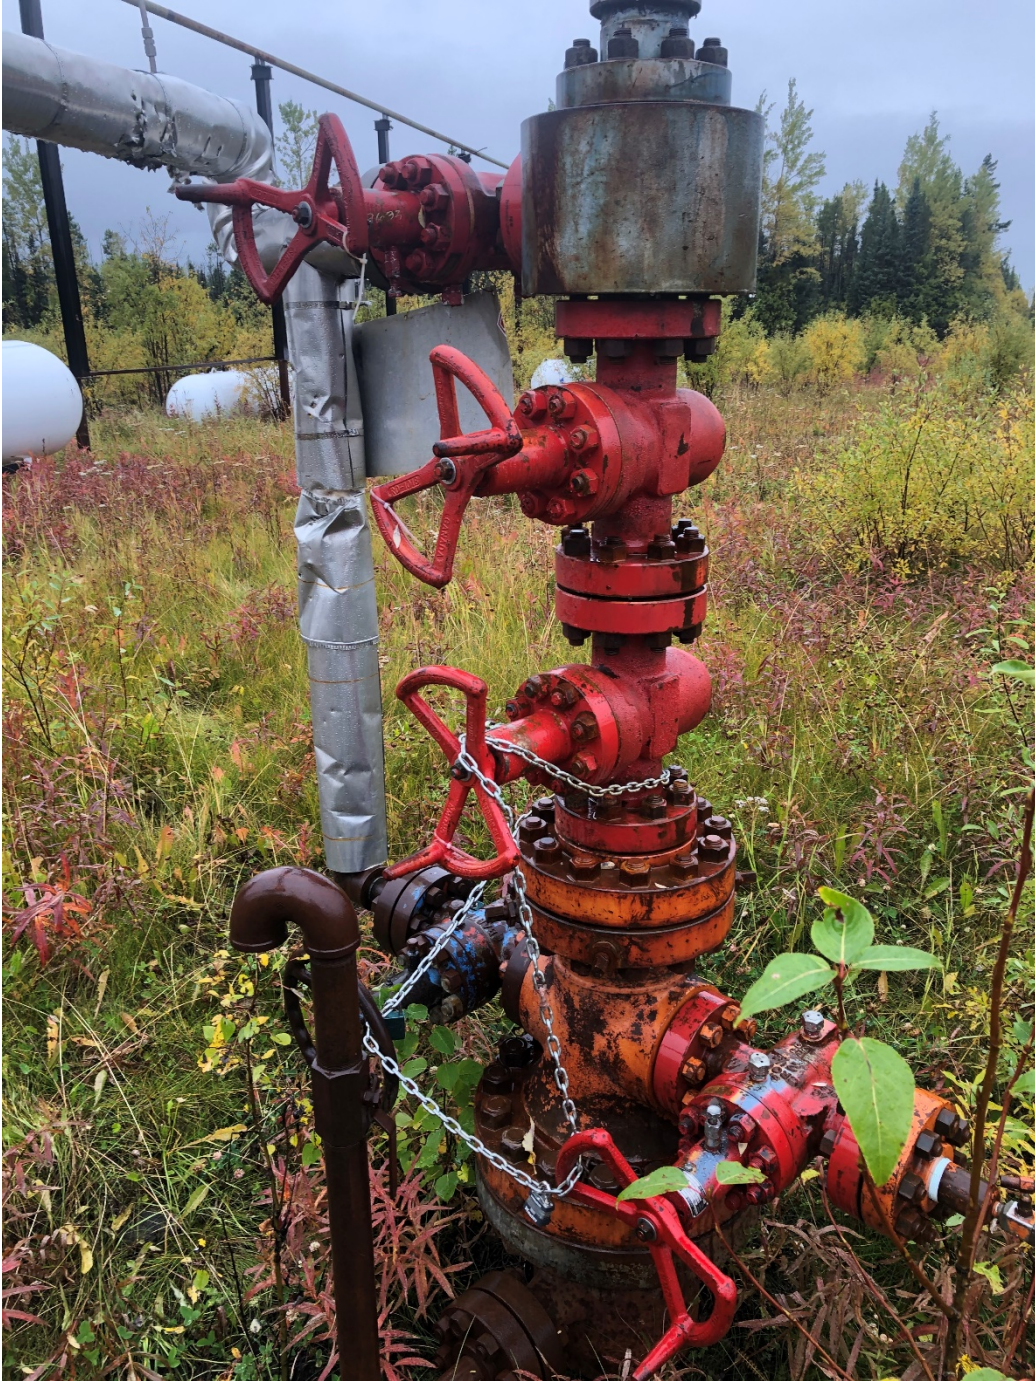
Photo #5: A-73 Wellhead
