WELLSITE SUMMARY INSPECTION REPORT

Well/Facility Name:	Cameron C-16	Operator:	Strategic Oil and Gas Ltd. (SOG)
Location of Inspection:	Cameron Hills	Access method:	Helicopter
Site Contractor:	None	Status:	Compliant Suspended – Production Well
Approval Info	OA-2018-003	WID:	2001
Date of Inspection	10/SEP/2020	H2S Site:	Yes

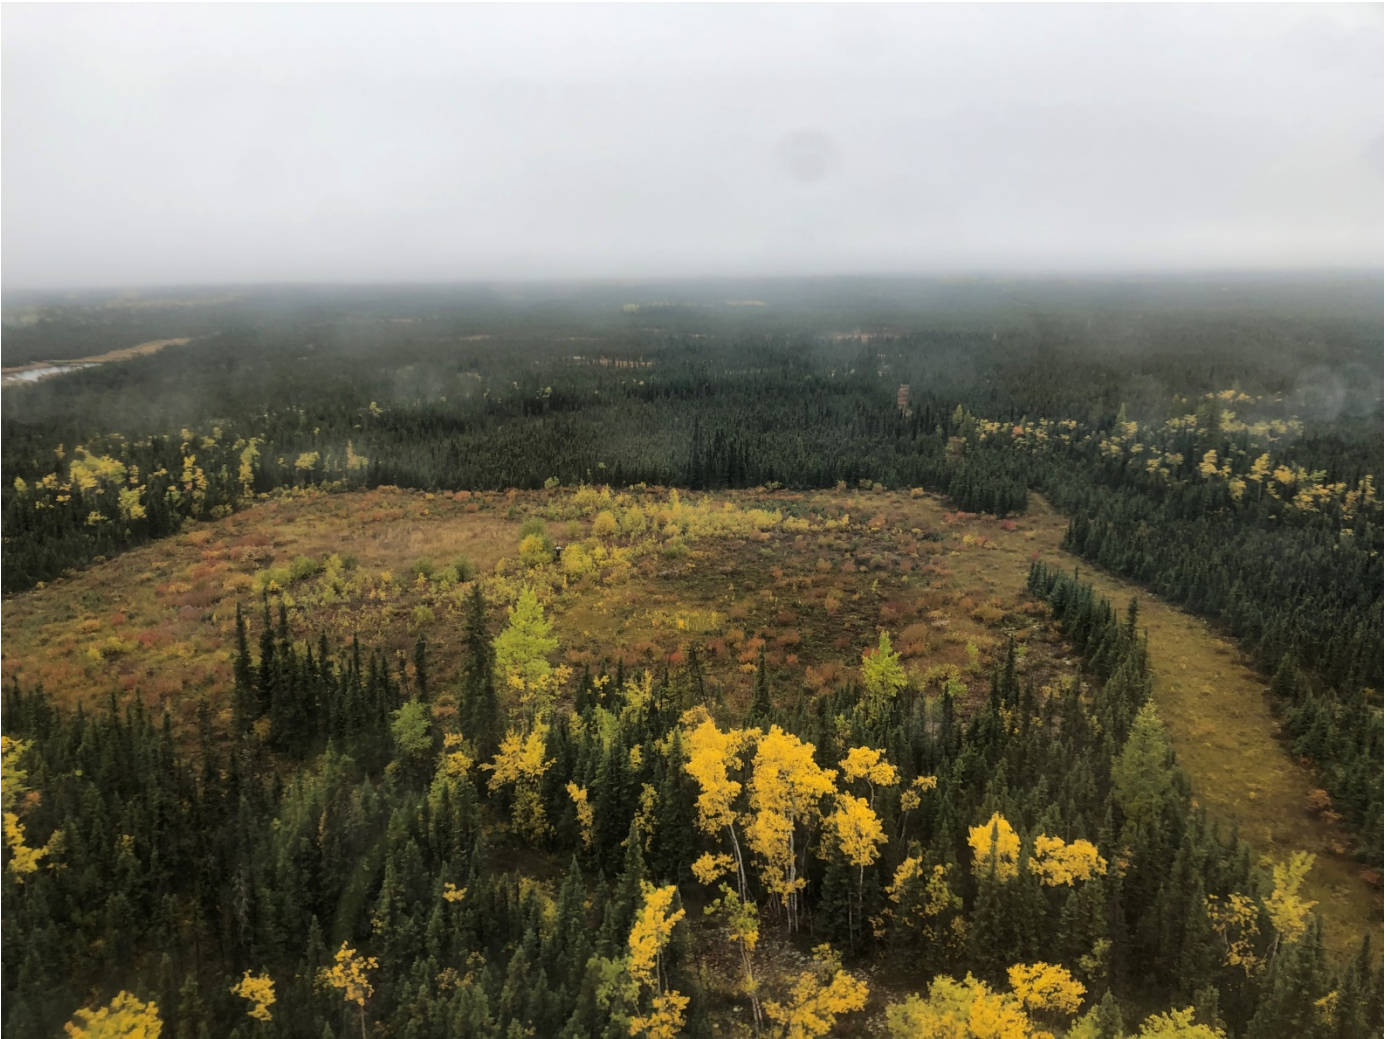
Photo #1: Brush growth on well site restricts safe helicopter landing. Brushing of lease site required to permit safe helicopter landing upwind from the wellhead in all directions.

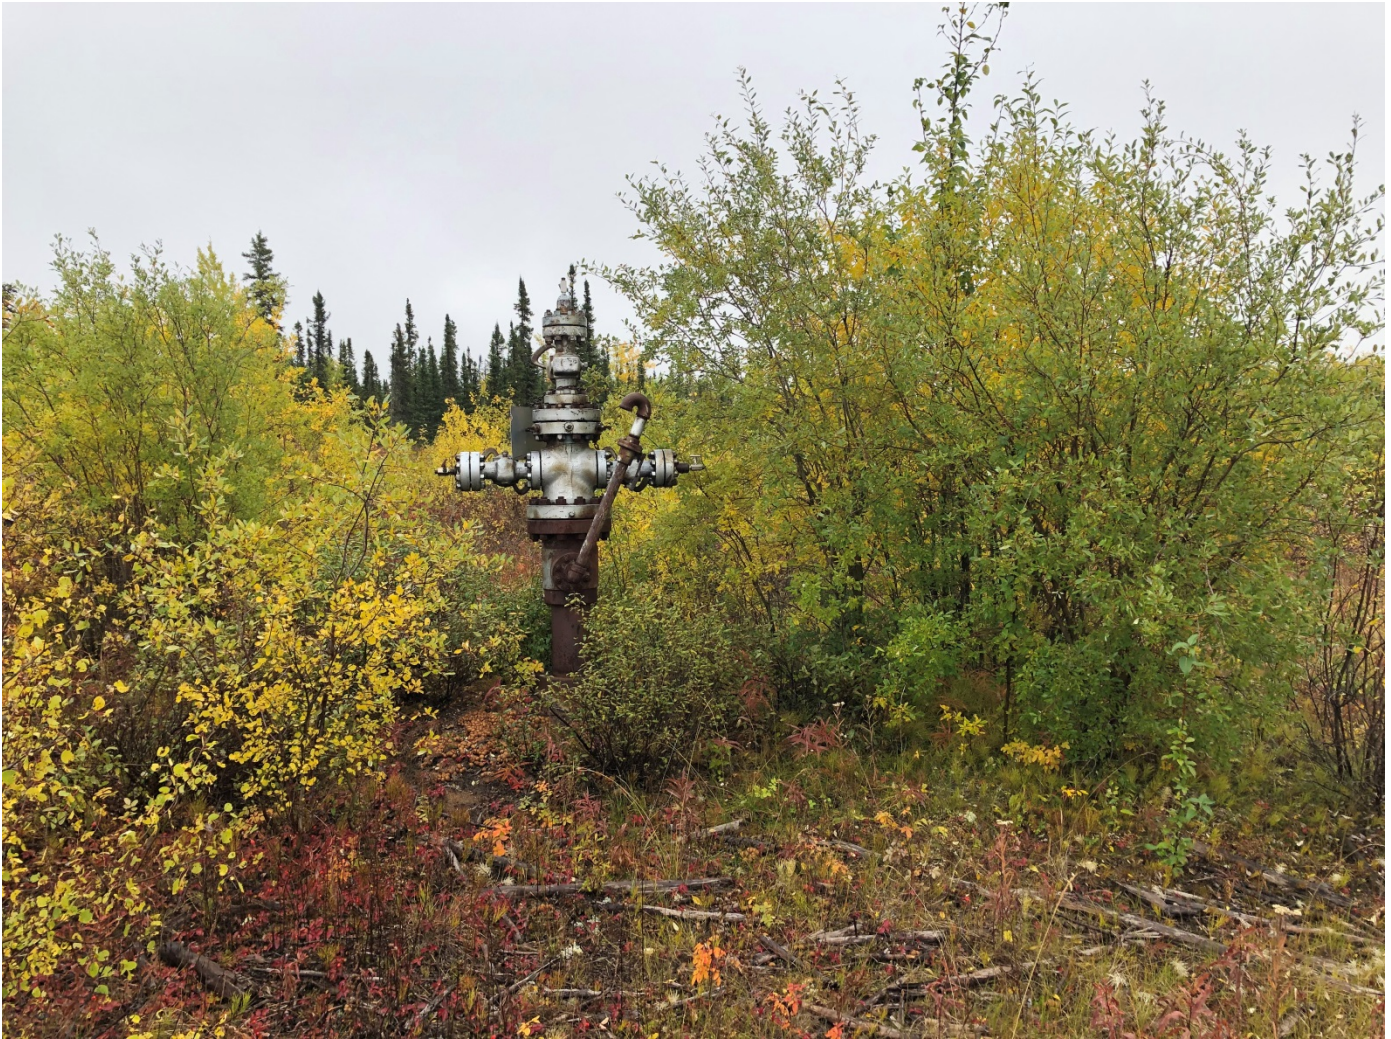
Photo #2: Brush growth adjacent to the well head. All brush must be cleared 10m around the well head. No wind indicator on well site. Wind indicator should be installed on well site.

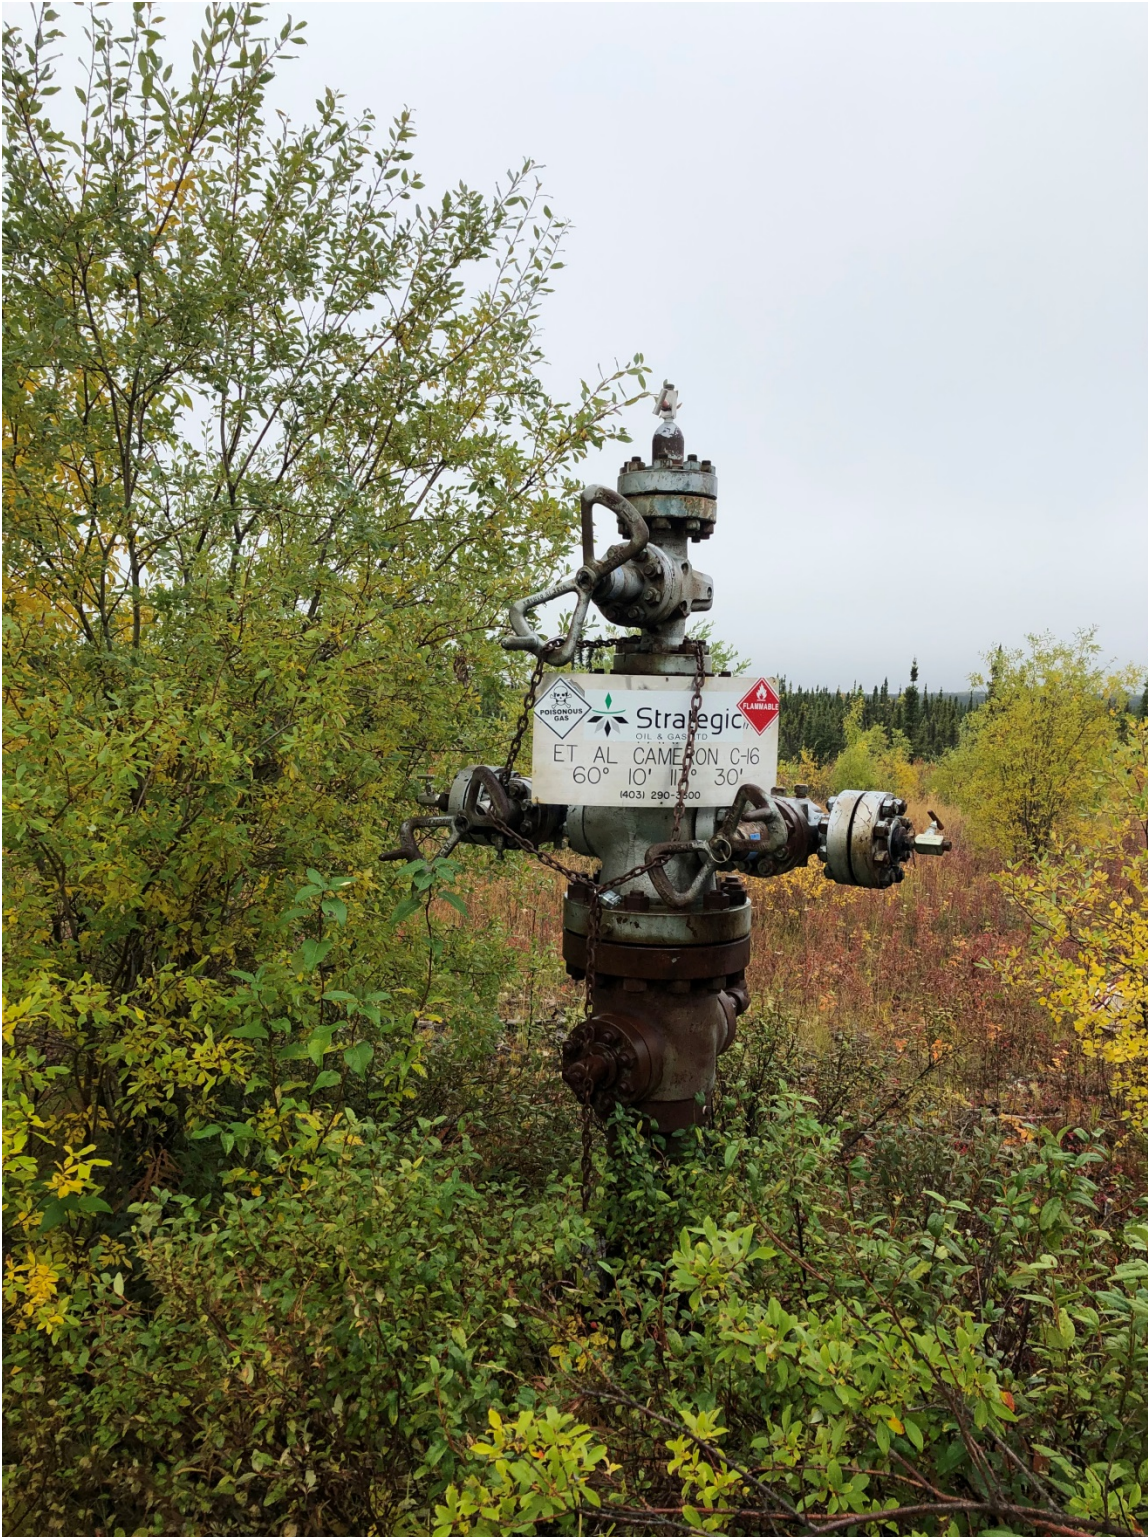
Signage	N ³	<p>Incorrect 24hr emergency contact number on well sign. (See Photo #3)</p> <ol style="list-style-type: none"> 3. The sign should include an emergency 24 hour contact number of the current owner/operator. 	
General Housekeeping	Y		
SCV Open and dead	Y	0 bubbles observed in 10 min.

Photo #3: Incorrect 24hr emergency contact number on well sign. .
