## WELLSITE SUMMARY INSPECTION REPORT

| Well/Facility Name: | Cameron N-28 | Operator: | Strategic Oil and Gas Ltd. (SOG) |
| Date of Inspection | 10/SEP/2020 | H2S Site: | Yes |

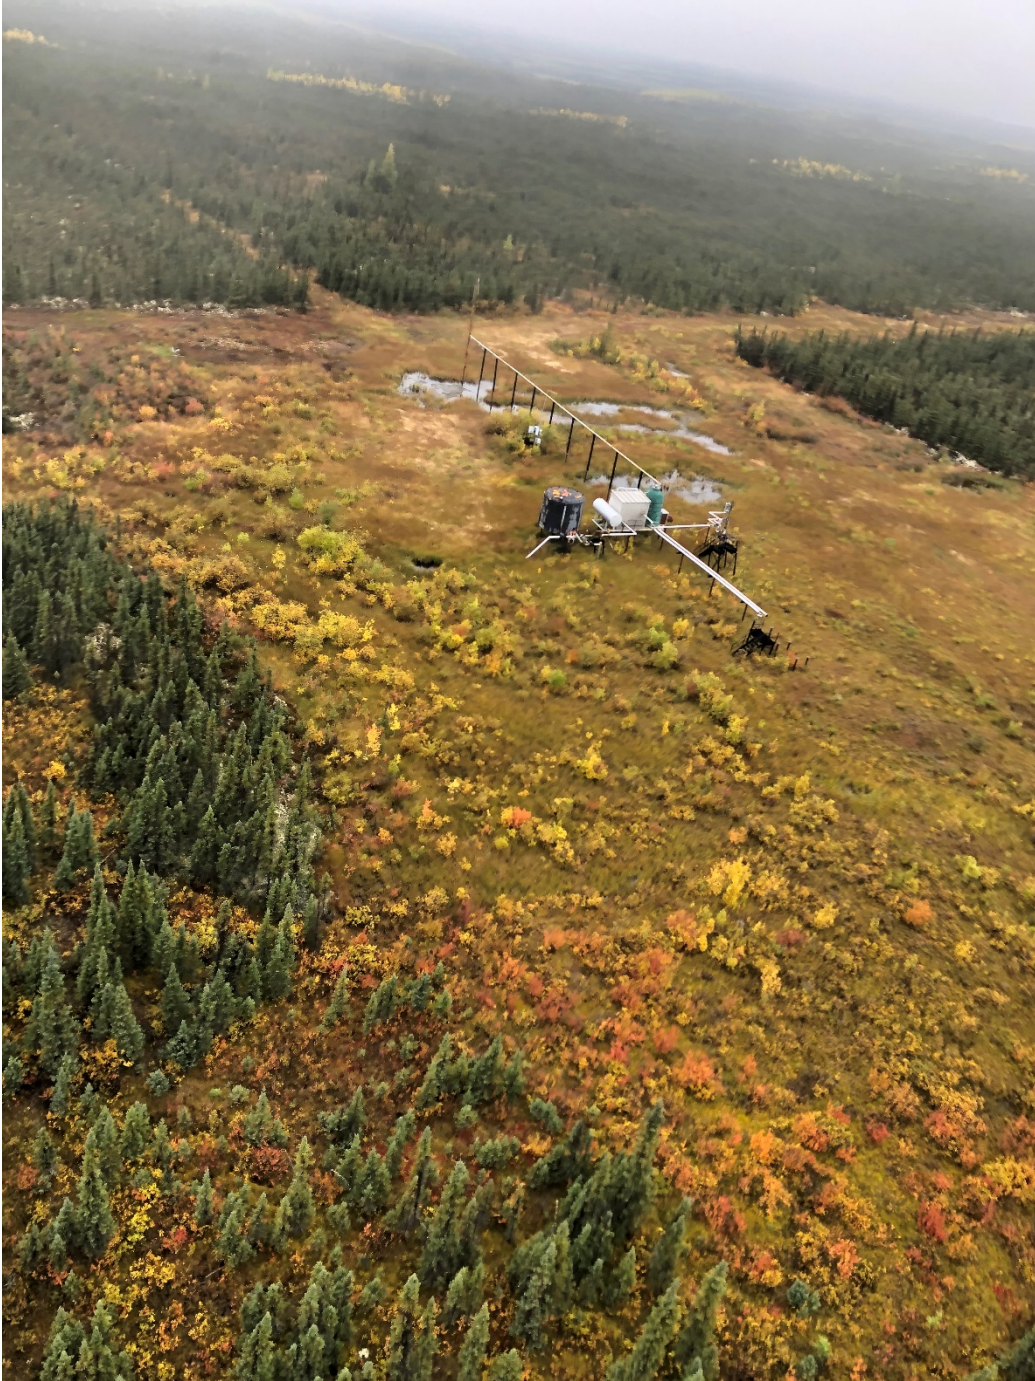
| Activity on site | Satisfactory (Y/N) | Comments |
|---|---|--|
| Site Access | Y | See Photo #1 |

Photo #1: Aerial view of N-28

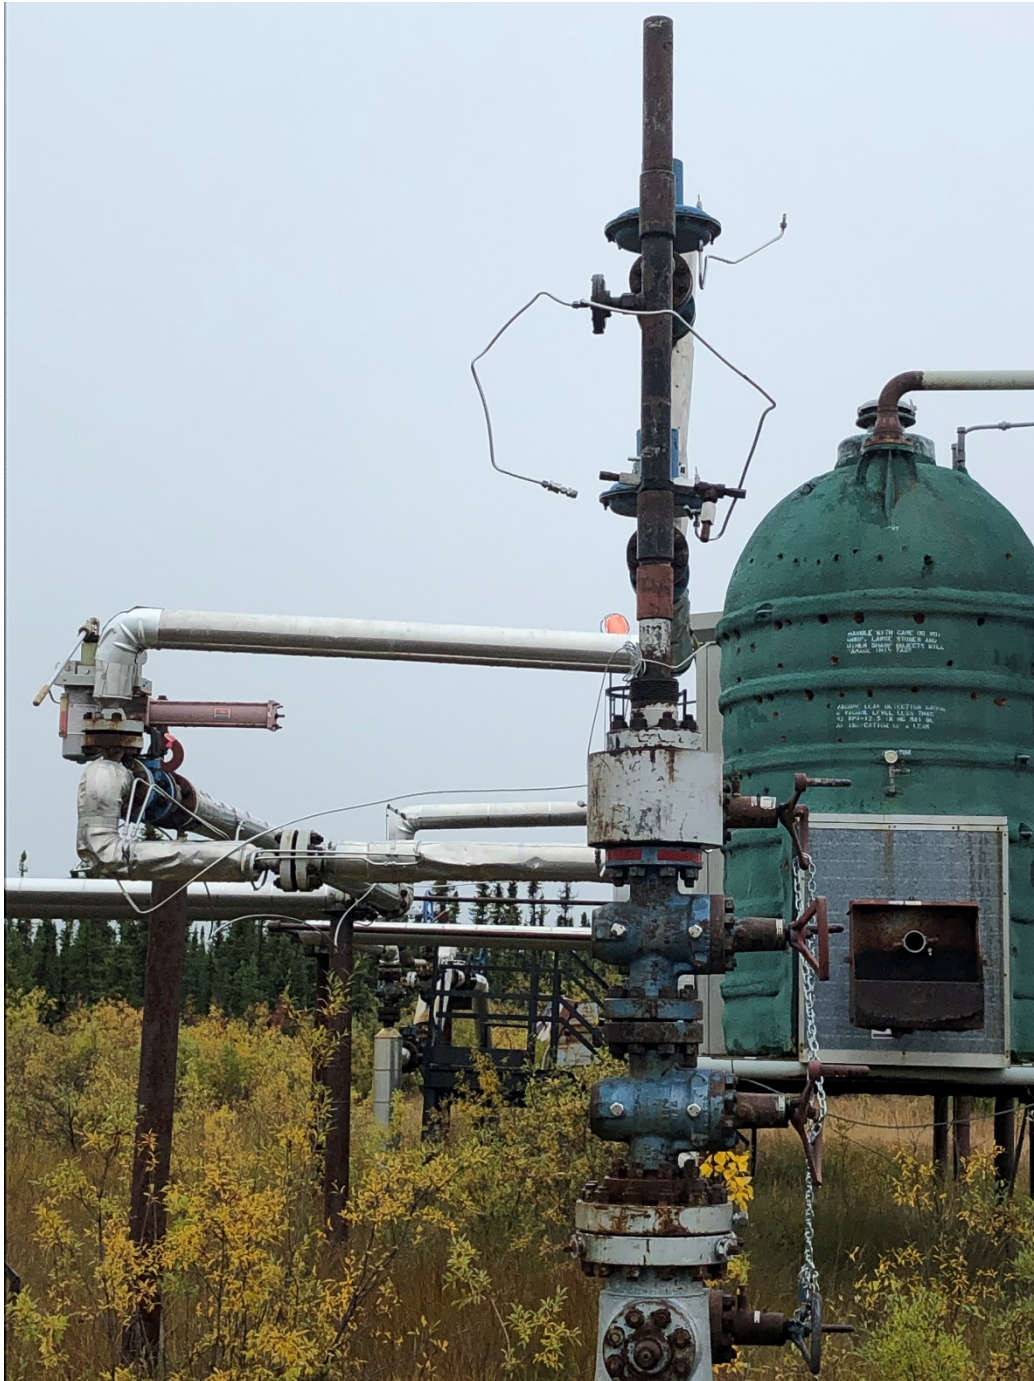
| Activity on site | Satisfactory (Y/N) | Comments |
|---|---|--|
| Signage | N <sup>1</sup> and <sup>2</sup> | <p>There was no well identification sign attached to the well head at the time of inspection (See Photo #2).</p> <p>1. A well identification sign must be installed at the well head and should include an emergency 24 hour contact number, well name and the current owner/operator.</p> |

Photo #2: N/28 Wellhead with no well identification sign.
