WELLSITE SUMMARY INSPECTION REPORT

Well/Facility Name:	Swede G-21	Operator:	Strategic Oil and Gas Ltd. (SOG)
Location of Inspection:	Cameron Hills	Access method:	Helicopter
Site Contractor:	None	Status:	Compliant Suspended – Exploratory Well
Approval Info	OA-2018-003	WID:	1764
Date of Inspection	10/SEP/2020	H2S Site:	Yes

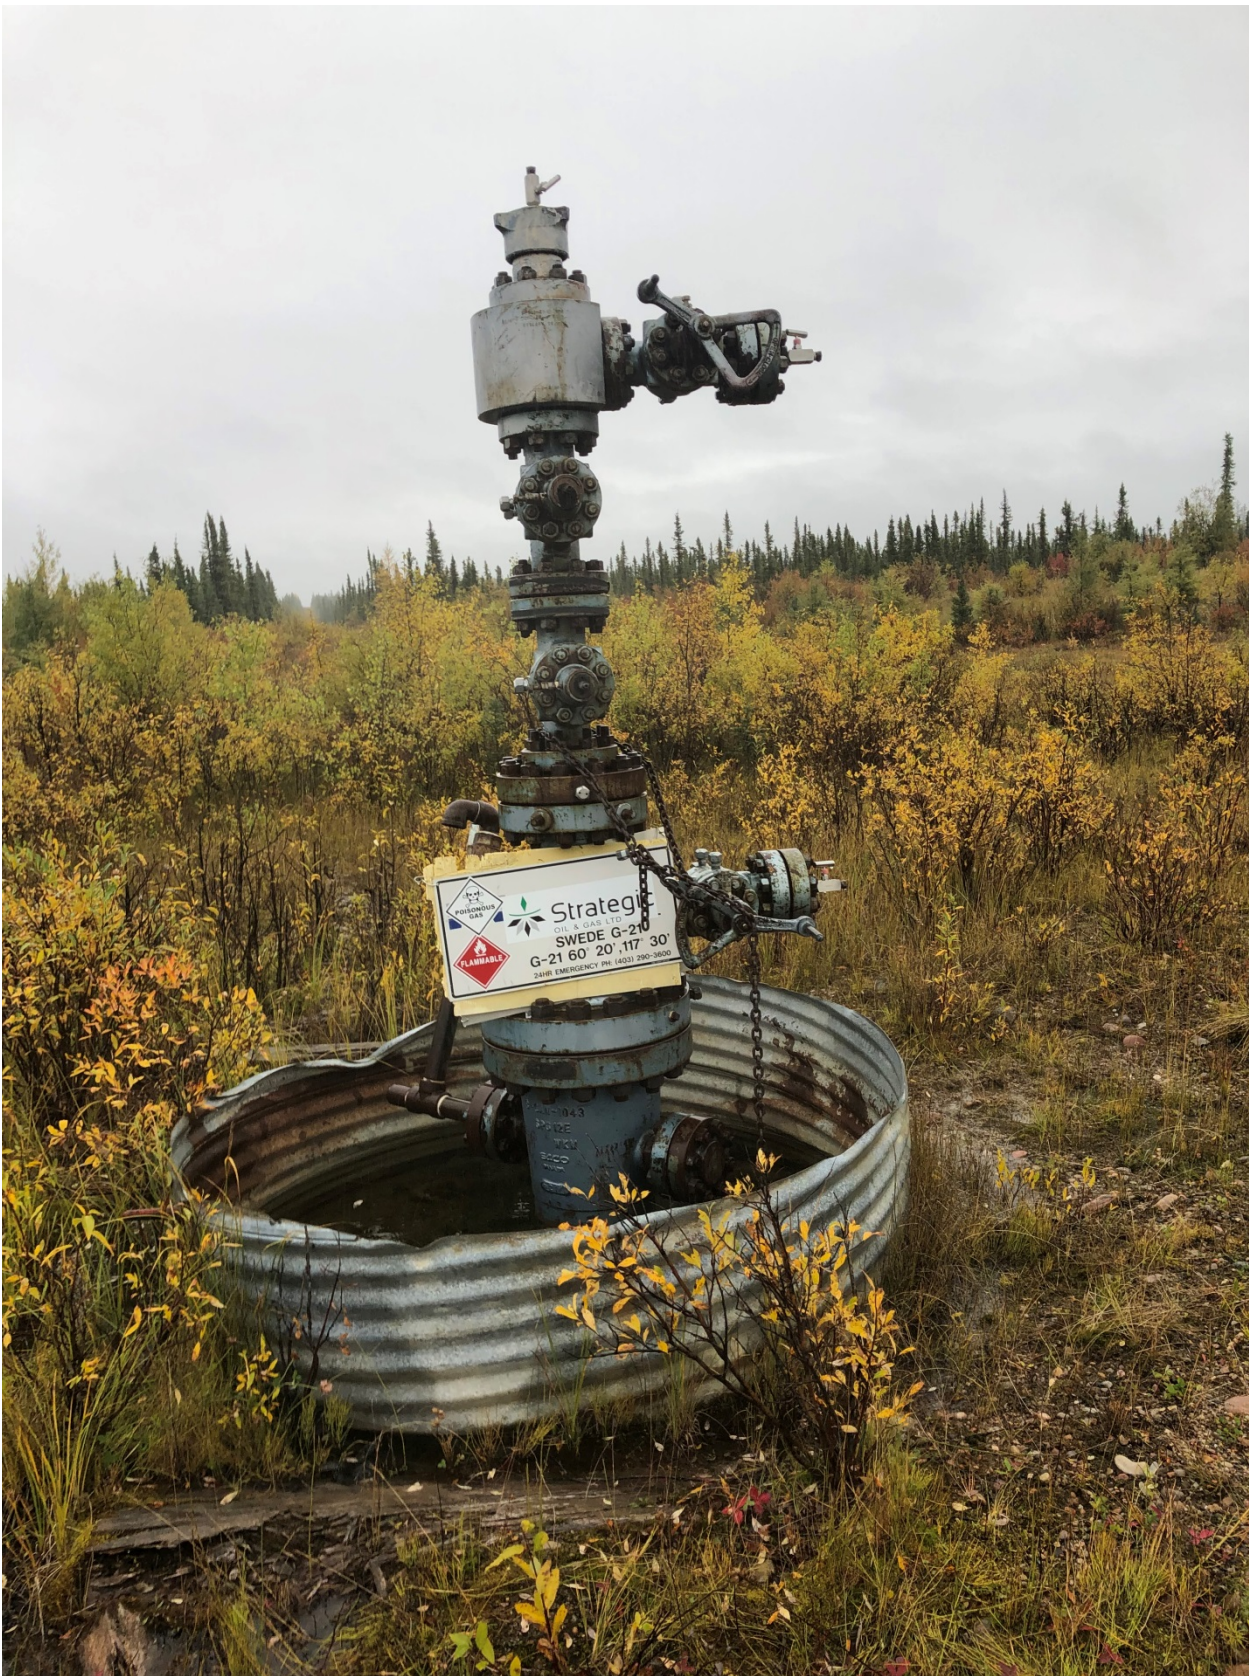
Activity on site		
Conditions	Satisfactory (Y/N)	Comments
Site Access	N ¹	<p>There were no wind indicators at the wellhead. To ensure safe access, wind indicators must be installed (See Photo #1).</p> <p>1. Section 5A of the Well Suspension and Abandonment Guidelines and Interpretation Notes requires that wells must be safely accessible for inspection and monitoring.</p>
Wellhead Access	N ²	<p>Three well head valves were not secured. (See Photo #1)</p> <p>Detached valve handles left on ground and in conductor hole. (See Photo # 2).</p> <p>2. Section 5A of the Well Suspension and Abandonment Guidelines and Interpretation Notes requires that valve handles must be chained and locked or, as an alternative, valve handles may be removed</p>
Signage	N ³	<p>Incorrect 24hr emergency contact number on well sign. (See Photo #3)</p> <p>3. The sign should include an emergency 24 hour contact number of the current owner/operator.</p>

Photo #: No wind indicator on well site. Wind indicator should be installed on well site. All well head valves should be secured to prevent unauthorized operation.

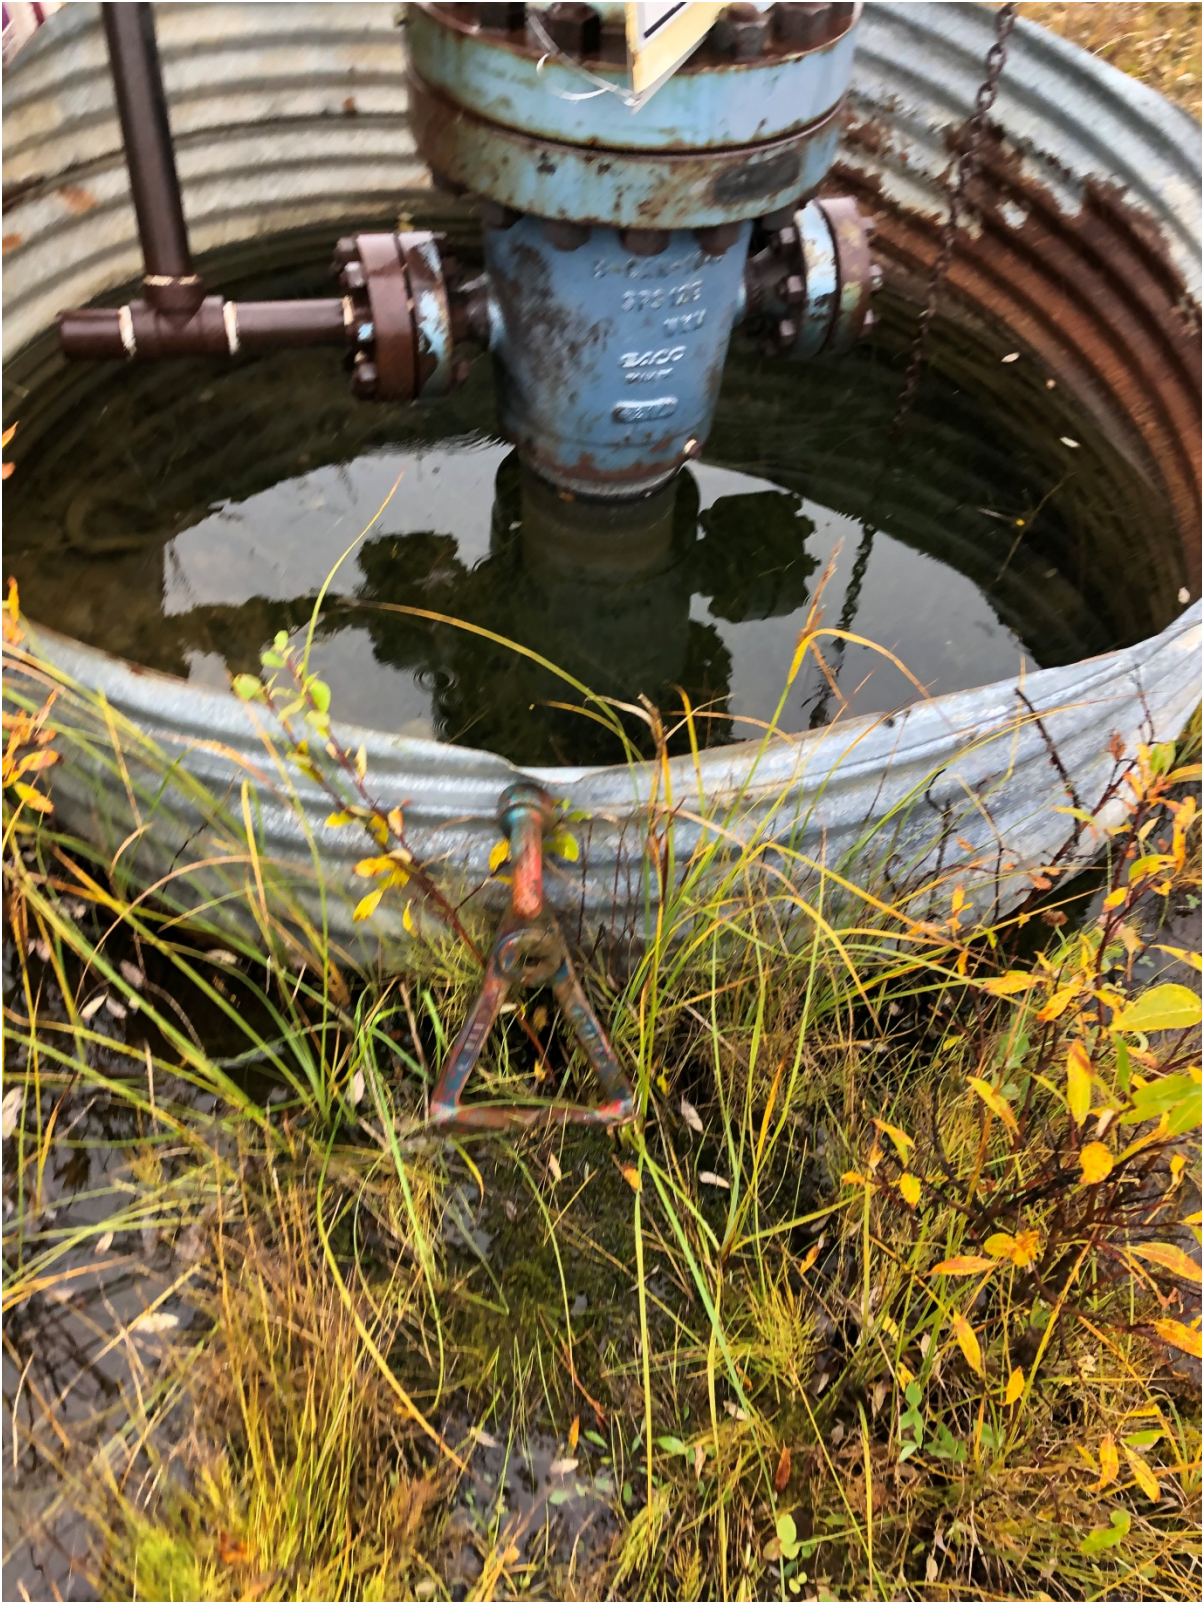
Photo #2: Detached valve handles left on ground and in conductor hole.

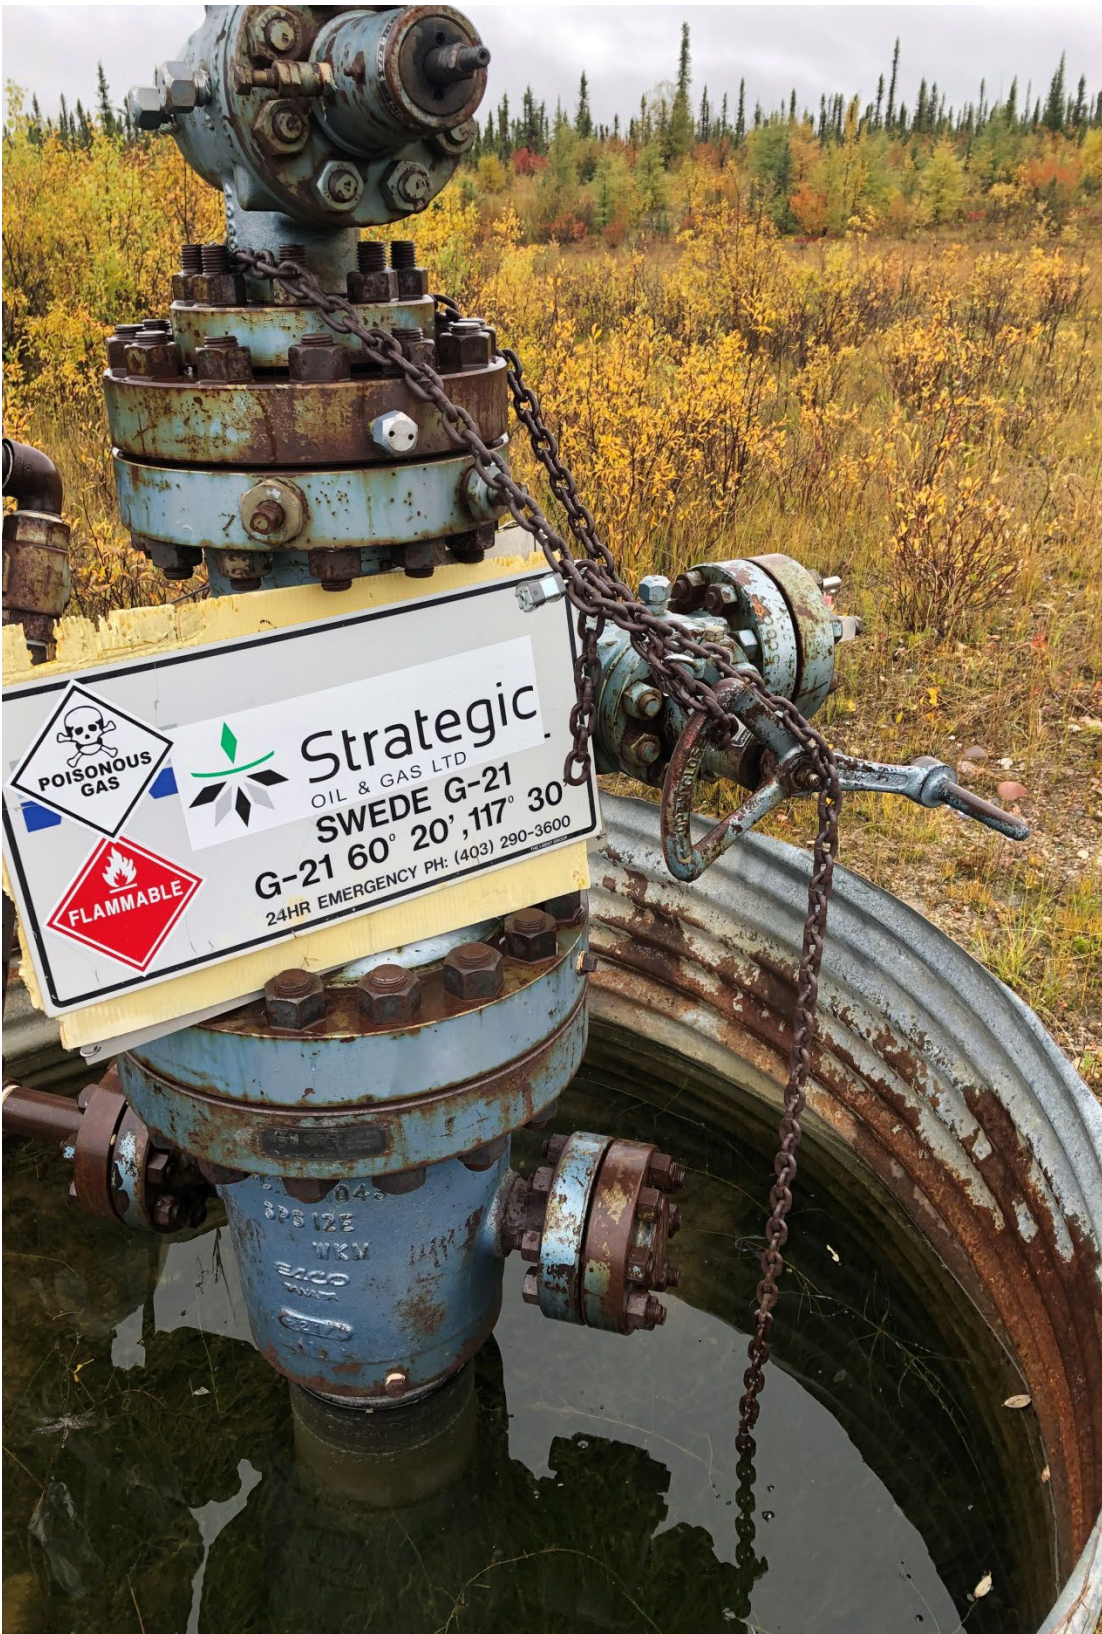
Photo #3: Incorrect 24hr emergency contact number on well sign.
