Well Inspection Report

Well name: I-73-60-10-117-15

I-73 Wellsite Inspection Pictures

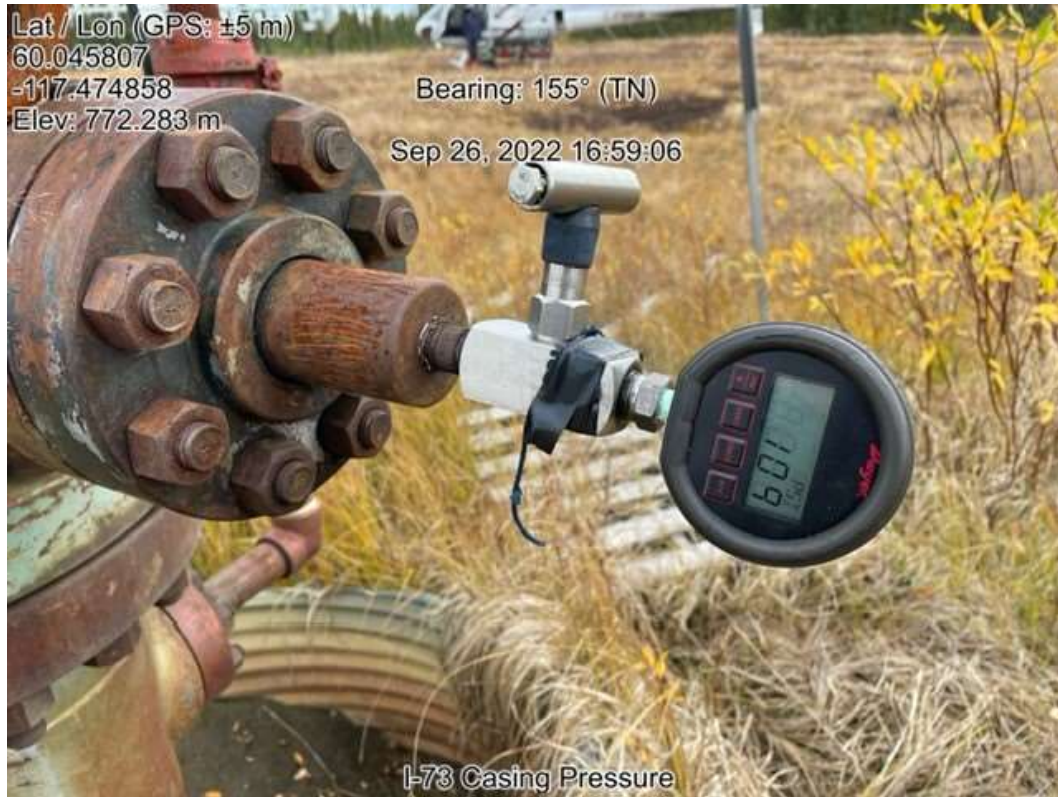
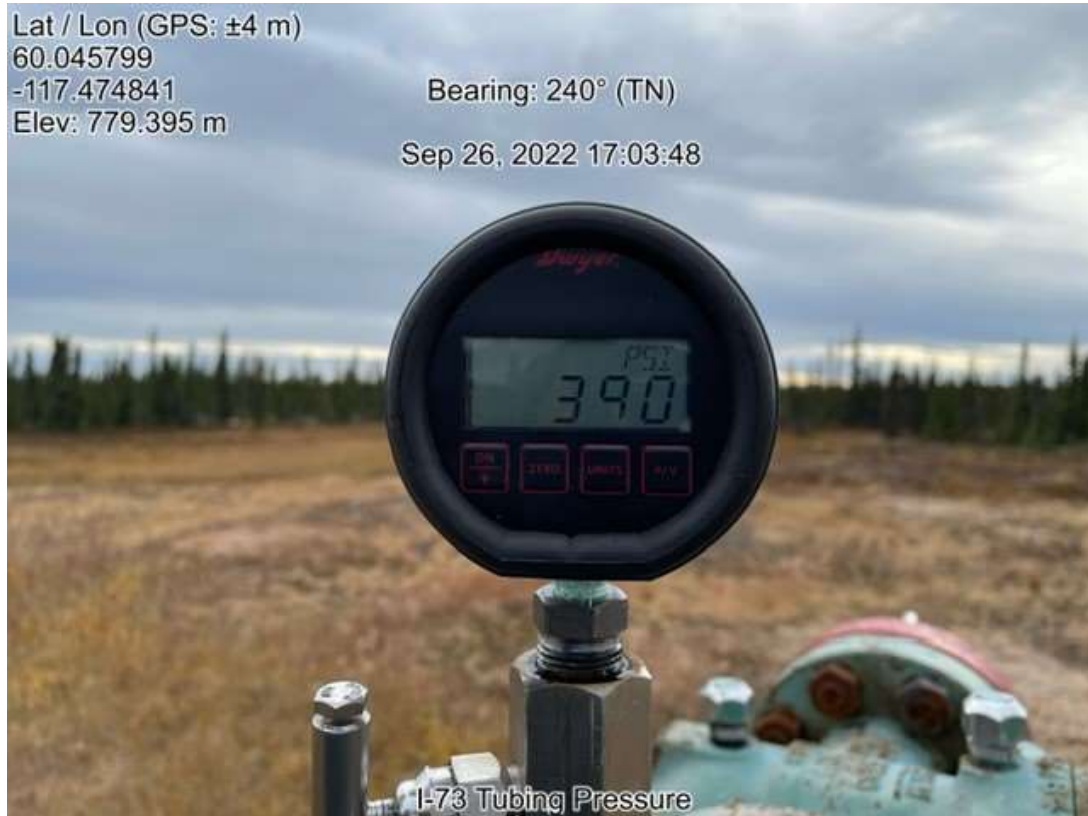
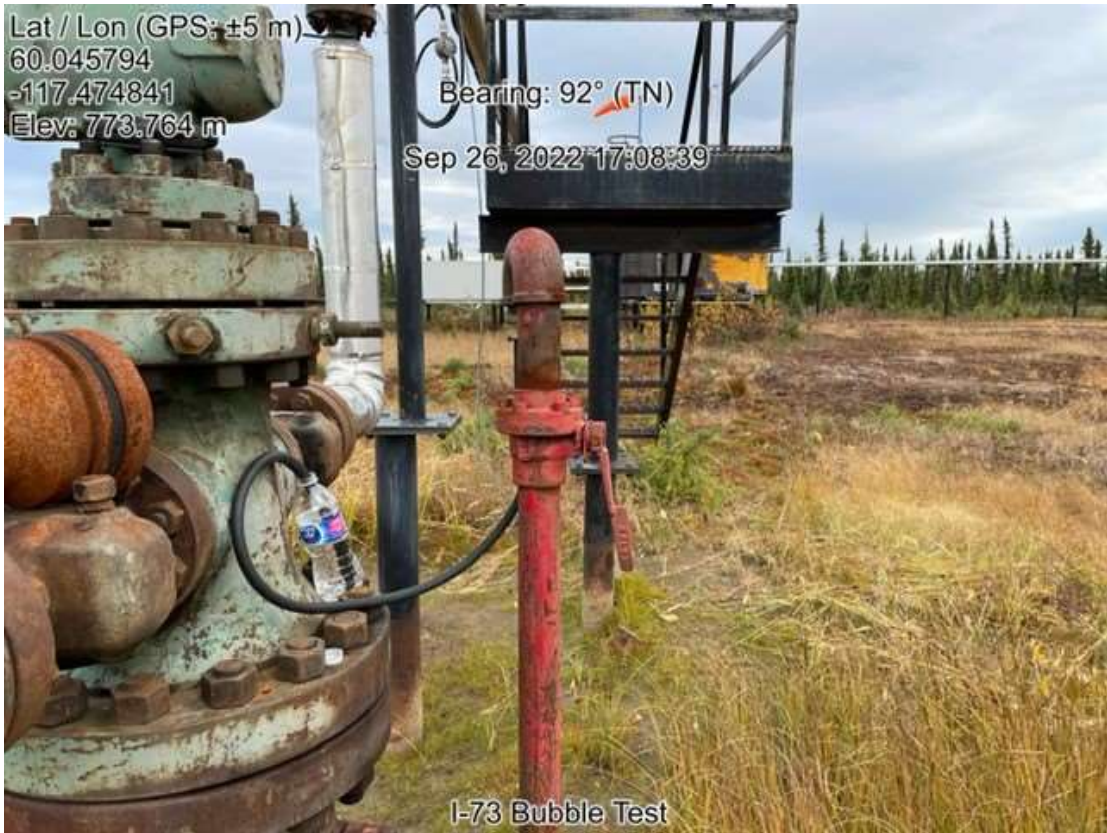
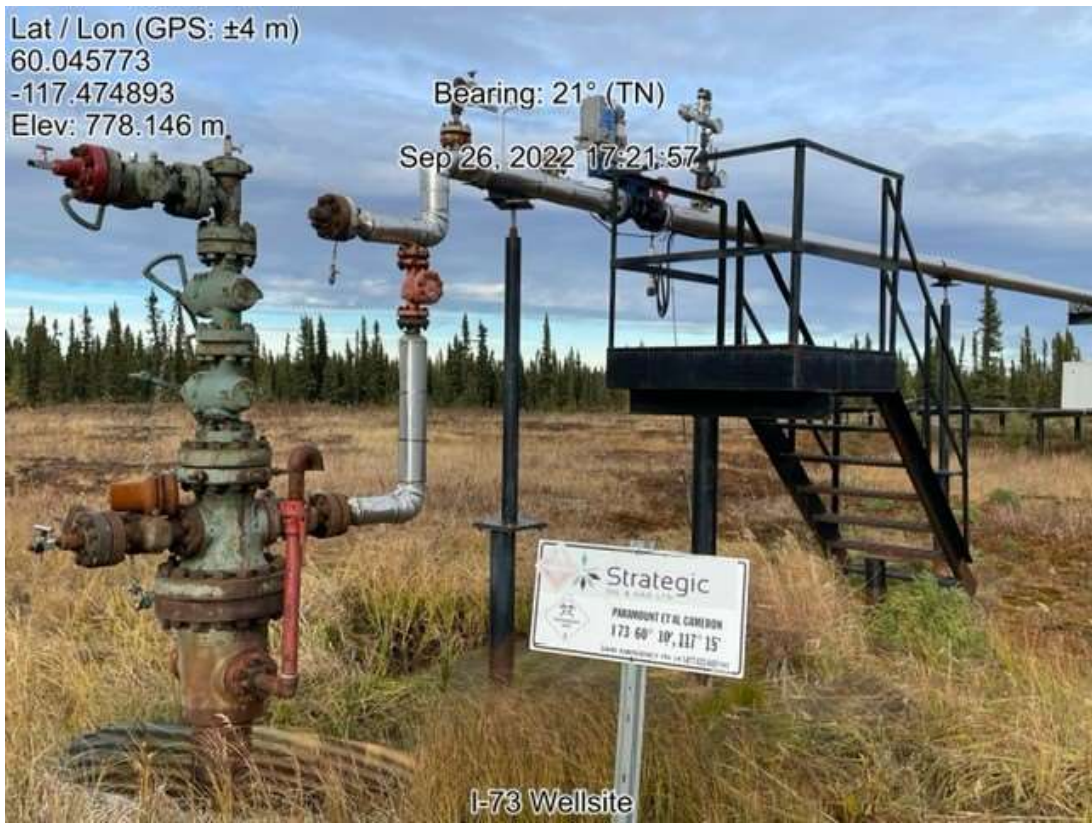
10 minute Bubble test completed on SCV, no visible bubbles or flow indicated. See attached pictures for shut in pressures taken on Tubing and Casing. This well had a previous SCVF detected in October 2019 that was addressed in winter 2019. No H2S or LEL detected while on site.

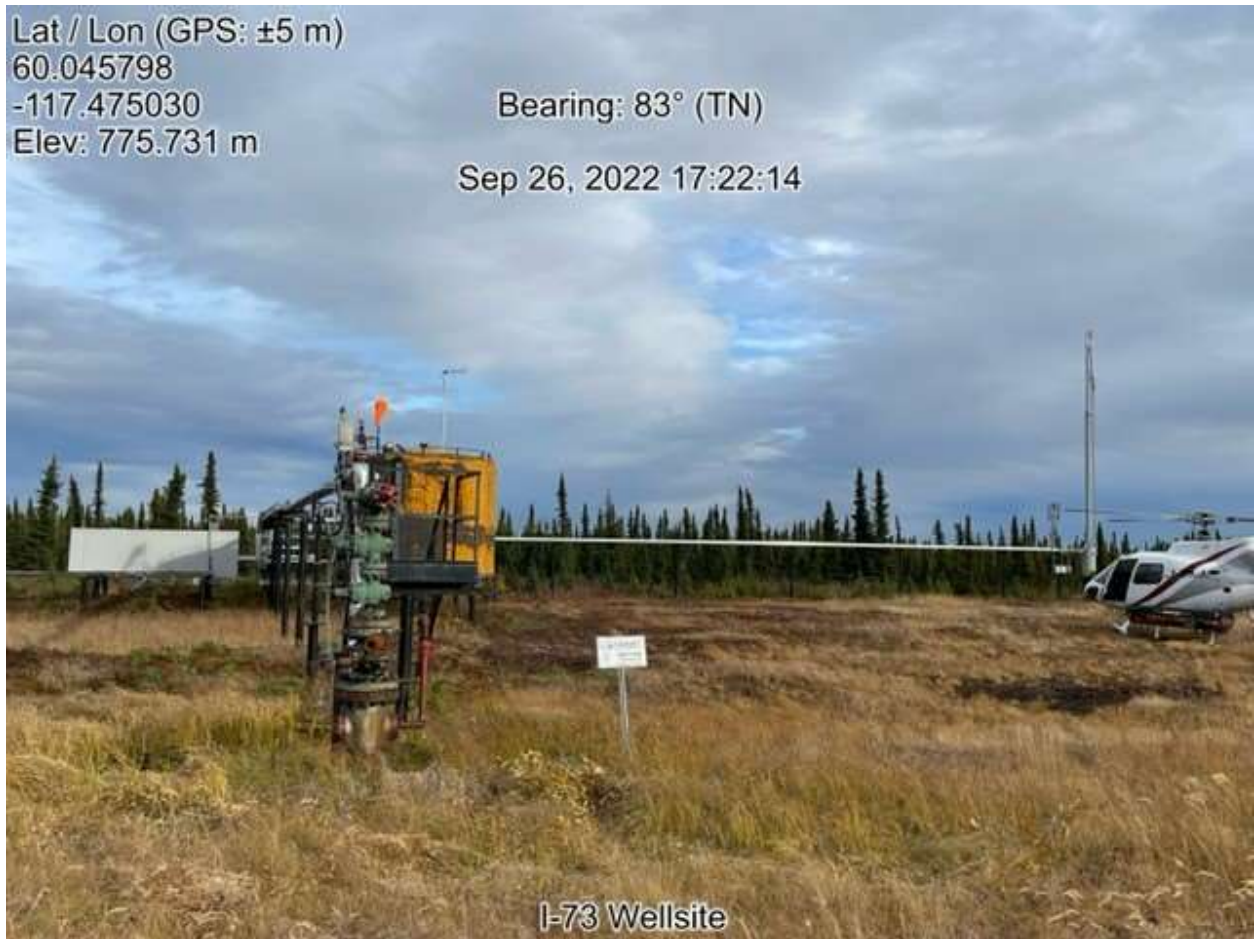
I-73 Wellsite

Lat / Lon (GPS: ± 5 m)
60.045798
-117.475030
Elev: 775.731 m

Bearing: 83° (TN)

Sep 26, 2022 17:22:14
