**RE: Municipal Water Licence (G08L8-002)**

## WATER LICENCE INSPECTION FORM

<b>DATE:</b>	May 7, 2009	<b>COMPANY REP:</b>	Jennifer Johnston
<b>LICENCEE:</b>	The Gwich'in Tribal Council	<b>LICENCE #:</b>	G08L8-002

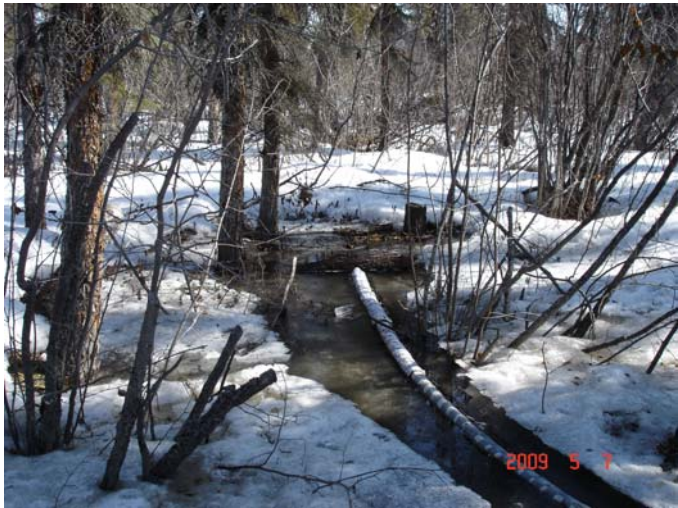
**Figure 1**

2. Length of sewage effluent discharge hose should continue to be monitored to make sure there is proper drainage given the close proximity of the discharge area to the camp. This will make certain the sewage effluent continues to drain away from camp area (see Figure 1).

Treated sewage effluent discharge hose and area located at the edge of the camp.

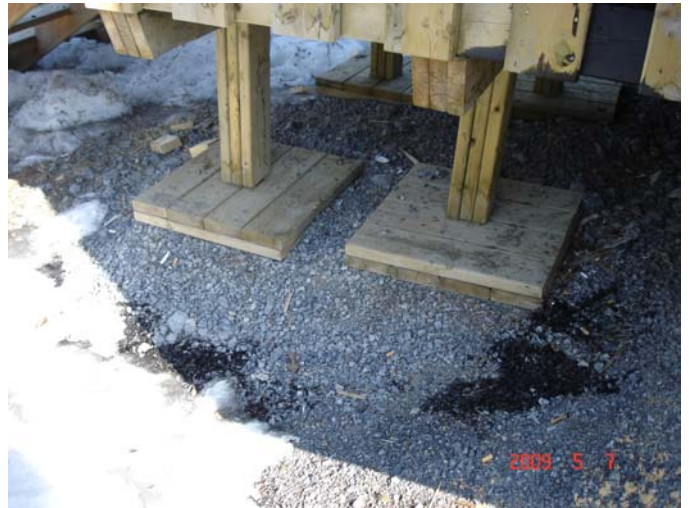
**Figure 2**

3. Used oil spilled from storage containers as a result of a recent oil change for the generators. Spillage needs to be cleaned up entirely as this has the potential to cause further damage to the environment. It is recommended that a more efficient and cleaner method is used to change and store used oil (see Figure 2).

Spillage of used oil on ground near used oil storage containers.

- Sewage Treatment Plant sludge removed by Bob's Welding Ltd. and taken for disposal to the Inuvik Sewage Lagoon.
- Overflow has occurred from primary tank during heavy loads. Pumps are reset so it doesn't overflow and prevent further occurrences.
- It is understood that the spilled oil has since been cleaned up.
