RE: Land Use Permit G13H004
 Fuel Storage, Camp and Land Farm
 James creek

ENVIRONMENTAL INSPECTION REPORT

Permittee:	GNWT Department of Transportation	Permit Expiry Date:	August 11, 2018
Land Use Permit No.	G13H004	Previous Inspection:	August 20, 2013
Quarrying Permit No.		Inspection Date:	April 16, 2014
Contractor:		Subcontractor:	
Location(s) Inspected:	James creek		
Current Stage of Operation:	on-going		
Program Modifications Approved:

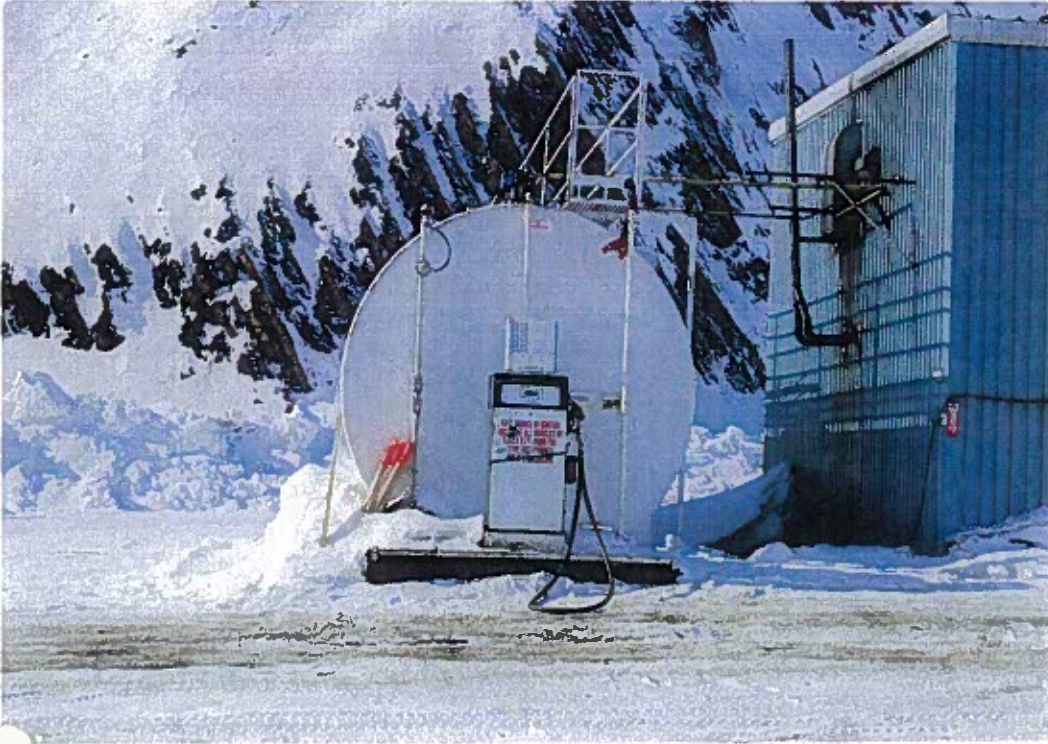
Image 1

Also observed was no secondary Containment for the Refuelling area and is in non-compliance with Condition # 26(1)(m) item 22:

No secondary containment at refueling point

Secondary Containment - Refuelling: The Permittee shall set up all refueling points with secondary containment.

Please note that these items are repetitive in previous inspections. It is also recommended that the Terms and Conditions be reviewed with the contractors and operators of the site.

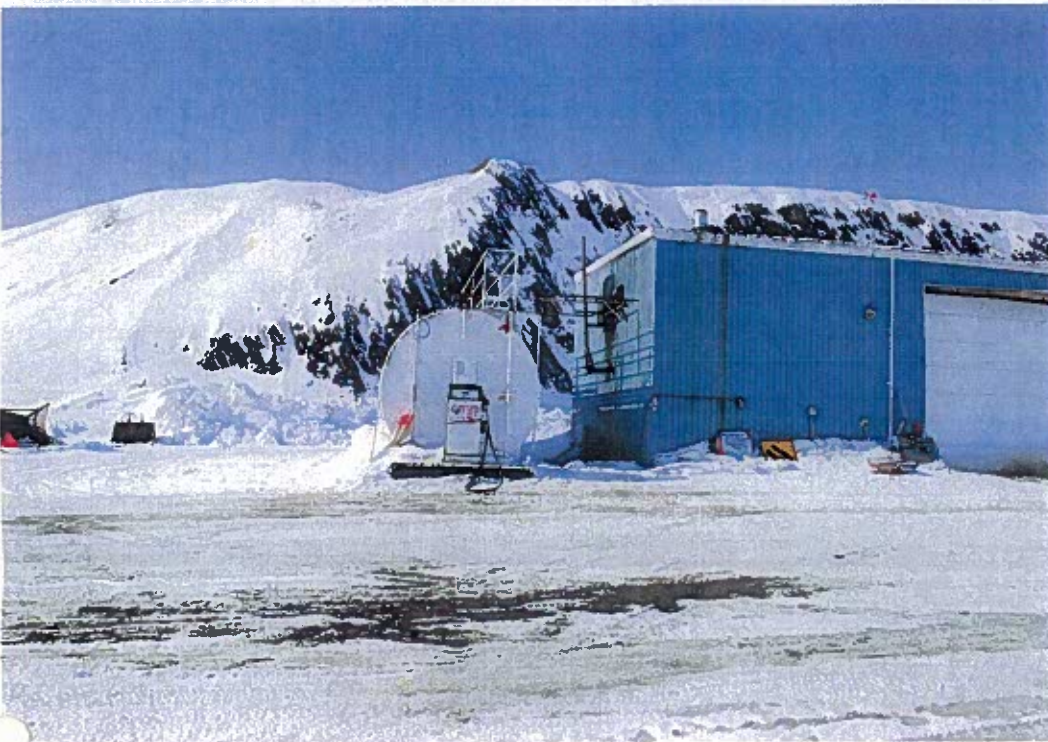
Figure 2

No secondary containment at refueling point

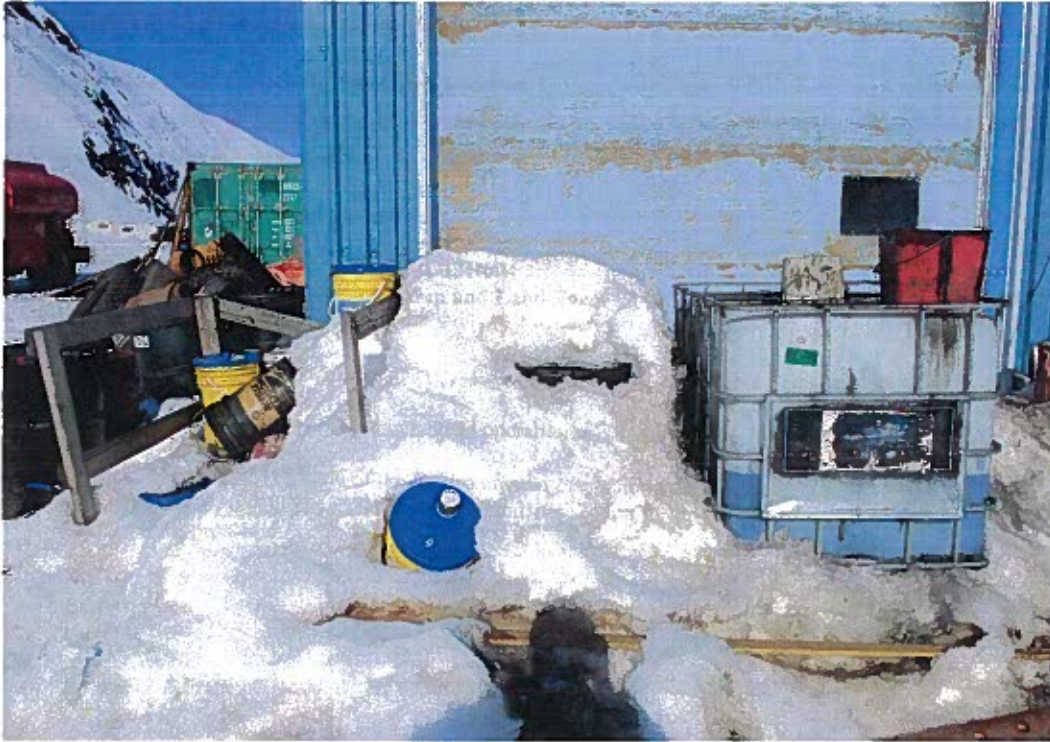
James Creek Fuel Storage: During this inspection it was observed that the waste oil behind garage stacked by building does not have secondary containment and is in non-compliance with Condition # 26(1)(g) item 10 :

Figure 3
waste petroleum

Waste Petroleum Disposal: The Permittee shall dispose of all combustible waste petroleum products by removal to an approved disposal facility.

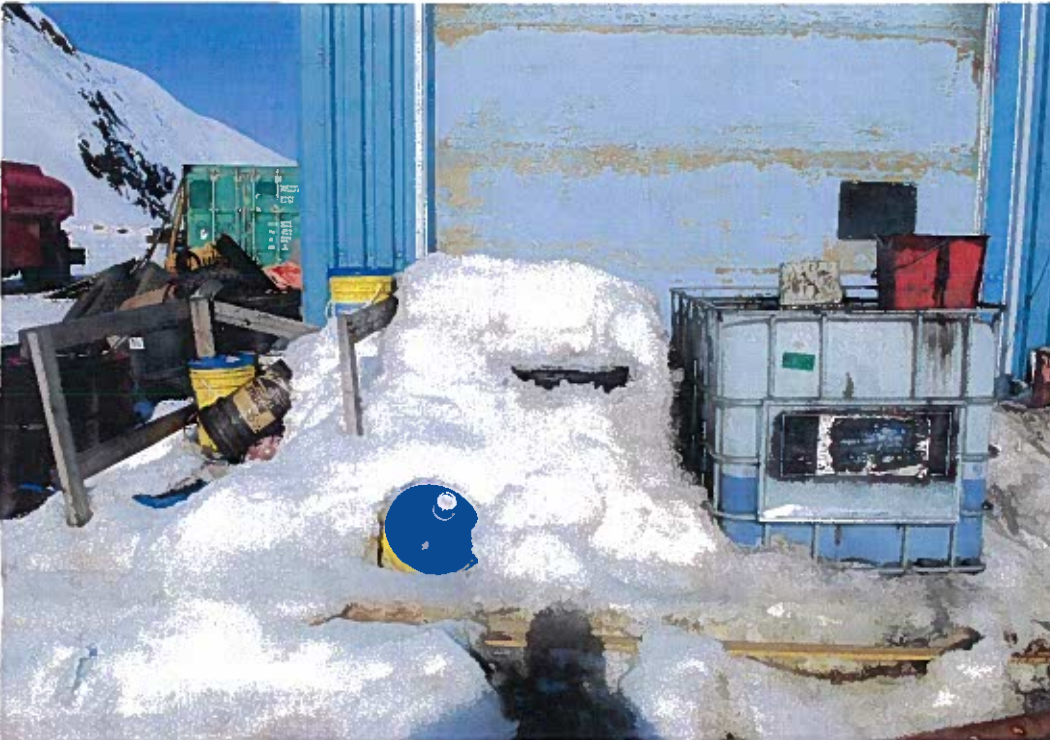
Figure 4
waste petroleum
