RE: Land Use Permit G13H004
FUEL CACHES

ENVIRONMENTAL INSPECTION REPORT

Permittee:	GNWT Department of Transportation	Permit Expiry Date:	August 11, 2018
Land Use Permit No.	G13H004	Previous Inspection:	New
Quarrying Permit No.		Inspection Date:	August 20, 2013
Contractor:		Subcontractor:	
Location(s) Inspected:	Km 14.2 James Creek		
Current Stage of Operation:	active		
Program Modifications Approved:

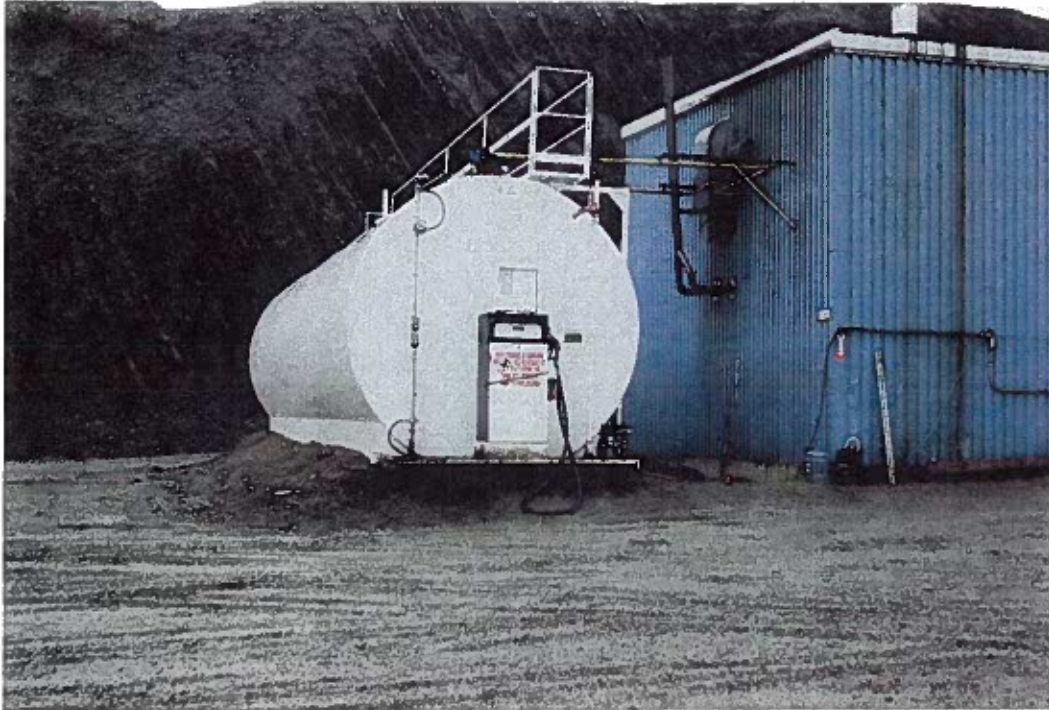
Figure 1

It was observed that the fuel refueling area does not have any secondary containment. This has been pointed out in past inspections again no secondary containment for the refuel area is observed.

Fuel tank refuel area – No secondary Containment

Condition # 22 - Secondary Containment – Refueling

The Permittee shall set up all refueling points with secondary containment.

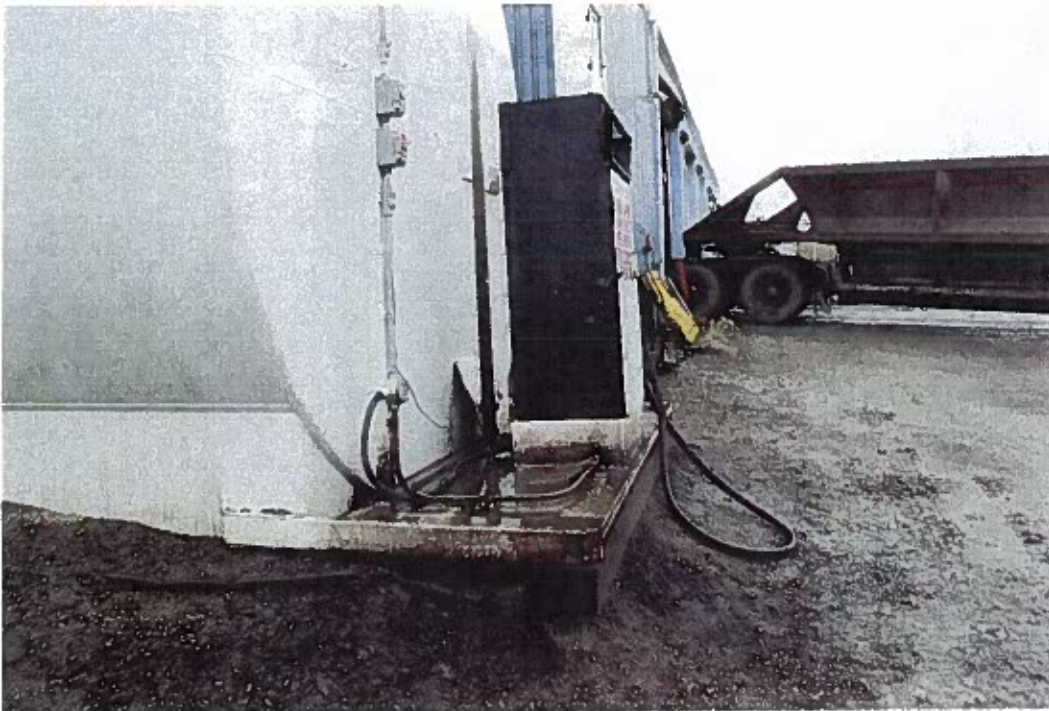
Figure 2

Fuel tank refuel area - No secondary Containment

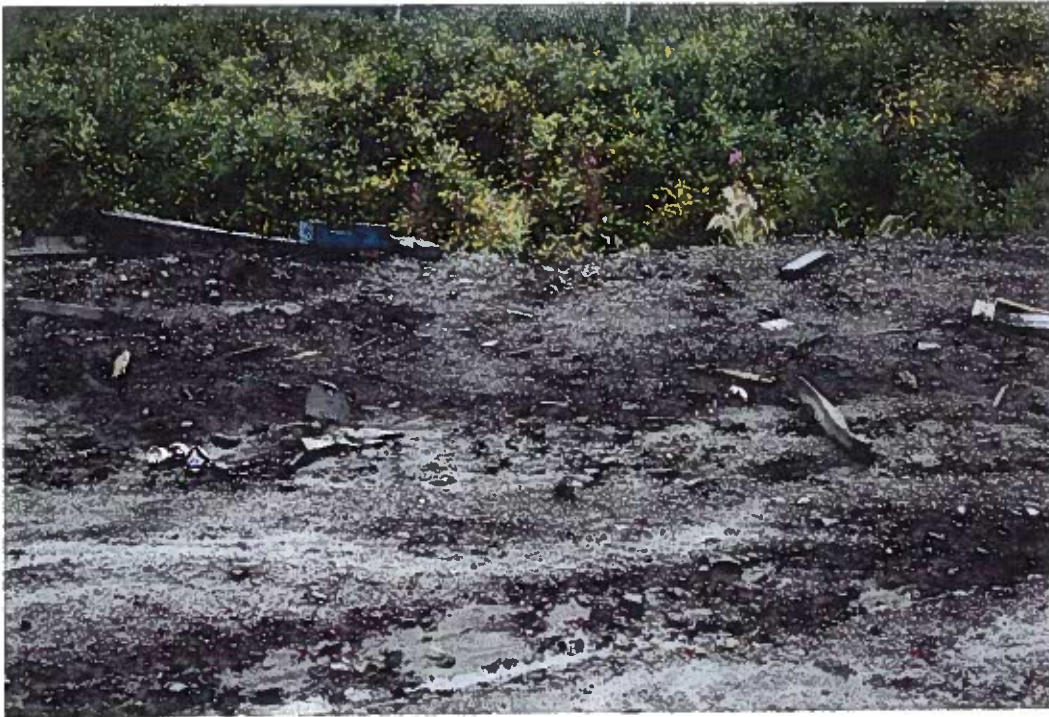
It was also observed that there is debris in front of the garage by the roads edge and as well behind the garage by hillside a caribou skin and debris.

Figure 3
debris by road edge

condition # 6 - Clean Work Area

The Permittee shall ensure that the land use area is kept clean at all times.

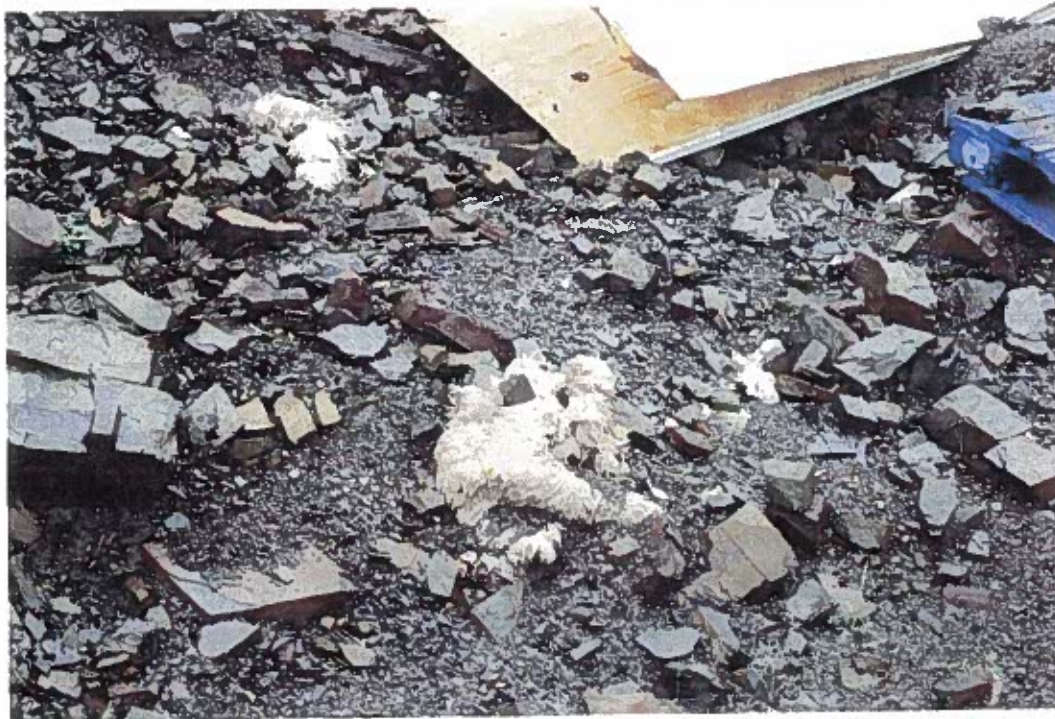
Figure 4
debris behind shop
