File Number: G13H004
Type of Operation: FUEL CACHES
Location: Km 14.2 James Creek

ENVIRONMENTAL INSPECTION REPORT

| Permittee: | GNWT Department of Transportation | Permit Expiry Date: | August 11, 2018 |
| Location(s) Inspected: | Km 14.2 James Creek | | |

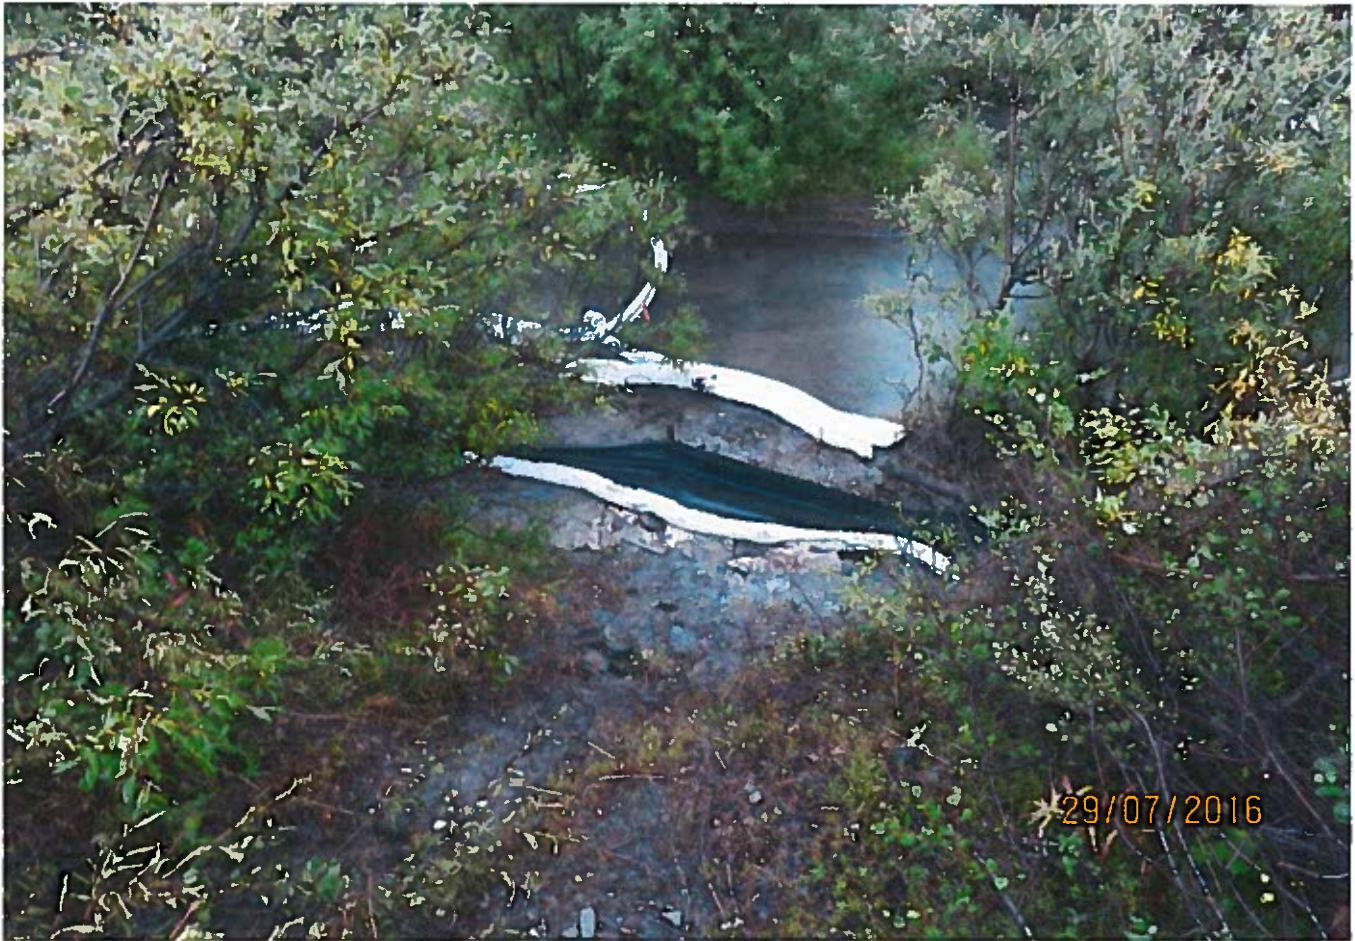
Figure 1

Clean - up work is on-going with a spill that had occurred earlier this month on July 4, 2016.. It was observed that more booms had been placed into the creek and at the fuel dispenser area work was also being done to hand shovel the contaminated material there as well.

booms set in place

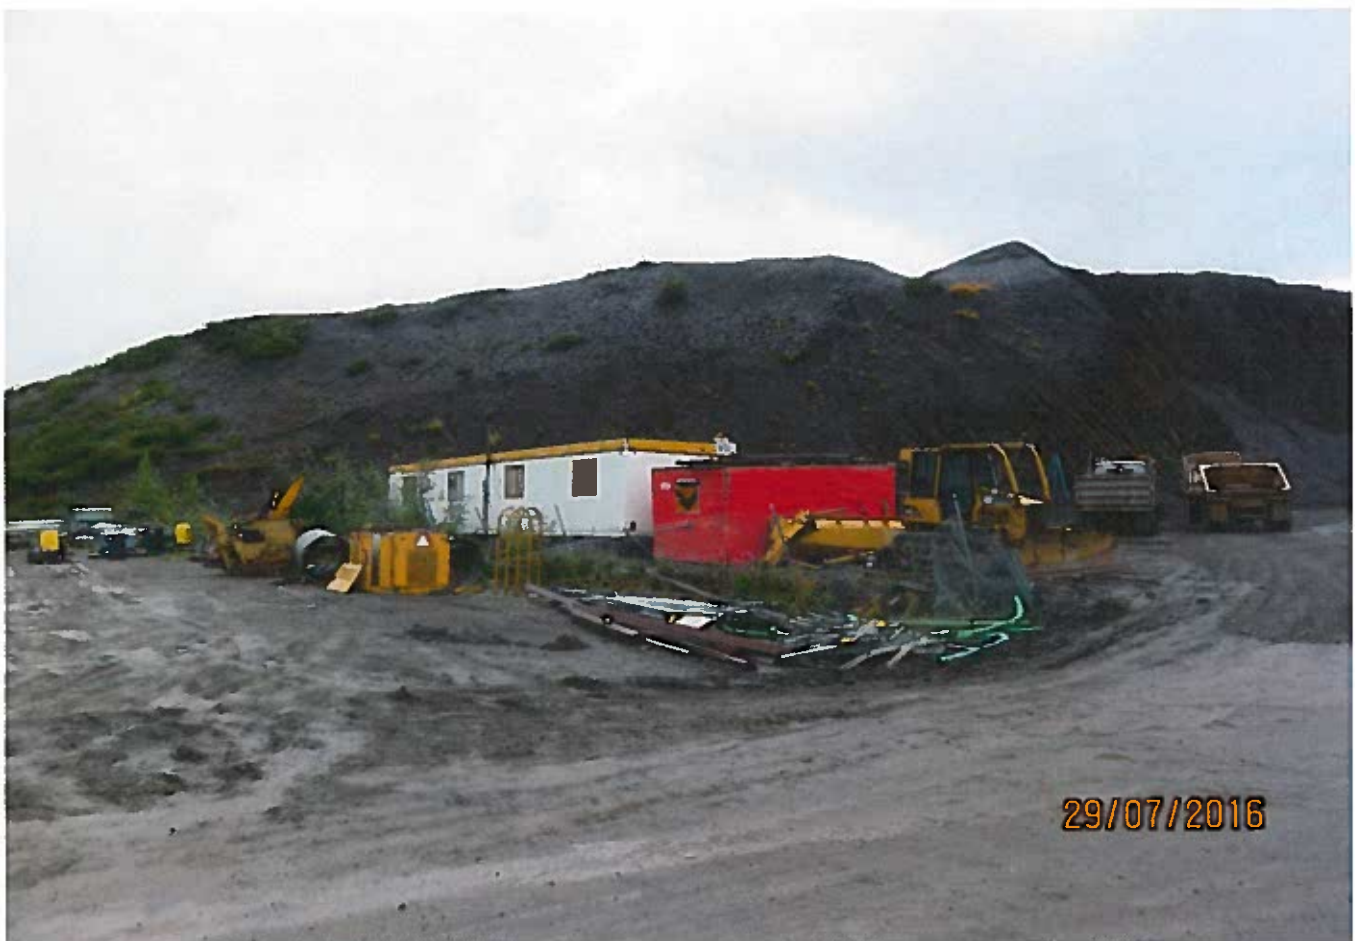
Figure 2

On the west side prior to the turn off to the dempster , there is a bunch of metal that should be removed from site as well, if they are not part of the permit issued for the maintenance camp.

Location of scrap metal

Ensure scrap metal material or unused tanks are removed if they are not part of the permits maintenance camp equipment.

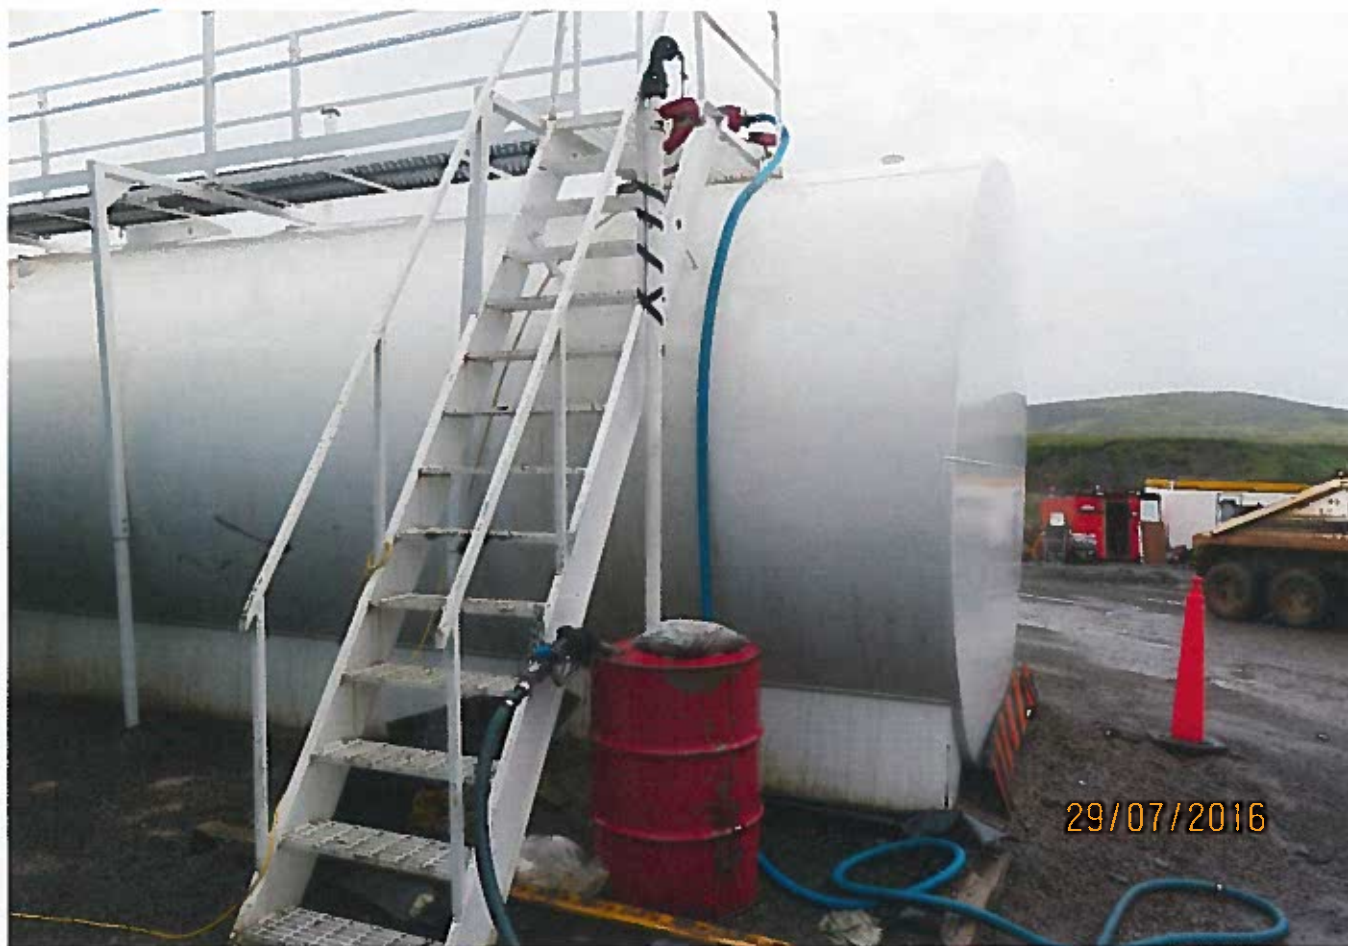
Figure 3
refuel location at back of fuel tank

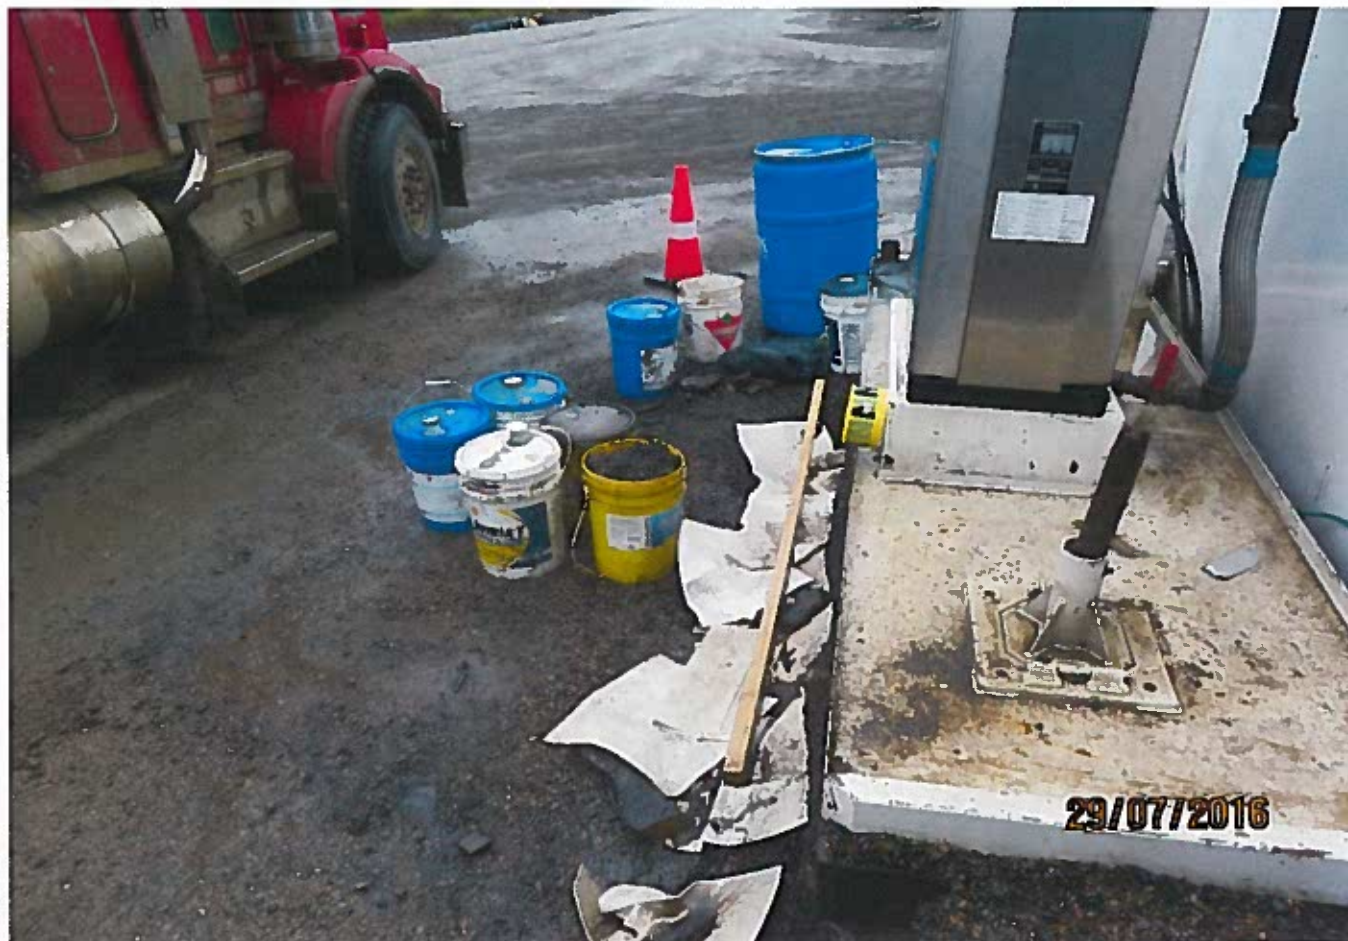
Figure 4
contaminated soil being collected.

It was later learned that a Remedial Action Plan was discussed at the D.O.L. office with the GLWB, D.O.T. and D.O.L. and that this plan will be commenced on August 2, 2016.
