File Number G14E002
Type of Operation QUARRY SITE - Existing
Location Km 06

ENVIRONMENTAL INSPECTION REPORT

Permittee:	GNWT Department of Infrastructure	Permit Expiry Date:	May 24, 2019
Land Use Permit No.	G14E002	Previous Inspection:	July 12, 2017
Quarrying Permit No.		Inspection Date:	October 12, 2017
Contractor:		Subcontractor:	
Location(s) Inspected:	Km 06		
Current Stage of Operation:	on-going		
Program Modifications Approved:	NIL

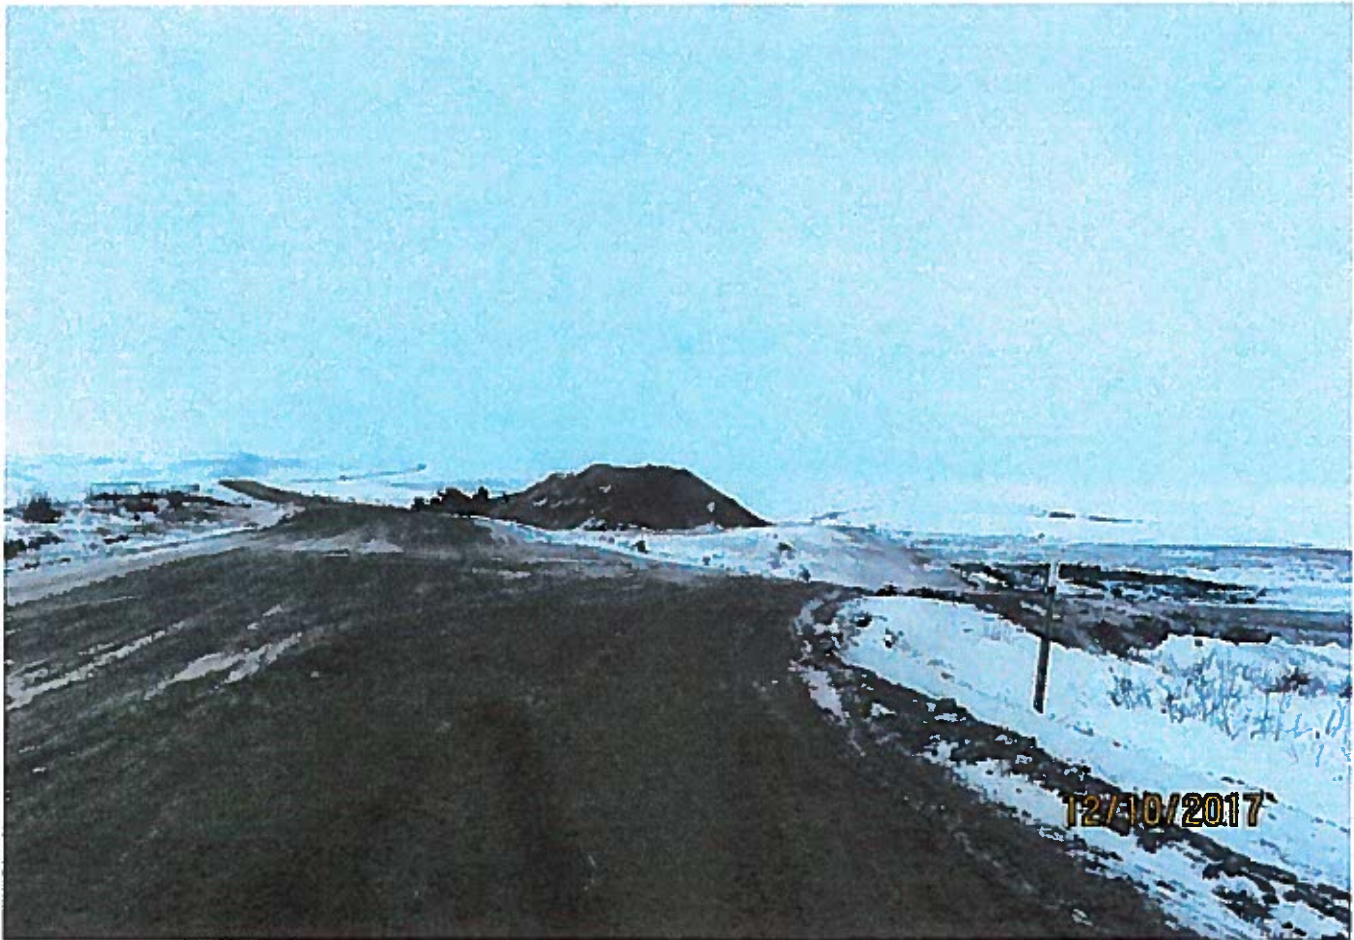
Inspection Images:
Figure 1

During the inspection it was observed that activity was occurring at Km 06 where a crusher and stock piles was observed.

Ensure crushing is ceased and valid quarry authorization and permits are obtained.

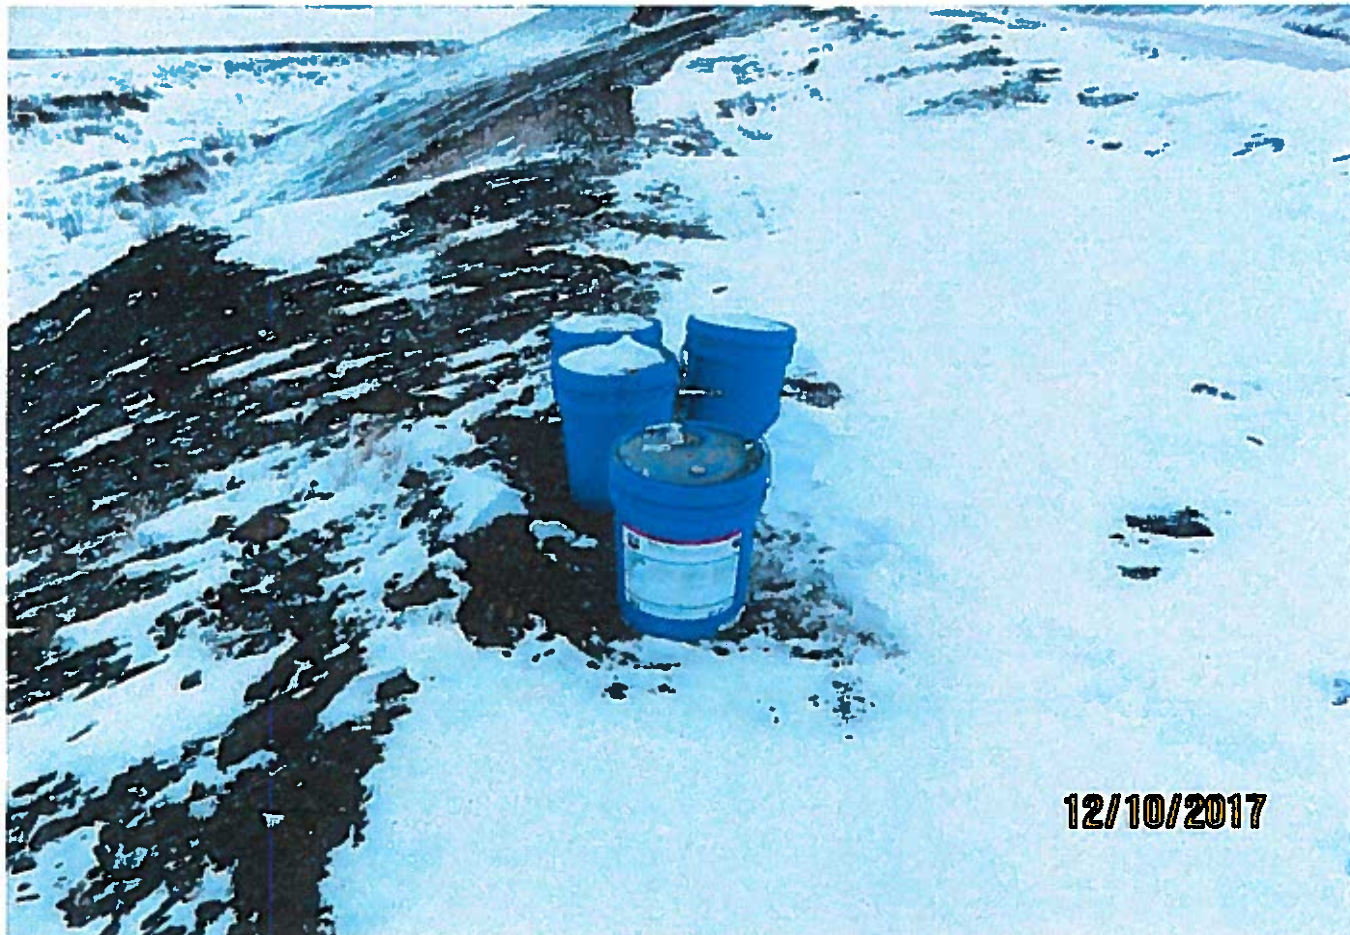
Further unacceptables observed are the blue plastic oil containers are to be 100 meters away from a water source as there is a creek just below where they are stored. Also observed at the side of road there is debris that is to be picked up and removed.

Figure 4
oil containers to close to creek below

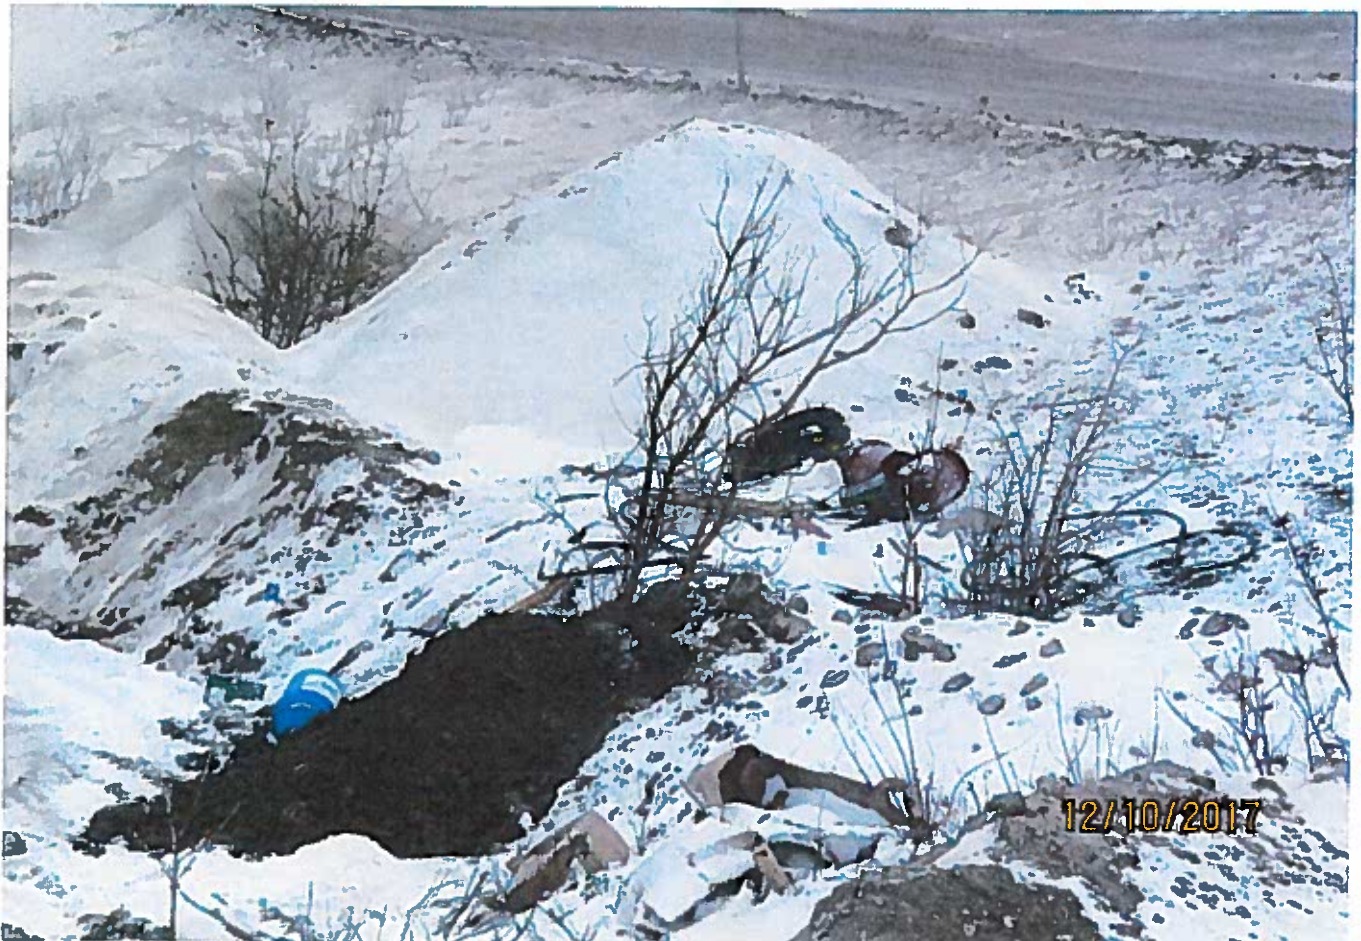
Figure 6
Garbage/Debris
