File Number G17X006
Type of Operation MISC.
Location Km 15

ENVIRONMENTAL INSPECTION REPORT

Permittee:	GNWT Department of Infrastructure	Permit Expiry Date:	May 02, 2023
Land Use Permit No.	G17X006	Previous Inspection:	January 23, 2019
Quarrying Permit No.		Inspection Date:	June 27, 2019
Contractor:		Subcontractor:	
Location(s) Inspected:	Km 15		
Current Stage of Operation:	waiting for closer		
Program Modifications Approved:

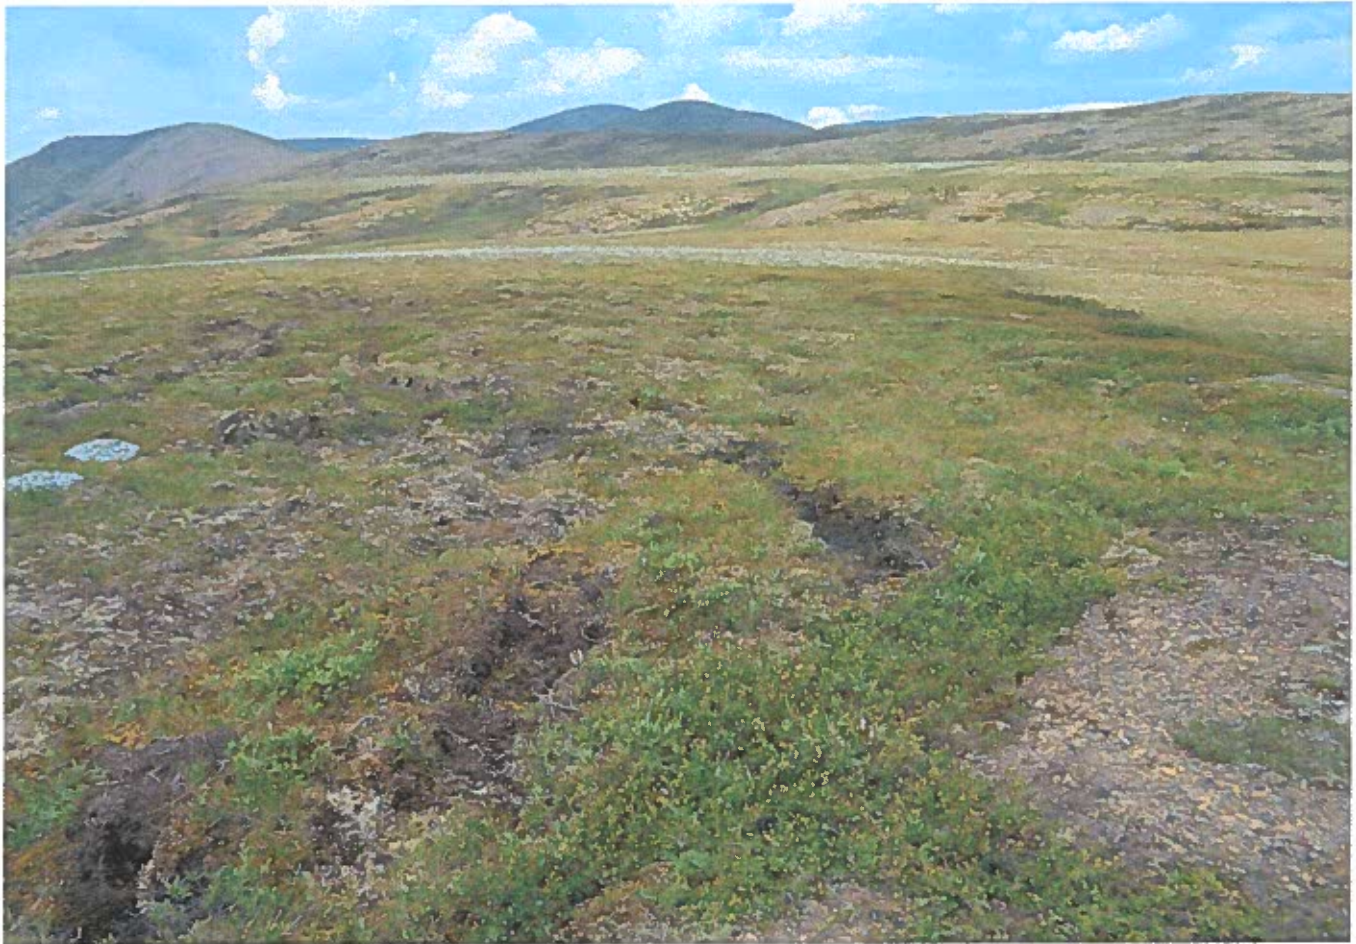
Figure 1

During the inspection on June 27, 2019 the inspectors noticed there were some rutting in the area where the thermistors were removed from. The rutting is deep enough to hold water and will be a concern when it rains and could cause erosion.

There is also 2 thermistor piping that are visible after they were cut above the ground level and should have been cut below ground level.

Prior to the expiry date of this permit, the permittee shall complete all cleanup and restoration of the land used.
