WATER LICENCE INSPECTION FORM

DATE:	November 18, 2009	COMPANY REP:	Evelyn Storr
LICENCEE:	Hamlet of Aklavik	LICENCE #:	G99L3-003 and N3L3-0570

WATER LICENCE INSPECTION REPORT Pg. 4 (Continued)

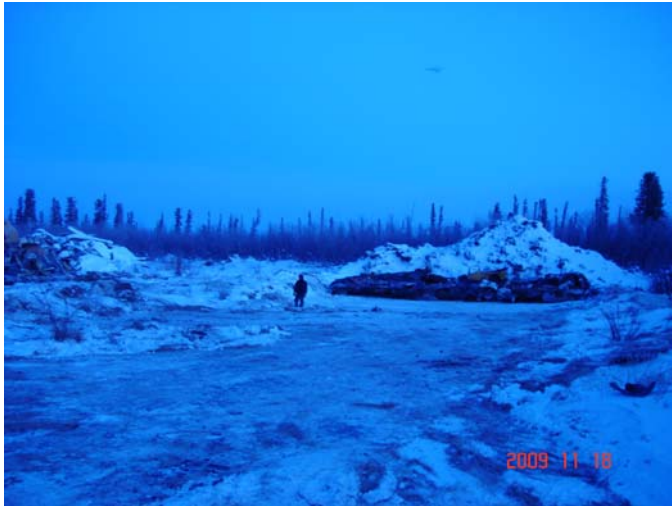
Figure 1

3. A lot of work has been done to improve the Solid Waste Disposal Facility(SWDF). Amongst the bulky metal waste area vehicles are being separated and crushed to be put in a designated cell, Hamlet foreman said vehicular fluids have been removed (see Figure 1). There is concern over whether the current cell for vehicle disposal is approved by the Board as per the current Operation and Maintenance Plan and this was expressed to the Hamlet. Vehicles will continue to be separated and crushed but the cell will not be closed. Only upon prior approval is confirmed by the Board will closure occur.

Crushed vehicle cell at bulky metal waste area.

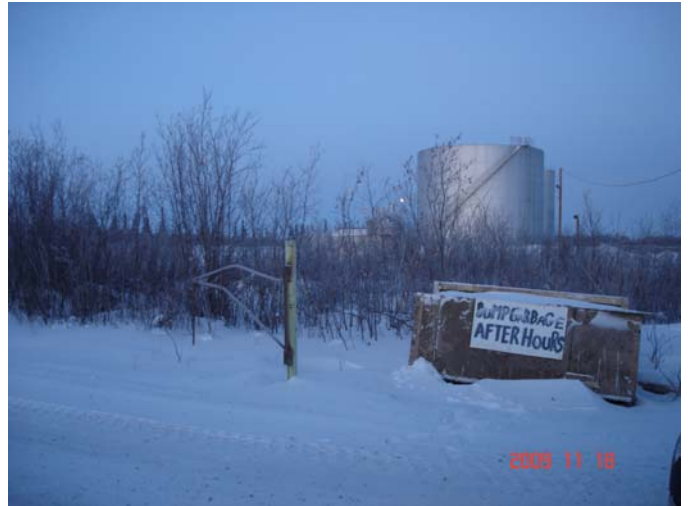
Figure 2

- The SWDF has a gated entrance to control access to the facility. After hours there is a drop off bin that allows the public to leave waste. The bin is then able to be picked up by equipment and taken to the designated areas in the SWDF to properly dispose of the waste (see Figure 2).

Gated entrance and after hours drop off bin which allows the public to still leave waste behind.

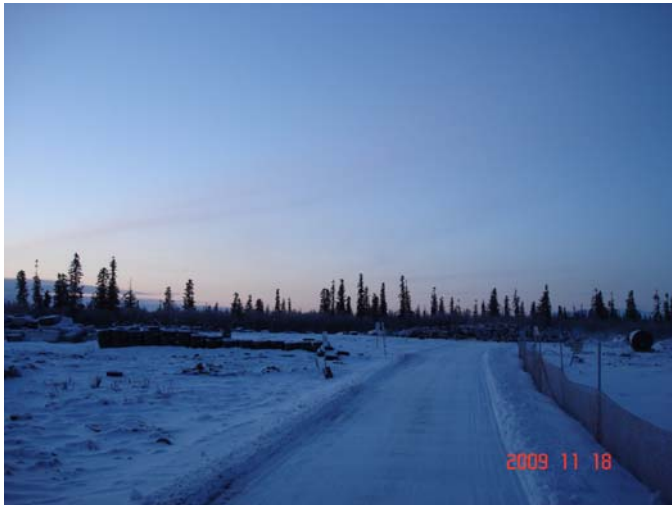
5. Many of the current waste cells have been covered over (see Figure 3 and 4). Continue to operate the SWDF so waste cells continue to be properly maintained and capped. The location where the asbestos is buried needs to be on record and noted for future activities .

- Signs and fencing are being used to direct people where to dispose of various waste including household waste. Tires are being used to direct where to put waste appliances (see Figure 3 and 4).

Overall picture of Solid Waste Disposal Facility on south side of access road.

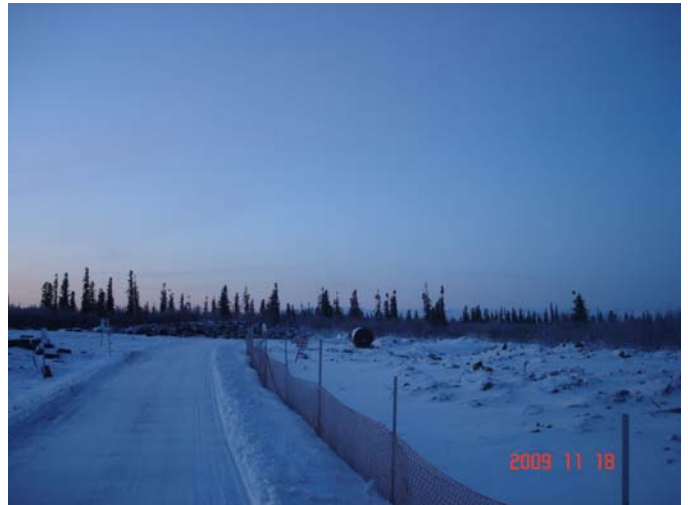
Figure 4

Overall picture of Solid Waste Disposal Facility on north side of access road.

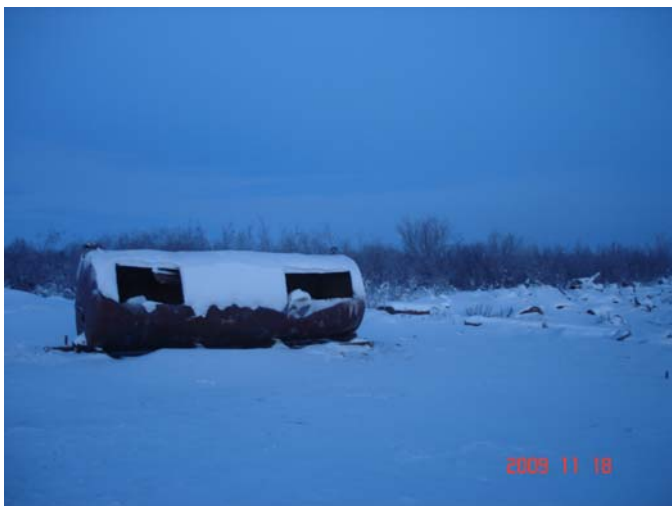
Figure 5

- Batteries are taken for storage at the Hamlet including any found at the SWDF.
- No evidence of burning occurring at the time of inspection but the Hamlet has designated a burn bin for burning approved materials. Reminder that municipal solid wastes that are conditionally suitable for open burning are paper products, paperboard packaging and untreated wood wastes according to the document from the GNWT Department of Environment and Natural Resources titled "Municipal Solid Wastes Suitable for Open Burning" (see Figure 5).

Burn bin at Solid Waste Disposal Facility to burn segregated waste- paper, cardboard, and untreated wood.

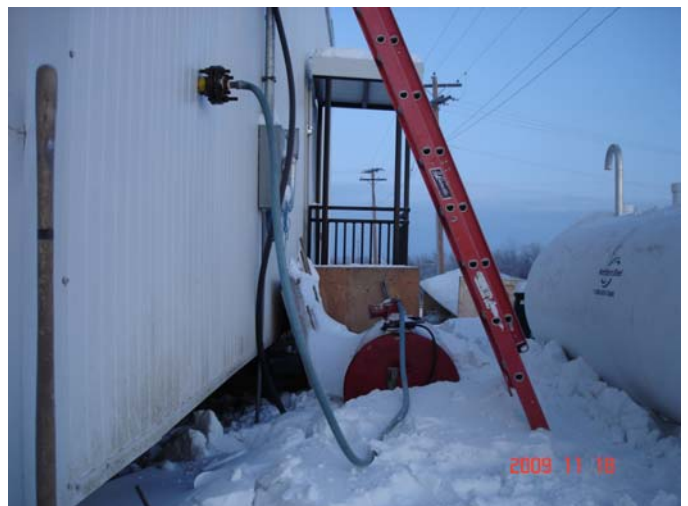
Figure 6

1. Flex pipe from old Water Treatment Plant to emergency generator is not straight and is showing signs that movement of buildings and piping is occurring. It is important to observe piping for any further movement that could cause problems/risk of leaks.
2. There was a tidy tank outside the new Water Treatment Plant (WTP) that was being used to supply fuel to the Plant. Safe operation is important as the fuel line is a hose and no secondary containment is present. It is highly recommended that an iced down snow berm be made to include the tank, hose and hook up etc. to allow a proper spill containment (see Figure 6).

Tidy tank connected by a hose the Water Treatment Plant and should have an iced down berm for secondary containment.
