### APPLICATION FOR WATER LICENCE, AMENDMENT OF LICENCE OR RENEWAL OF LICENCE

APPLICATION/LICENCE NO: G99L3-003  
(Amendment or Renewal only)

Hamlet of Aklavik

## Background Report for Water Licence Renewal

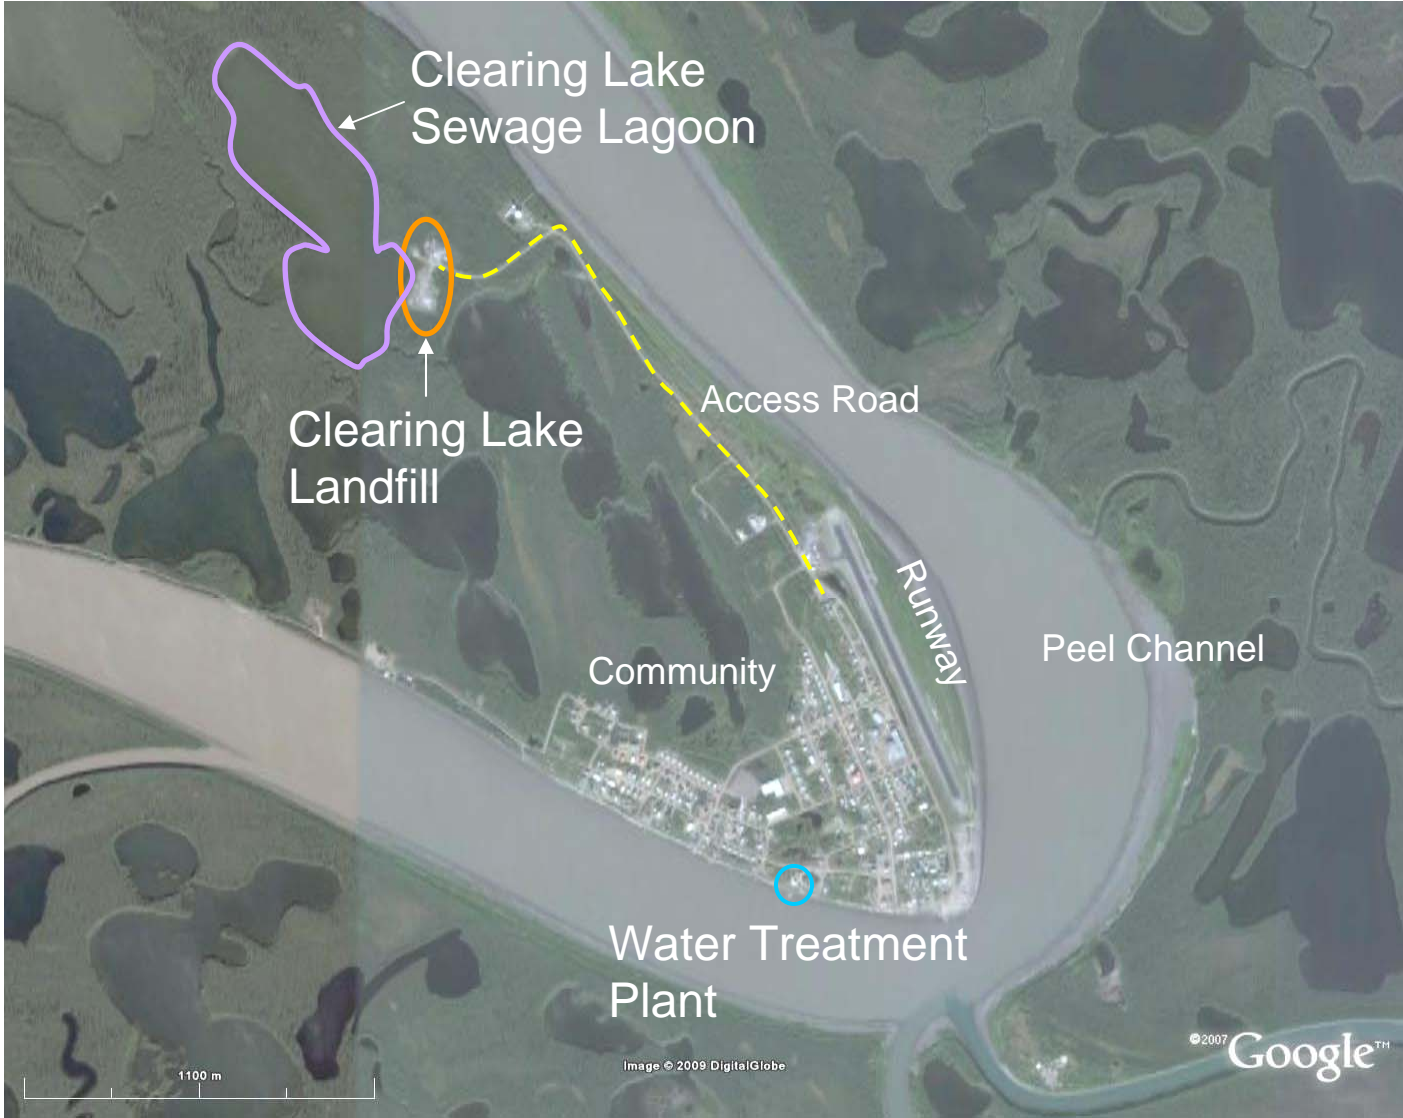
**Figure 1. Infrastructure Locations**

The Hamlet of Aklavik ("Place of the Barren Land Grizzly Bear") is located on the west shore of the Peel Channel in the Mackenzie River Delta. The community is accessible year-round by air and in the winter Aklavik can be reached via an ice road from Inuvik. **Figure 1** shows the location of the community.

See Figure 1 of "Hamlet of Aklavik Background  
Report for Water Licence Renewal"

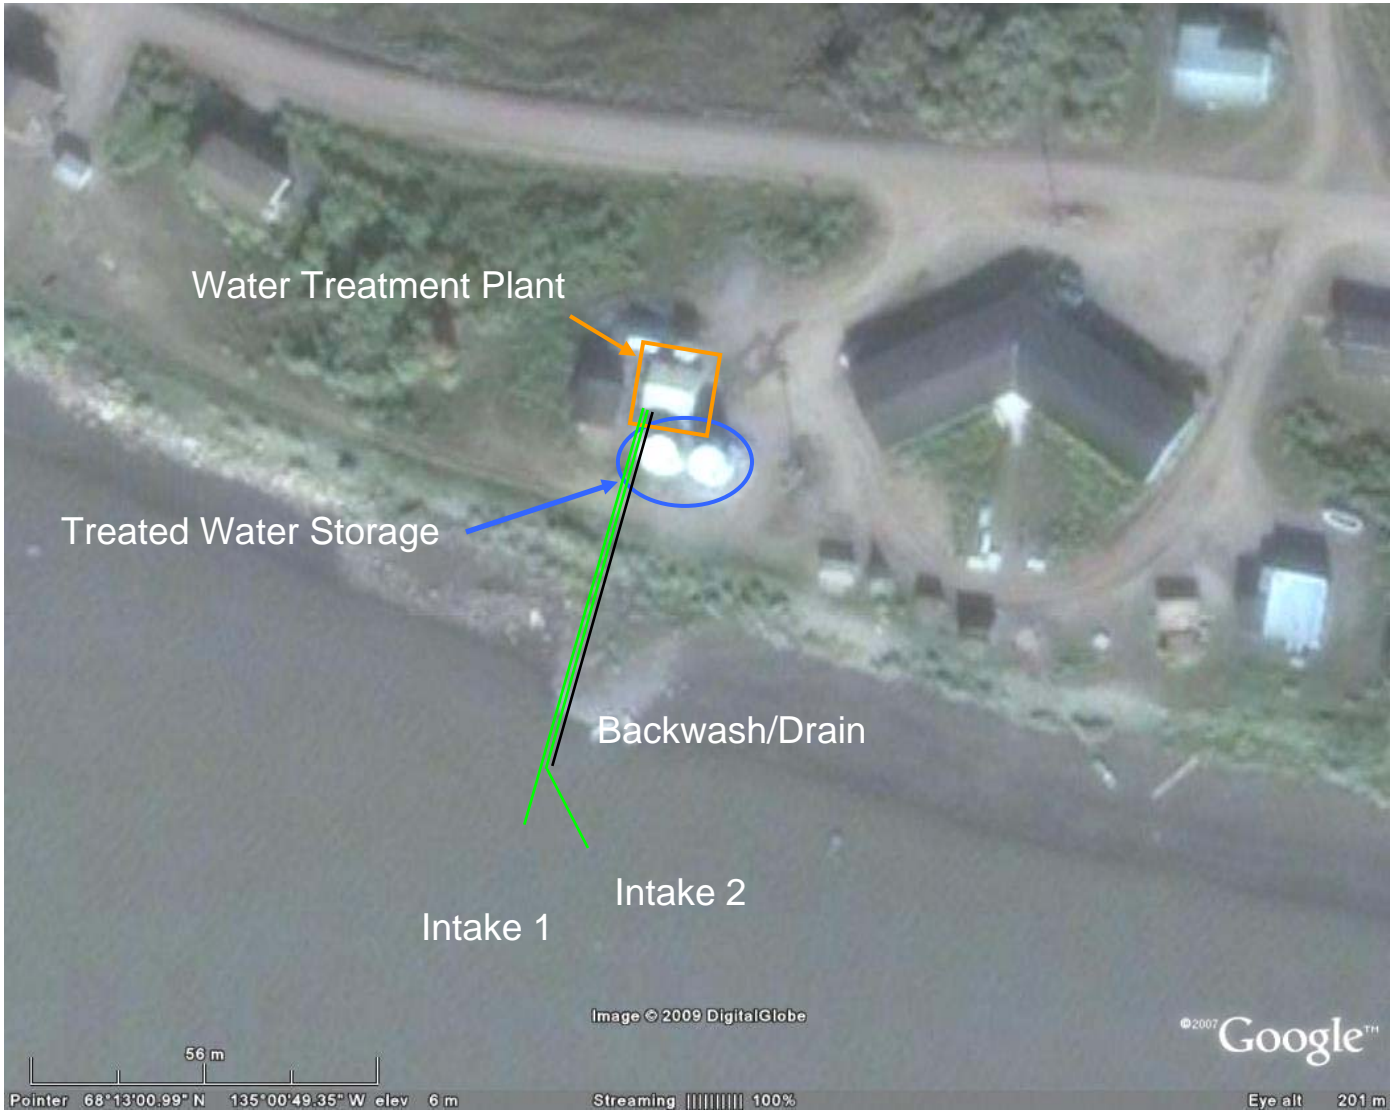
**Figure 2. Water Supply Site Plan**

Aklavik's raw water comes from the Peel Channel. After water is pumped to the treatment facility, it passes through a pre-treatment clarifier and a packaged Water Treatment Plant (WTP), where it undergoes coagulation/flocculation, clarification and filtration. Water is disinfected through chlorination prior to distribution. Treated water is stored in two above-ground storage tanks before it is delivered by water truck to residents. See **Figure 2** for the water supply site plan.

Aklavik's WTP is supplied with raw water via one of two 50mm diameter HDPE intake pipes which extend approximately 80 m into Peel Channel. The intake lines, installed in 1979, are surrounded by partially insulated, submerged HDPE series 100 carrier pipes (250mm diameter). Electric heat trace cables provide freeze protection for the intake lines. Coarse mesh galvanized screens are provided at the intake mouths to prevent entrainment of fish.

Treated water is pumped to two pre-insulated steel storage tanks next to the WTP. One of these tanks was installed in 2000, and the other in 2002, to replace two older steel storage tanks and to meet storage requirements. Each tank is 6.1m high and 5.6m in diameter, with a total volume between the two tanks of 289 m<sup>3</sup>, of which 229 m<sup>3</sup> is allocated for daily consumption and plant use and 60 m<sup>3</sup> is an emergency fire reserve. Water in the tanks is freeze-protected by two means: a circulation system between the tanks and the WTP, and hot water injection to maintain the water temperature above 0°C.

This section provides an overview of Aklavik's water supply and waste disposal systems. See **Figure 2** for the locations of the water and waste infrastructure described below.

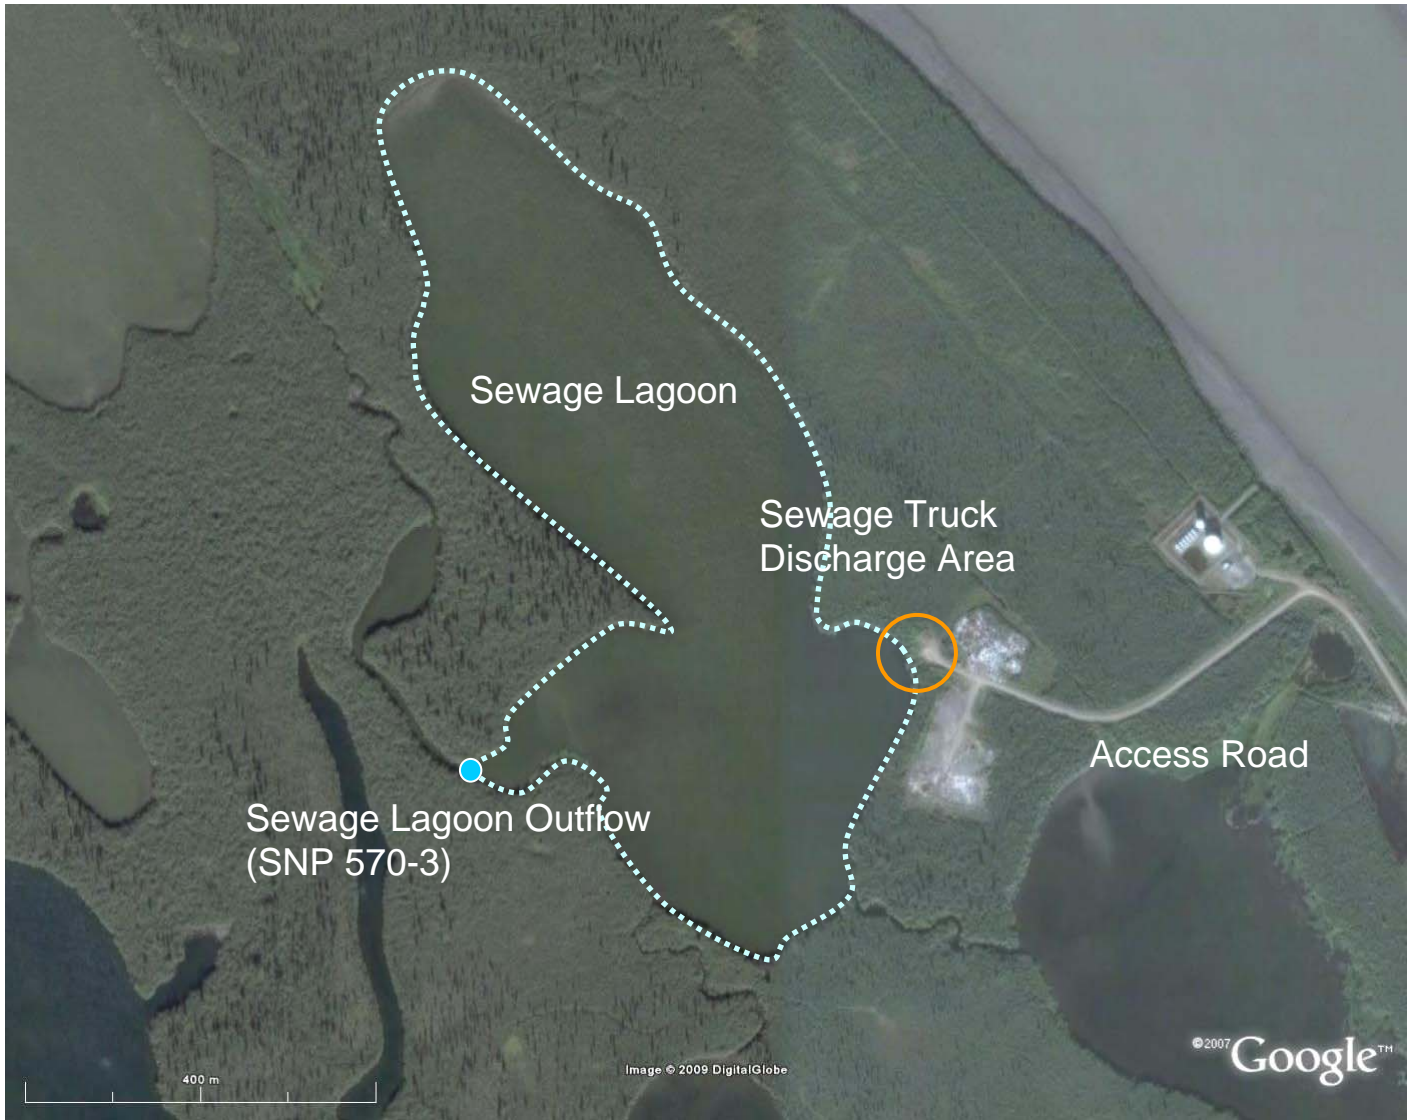
**Figure 3. Sewage Lagoon Site Plan**

Aklavik's sewage is collected using trucked pumpout services. The sewage is treated at the Clearing Lake Sewage Lagoon, shown in **Figure 3**, approximately 2 km northwest of the community.

The sewage is trucked approximately 2 km to the lagoon site via a gravel/dirt road. Sewage is emptied into the lagoon at a truck dump on the east side of the lagoon. The trucks empty into the lagoon through a discharge culvert at the edge of the discharge area.

The lagoon covers an area of approximately 290,000 m<sup>2</sup> and is about 1.5 m (5 ft) deep. The lagoon can therefore hold roughly 435,000 m<sup>3</sup> of sewage. For an average sewage input of 78 m<sup>3</sup>/day (based on potable water use), the lagoon theoretically provides a retention time of 5577 days (15 years).

Effluent discharges continuously from the Clearing Lake Sewage Lagoon into the adjacent wetland area. The outflow point, which is the location of SNP station 570-3, is on the west side of the lagoon, across from the sewage truck discharge area.

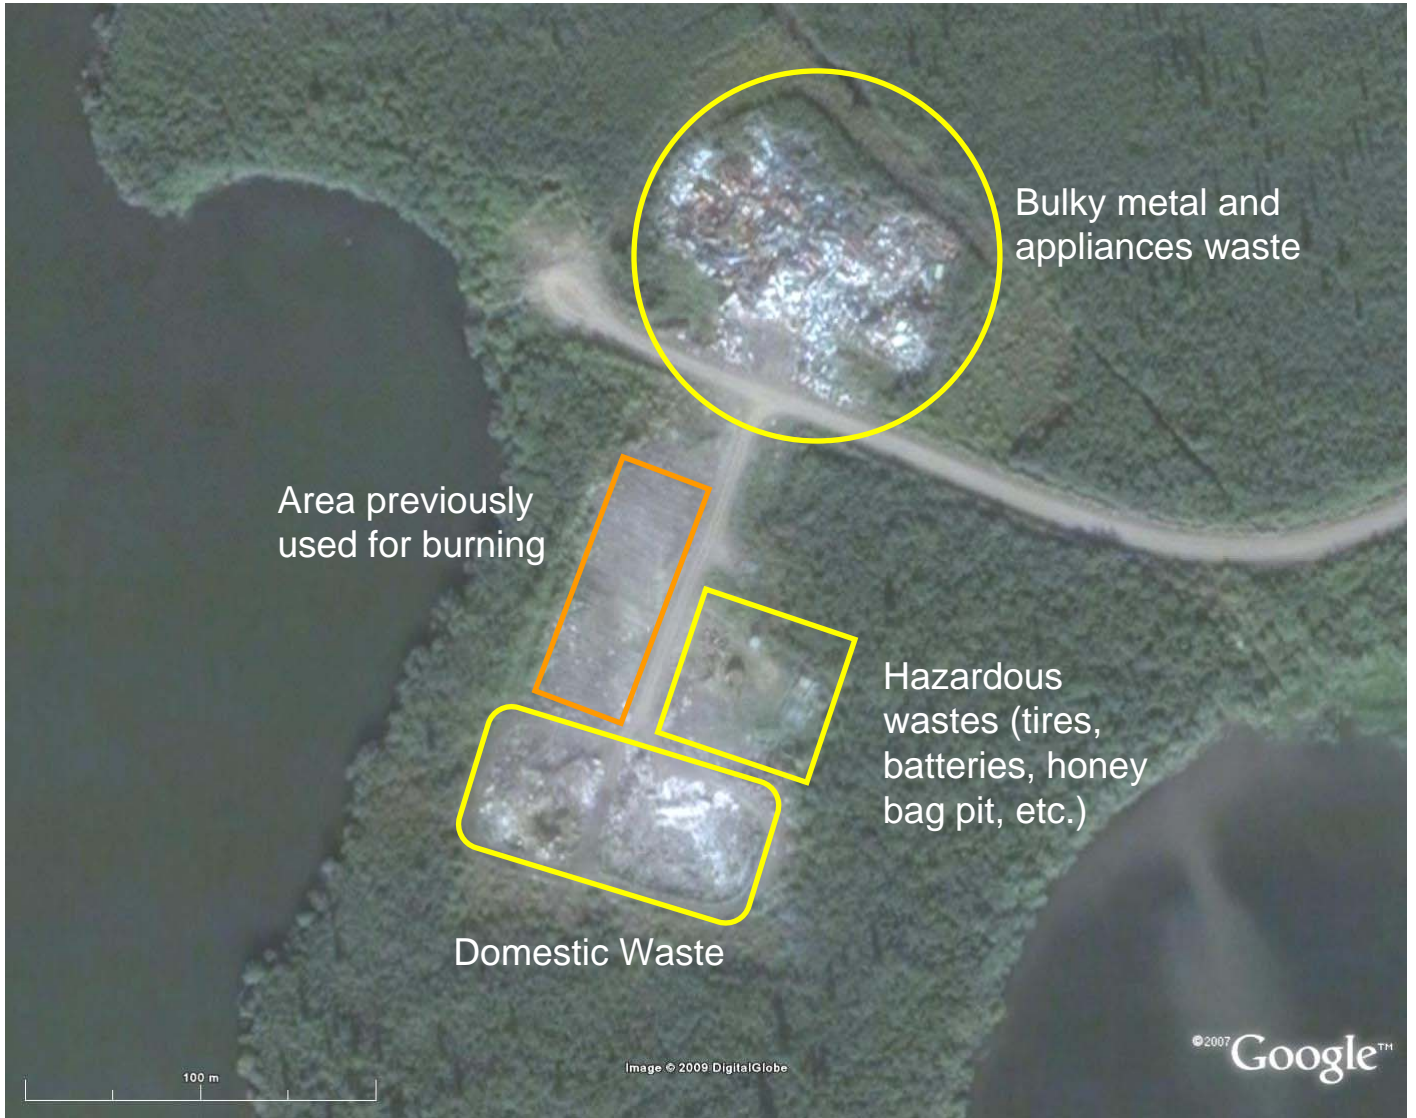
**Figure 4. Landfill Site Plan**

Solid waste is collected from Aklavik by truck and deposited at the Clearing Lake Solid Waste Facility approximately 2 km northwest of the community, near the Sewage Lagoon. The landfill site plan is shown in **Figure 4**.

The Clearing Lake landfill is located 2 km northwest of the community, just east of the Clearing Lake Sewage Lagoon. The landfill is a ground-level site, although there are low berms surrounding the bulky metal waste and honeybag areas. The entire site covers approximately 20,000 square metres (235 x 85 m). The landfill is not fenced, but is surrounded by trees which help keep windblown debris contained.

The landfill is organized to segregate some types of waste. Some signs are present, such as a "Danger: Solid Waste Site" near the entrance, "Metal Only", "No Dumping Garbage", etc. A bulky metal waste area is located north of the access road; this area is currently close to full. The rest of the landfill is south of the road. Hazardous wastes (tires, batteries, etc.) are separated from other wastes. There is a partially bermed pit for honeybags, however, all residents of Aklavik now use trucked sewage pumpout from tanks. Domestic waste is located in the area at the back (south side) of the landfill site. See **Figure 4** for the landfill site plan.
