File Number MV2004W0041
Type of Operation LOGGING
Location Sawmill on south-east side of HWY 6 KM 74

ENVIRONMENTAL INSPECTION REPORT

Permittee:	Deninu K'ue Development Corp.	Permit Expiry Date:	December 15, 2009
Land Use Permit No.	MV2004W0041	Previous Inspection:	May 21, 2015
Quarrying Permit No.	N/A	Inspection Date:	July 04, 2016
Contractor:		Subcontractor:	
Location(s) Inspected:	Sawmill on south-east side of HWY 6 KM 74		
Current Stage of Operation:	Site is inactive. Land Use Permit expired December 15, 2009.		
Program Modifications Approved:

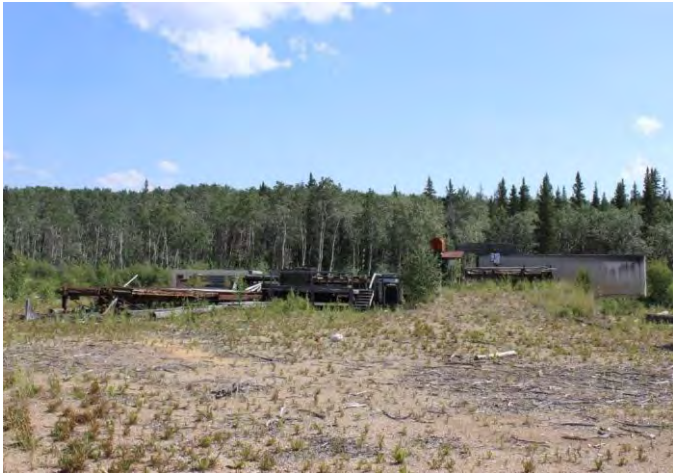
Figure 1

General view of mill structures left on site.

61 Restoration of Lands: The Land Use Permit for this site has expired as of December 15, 2009. A final plan regarding restoration, clean up, and removal of equipment and buildings needs to be completed.

A final plan regarding restoration, clean up , and removal of equipment and buildings needs to be completed and submitted.

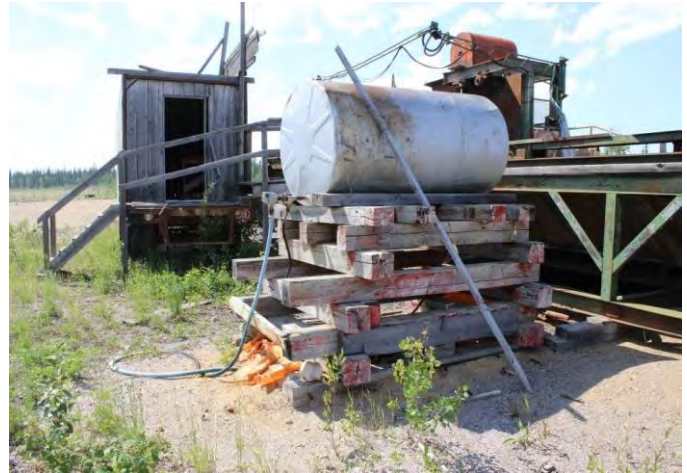
Figure 2

48 Fuel Storage: There are fuel spills on site.

Fuel Tank behind the mill.

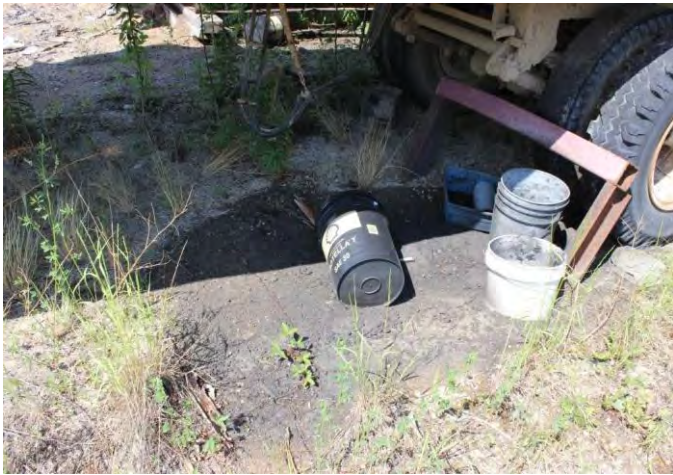
Figure 3

Oil spill under the saw mill.

30 Chemicals: Spills and containers remain on site. Spills need to be cleaned up and chemicals removed to a proper disposal facility.

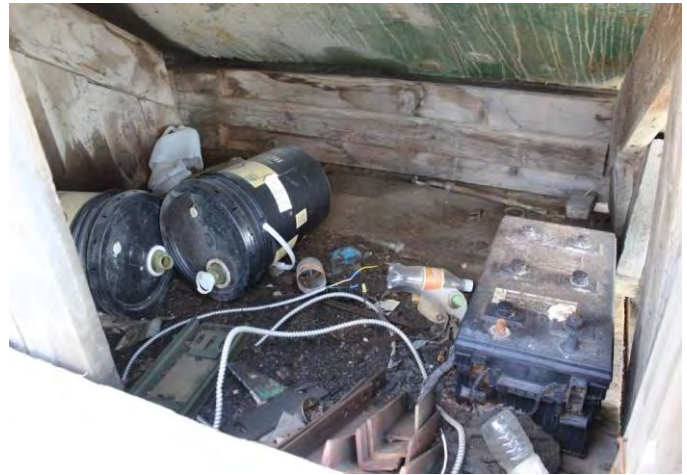
Figure 4

Petroleum containers, batteries, and garbage remaining on site.

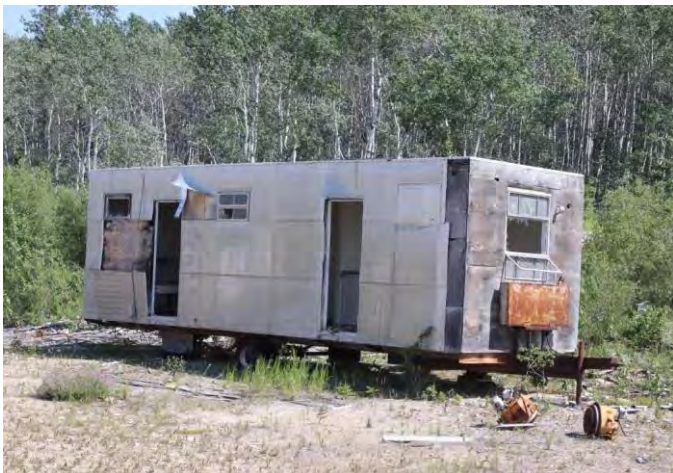
Figure 5

Residence trailer left on site.

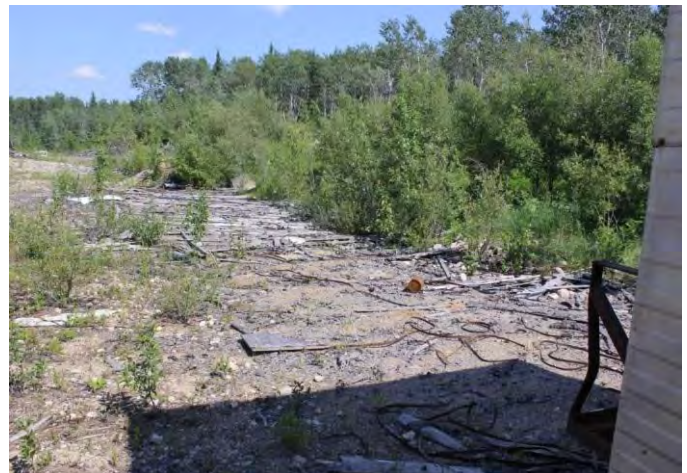
Figure 6

41 Wastes: Scrap metal is scattered around the site. It needs to be removed and disposed of properly.

Scrap metal and wood scattered on the ground.

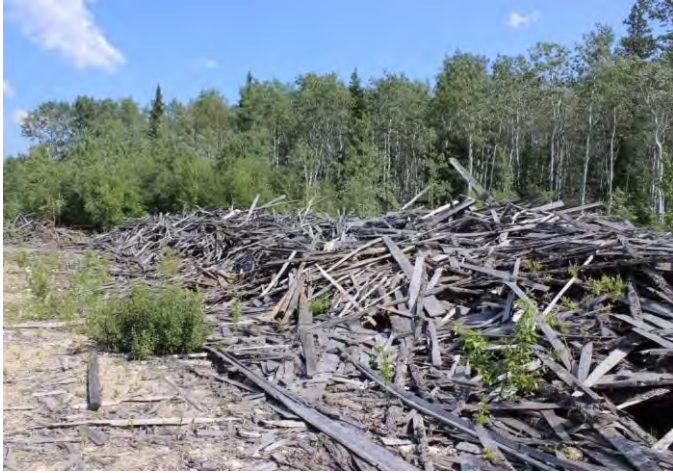
Figure 7

55 Brush Disposal: Piles of brush remain on site and are a fire hazard. These need to be burned when weather is permitting.

Large piles of wood remain on site.
