Re: Follow-up Spill Report – Overfill Event at 500K Fuel Farm – De Beers Gahcho Kue Mine – February 8 2015

Incident Summary:

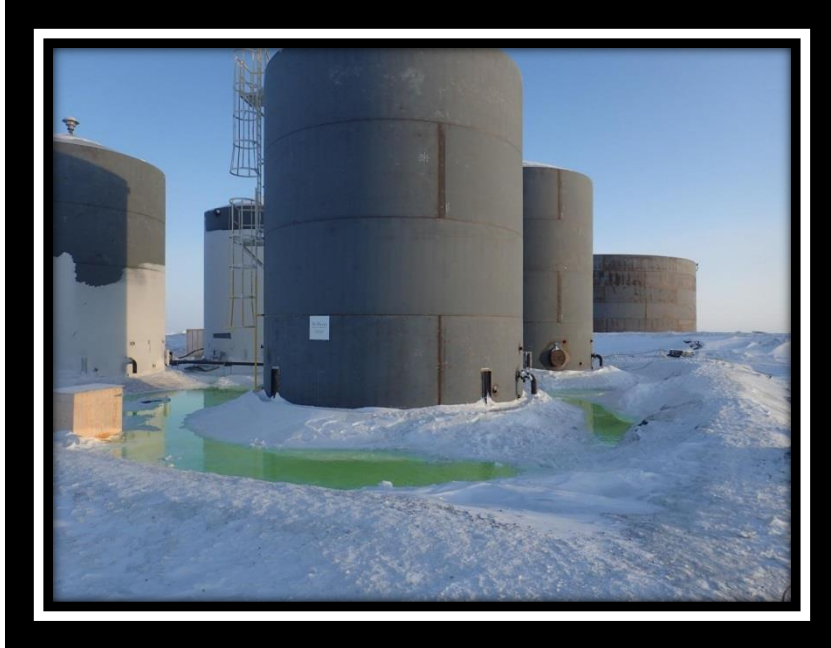
Photo 1 – Free Product Within Lined Containment Day After Spill

portion of the facility allowing the released diesel to be collected and accessed by crews. Visible free product was pumped into drummed storage using a “trash pump”. Once the free product was recovered, contaminated snow was collected using hand shovels and a bobcat taking care to not affect the liner beneath the crush fill material.

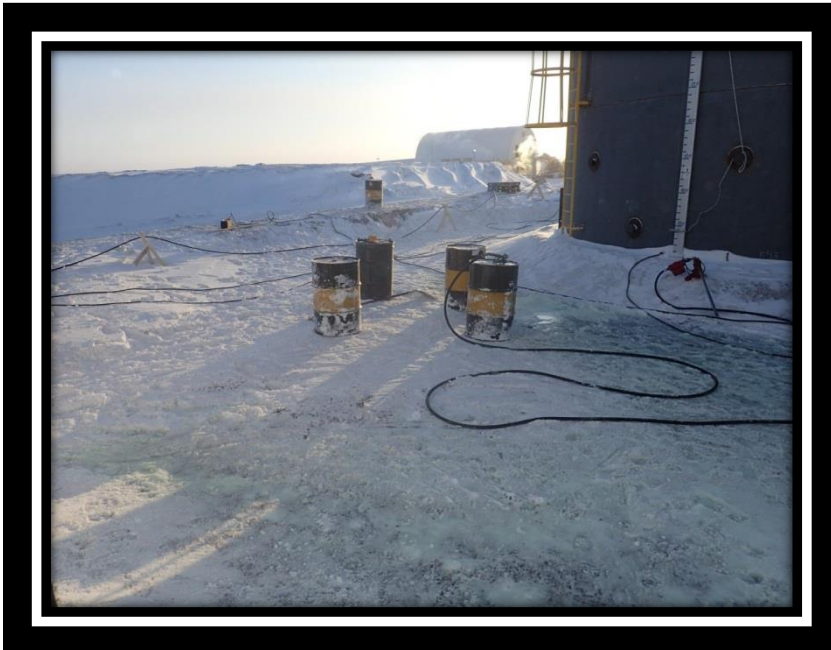
Photo 2 – Clean-up Operations In Process Using Pumps and Drums for Containment

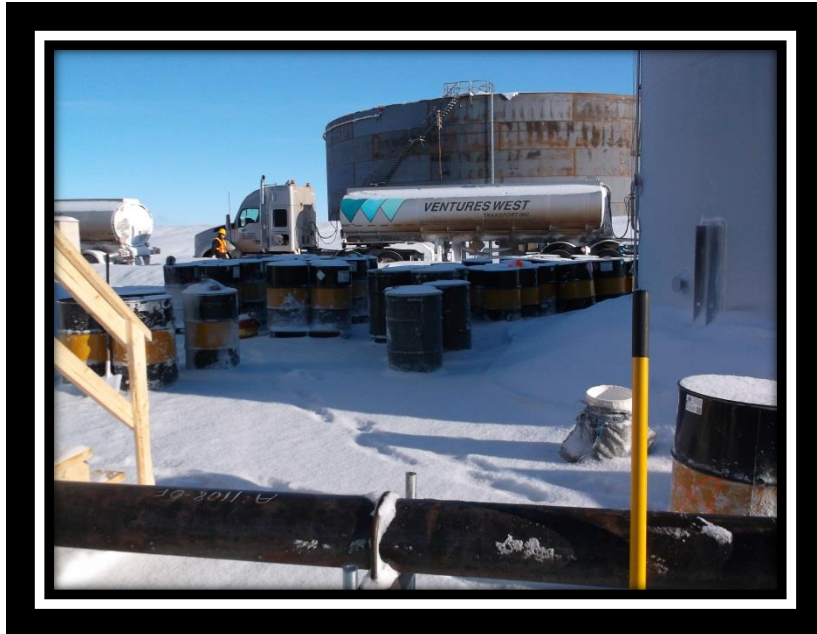
Photo 3 – Drummed Recovered Fuel After Clean-Up Activities Completed

Diesel impacted snow recovered from the fuel facility was placed within the oil water separator snow containment tank where it will be treated, tested and released in the warmer months. Drummed free product will be used to fuel the sites waste oil heaters..

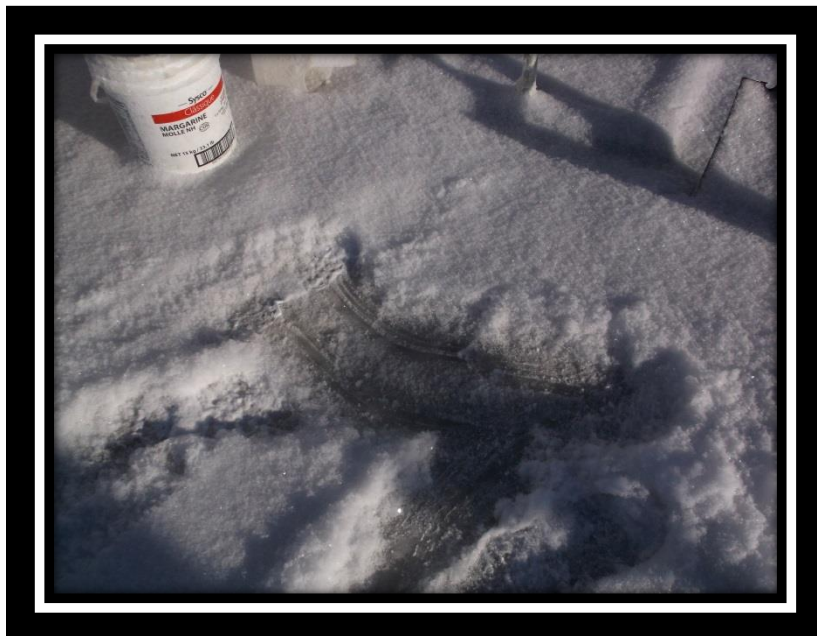
Photo 4 – Removal of Snow Cover in Known Affected Area – Note Limited Remaining Free Product

After clean-up of the spill was completed, inventory reconciliation estimated that approximately 6,000 litres of free product was recovered while approximately 3,500 litres were accounted for as part of the contaminated snow removal operations. Residual volumes related to the overfill event remain within the impermeable HDPE liner and overlaying fine crushed material. The total containment volume of the fuel farm has been calculated to be 871,050 litres thereby providing containment well in excess of the 110% requirement (>174%) and ensuring that any remaining diesel will not impede on the facilities required containment volume.
